Structural Investigations & Geotech Report

Summary Report
Structural Floor System Capacity Assessment – Austin Fire Department
Fire Station No. 3 – 201 W. 30th St., Austin, TX
Fire Station No. 22 – 5309 E. Riverside Dr., Austin, TX
CTLGroup Project No. 231701

**GEOTECHNICAL ENGINEERING STUDY
FIRE STATION #3 AND #22 BAY REPLACEMENT
201 W. 30TH STREET / 5309 EAST RIVERSIDE DRIVE
AUSTIN, TEXAS**

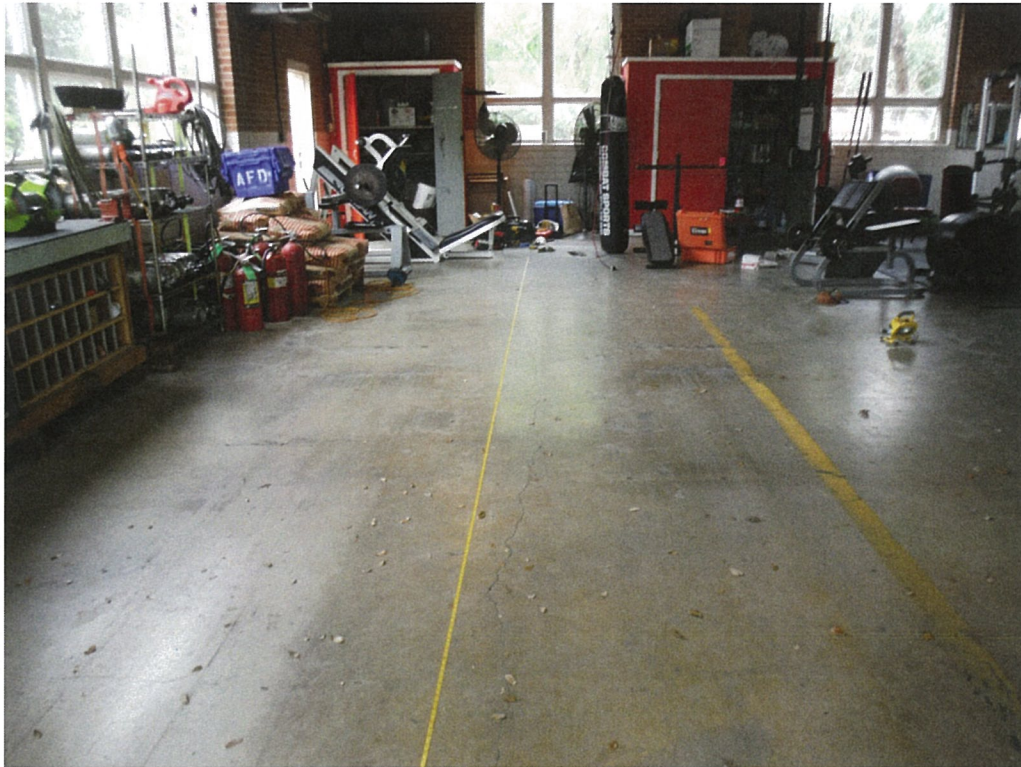
Figure B5 – General view at interior of Fire Station No. 3 garage

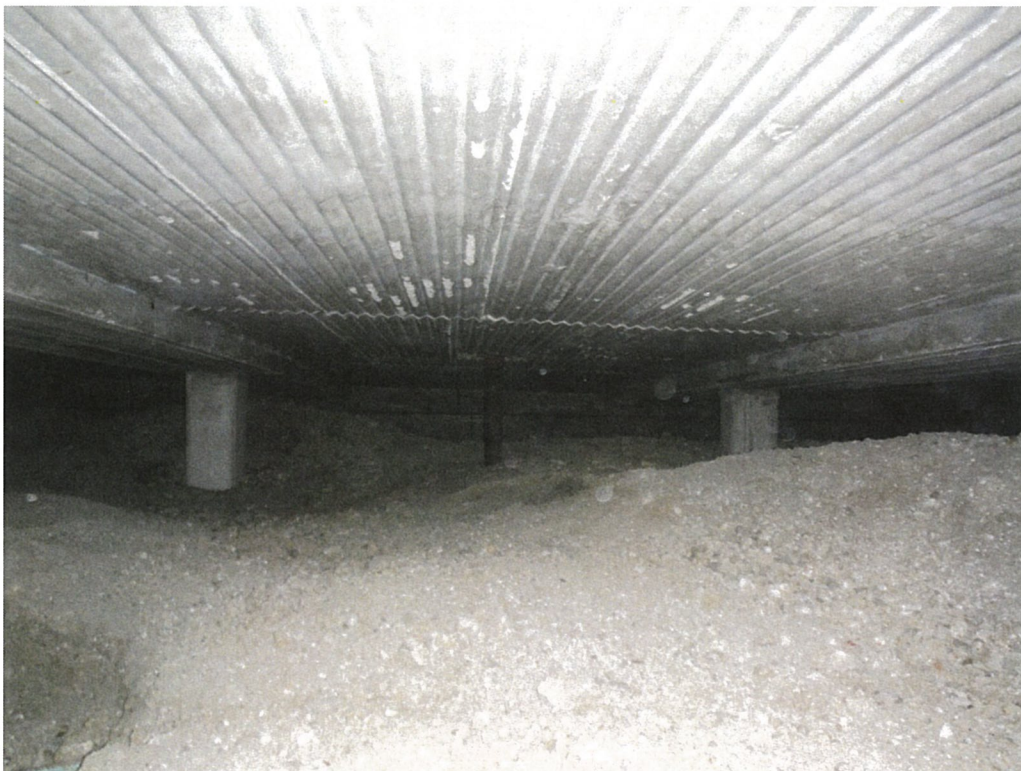
Figure B6 – General view of crawlspace beneath Fire Station No. 3 garage

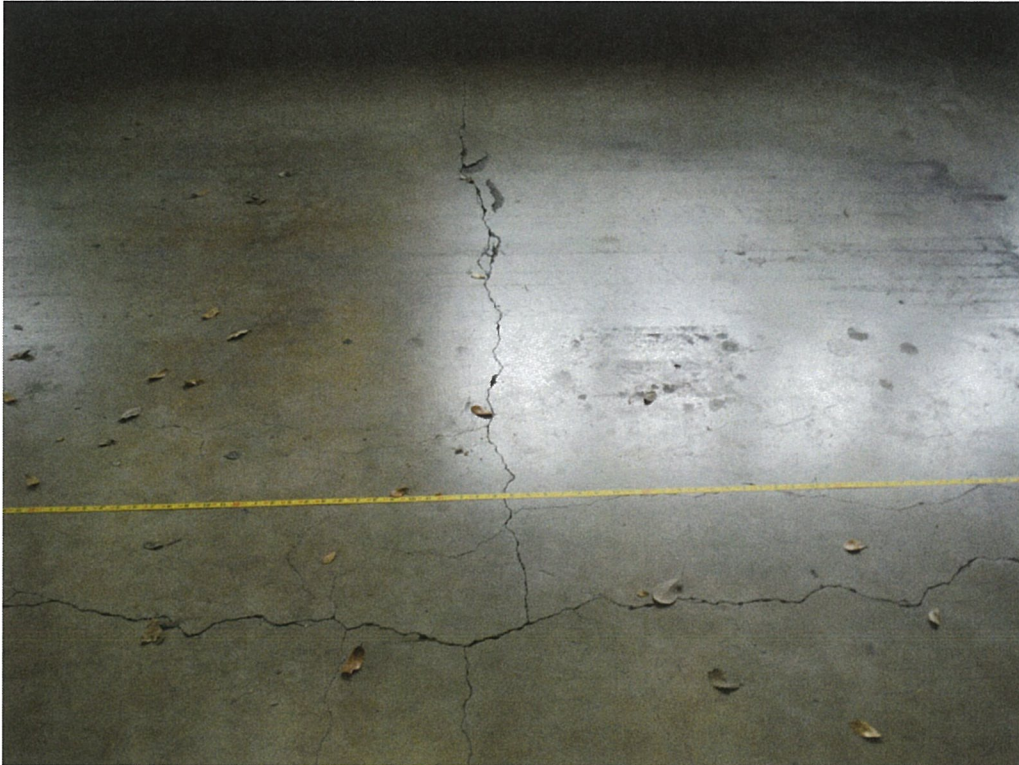
Cracks were observed in the top of the slab, as viewed from the interior of the garage (Figure B7). Cracks were oriented transverse across the floor slab. The spacing of the transverse cracks varied throughout. Longitudinal cracking was also observed. The longitudinal cracks were generally aligned above the sides/edges of both beams. The largest crack widths measured approximately 0.06 in.

The longitudinal cracking in the top of the slab at Fire Station No. 3 may have been caused by negative moment flexural cracking at the slab-to-beam interface, which is further evidence that the slab at this garage may have been overloaded. However, restraint shrinkage may have also caused/contributed to the longitudinal cracking. Restrained shrinkage of the slab is also likely the cause of the observed transverse cracking.

Figure B7 – Typical cracking in top of slab at Fire Station No. 3 garage

Additionally, the cracks in the topping slab should be filled by epoxy injection and/or gravity feed to enhance durability.

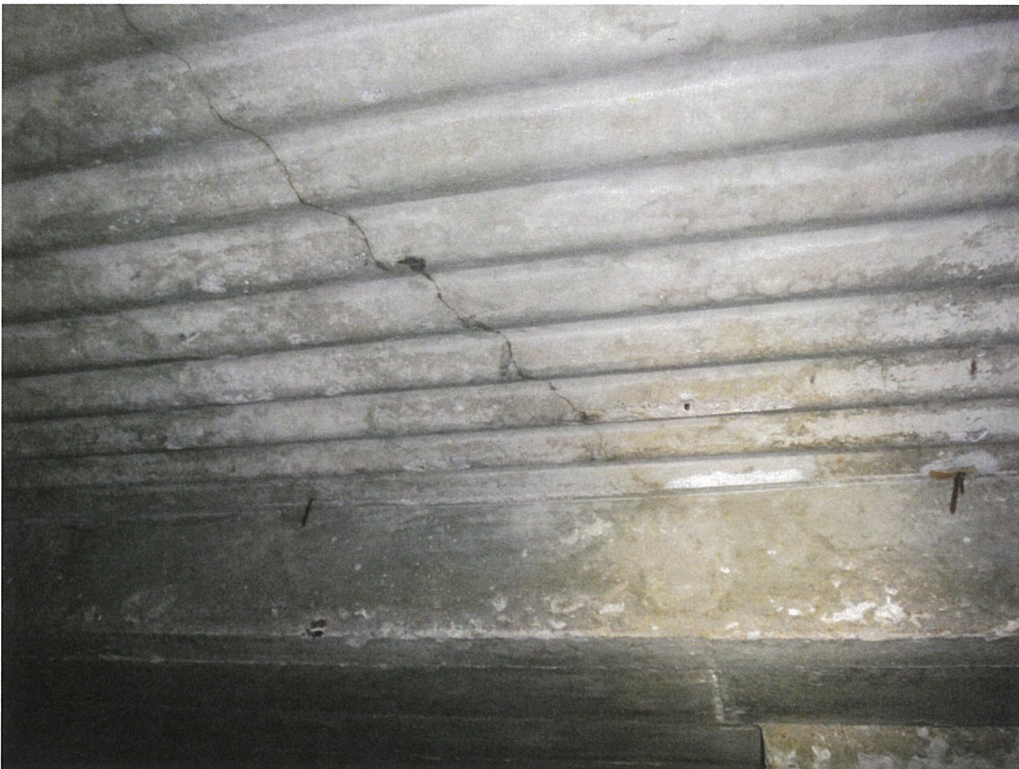
Transverse cracks were also observed in the underside of the slab, as viewed from within the crawlspace (Figure B8). The cracks appeared to originate adjacent to the column-to-beam supports. The visible portions of the beams were in good condition, as viewed from within the crawlspace. A diagonal crack was observed in the west beam above the first column from the north end of the garage (Figure B9). No other cracks were found in the beams.

Figure B8 – Typical cracking in underside of slab at Fire Station No. 3 garage

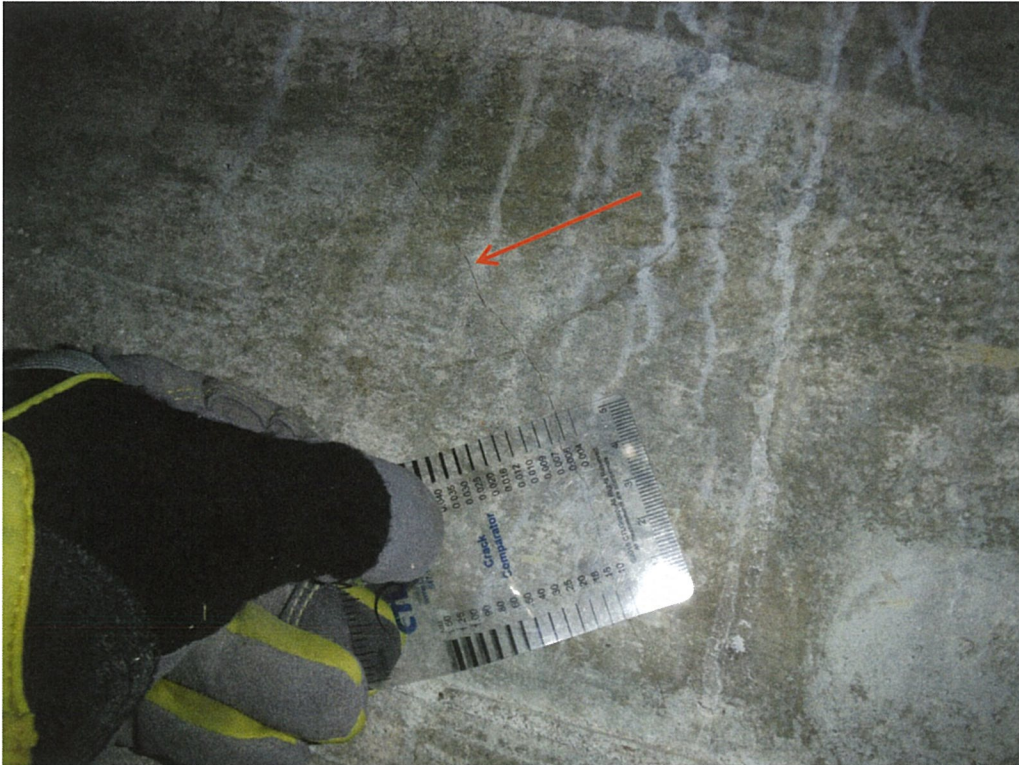
Figure B9 – Crack in west beam at north end of garage at Fire Station No. 3

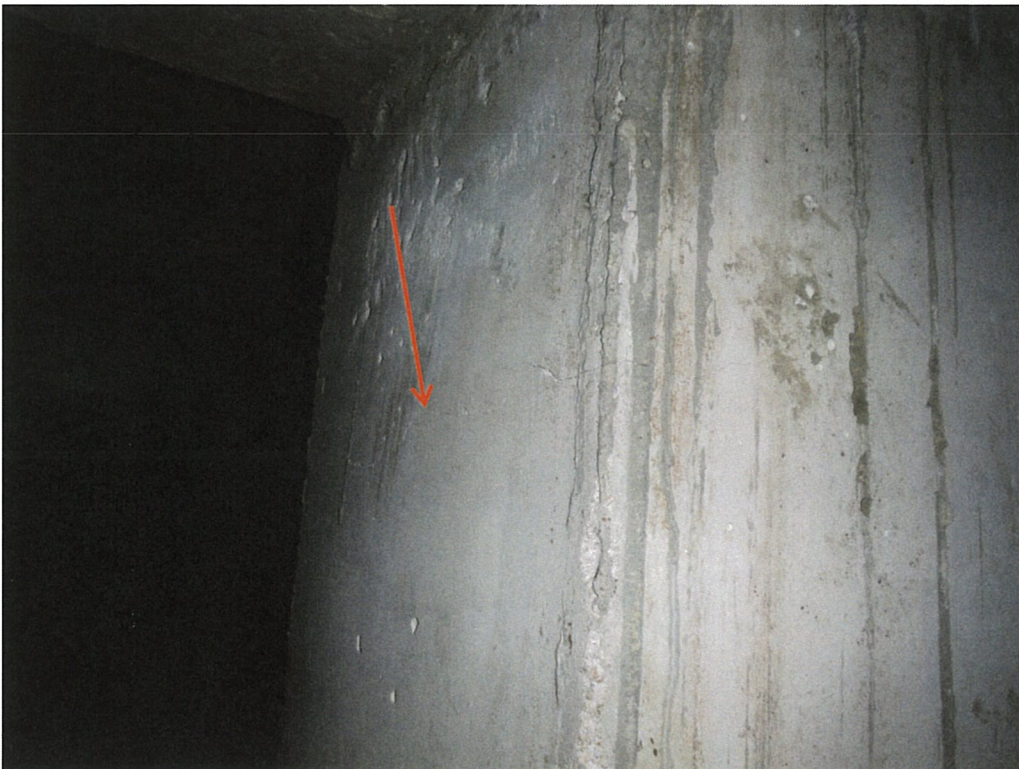
Horizontal cracks were observed in the columns (Figure B10). The cracks were generally located in the top portions of the columns, beneath the underside of the beams.

Figure B10 – Typical horizontal crack in column at Fire Station No. 3

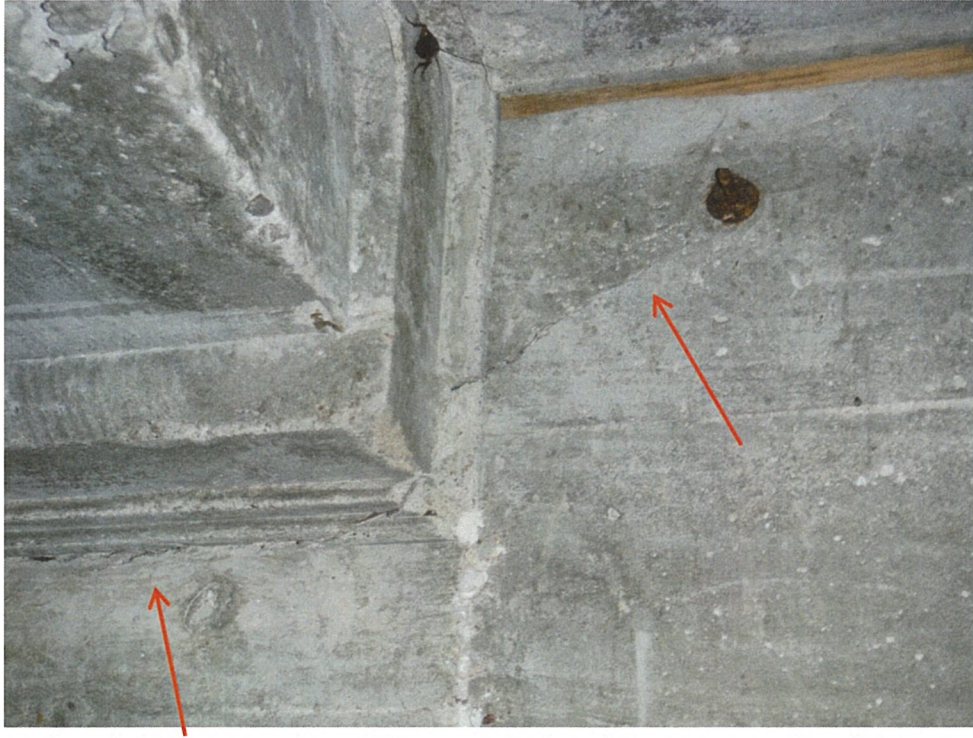
Horizontal cracks were found in the foundation walls directly beneath the middle beams at both the north and south ends of the west garage bay and at the south end of the east garage bay (Figure B11). Diagonal cracks were also observed in the walls at these locations adjacent to the beams (refer to B11). A similar diagonal crack was found in the foundation wall at the northwest corner of the garage. Additional cracks were observed in the foundation walls. This includes the following: vertical cracks in the east wall directly above the first and second piers from the northeast corner, vertical crack at the northwest corner directly below the north end of the west beam, and a vertical crack at the southwest corner.

Figure B11 – Typical cracks in foundation wall at ends of middle beams at Fire Station No. 3

- The observed cracking in the foundation walls adjacent to the north and south ends of the beams at Fire Station No. 3 are concerning. These cracks should be further evaluated and the wall supports beneath the ends of the beams should be analyzed to ensure that they are adequate to support the anticipated loads. The foundation walls were not included as part of CTLGroup's Phase 1 scope.

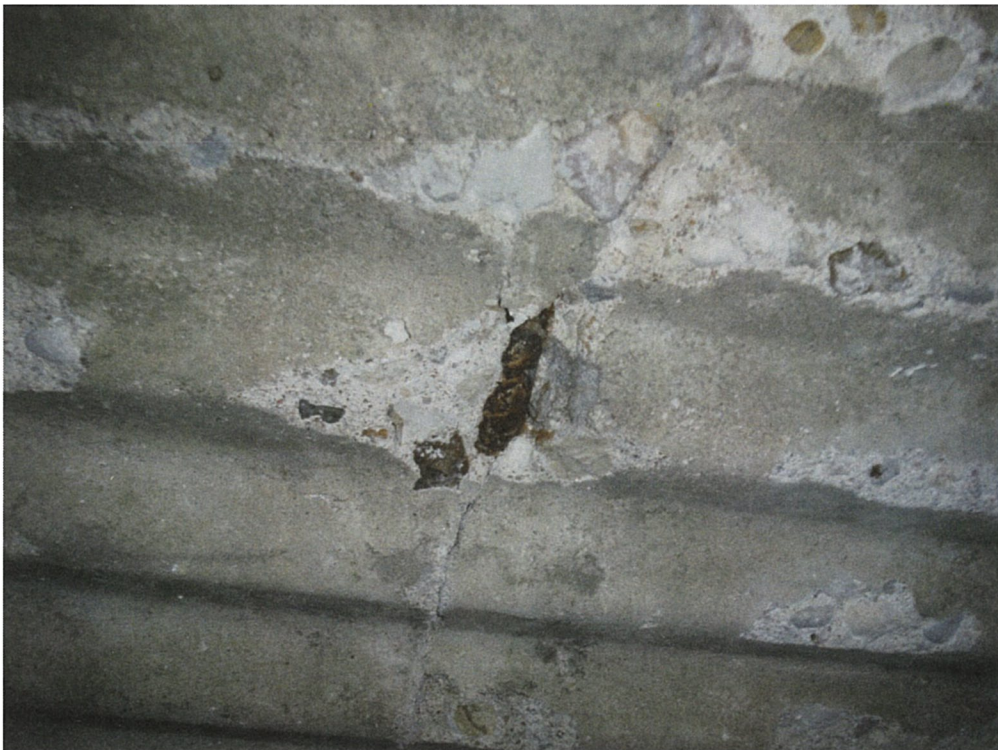
The underside of the slab was spalled at several locations (Figure B12). At several spalled areas, the reinforcing steel was exposed and was visibly corroded/rusted.

Figure B12 – Spalled concrete and corroded reinforcement at underside of slab at Fire Station No. 3

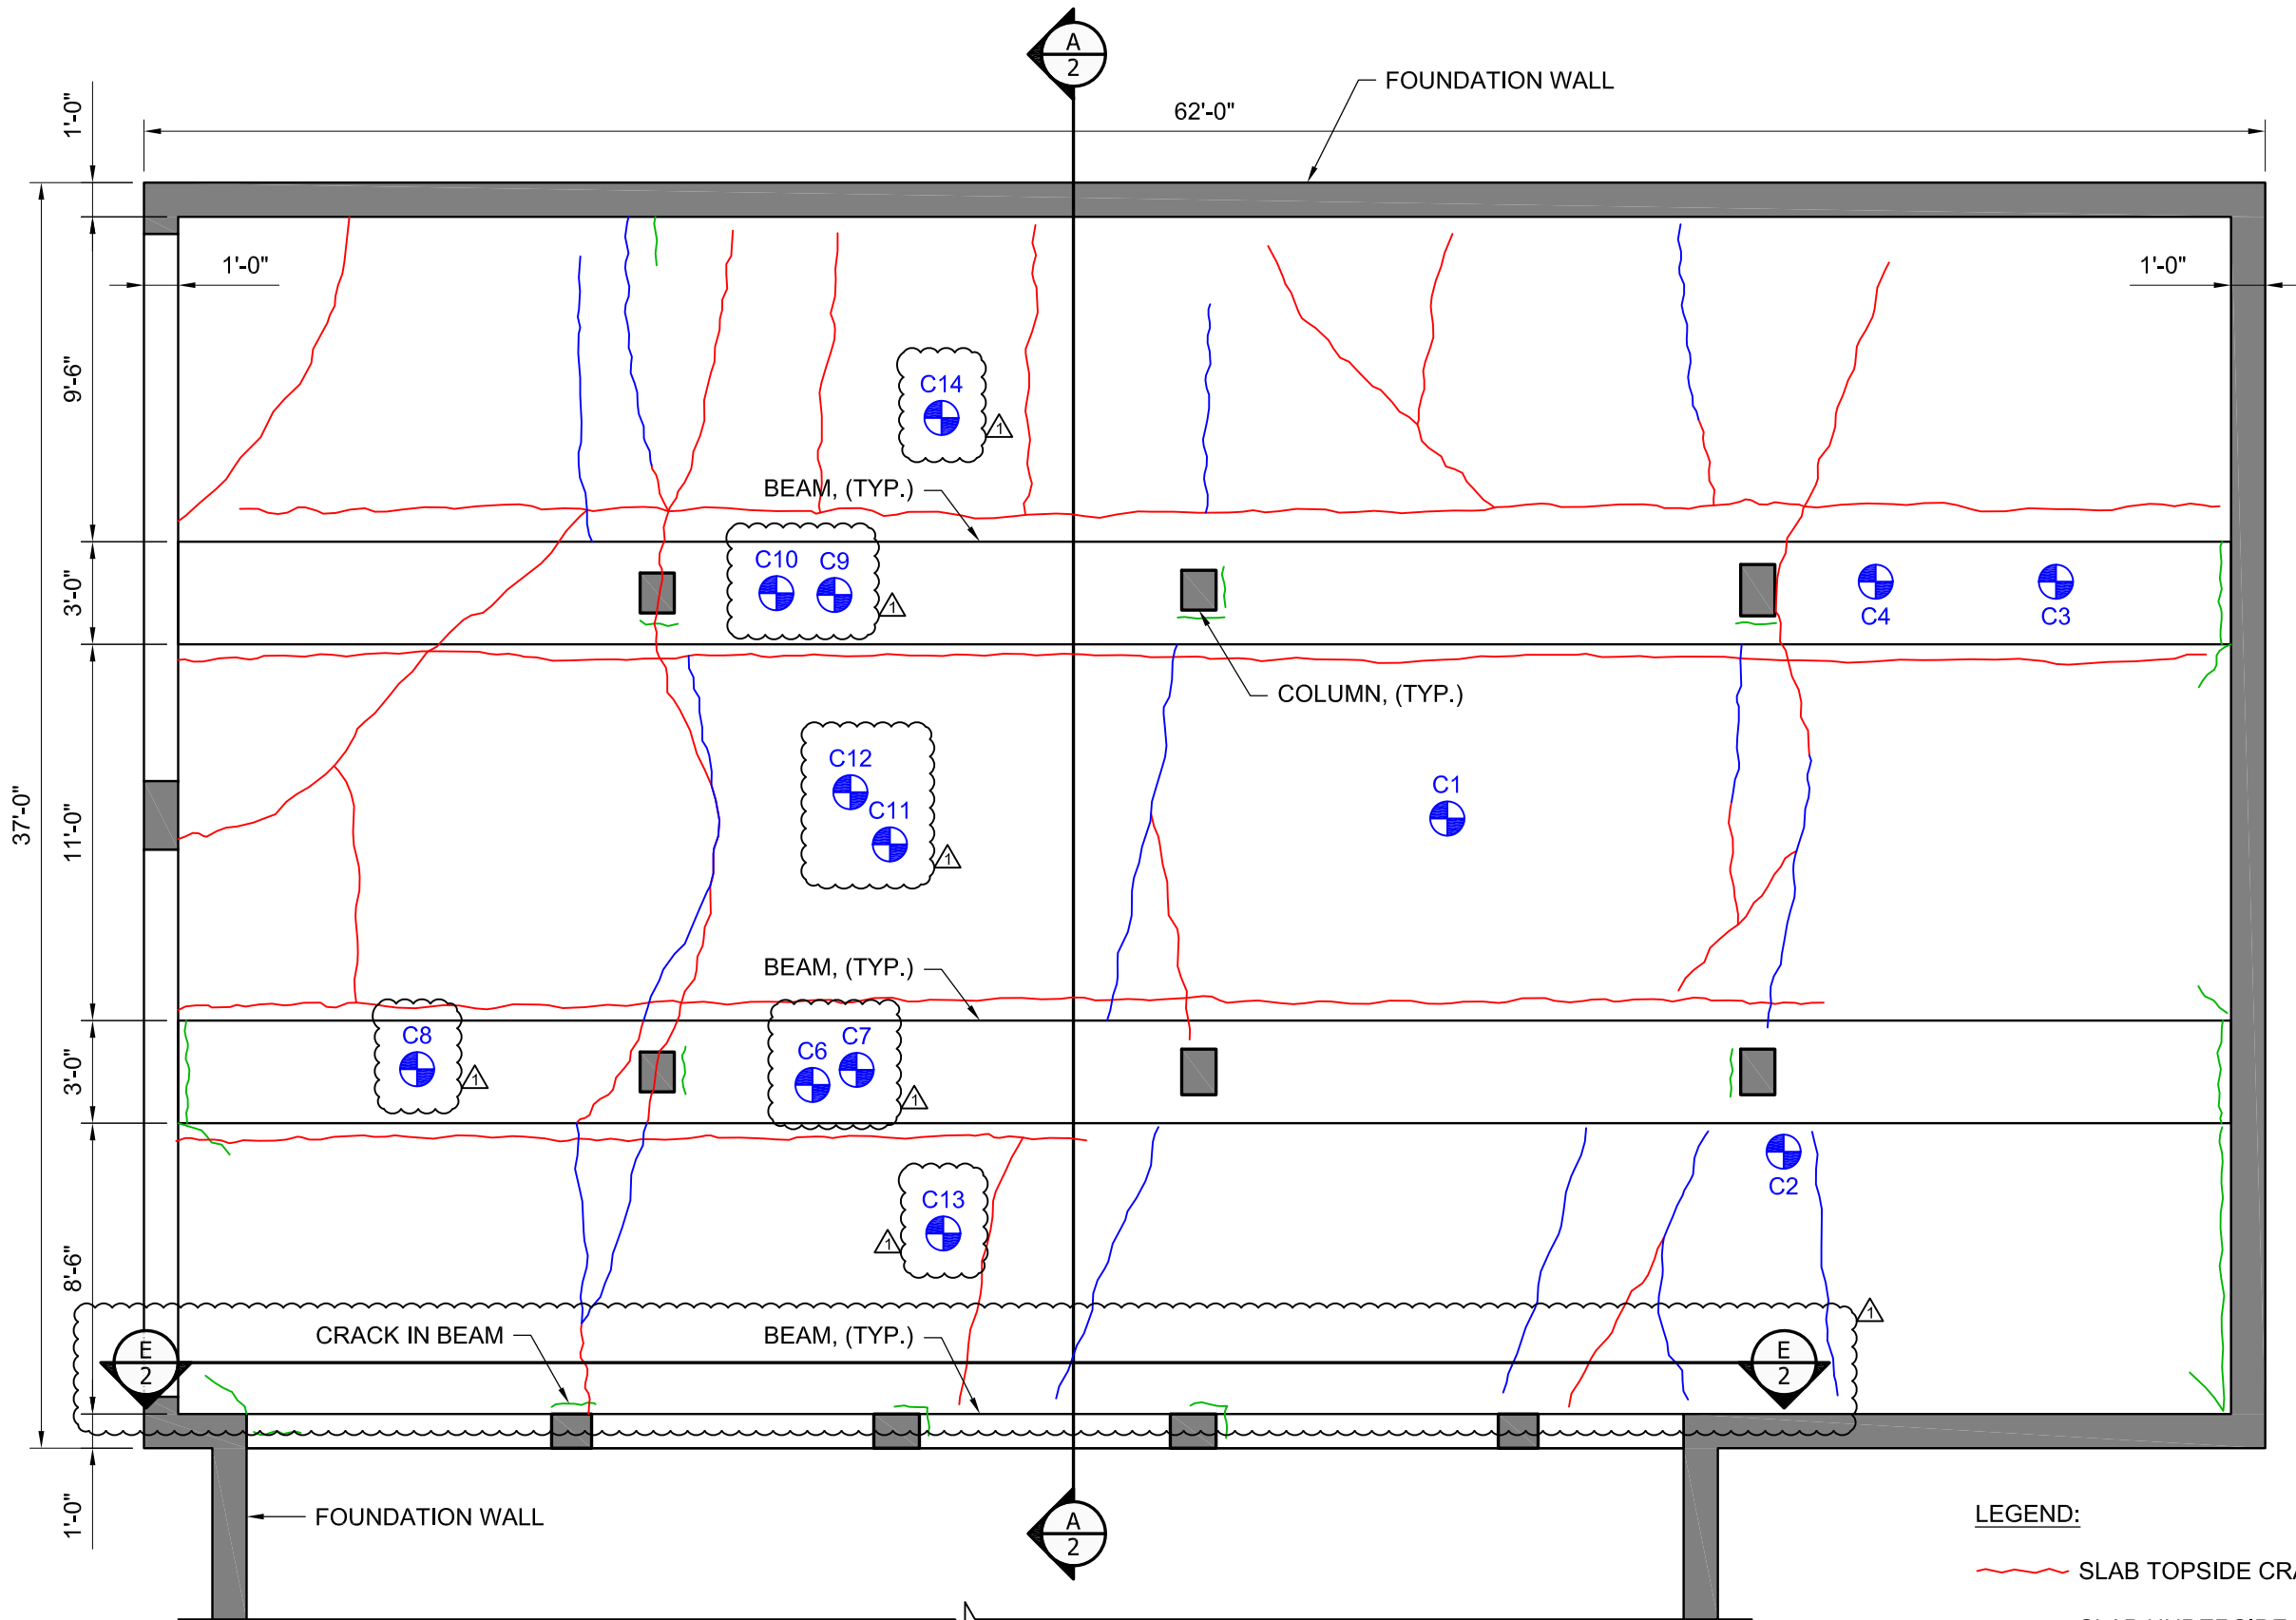
1 GARAGE FLOOR PLAN
3/16" = 1'-0"

The approximate locations of the above discussed cracking in the slab, columns and foundation walls can be found on the plan view of the garage in **Appendix A**.

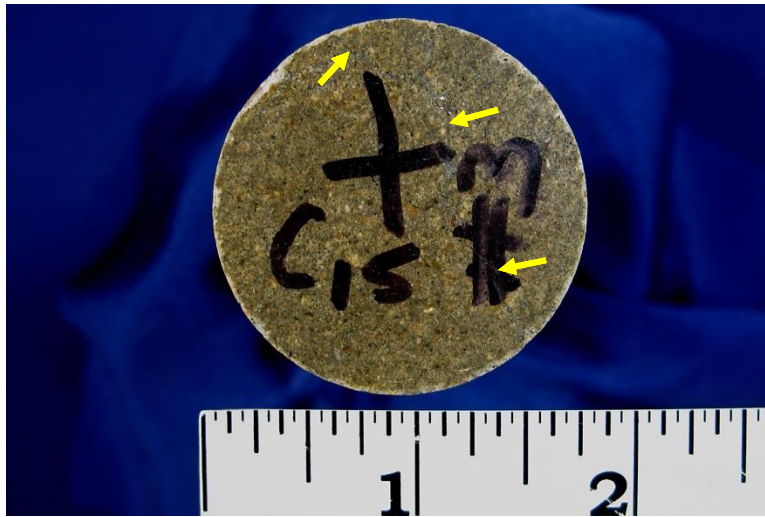
1a. Core top surface. Surface is flat, even concrete surface with a very thin layer of clear topping material. Yellow arrows point to hairline cracks.
