911-09-07 Congress Avenue

Grandberry Building and Mitchell-Robertson Building,
911 Congress Avenue Historic District

May 24, 2021

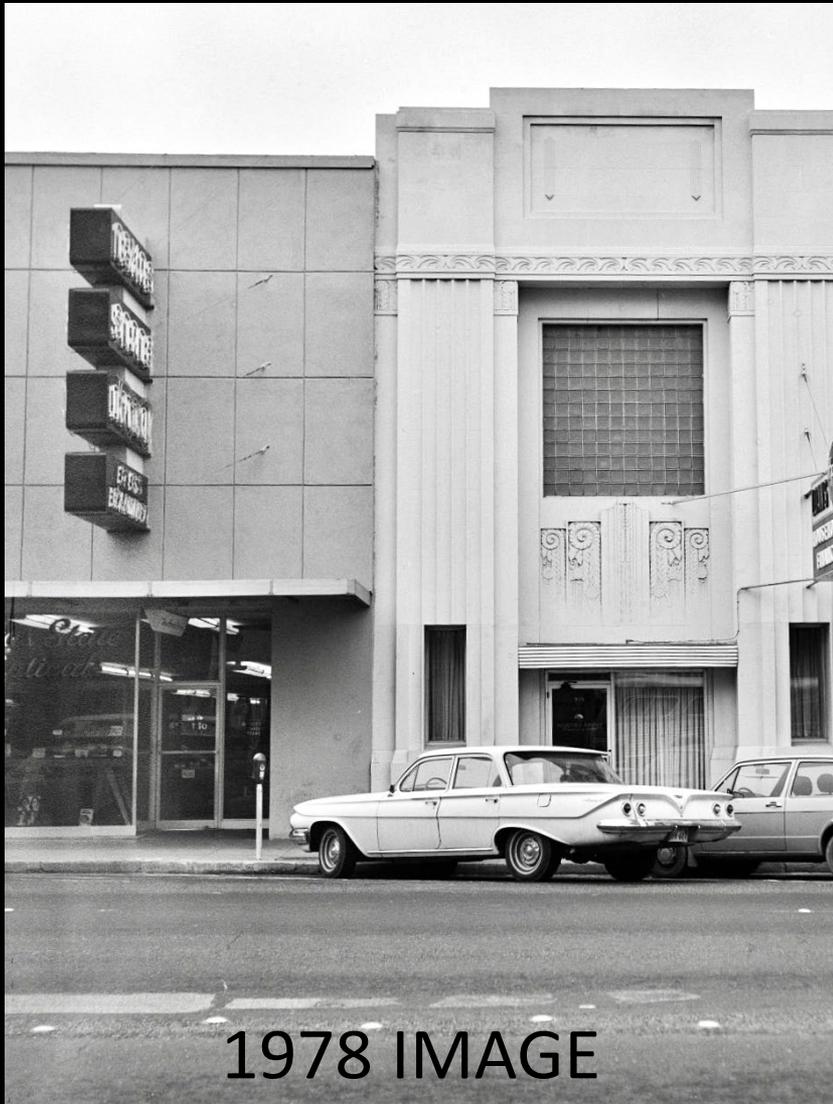
- Received a 1985 memo of 907 written by Bell, Klein and Hoffman from Austin History Center which states, “[the brick] appears to be fire damaged in areas. After that was stuccoed and scored.”

- looked at historic photo of c. 1881-2. By tonal qualities, appeared to be exposed brick w/ limestone accents & storefront.
- Paint (red) applied later & appears fire-damaged in areas after that was stuccoed & scored.
- 1880's photo indicates frame painted dark color & arch light.
- took sample of frame, Sandy to provide of brick sample.

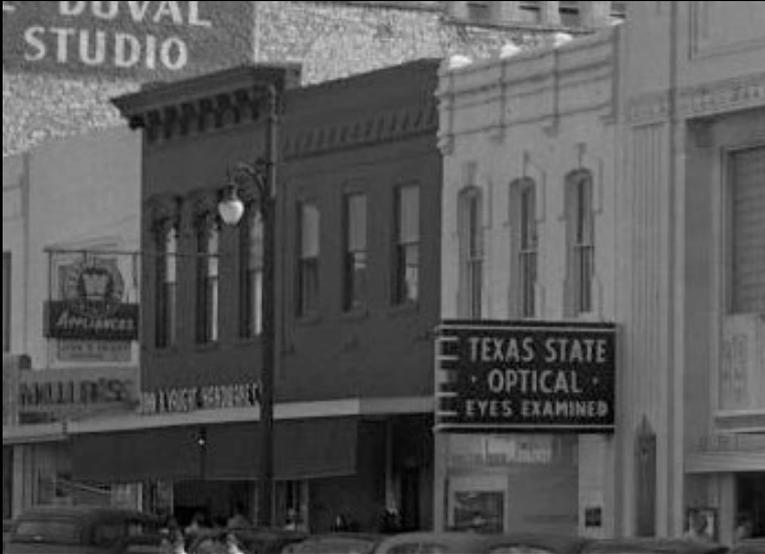
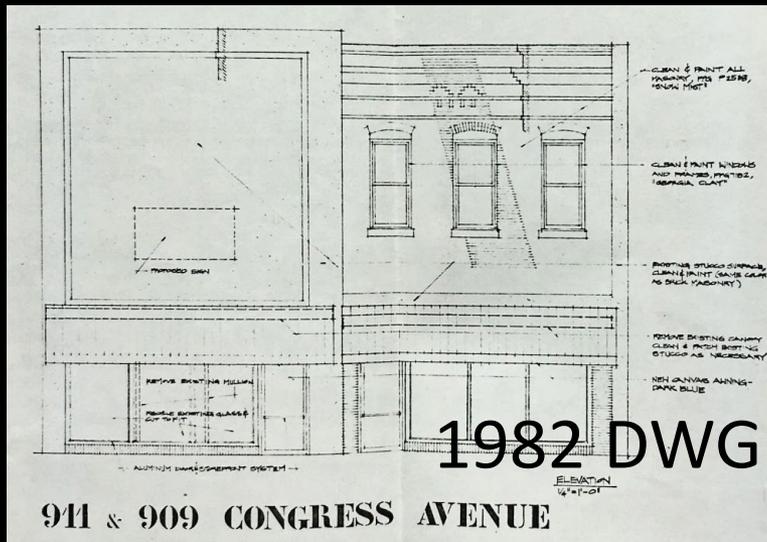
- At some point in the late 70s 911 was covered in stucco.
- Facades have been hidden for a long time.
- Modifications have done damage to the original fabric.
- All ornamentation is missing and would need to be replaced with new based on historic photographs.

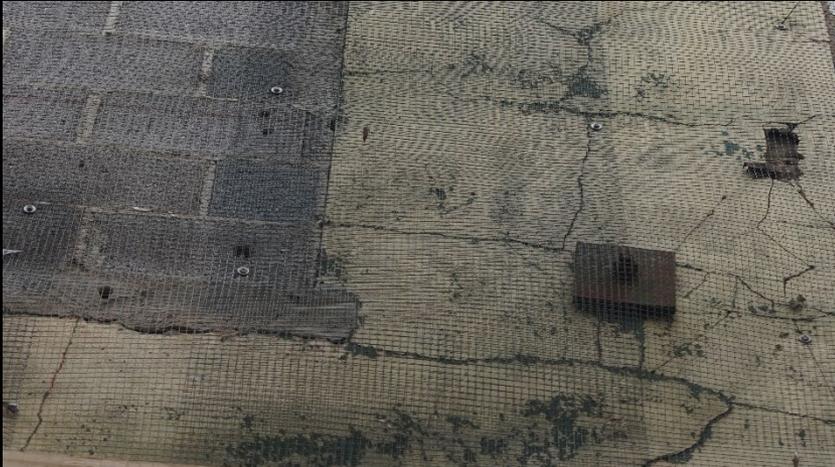
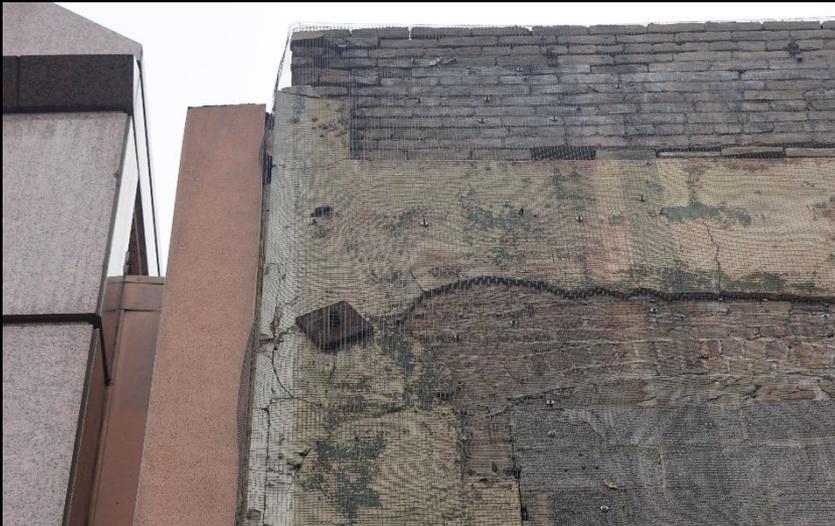
911 - Visual Assessment

- Brick has been scored and stucco adhered directly.
- All ornamentation of the window headers, cornice, and brick sills were removed in the late 70s to early 80s for the addition of stucco.
- Most of the original façade has been lost.
- Stucco has severe deterioration.

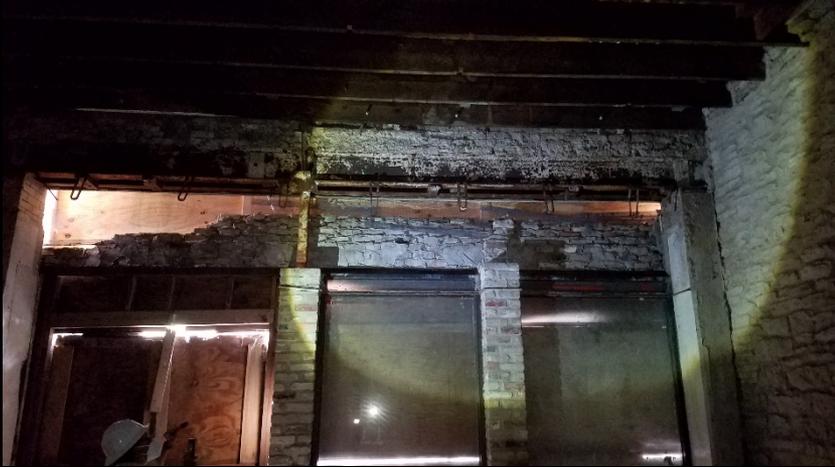
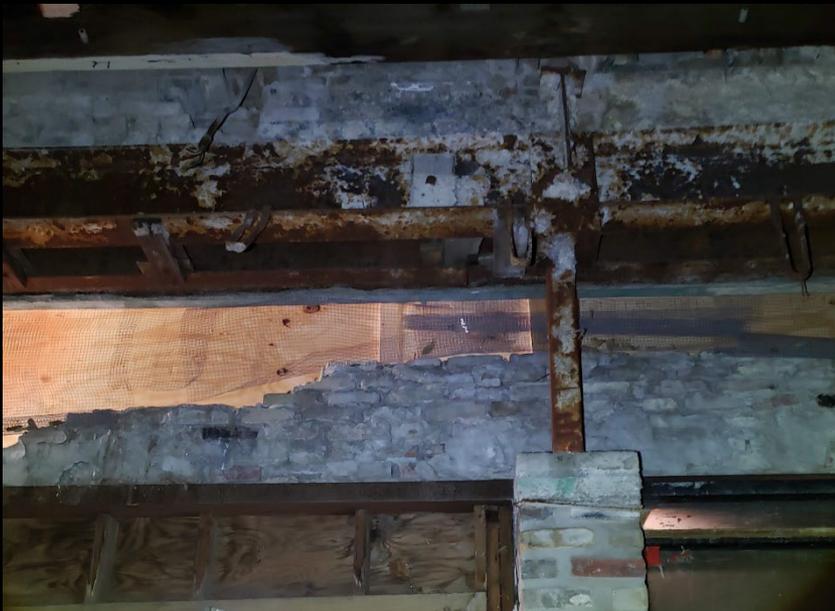
909 - Visual Assessment

- Storefront is missing.
- Steel header is not adequate due to rust and deflection.
- Noticeable cracks in the front façade.
- Structural columns are modern and not original.
- Existing (potentially original) brick below steel header has deteriorated and collapsed.
- Upper portion of the building is in the best condition of the three structures.

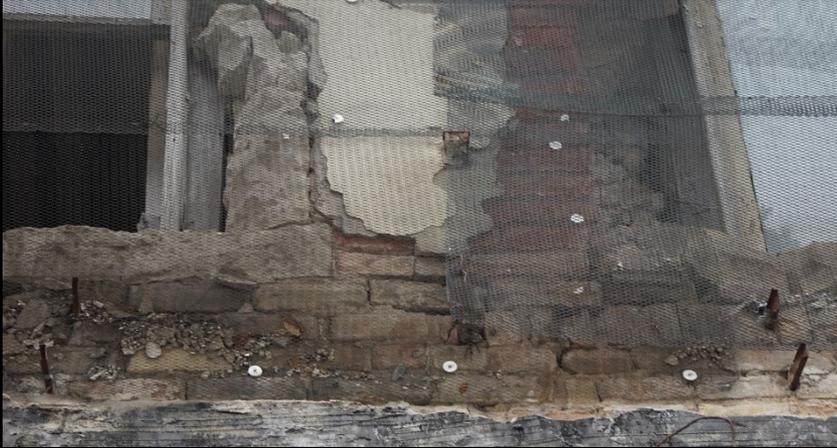
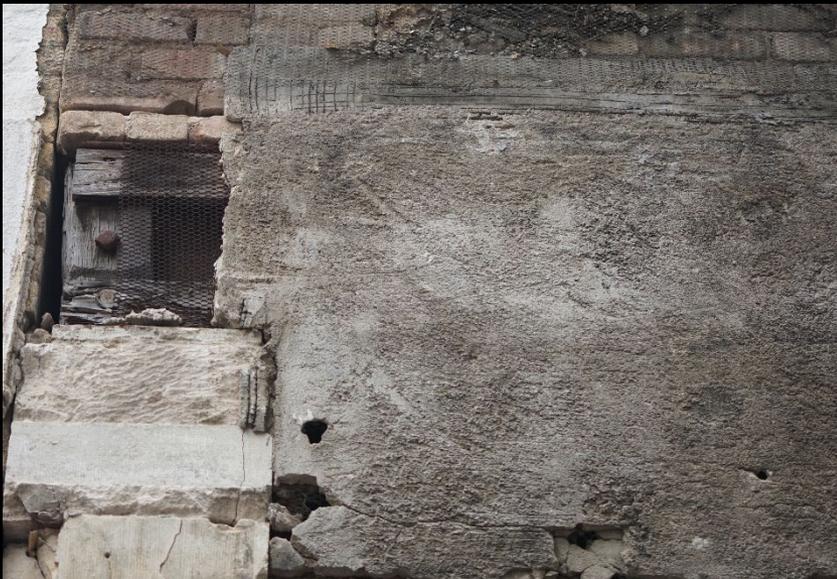
907 - Visual Assessment

- Most original features are missing.
- Stone, brick, and mortar are in poor condition with evidence of missing and replacement stone and brick.
- Exposed structural timber over storefront is rotted and close to failure.

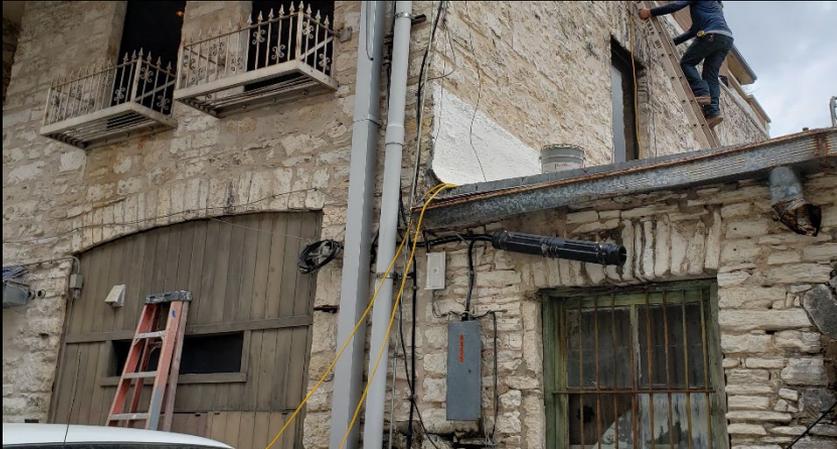
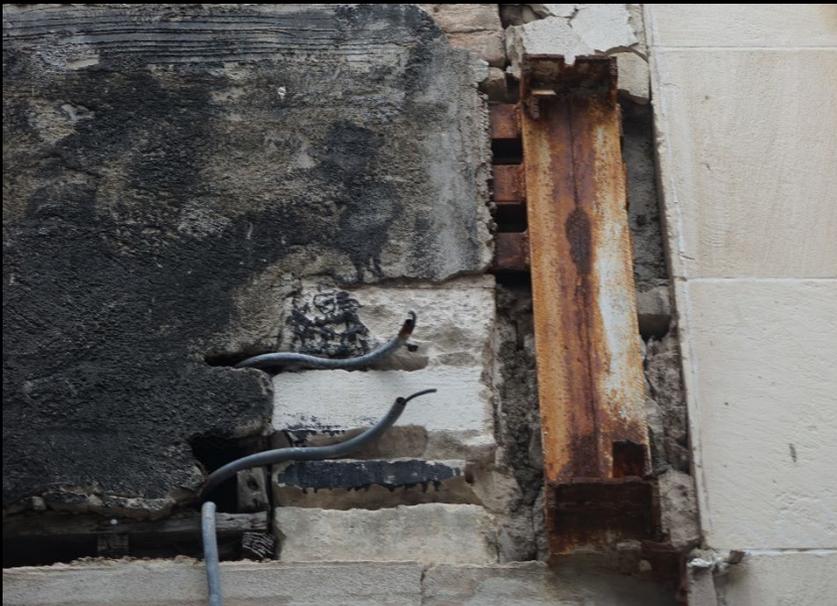
907 - Visual Assessment

- Need to completely separate 907 from adjacent property at 905 to allow for proper waterproofing and support.
- Roof failure has caused water damaged and trapped moisture in shared wall.

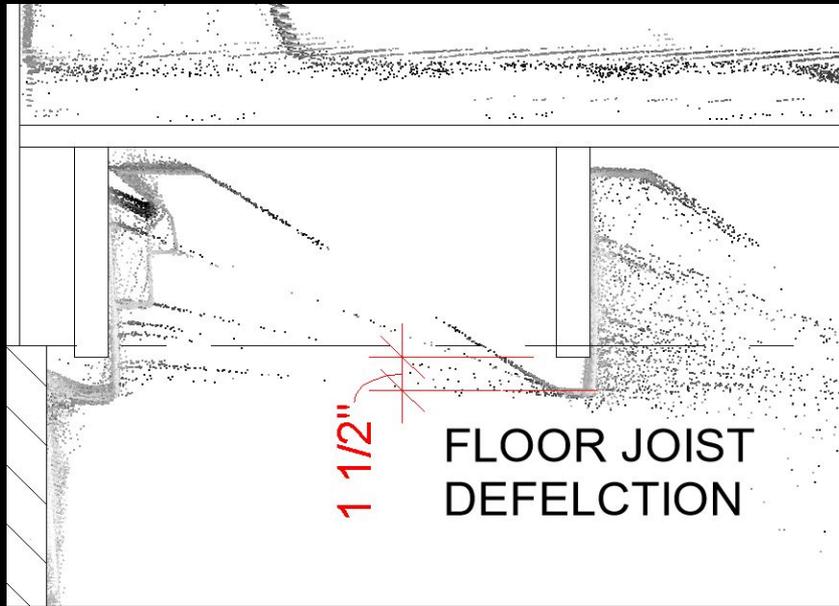
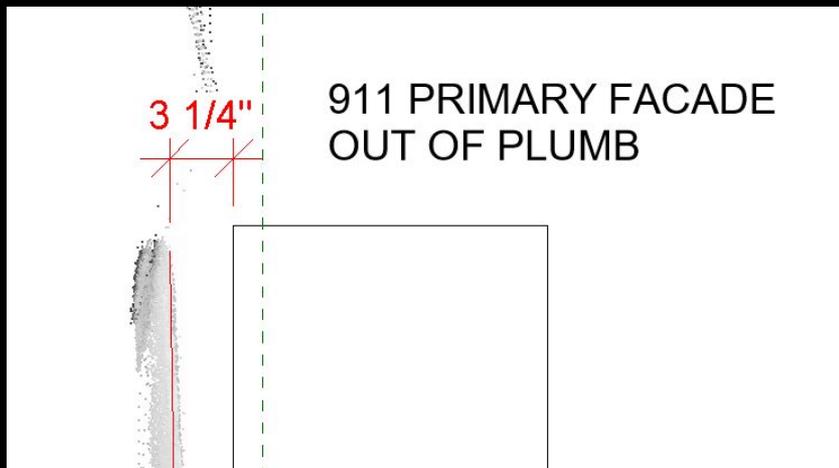
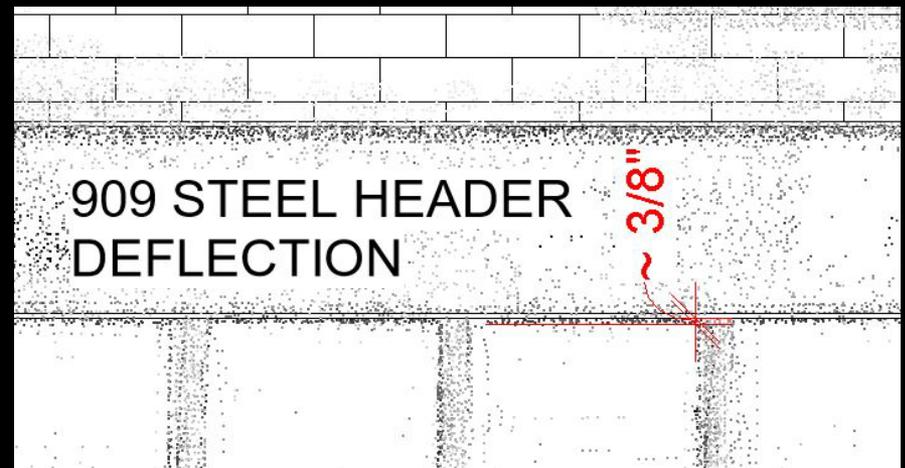
Initial Laser Scan Assessment

- Preliminary comparison of the laser scans to rectified elements within the 3D model show deterioration to some of the structural elements.

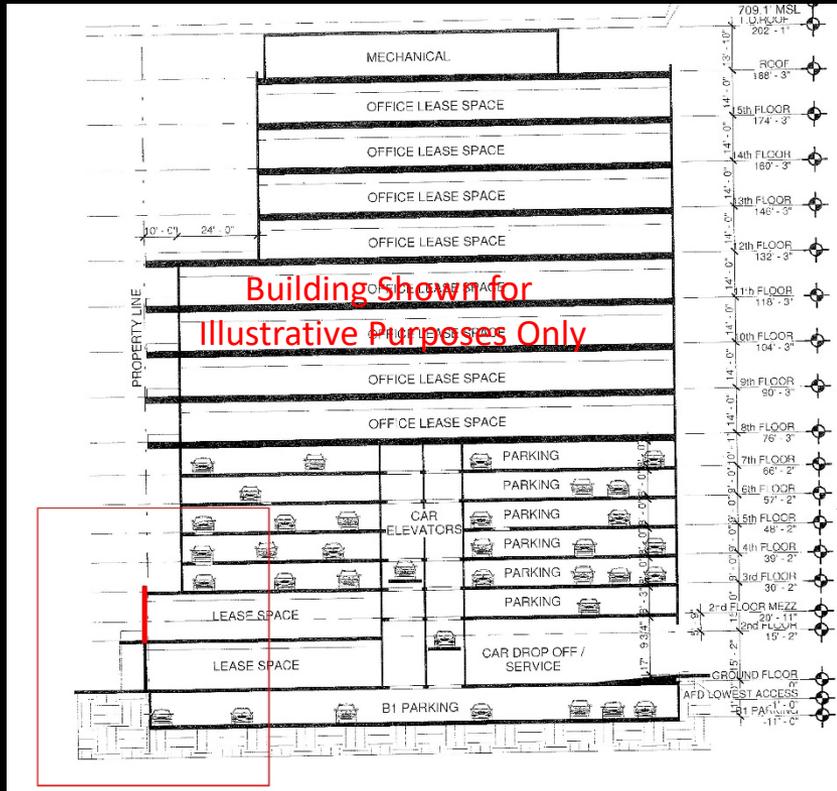
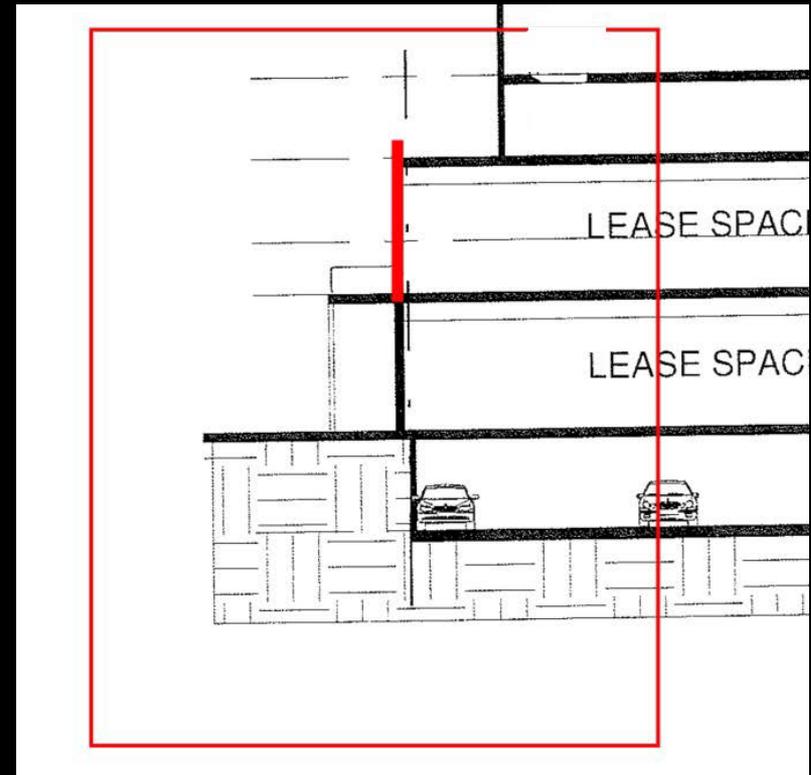
Structural Issues & Access

- Structural and access concerns.
