City of Austin  
Fire Station No. 3

# Damage

# Structural Damage

Historic Landmark Commission – Design Overview Presentations  
24 May 2021

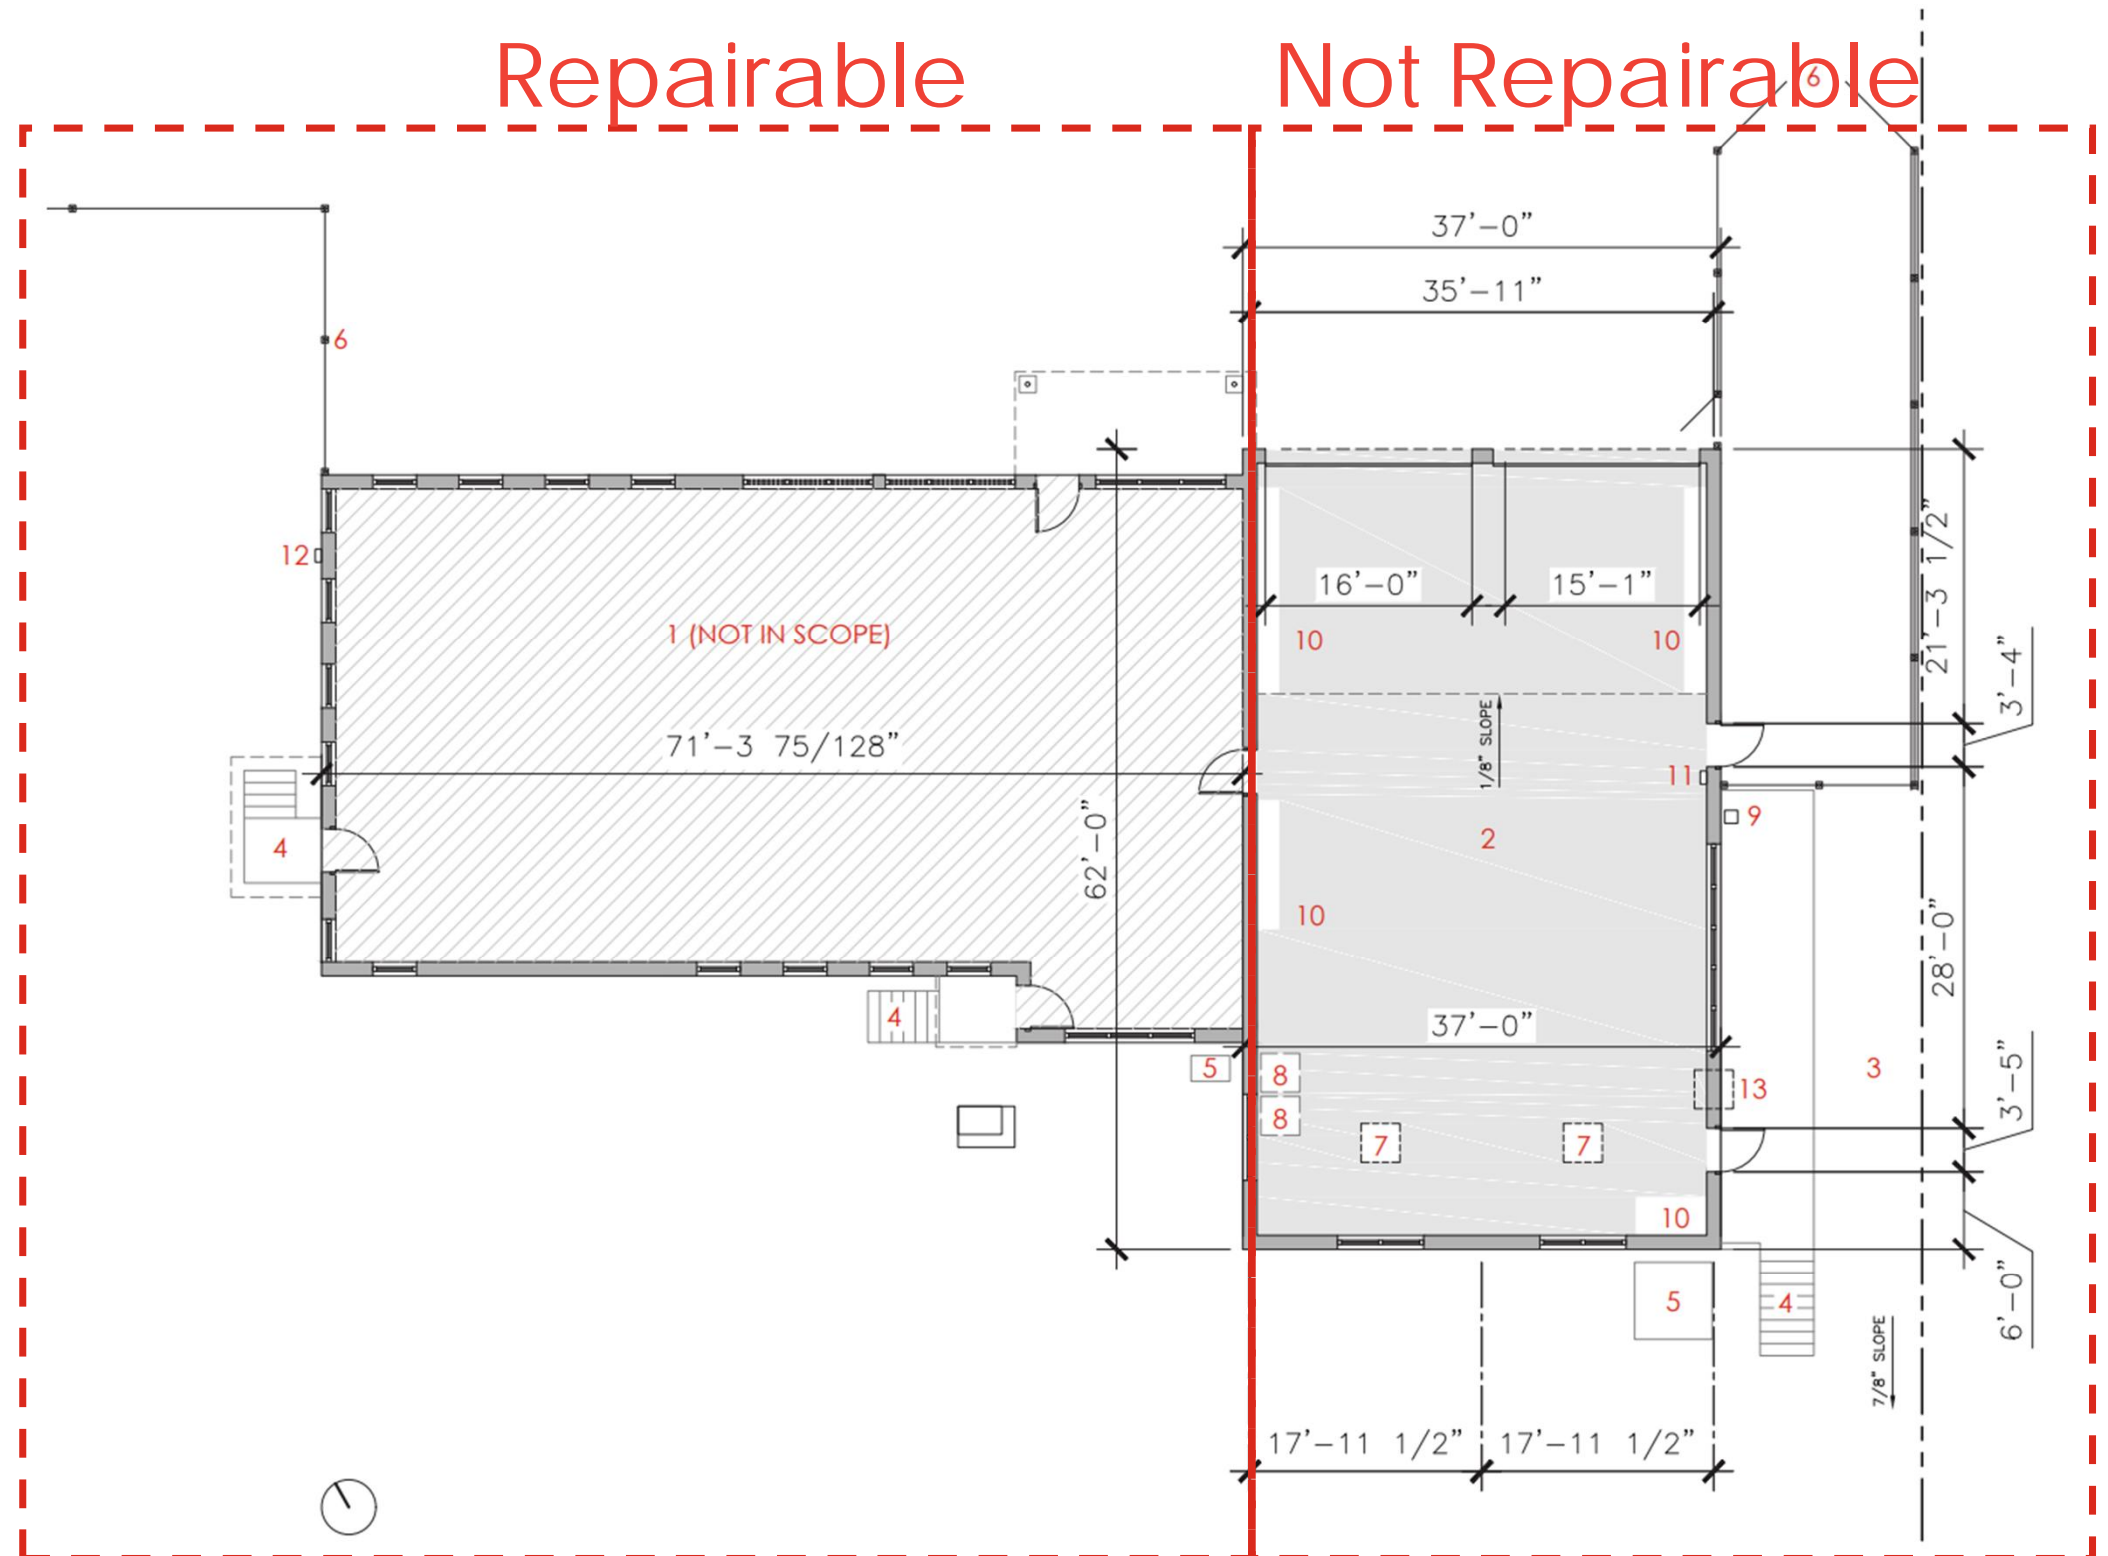
The building has suffered two types of structural damage:

- 1) General wear and tear based on age. (entire structure)
- 2) Overstressing of the foundation due to parking trucks that are heavier than the original design load. (apparatus bay only)

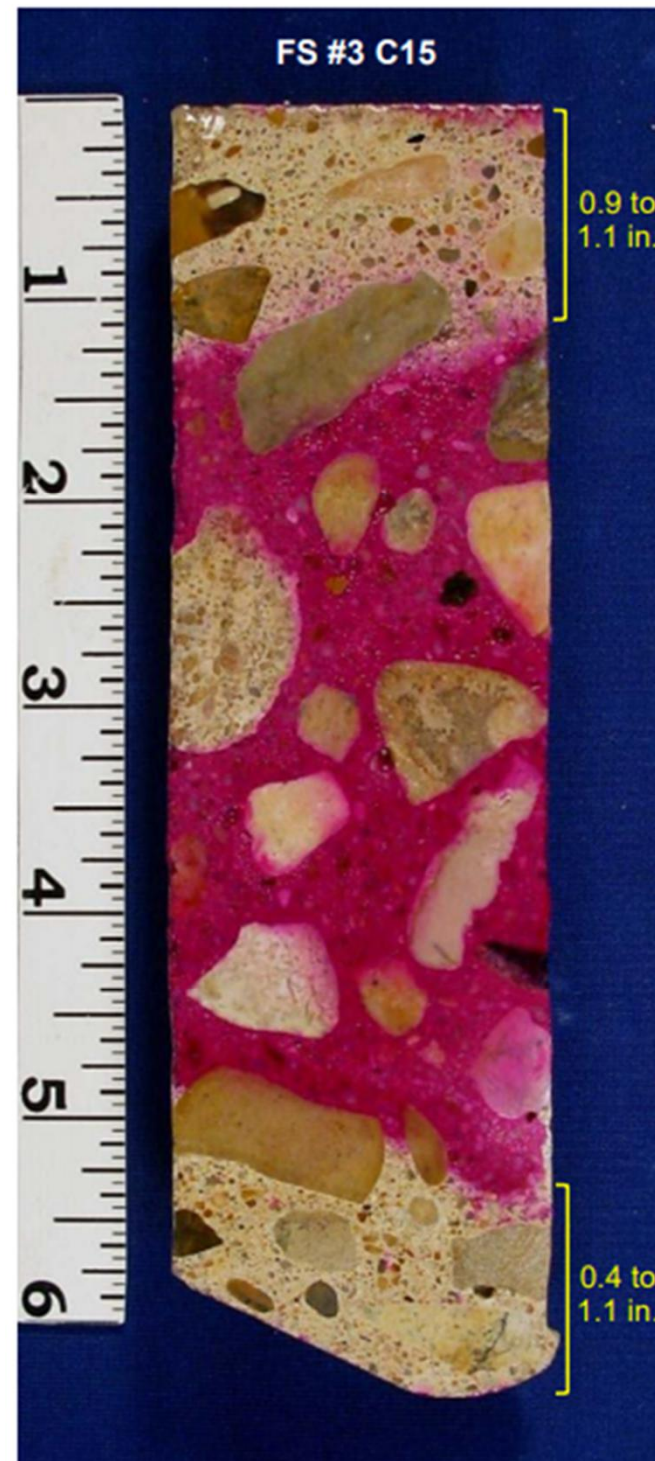
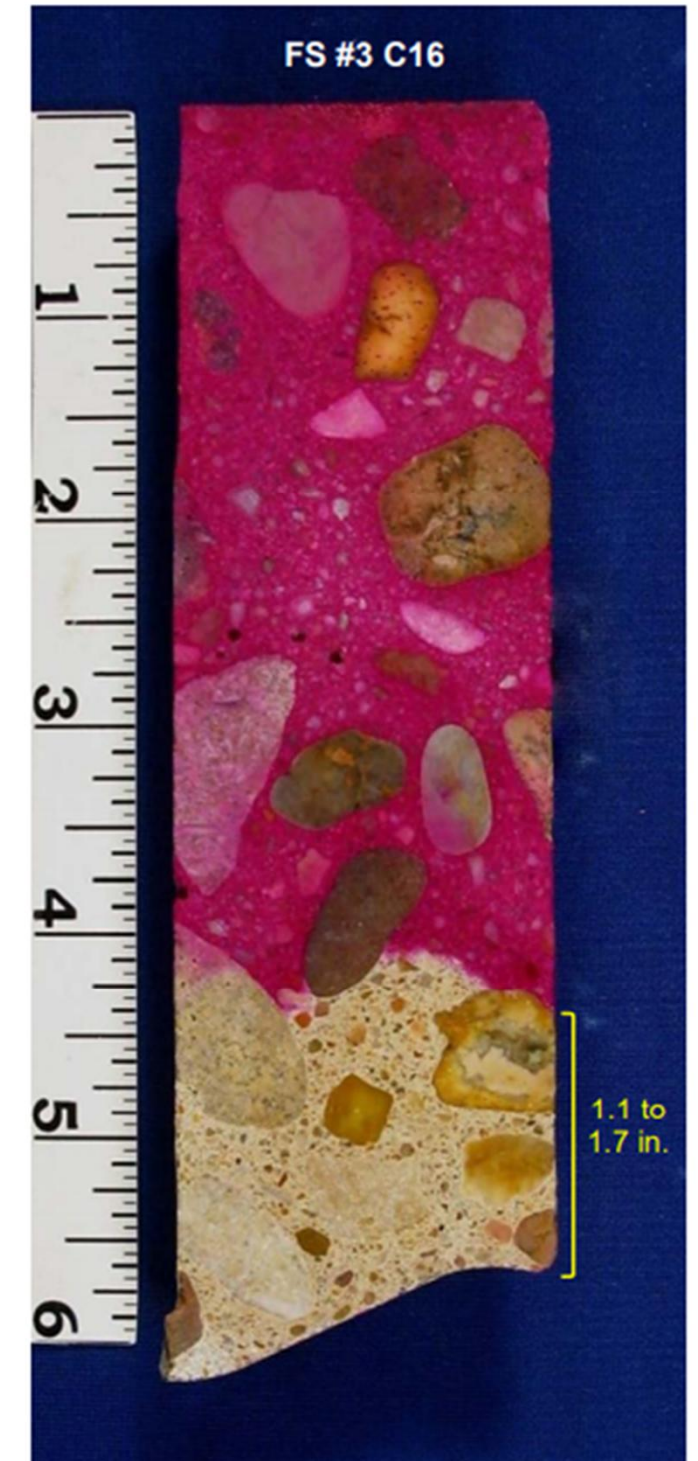
- Ground Penetrating Radar
- Localized Concrete Removal
- Visual Observation
- Core Samples
- Compressive Strength Testing
- Carbonation Depth Testing
- Geotechnical Borings

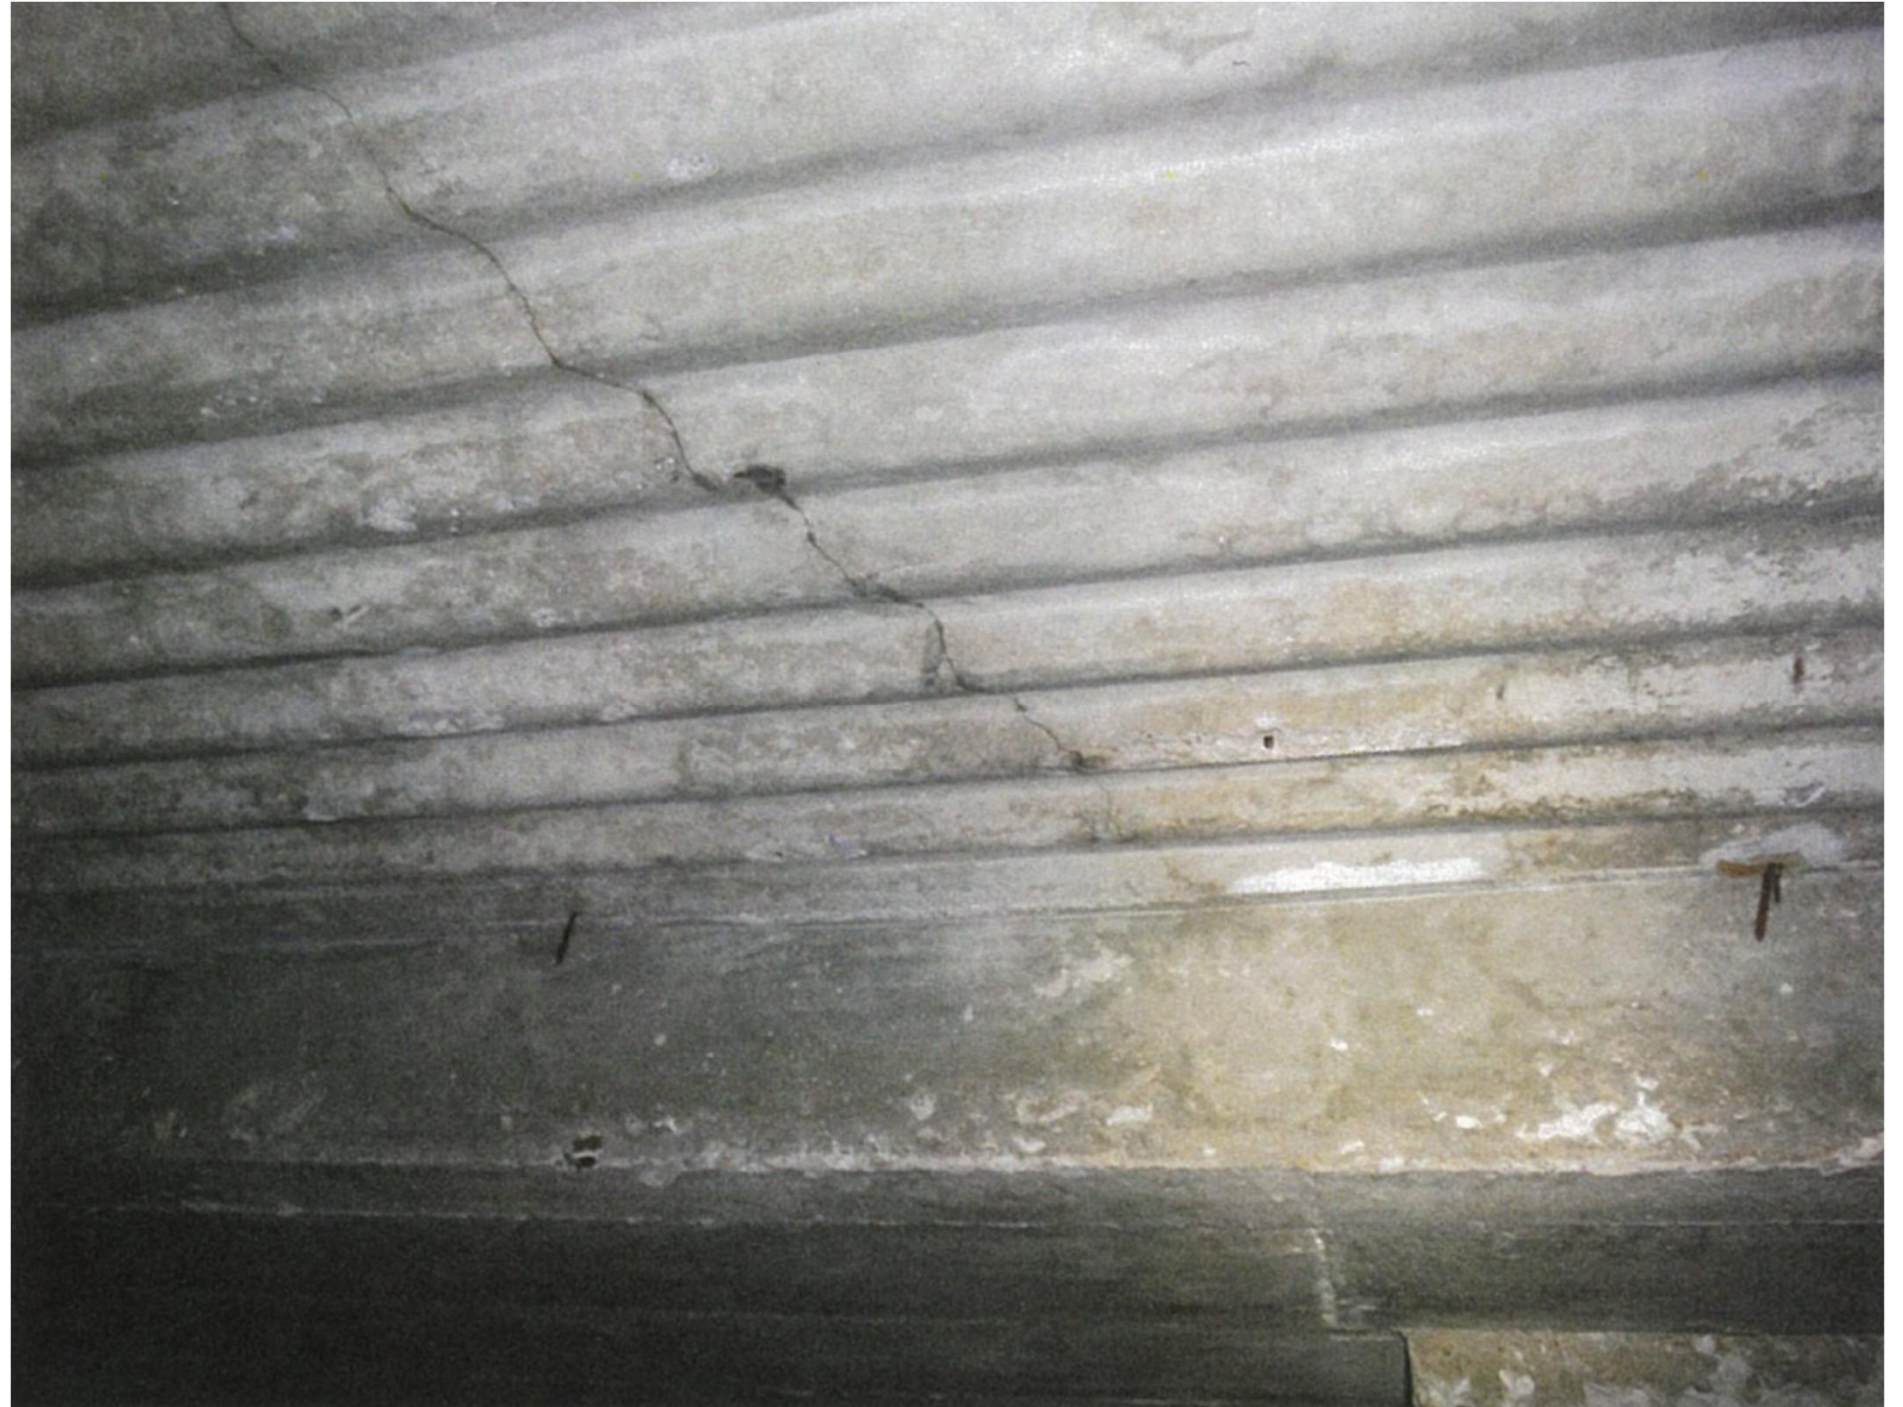
- Cracks
- Spalling
- Exposed, rusted reinforcing steel
- Carbonation depths exceed the depth to the reinforcing steel
- Calculations of necessary design loads far exceed that of the current structure
- All options for repair were considered costly, risky, and/or ineffectual
