Alton E. Greeven, P.E.
Consulting Engineer, TBPE Firm F-18
2611 Woodmont Ave.
Austin, Texas 78703
Phone 512-477-8811 - Fax 512-474-2266

**Structural Condition Study
3400 Hillview
Austin, Texas 78703**

**Appeal of Lloyd P. Lochridge, Jr. to the Travis Appraisal Review Board
from the 2010 Alleged Market Value for the .71 acres
of land and improvements at 3400 Hillview Road**

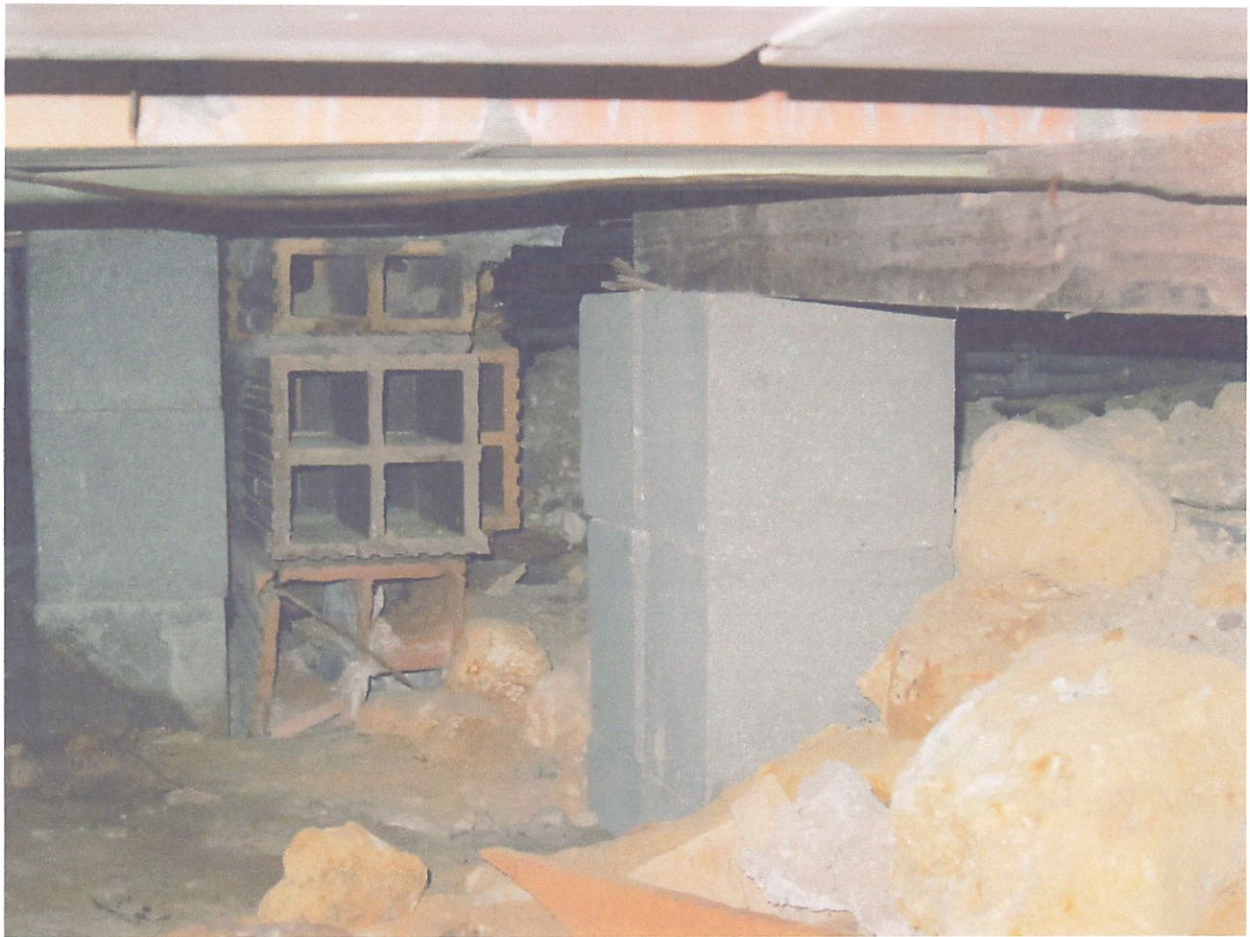
Another picture of crawl space below
kitchen and dining room showing
masonry supports of floor joists

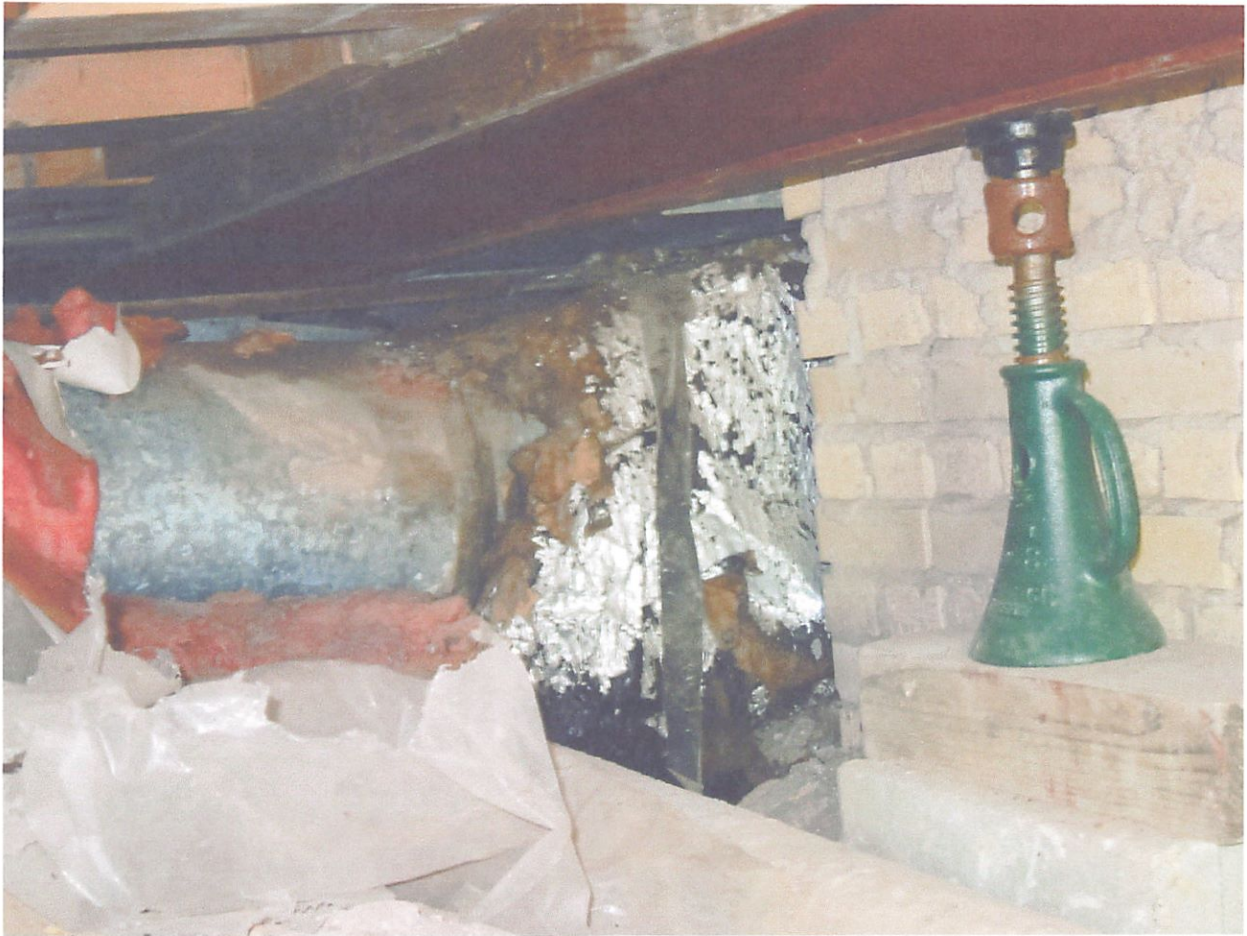
Picture of substructure below kitchen
and dining room area showing jack
remaining in place

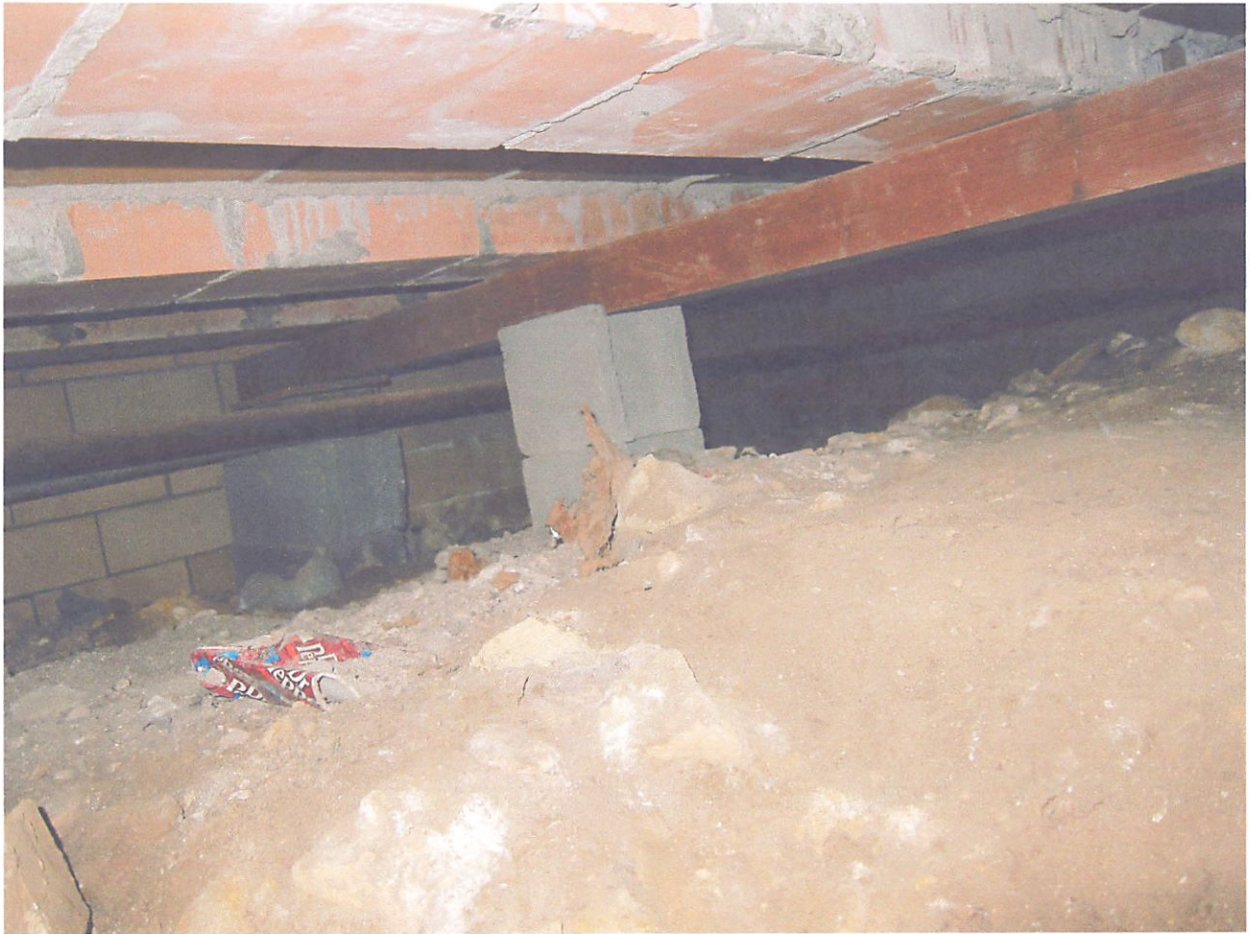
Area beneath dining room showing
masonry block installation supporting
floor joists

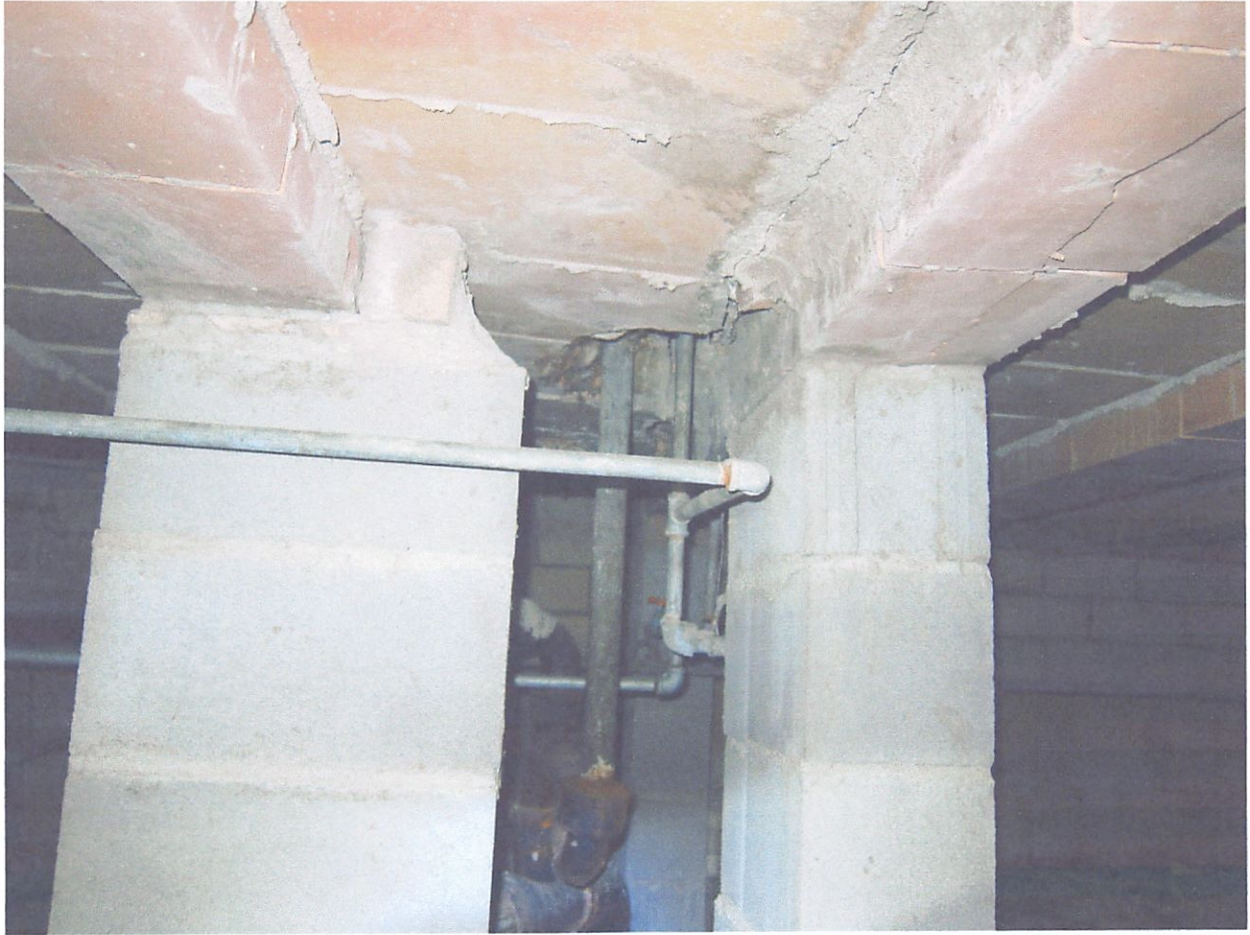
Area below room on west side of garage showing concrete masonry supports of floor joists, the installation of which was made prior to 1959

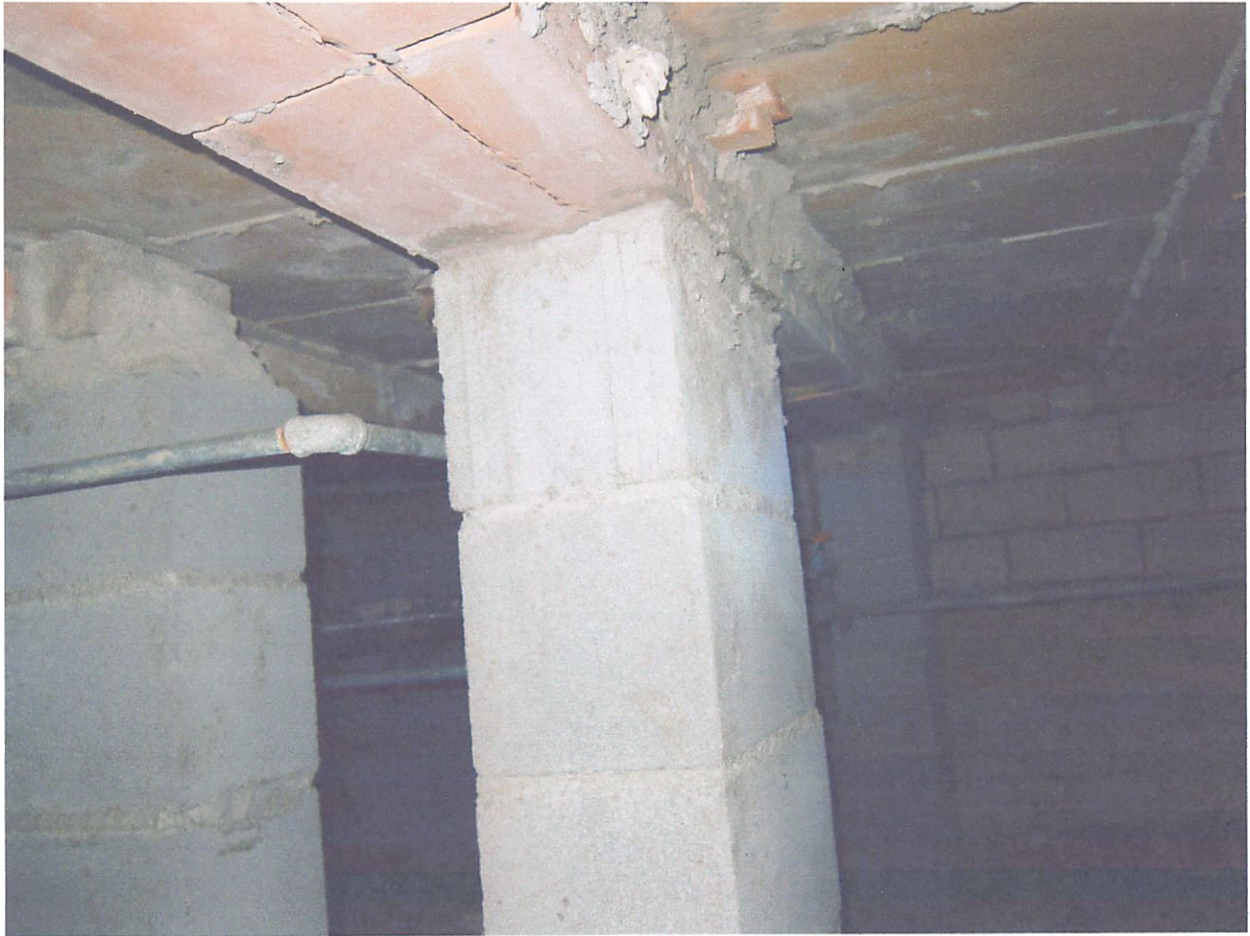
Another photograph of supporting masonry column believed to have been installed prior to 1959 under floor of room on west side of garage
