**APPEAL TO  
PLANNING COMMISSION  
HISTORIC LANDMARK COMMISSION DENIAL OF A CERTIFICATE OF APPROPRIATENESS  
REVIEW SHEET**

CASE NUMBER: HR-2021-085739      HISTORIC LANDMARK COMMISSION: March 22, 2021, postponed  
April 26, 2021, postponed  
May 24, 2021, feedback provided  
July 26, 2021, denied  
August 24, 2021

HISTORIC NAME: Mitchell-Robertson Building (C14H-2004-0008)

ADDRESS: 909 Congress Avenue

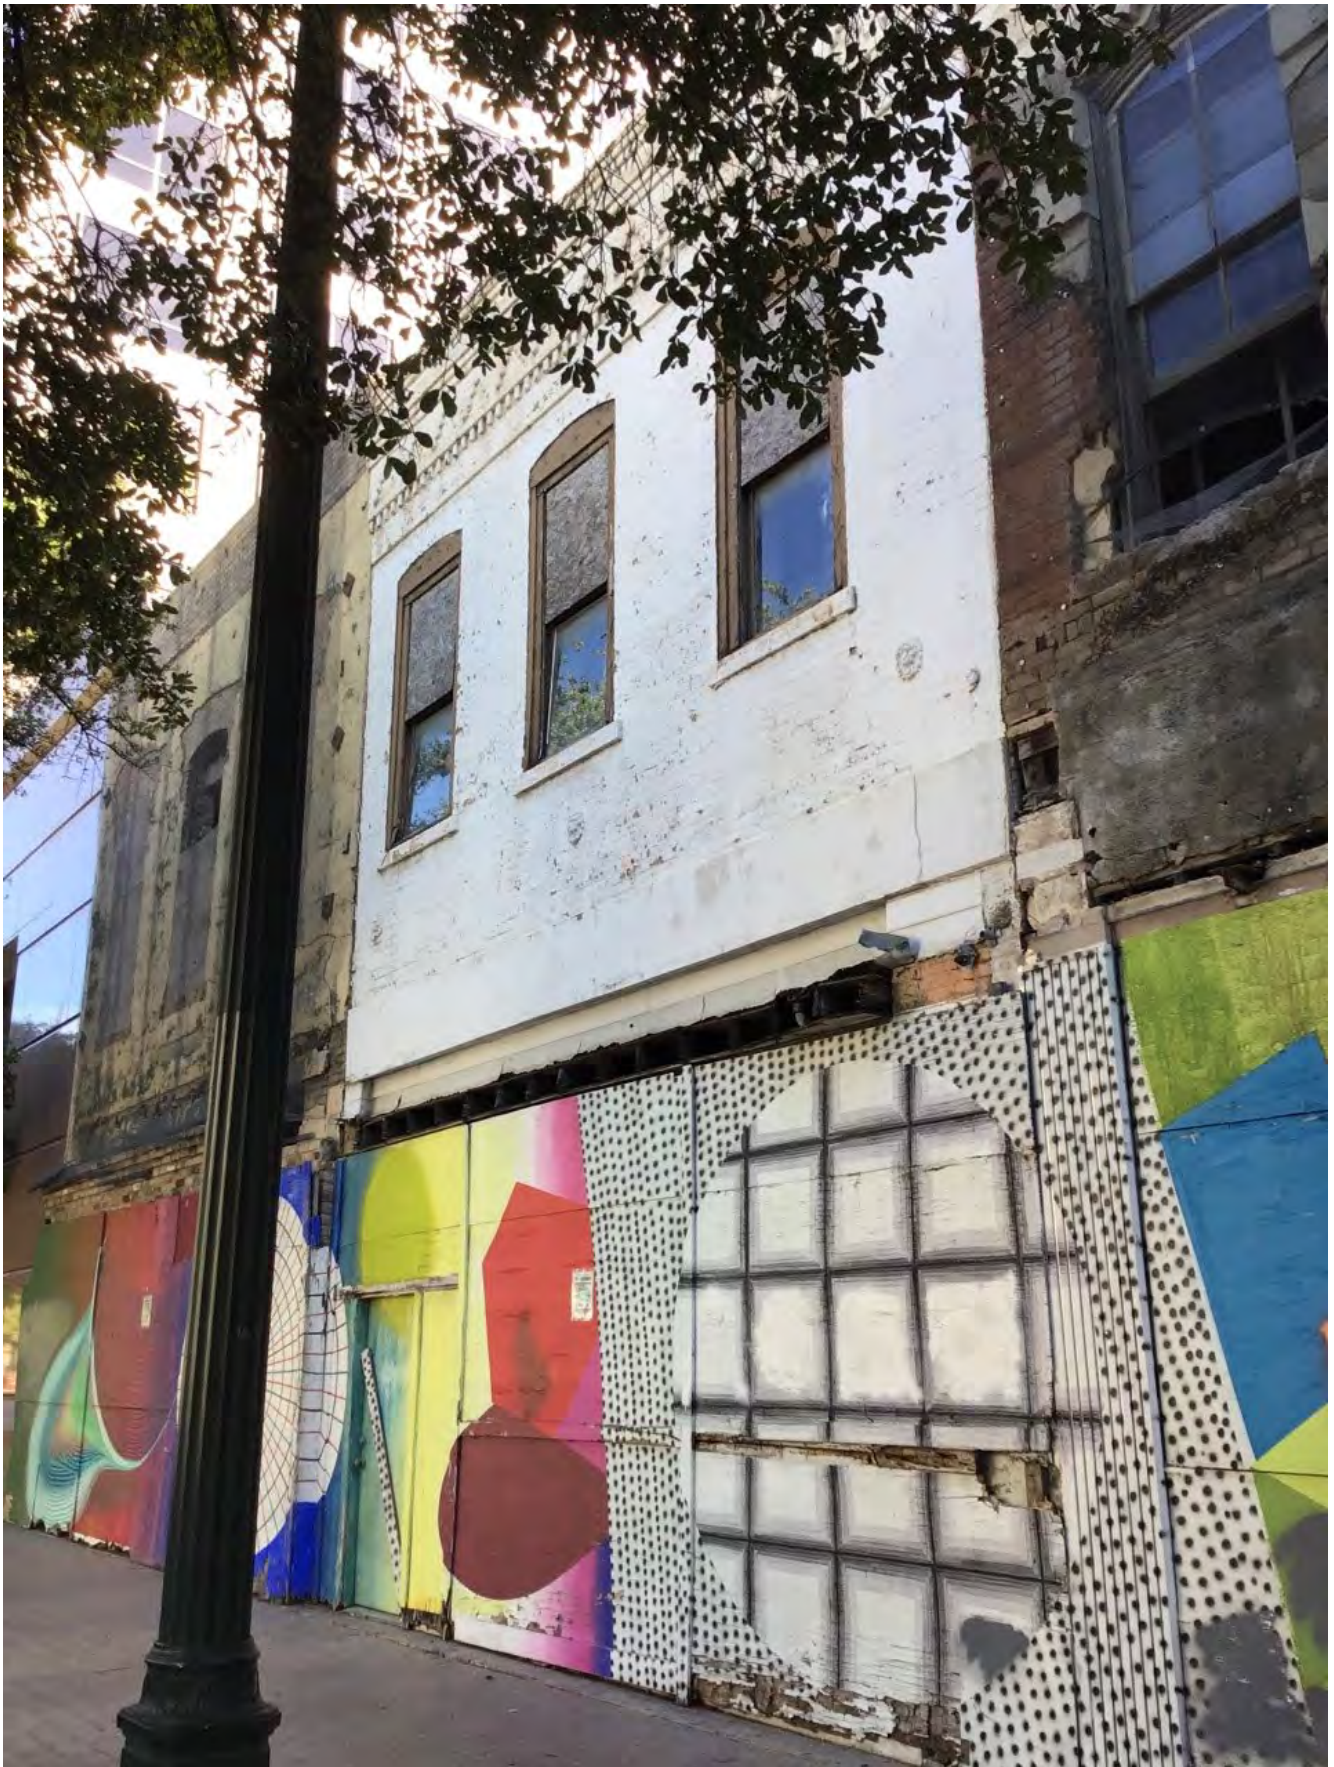
*909 Congress Avenue, Historic Preservation Office staff, historic landmark inspections, 2020-2021.*

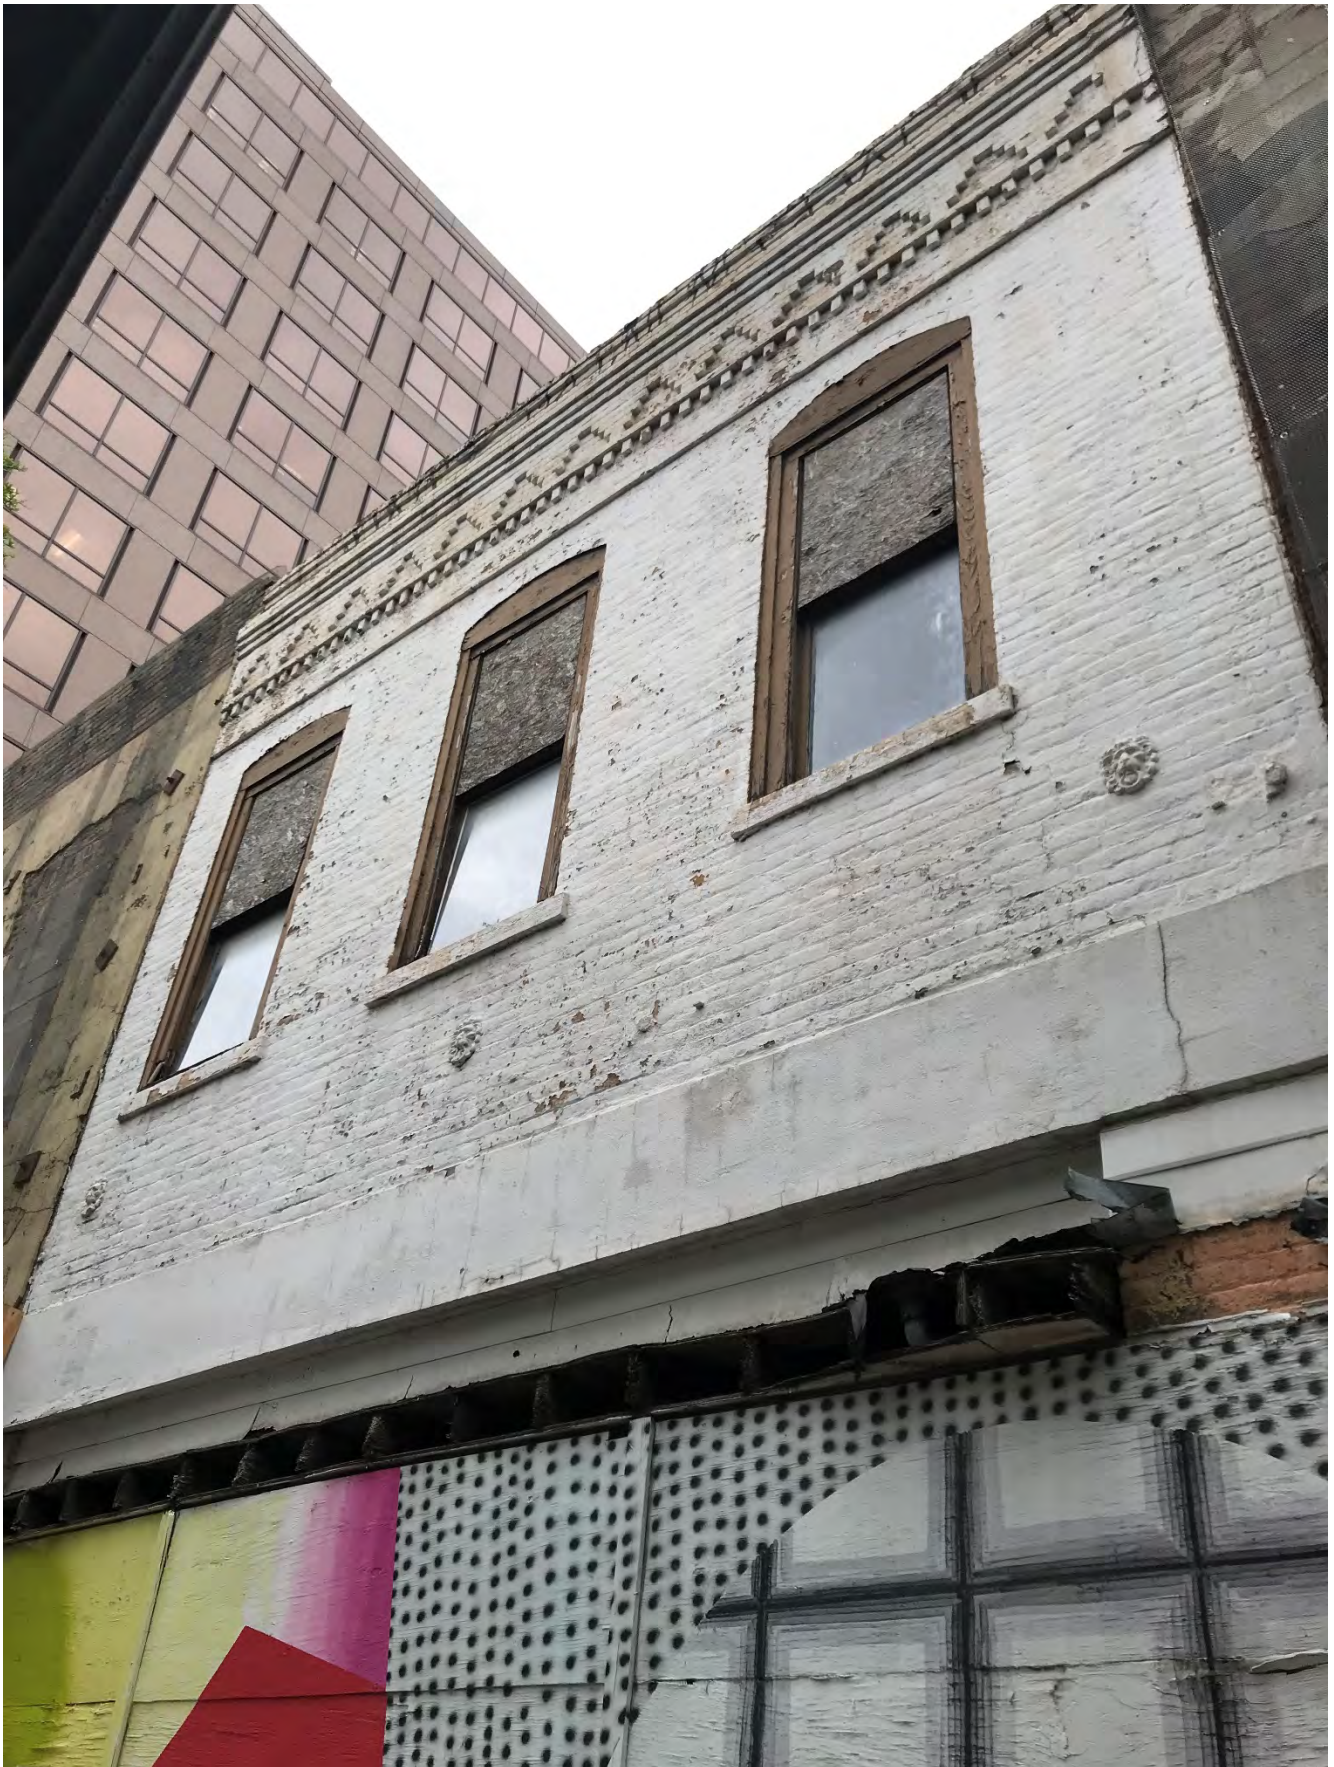
*Current condition of 909 Congress Ave. façade, Historic Preservation Office staff, May 2021.*

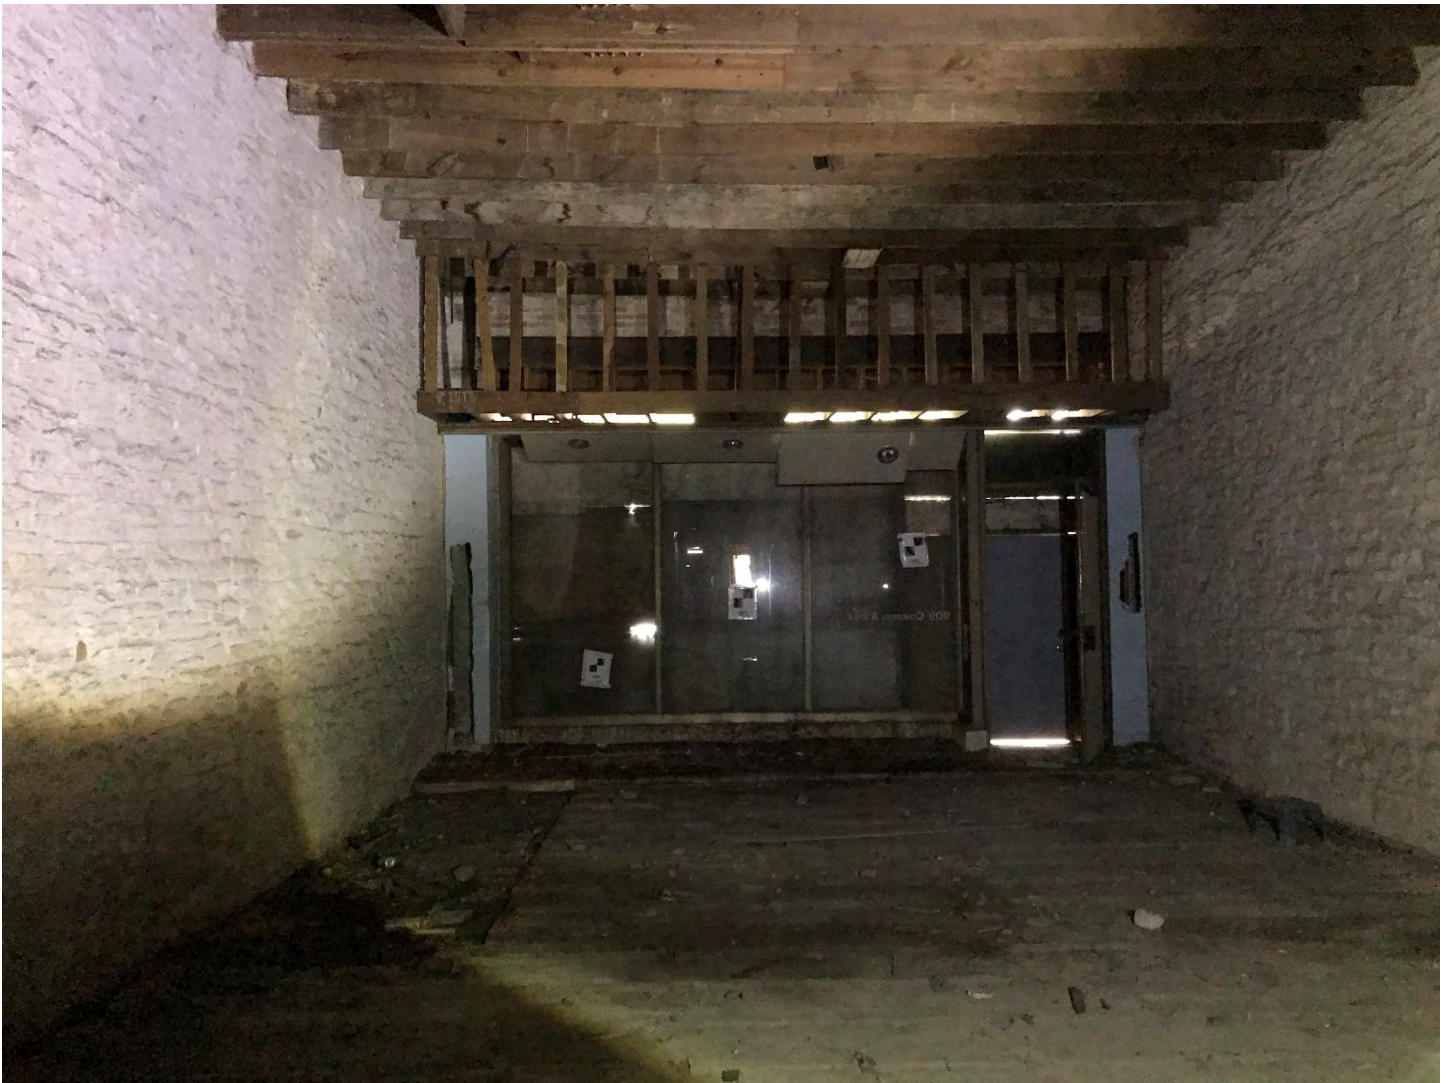
*Interior of 909 Congress Ave. storefront, Historic Preservation Office staff, May 2021.*

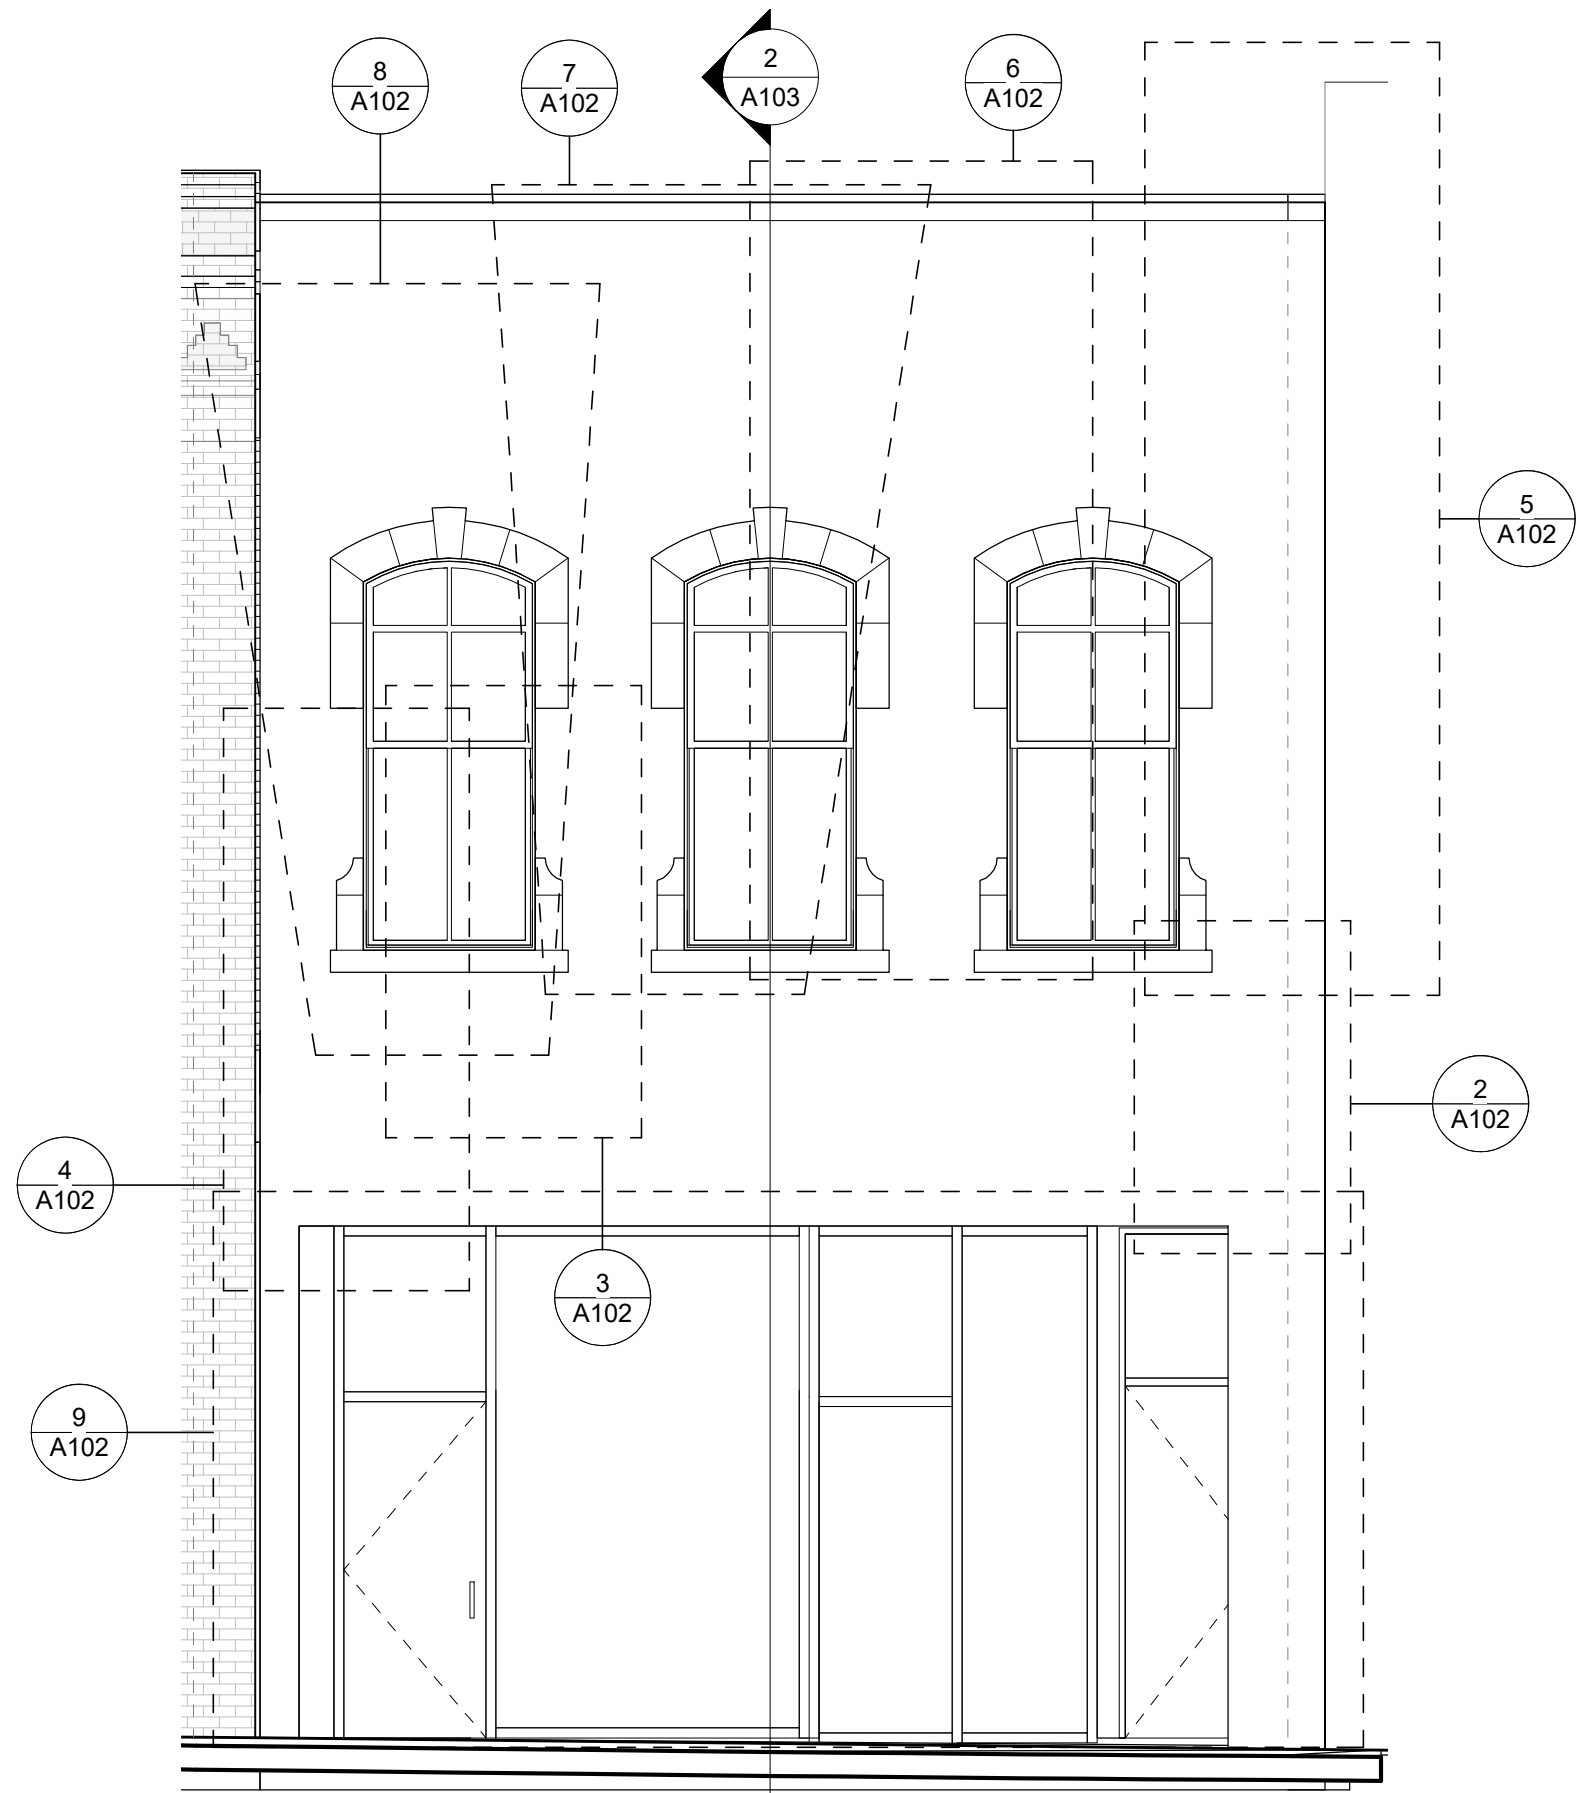
1 907 EXISTING ELEVATION PHOTOS  
1/4" = 1'-0"

NOTE: EMBEDDED STONE AND WOOD STRUCTURE ARE PRESUMED TO BE ORIGINAL. AS STUCCO IS REMOVED MAY REVEAL ADDITIONAL INFORMATION ABOUT ORIGINAL STREET LEVEL CONSTRUCTIONS.
