# **Third Coast Home Inspection**

1901 Hamilton Austin, TX 78702 Third Coast Home Inspection 8906 Ampezo Trail Austin, TX 78749

### PROPERTY INSPECTION REPORT

Report Identification: 20210914-01, 1901 Hamilton, Austin, TX					
				litions revealed by an inspection. The o the parties to the contract for the sale	
INFORMATION INCLUDED UNDER "ADDITIONAL INFORMATION PROVIDED BY INSPECTOR", OR PROVIDED AS AN ATTACHMENT WITH THE STANDARD FORM, IS NOT REQUIRED BY THE COMMISSION AND MAY CONTAIN CONTRACTUAL TERMS BETWEEN THE INSPECTOR AND YOU, AS THE CLIENT. THE COMMISSION DOES NOT REGULATE CONTRACTUAL TERMS BETWEEN PARTIES. IF YOU DO NOT UNDERSTAND THE EFFECT OF ANY CONTRACTUAL TERM CONTAINED IN THIS SECTION OR ANY ATTACHMENTS, CONSULT AN ATTORNEY.					
	ADDITIO	ONAL INFORMATION	N PROVIDED BY INSI	PECTOR	
Present at Inspection:	☑ Buyer	☐ Selling Agent	☐ Listing Agent	☐ Occupant	
Building Status:	✓ Vacant	Owner Occupied	☐ Tenant Occupied	Other	
Weather Conditions:	✓ Fair	☐ Cloudy	Rain	Temp: 77 degrees at 8:30 am	
Utilities On: Special Notes:	☐ Yes	☑ No Water	☑ No Electricity	☑ No Gas

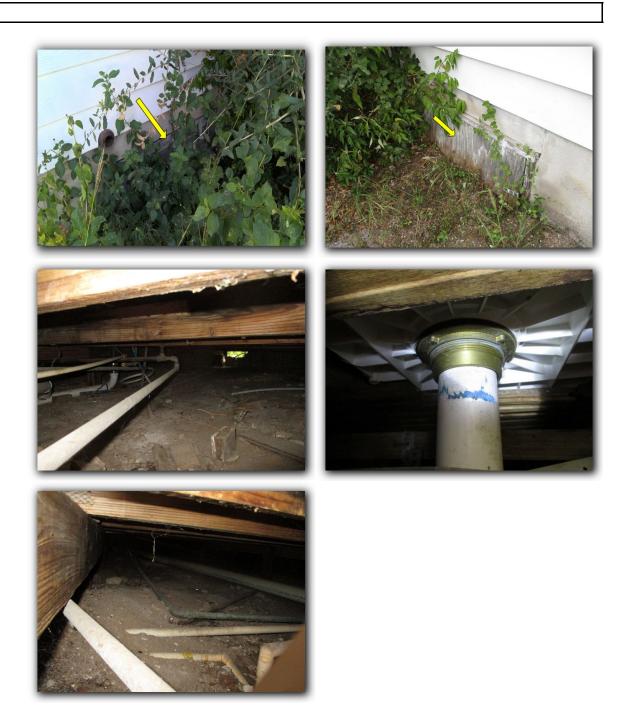
☑ Unable to enter under the house due to blocked entrances. From the inside the flooring is soft in areas, uneven in others. Structure support appears very unstable.

. ☑ Cracks in foundation skirting, missing vent covers.

Signs of structural movement noted; suggest that an expert in this field be consulted for further evaluation of the structure and to provide suggestions as to what, if any, corrective actions should be taken.

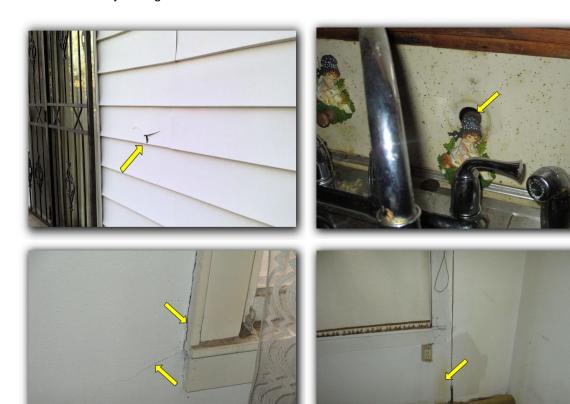
☑ Interior walls show settlement cracks, present of mold from water intrusion.

☑ Repair, caulk and paint needed to the exterior siding and trim in various locations, unable to see belie the vinyl siding..

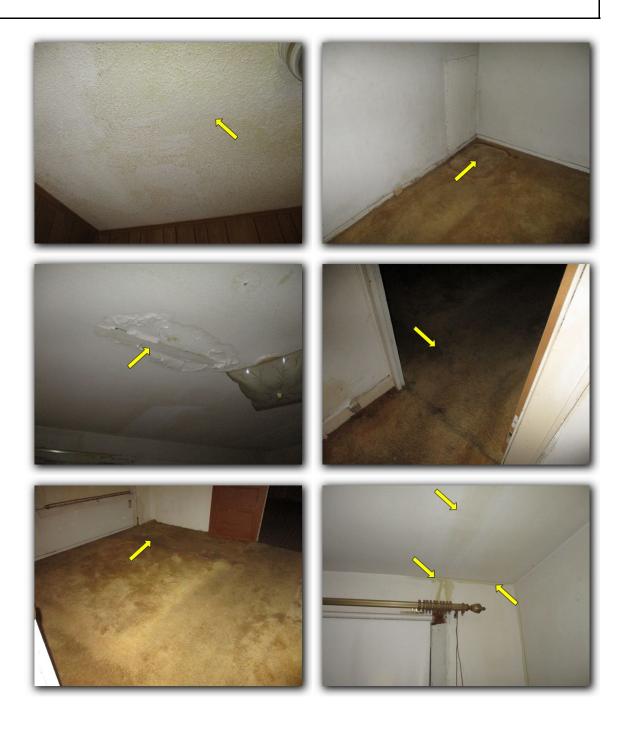
☑ Flooring damaged,, moldy carpet in numerous locations.

$\ensuremath{\overline{\square}}$  Water stains and water damage on ceiling . Evidence of roof leaks.
