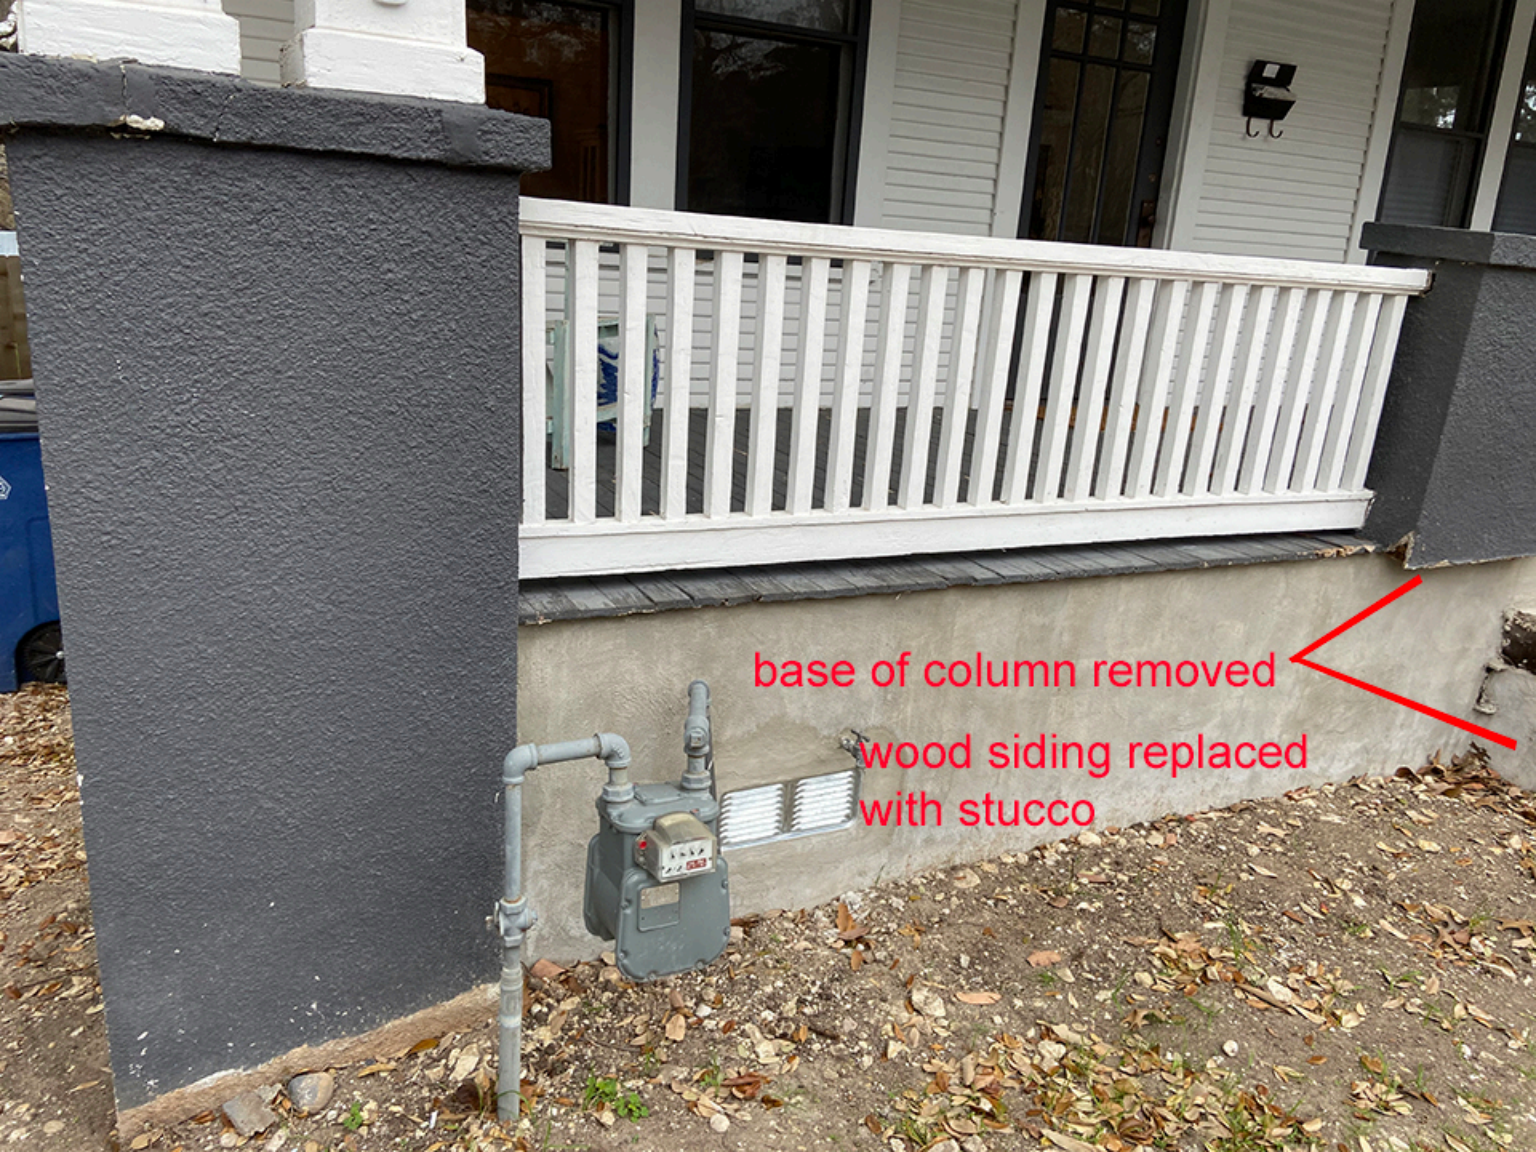
base of column removed
