## Structural Evaluation Report

1204 East 6<sup>th</sup> Street.

**Report Issued: September 23<sup>th</sup>, 2021**

**Subject: Structural Evaluation Report – 1204 East 6<sup>th</sup> Street, Austin TX, 78702**

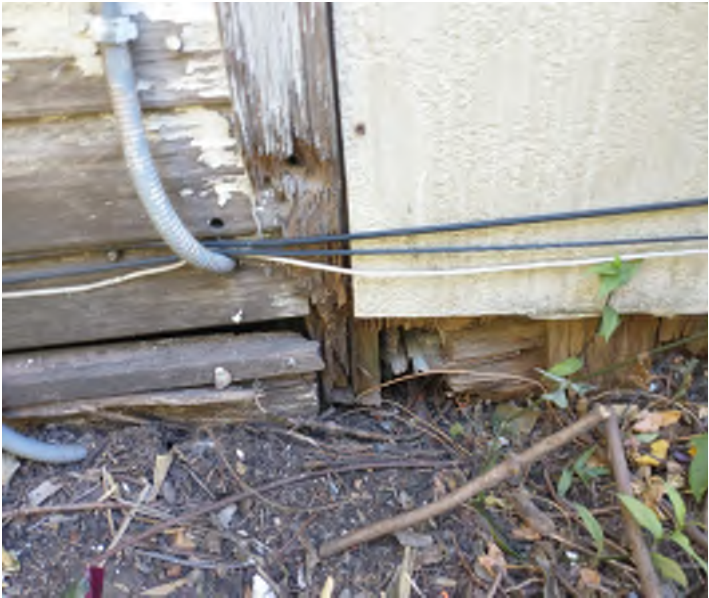
Rotted Wood in Contact with Ground

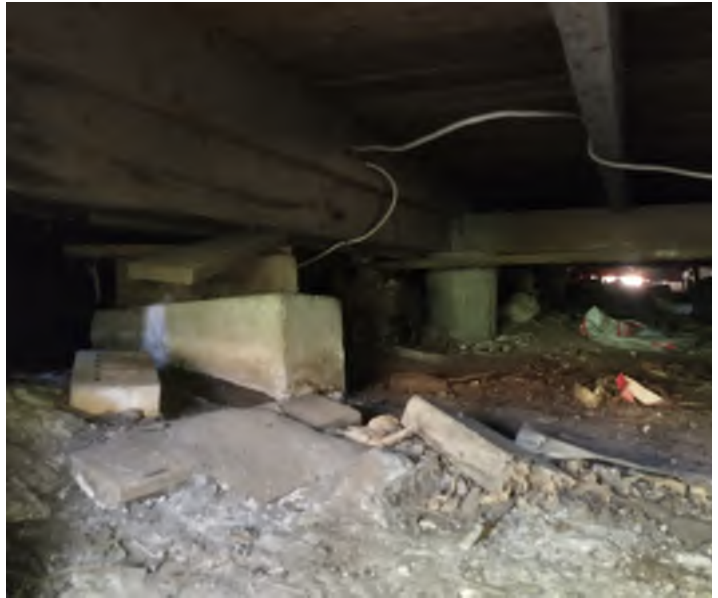
Foundation Crawlspace – Block and Conc Pier

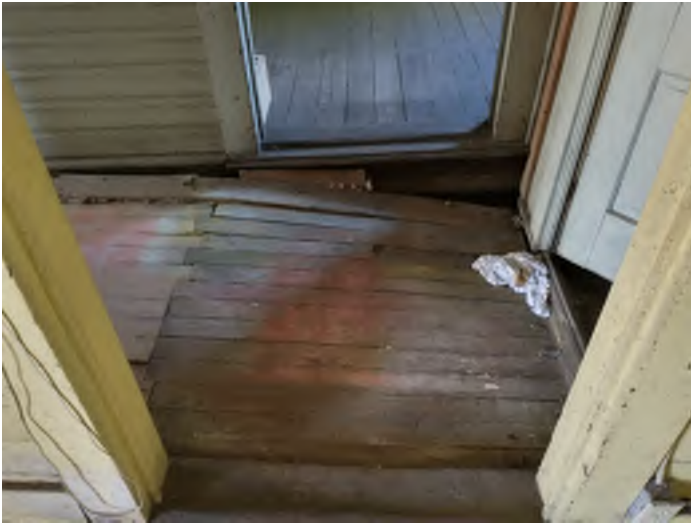
- **Extremely High levels of floor foundation movement** were recorded throughout the structure. Many of the floors are significantly sloping which indicates **foundation support system has failed, is not structurally stable**, and will likely continue to deteriorate

High Levels of Foundation Movement

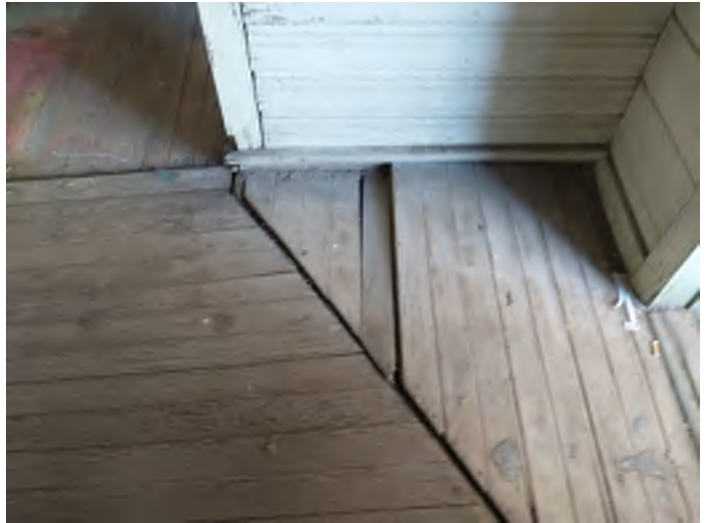
High Levels of Foundation Movement

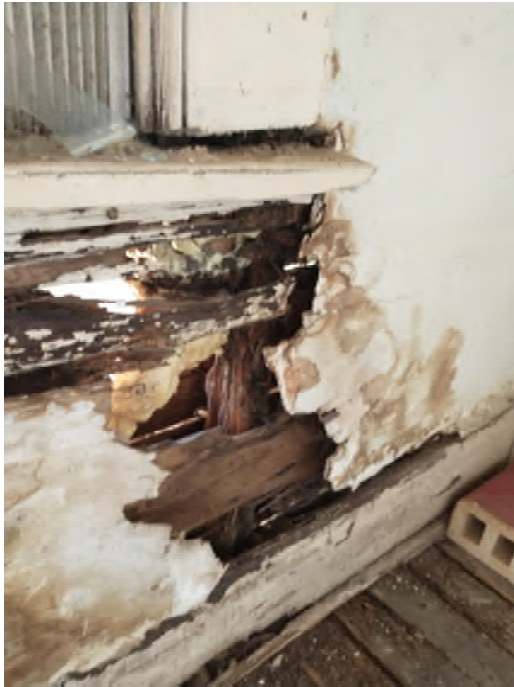
- There is **widespread evidence of water damage** at the building exterior walls. Evidence of water infiltration was observed at windowsills at the building exterior throughout the structure. There are numerous water damaged sheathing and structural studs that compromise the integrity of the structure. There are widespread areas of water staining, chipping/peeling paint. Though not directly observed, there is likely widespread framing rot and deterioration at the exterior walls and foundation framing at areas prone to water intrusion.

Water Damaged Studs and Sheathing

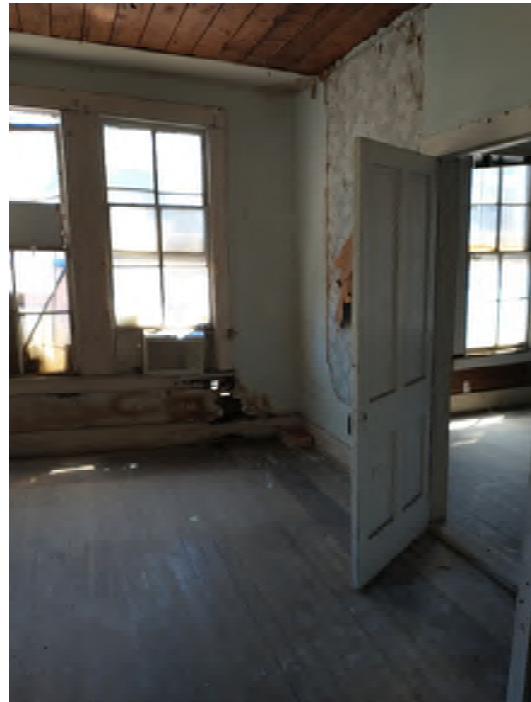
Water Damaged Studs and Sheathing

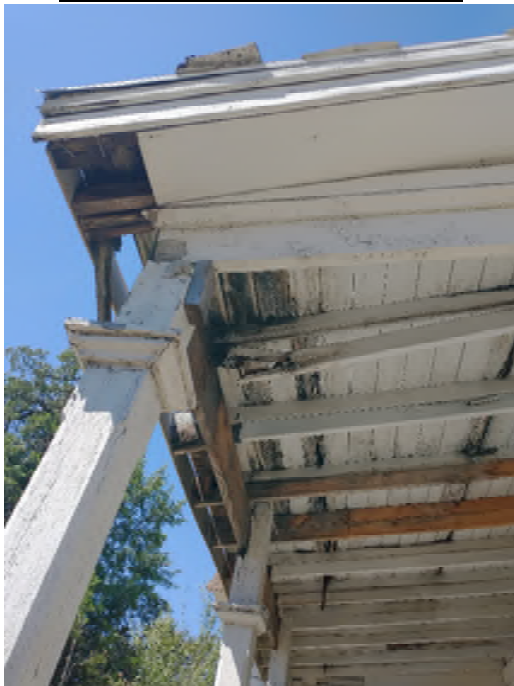
- Multiple portions of the roof are show signs of **rot and deterioration**
- The screen porch framing at the rear of the structure is **structurally inadequate**. The structure framing is extremely weathered and shows signs of deterioration and does not meet the requirements of the International Residential Code.

Rotted and Damaged Roof Framing

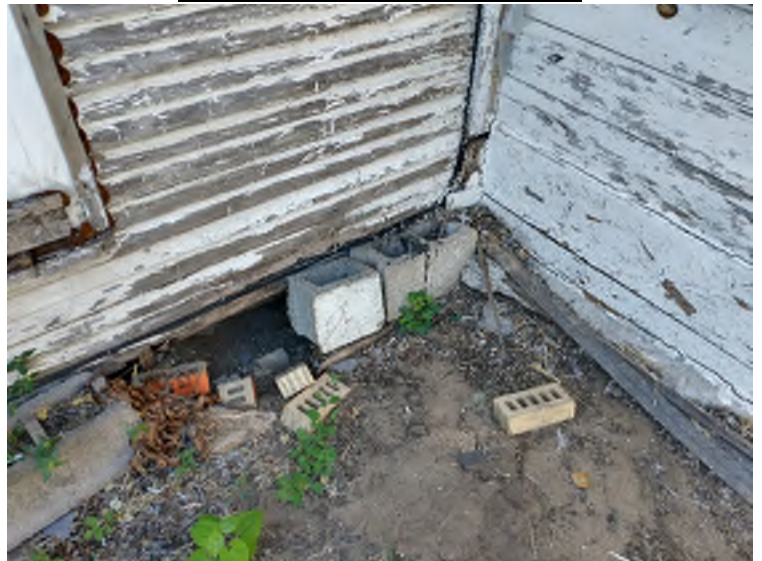
Peeling Paint, Damaged Wood, Ground Contact
