ITEM FOR ENVIRONMENTAL COMMISSION AGENDA

NAME & NUMBER OF PROJECT: Rainey Tower
SPC-2021-0129C

MEMORANDUM

CASE FOLDER: SPC-2021-0129C

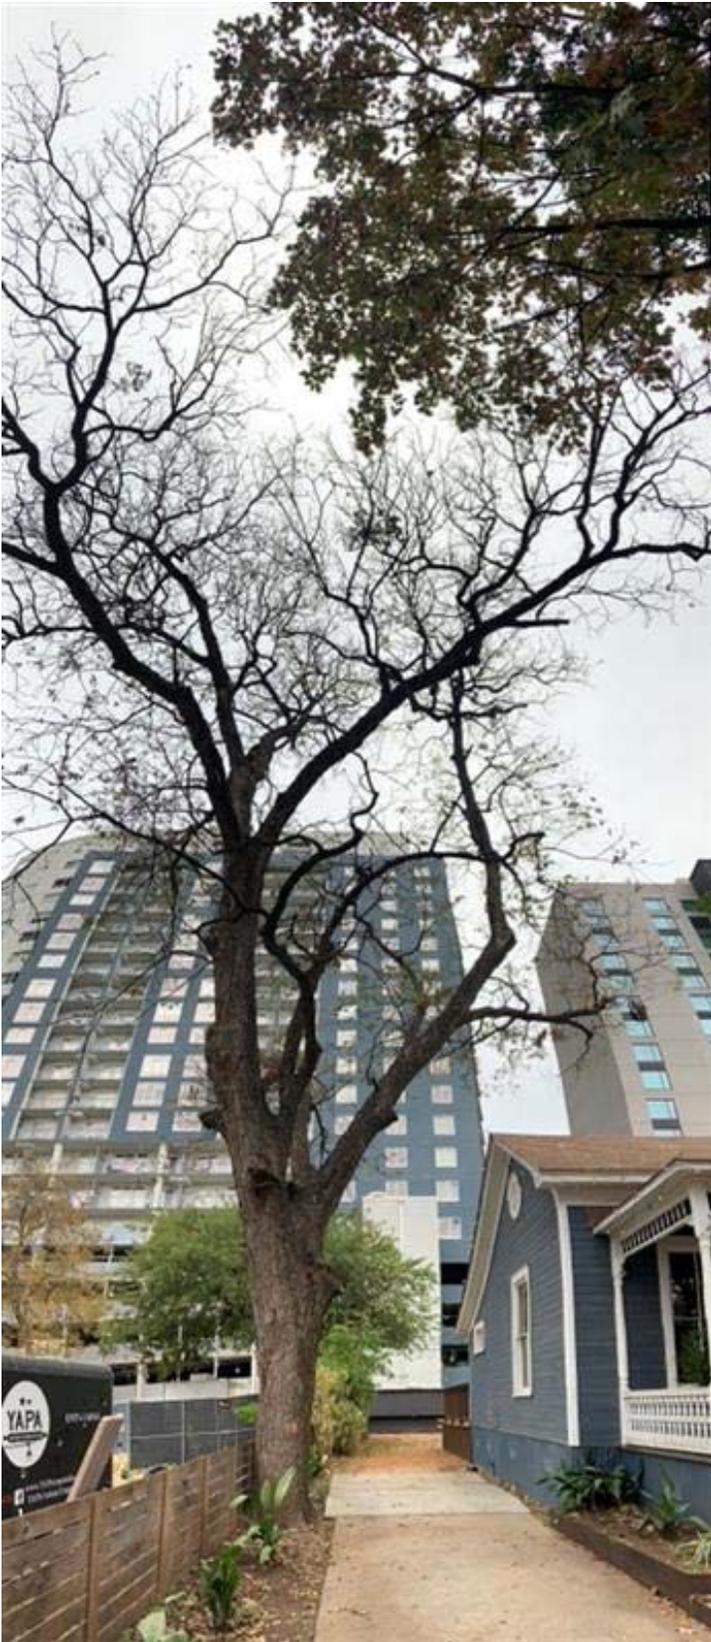
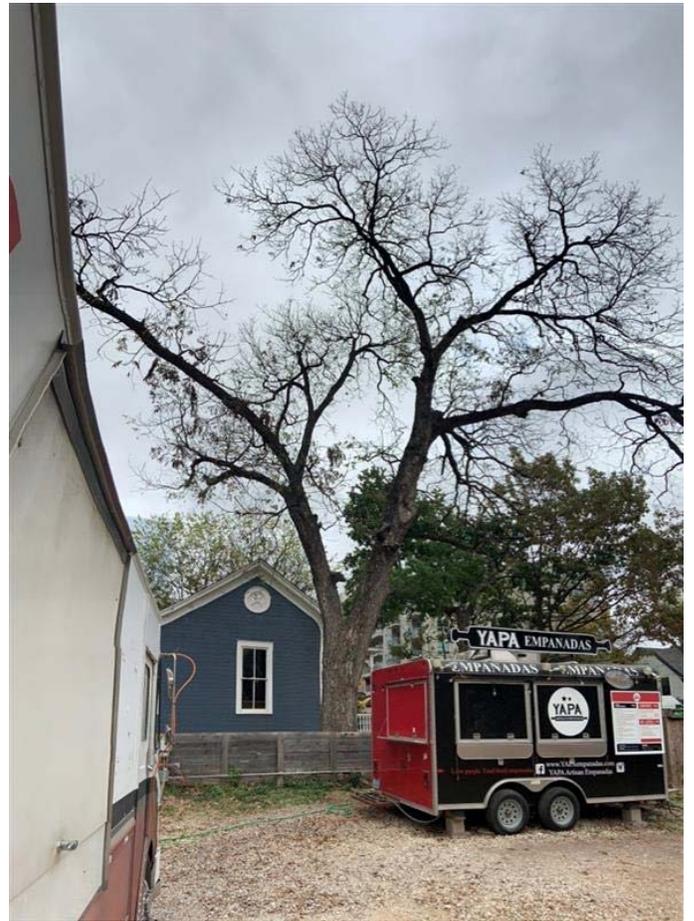
Co-dominant leaders; previous 10" limb failure south side of trunk; previous 8" limb failure north side resulting in damage to roof and house of adjacent building; 27" longitudinal crack in main trunk (west side) 7 ft from grade. Tomography was done at the supporting union of the canopy, results indicate it may be structurally compromised.

Exhibit 1: Whole tree and co-dominant leaders

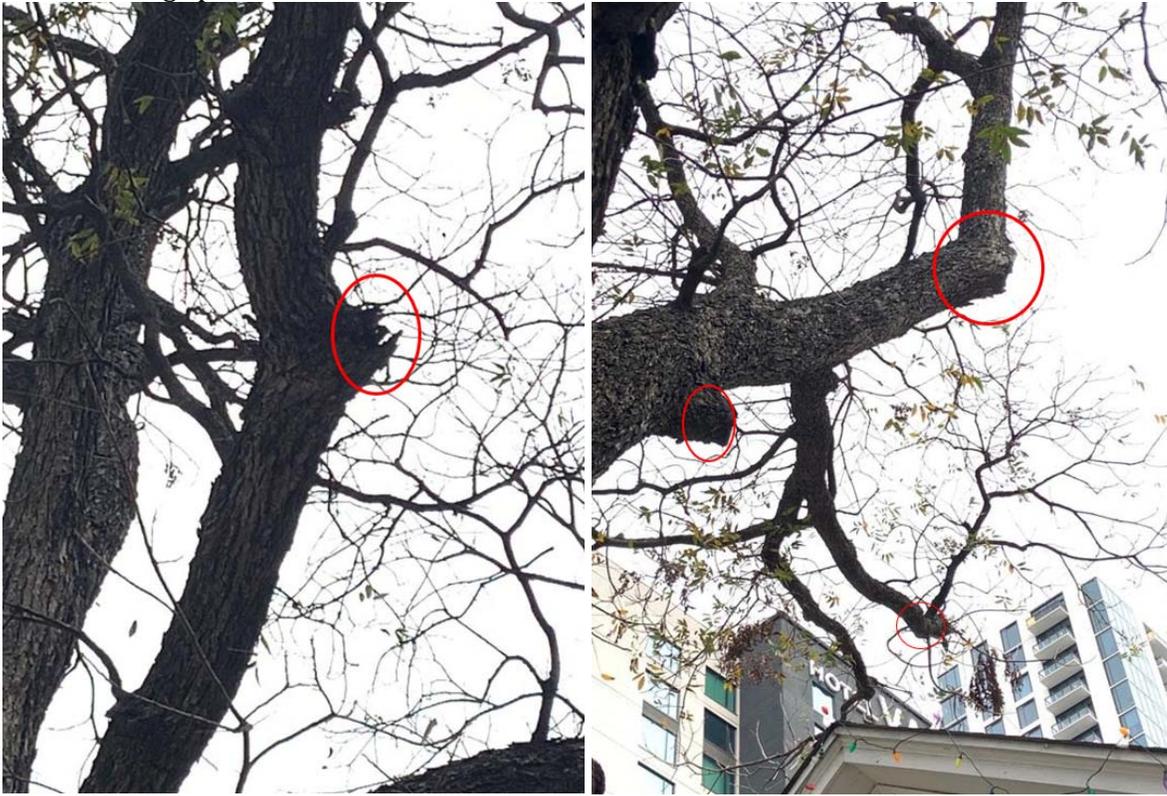
Fair condition; poor structure; history of large previous failures

Exhibit 2: Large previous failures

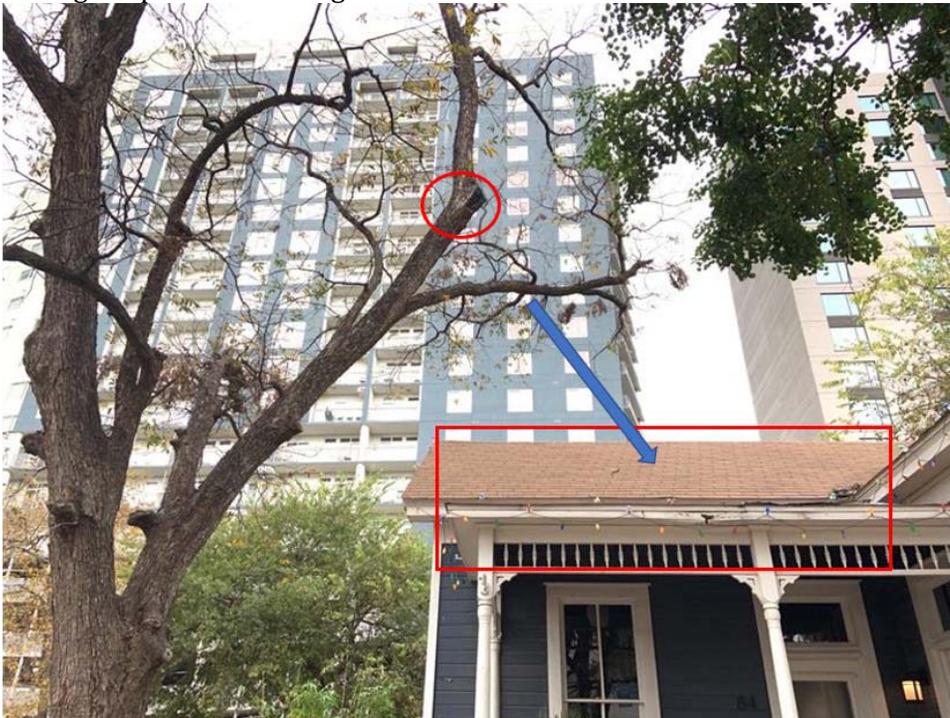
Damage to present building

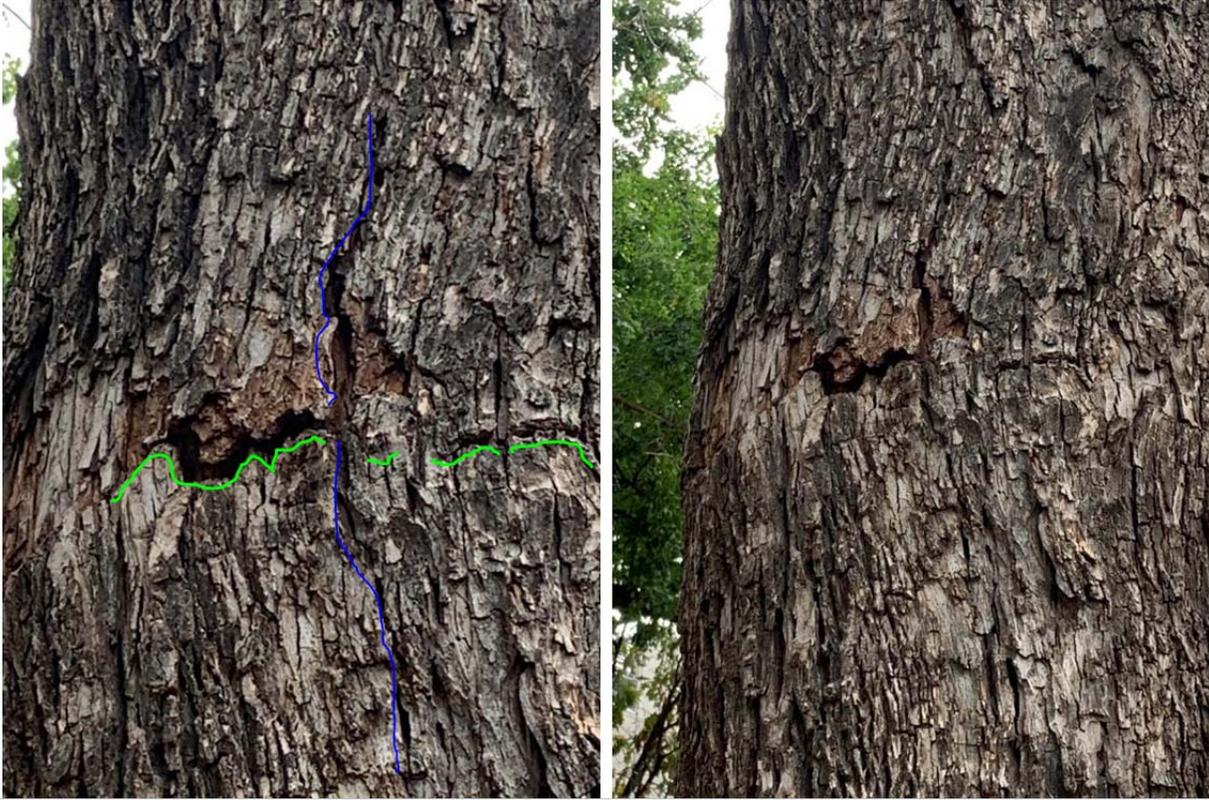
Exhibit 3: Horizontal and longitudinal cracks 7ft above grade

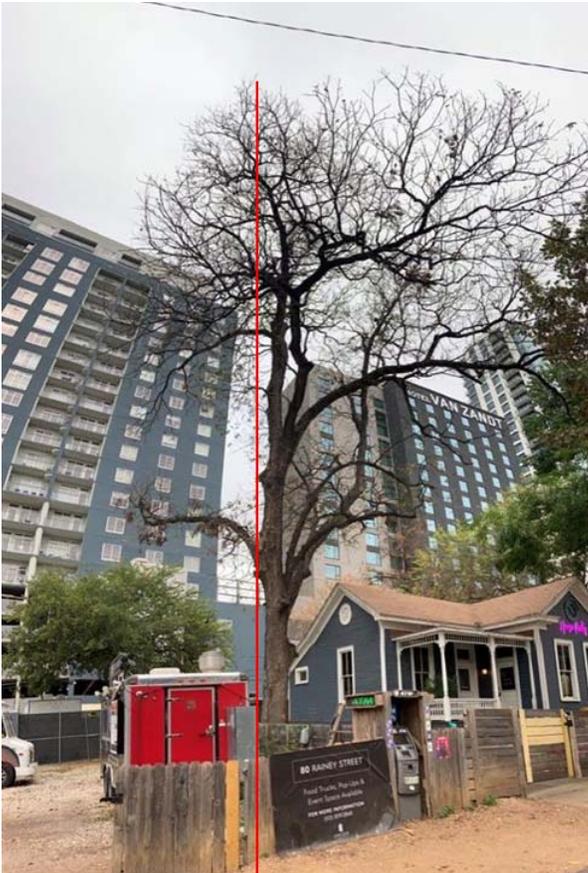
Unbalanced crown; thin canopy; 12+ limb breaks 3-6” diameter in canopy; heavily pruned likely due to several previous failures

Exhibit 4: Unbalanced crown

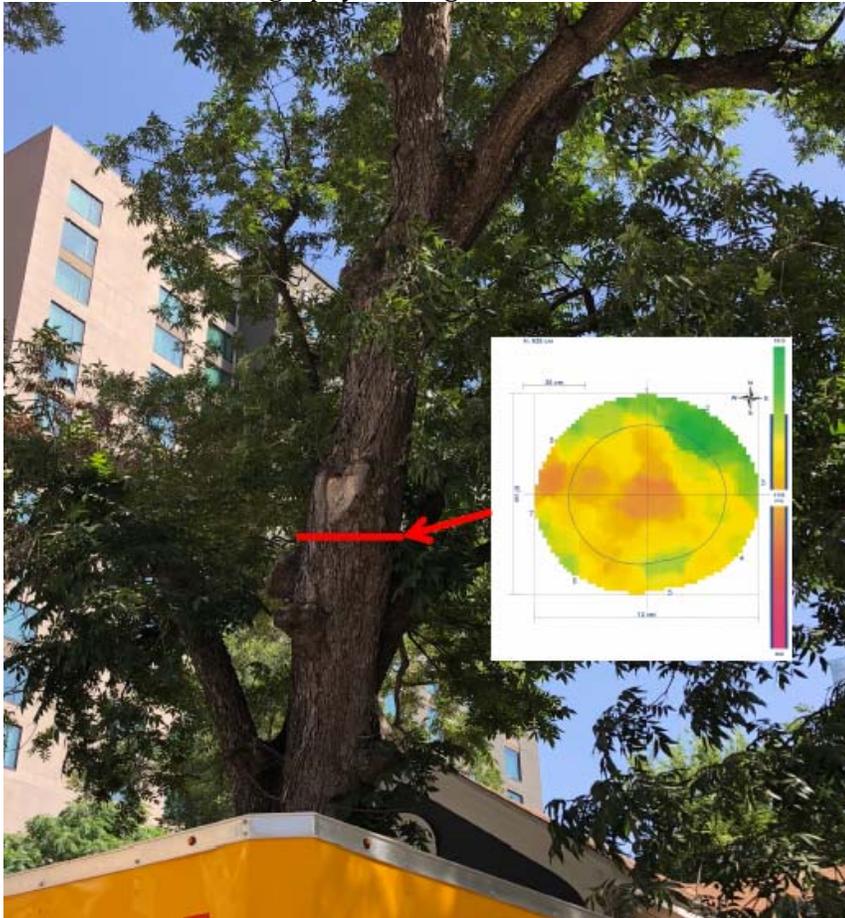
Scan at 625 cm

Exhibit 5: Sonic Tomography reading

This scan shows less sound wood in the center and extending outwards through the shell wall between sensors 3-8, and between 8-1. This scan was taken below an old, exposed pruning wound, and above branch nubs. Failure of this portion of the tree would result in the loss of a significant part of the tree canopy (Image 2). Eight sensors were used in this scan. The scan at this level is structurally compromised.

The City Arborist recommends removal of the tree due to the applicant demonstrating that the tree prevents reasonable use of the site.
