2002 SCENIC DRIVE RESIDENCE, EXISTING CONDITIONS | JUNE 28, 2022

2002 SCENIC DRIVE
EXISTING CONDITIONS

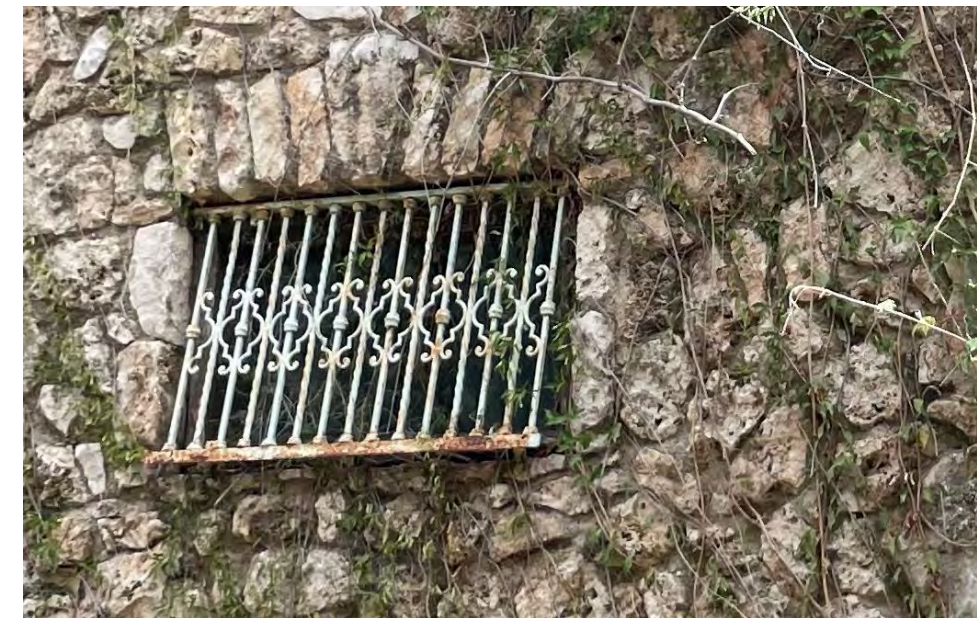
1. METAL IS RUSTED AND VINES ARE ENTERING INTO APARTMENT.
2. WOOD WINDOWS - JAMBS, SILLS, AND FRAME ARE ROTTED. BROKEN PANES THROUGHOUT. VINES ARE OVERGROWN AND ARE ENTERING INTO THE INTERIOR.

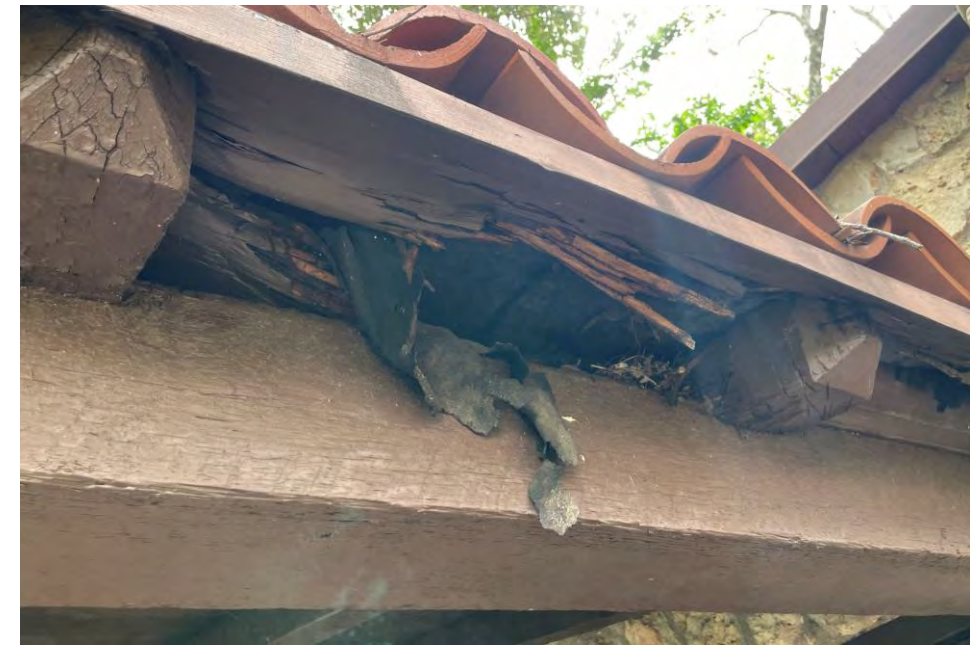
1. THE ROOF IS FALLING APART AND IS SHOWING SIGNS OF WATER DAMAGE.
2. THE ROOF IS SLANTING, WHICH IS A SIGN OF STRUCTURAL FAILURE AND MATERIAL DETERIORATION.

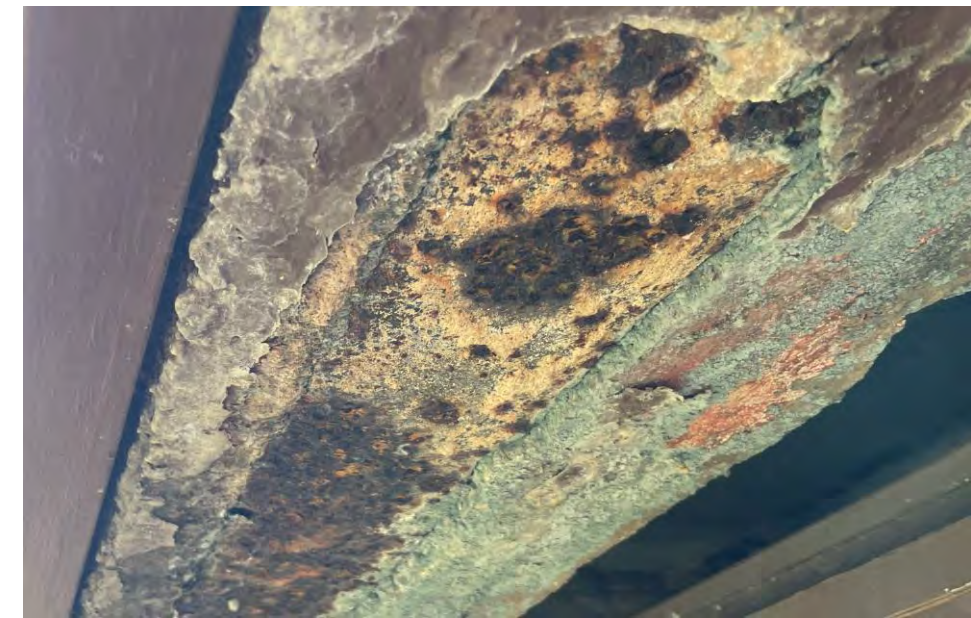
1. THE UNDERSIDE OF THE GARAGE ROCK WALL IS SHOWING SIGNS OF MOLDING.
2. THE ROOF OF THE GARAGE IS MOLDING AND HAS WATER DAMAGE.

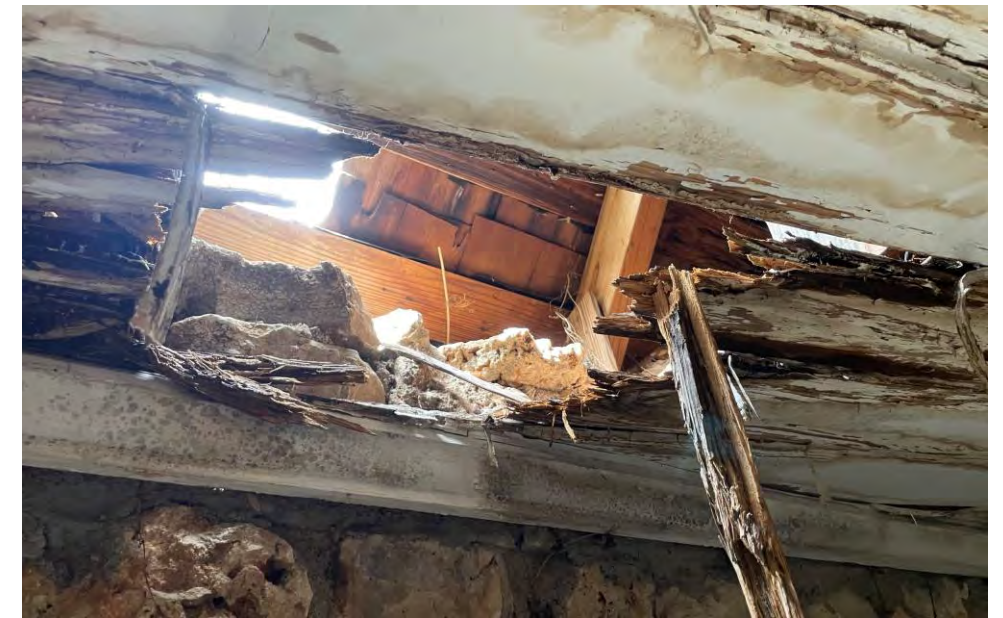
1. HOLES IN CEILING AND ROOF – SKY VISIBLE THROUGH INTERIOR CEILINGS AND ROOF. VINES HAVE INVADDED STRUCTURE THROUGH BOTH ROOF AND BROKEN WINDOWS.
2. WATER DAMAGE – EVIDENCE OF LONG-TERM WATER DAMAGE APPARENT ON CEILINGS, WALLS, AND FLOORS.

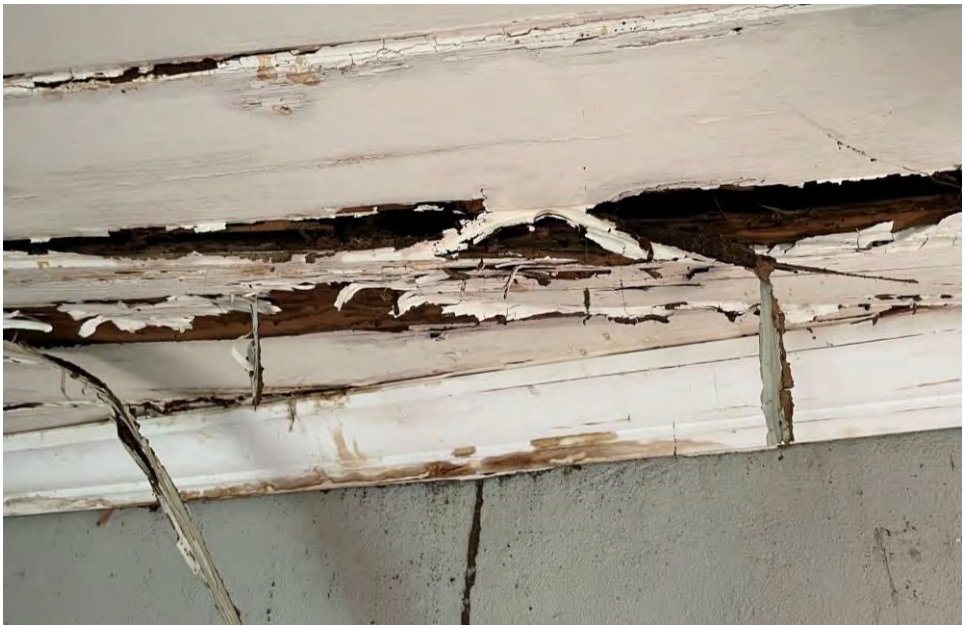
1. THE CEILING IS BOWED AND SHOWS SIGNS OF WATER DAMAGE AND DETERIORATION.
2. DUE TO THE CEILING FAILURE, DIRT AND DEBRIS ARE COLLECTING ON THE FLOOR BELOW.

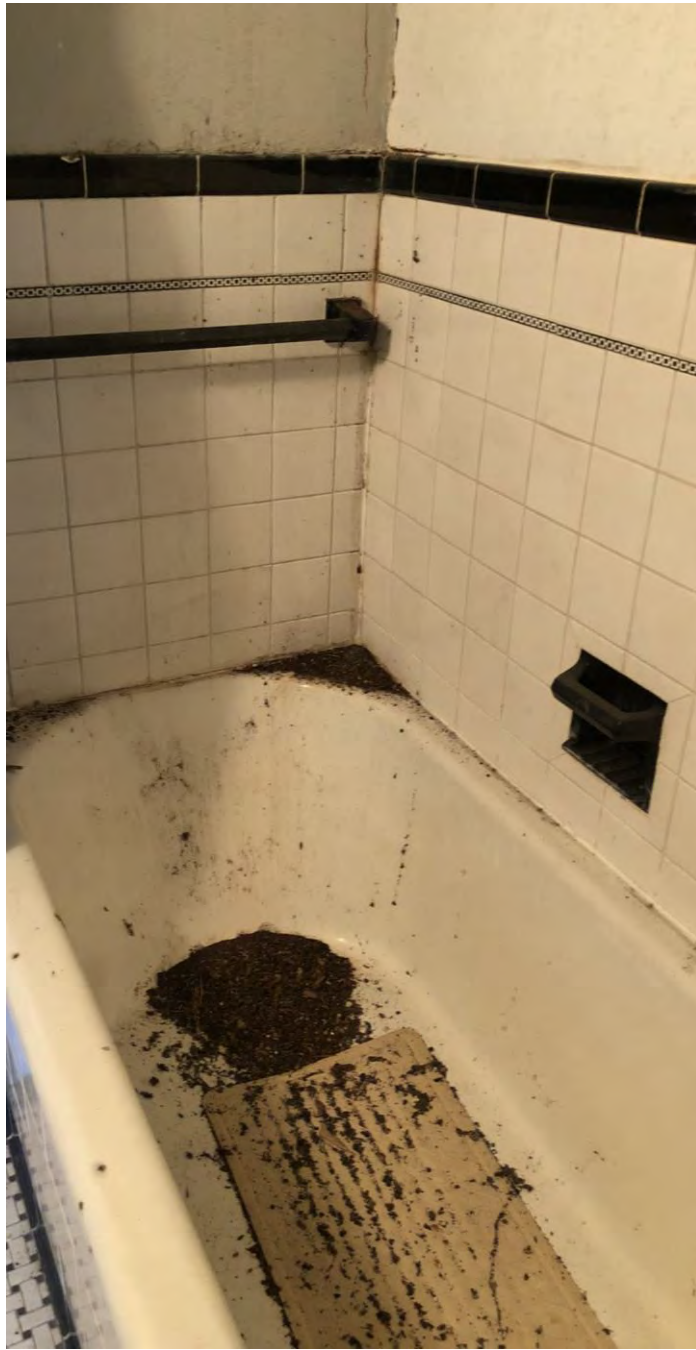
1. DEBRIS HAS COLLECTED INSIDE THE BATHTUB, SHOWING WATER DAMAGE AND CEILING FAILURE.
2. THE CEILING HAS MOLD GROWING ON THE SURFACE OF THE WOOD, WHICH IS CAUSING FAILURE AND COMPROMISING THE MATERIAL.

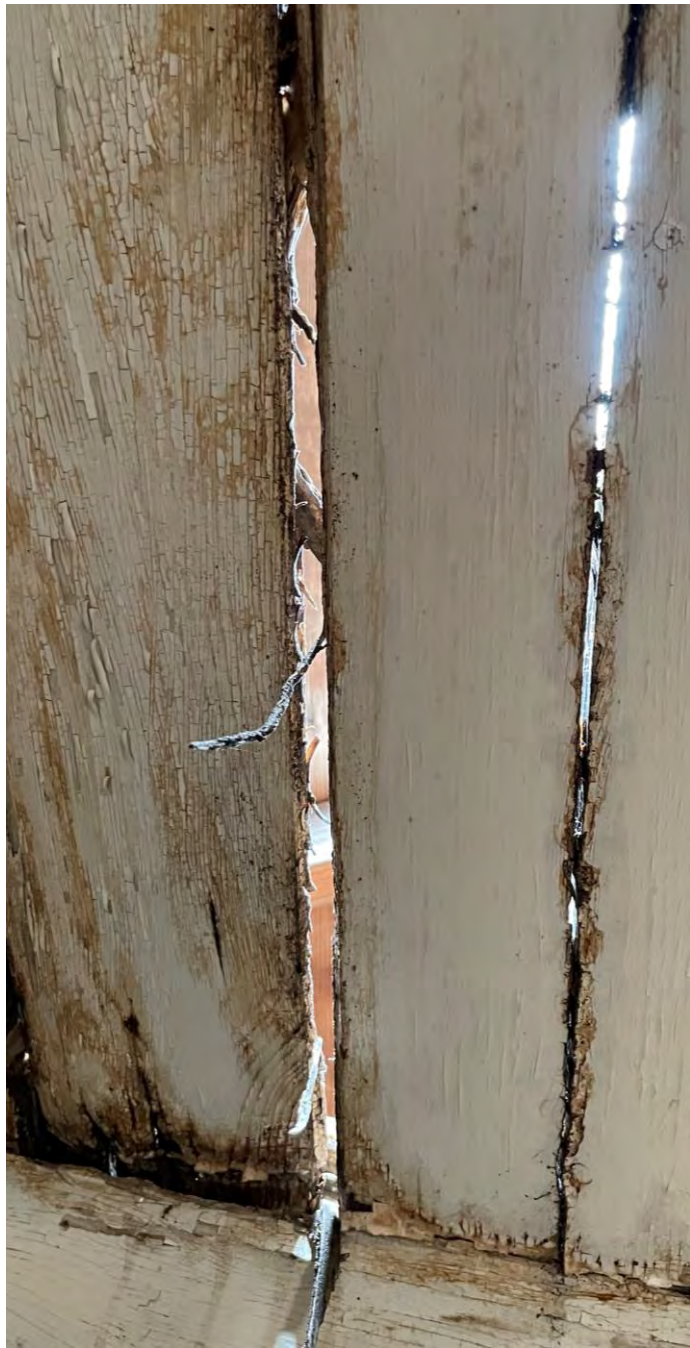
1. WOOD CEILING IS ROTTED, FALLING APART, AND SEPERATING.
2. CEILING FAILURE HAS OPENDED THE INTERIOR UP TO EXTERIOR LIGHT, WATER, AND AIR. WATER DAMAGE CAN BE SEEN ON THE WALL AND CEILING.
3. THE KITCHEN CEILING AND STRUCTURE HAS DETERIORATED AND IS FALLING APART.

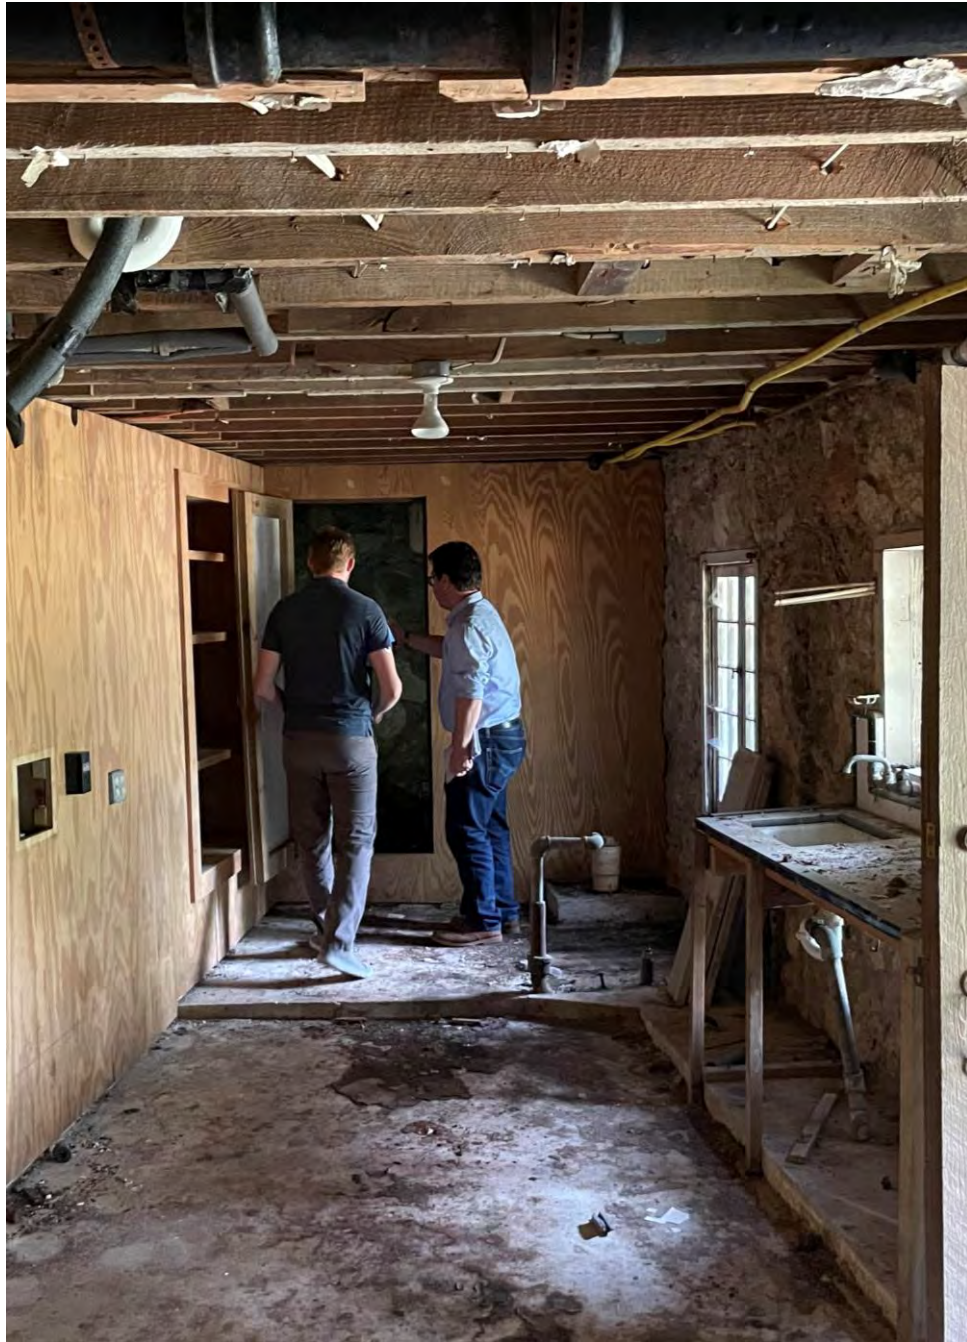
1. WATER IS LEAKING THROUGH THE RETAINING WALL AND INTO THE APARTMENT. WATER CAN ACTIVELY BE SEEN DRIPPING DOWN THE ROCK WALL.
2. IN ORDER TO HOLD UP THE SECOND FLOOR, RAILWAY TIES ARE USED AS STEEL BEAMS.
3. WATER IS DRIPPING DOWN THE ROCK AND FINDS ITS WAY TO THE STRUCTURE'S CONCRETE BASE.

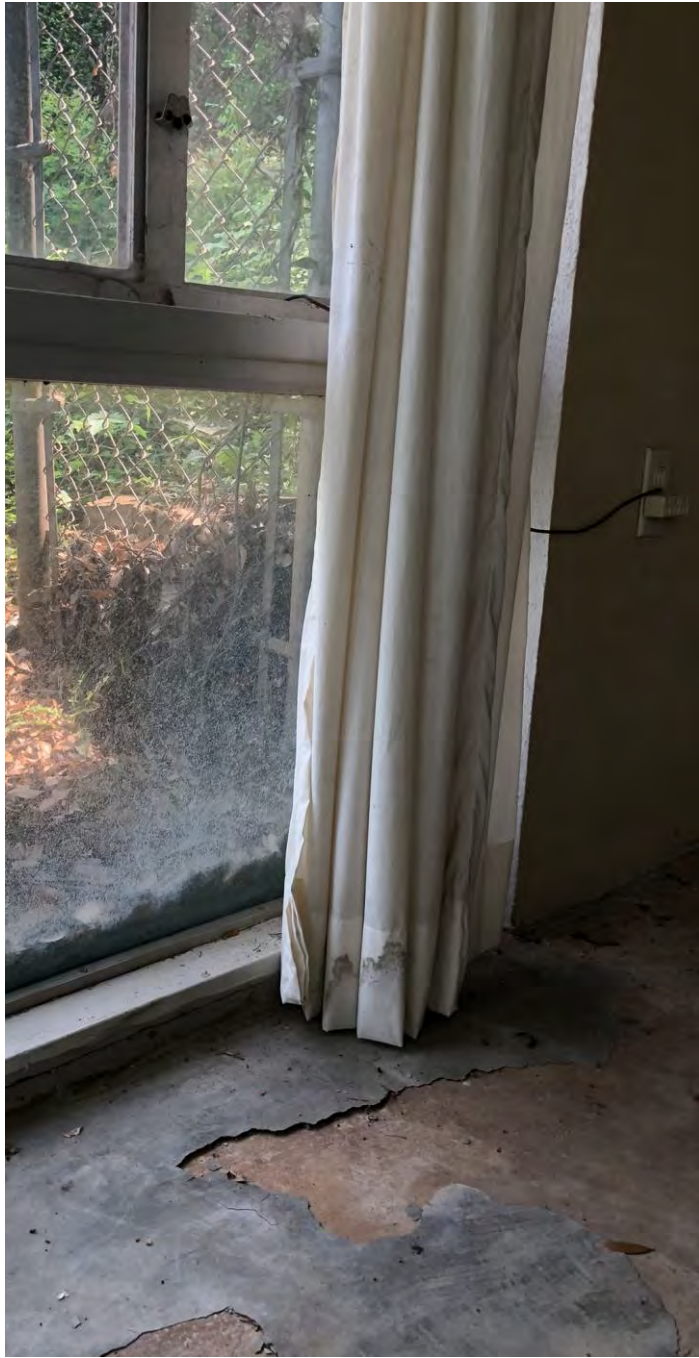
1. THE FLOOR IS DAMAGED AND FLAKING. ON THE EXTERIOR, THE HEIGHT OF THE GROUND IS HIGHER THAN THE HEIGHT OF THE WINDOW SILL, ALLOWING WATER TO FLOW INTO THE HOUSE.
2. WATER IS DAMAGING THE CEILING IN LARGE AREAS. BLACK MOLD IS EVIDENT IN MULTIPLE LOCATIONS.
3. IN THIS LOCATION THE WATER DAMAGE IS ESPECIALLY EVIDENT AND DESTRUCTIVE. MOLD IS A POTENTIAL HEALTH HAZARD AND WOULD REQUIRE AN EXTENSIVE MITIGATION EFFORT.

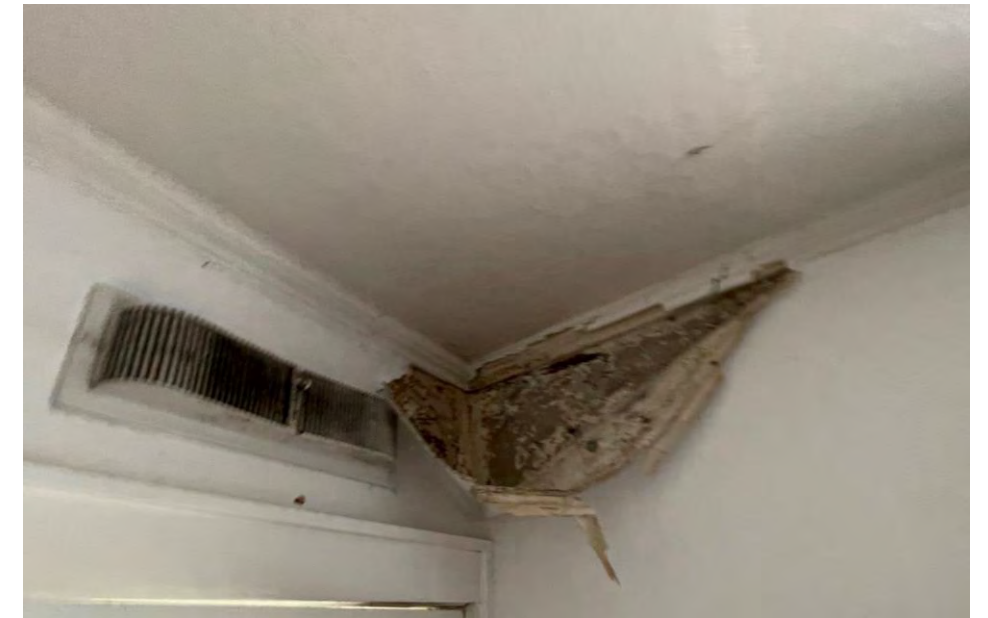
1. THE PLASTER AND THE TRIM ARE FALLING APART AND EXPOSING THE WALL BENEATH.
2. THE PLASTER IS CRACKING.

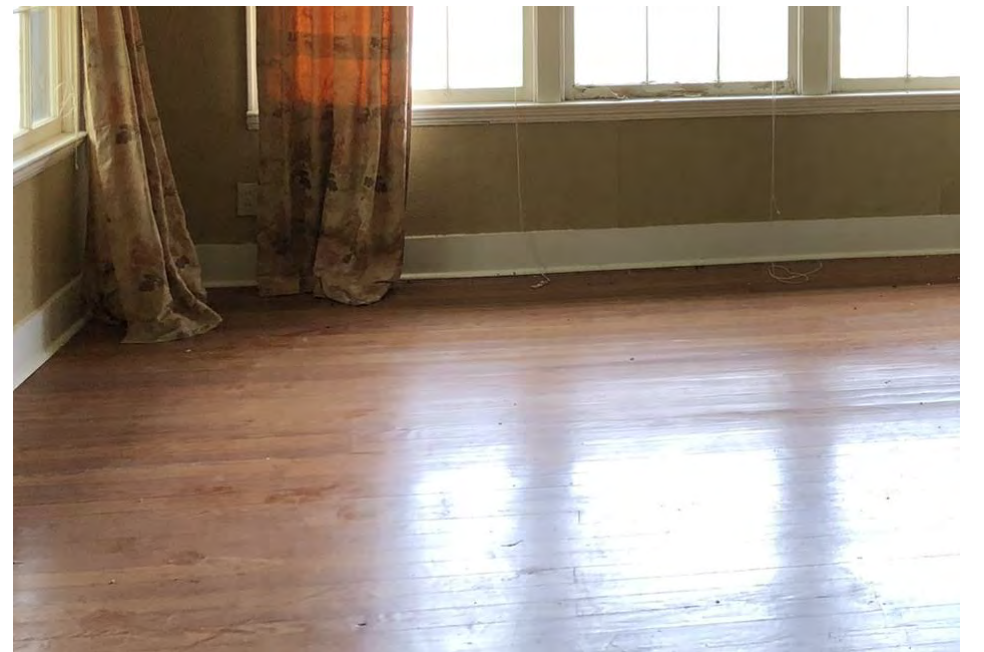
1. THE WINDOWSILL IS FALLING APART AND IS DROPPING DEBRIS ONTO THE WINDOW SILL AND FLOOR.
2. THE FLOOR IS BOWING DUE TO THE LACK OF STRUCTURAL SUPPORT BELOW.

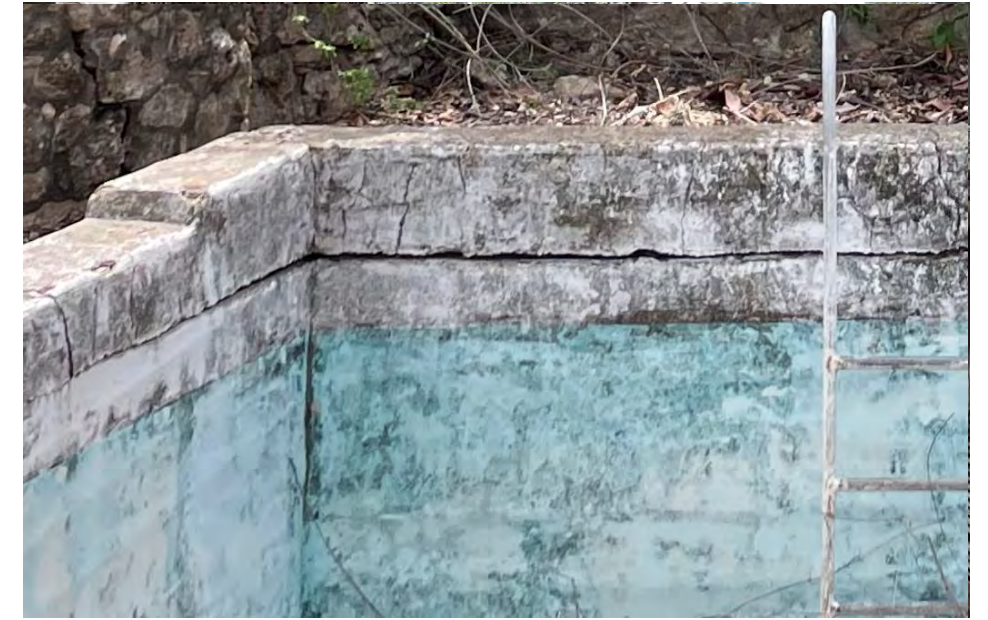
1. THE POOL'S STONE AND CONCRETE ARE SPLITTING APART AND CRACKING.
