# Engineer's Report

Assessment of structural conditions  
2002 Scenic Drive, Austin, Texas

21206.01

June 20, 2022

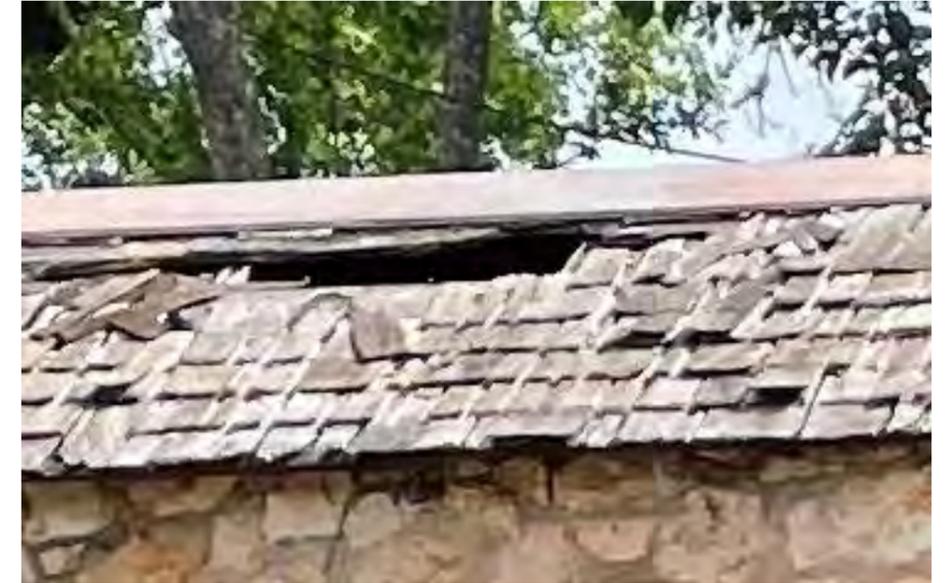
1. ROOF DAMAGE INDICATED BY DISPLACED, DAMAGAGED AND MISSING SHINGLES. HOLES IN THE ROOF POINT TO BROAD WATER DAMAGE WITHIN AND POTENTIAL DAMAGE TO STRUCTURE.
2. WOOD WINDOWS - JAMBS, SILLS, AND FRAME ARE ROTTED. BROKEN PANES THROUGHOUT.

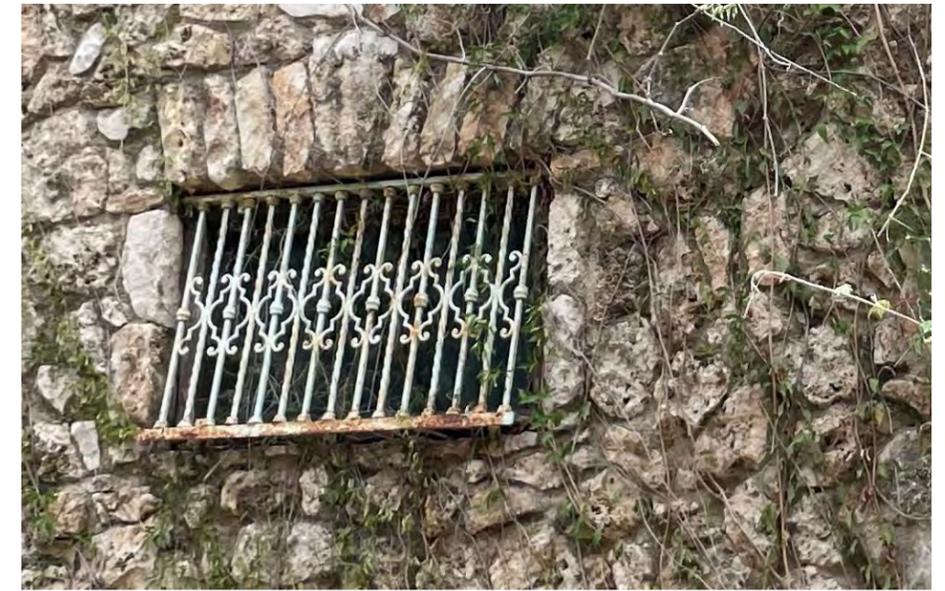
1. METAL IS RUSTED AND VINES ARE ENTERING INTO APARTMENT.
2. WOOD WINDOWS - JAMBS, SILLS, AND FRAME ARE ROTTED. BROKEN PANES THROUGHOUT. VINES ARE OVERGROWN AND ARE ENTERING INTO THE INTERIOR.

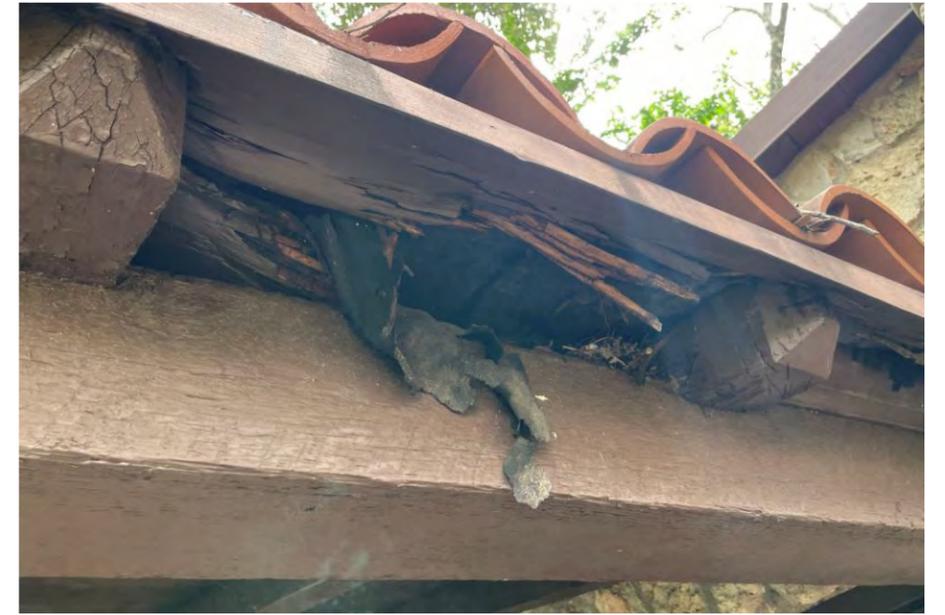
1. THE ROOF IS FALLING APART AND IS SHOWING SIGNS OF WATER DAMAGE.
2. THE ROOF IS SLANTING, WHICH IS A SIGN OF STRUCTURAL FAILURE AND MATERIAL DETERIORATION.

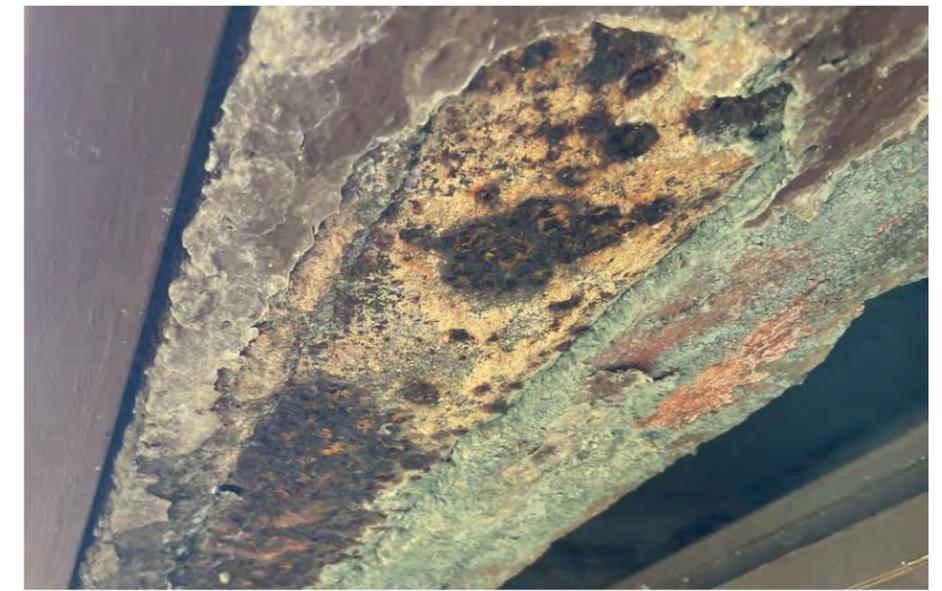
1. THE UNDERSIDE OF THE GARAGE ROCK WALL IS SHOWING SIGNS OF MOLDING.
2. THE ROOF OF THE GARAGE IS MOLDING AND HAS WATER DAMAGE.

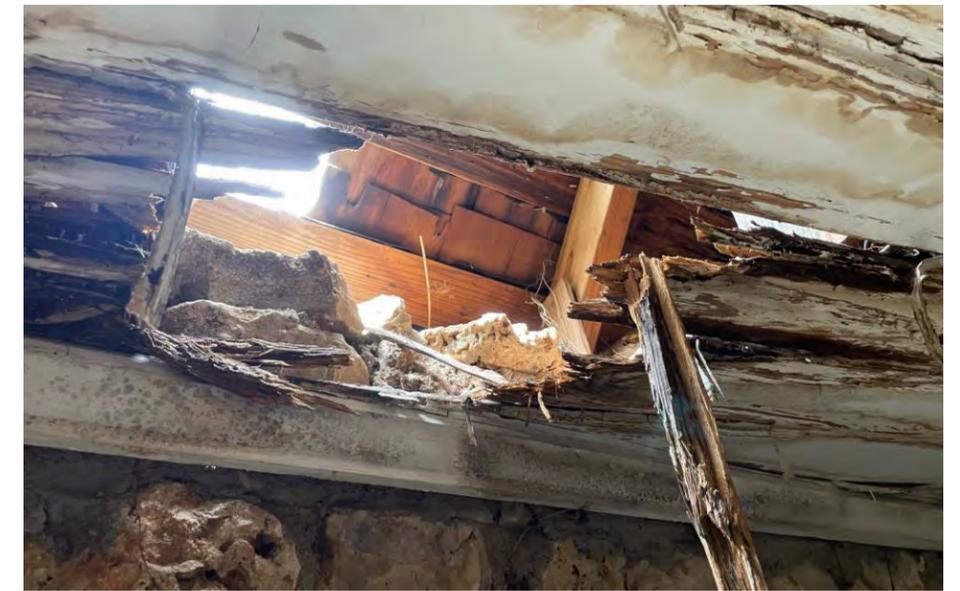
The degradation of the roof and windows has allowed water into the building for an unknown but obviously prolonged period of time. The wood roof framing has obvious rot in areas exposed by holes, and I believe it is likely that further investigation will reveal that none of the roof framing is salvageable. Given the excessive deflection of the roof (photo on page 12) and the concerns about the floor joists mentioned below, I caution against entering this building until the roof and floor can be adequately shored.

1. HOLES IN CEILING AND ROOF - SKY VISIBLE THROUGH INTERIOR CEILINGS AND ROOF. VINES HAVE INVADDED STRUCTURE THROUGH BOTH ROOF AND BROKEN WINDOWS.
2. WATER DAMAGE - EVIDENCE OF LONG-TERM WATER DAMAGE APPARENT ON CEILINGS, WALLS, AND FLOORS.

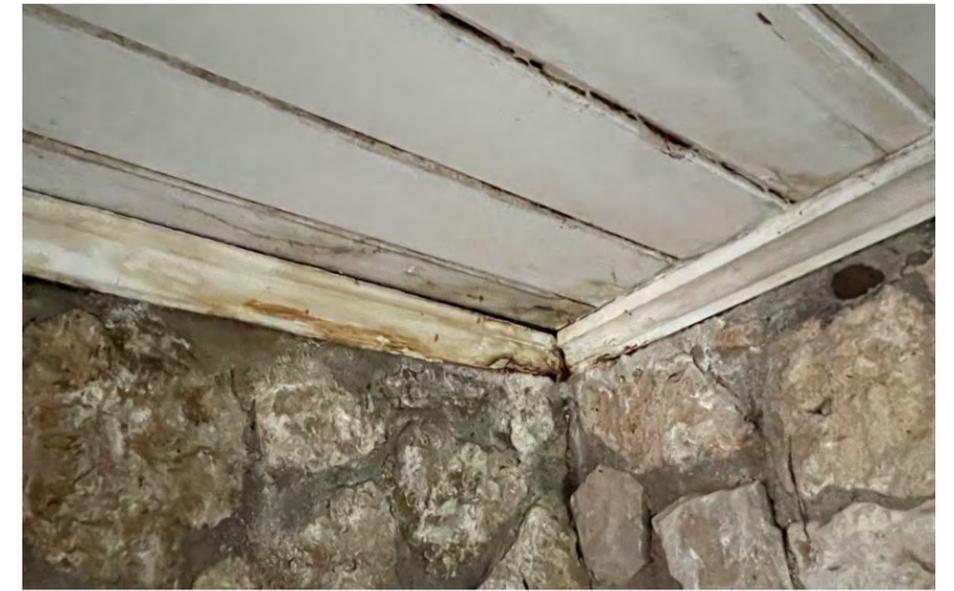
1. DISCOLORATION AND ROT SHOWS SIGNS OF WATER DAMAGE.
2. WATER DAMAGE - DISCOLORATION AND DEBRIS INDICATE LONG-TERM WATER DAMAGE ON CEILINGS, WALLS, AND FLOORS.

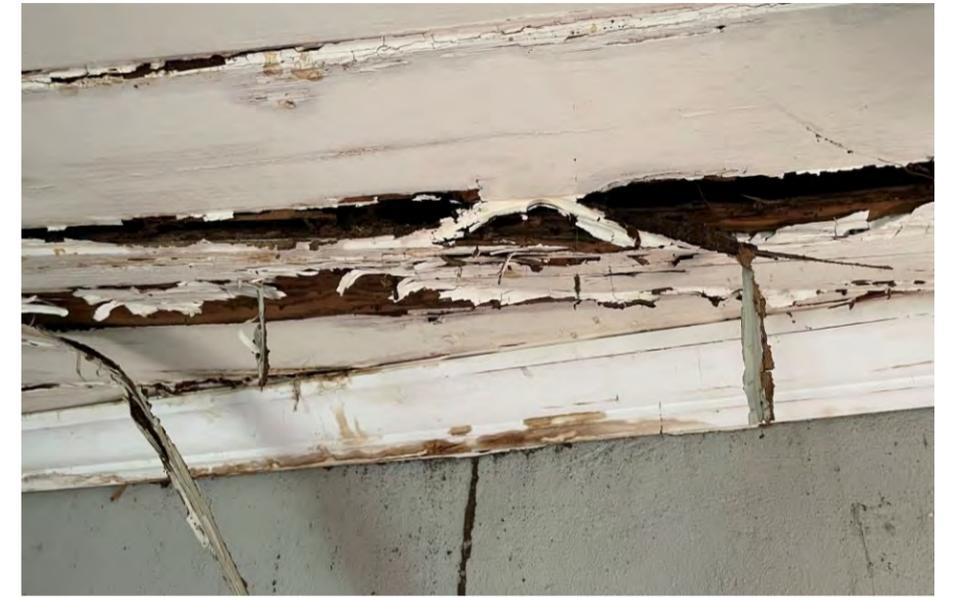
1. THE CEILING IS BOWED AND SHOWS SIGNS OF WATER DAMAGE AND DETERIORATION.
2. DUE TO THE CEILING FAILURE, DIRT AND DEBRIS ARE COLLECTING ON THE FLOOR BELOW.

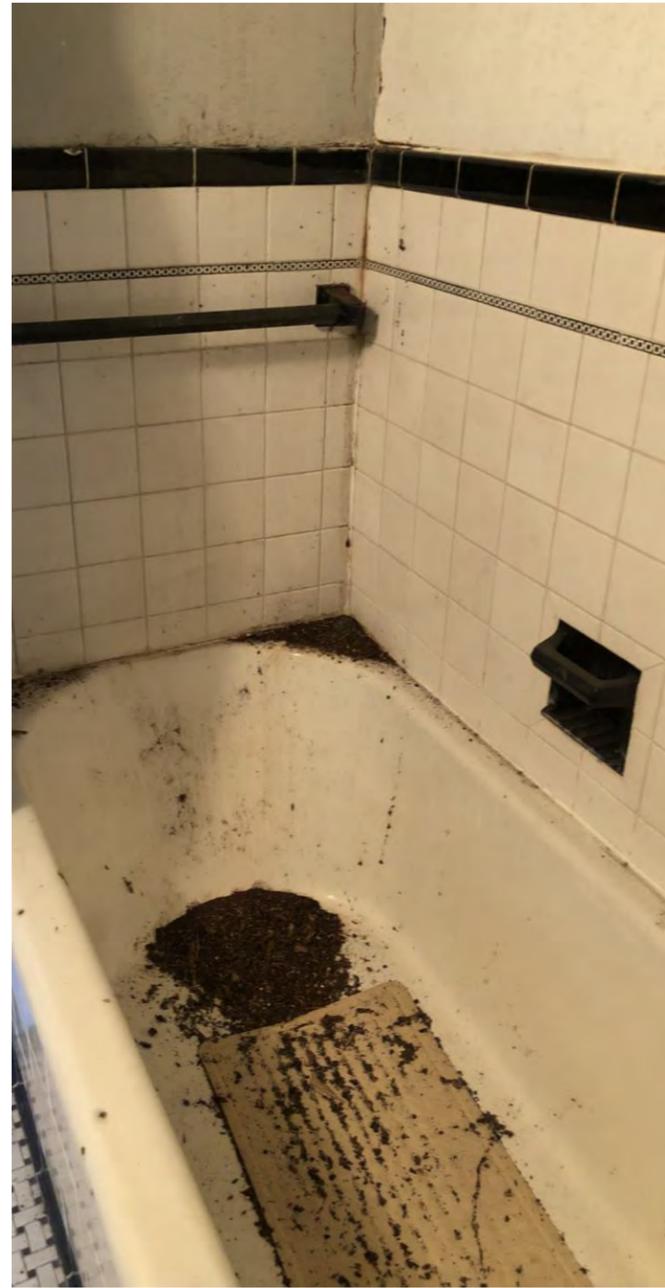
1. DEBRIS HAS COLLECTED INSIDE THE BATHTUB, SHOWING WATER DAMAGE AND CEILING FAILURE.
2. THE CEILING HAS MOLD GROWING ON THE SURFACE OF THE WOOD, WHICH IS CAUSING FAILURE AND COMPROMISING THE MATERIAL.

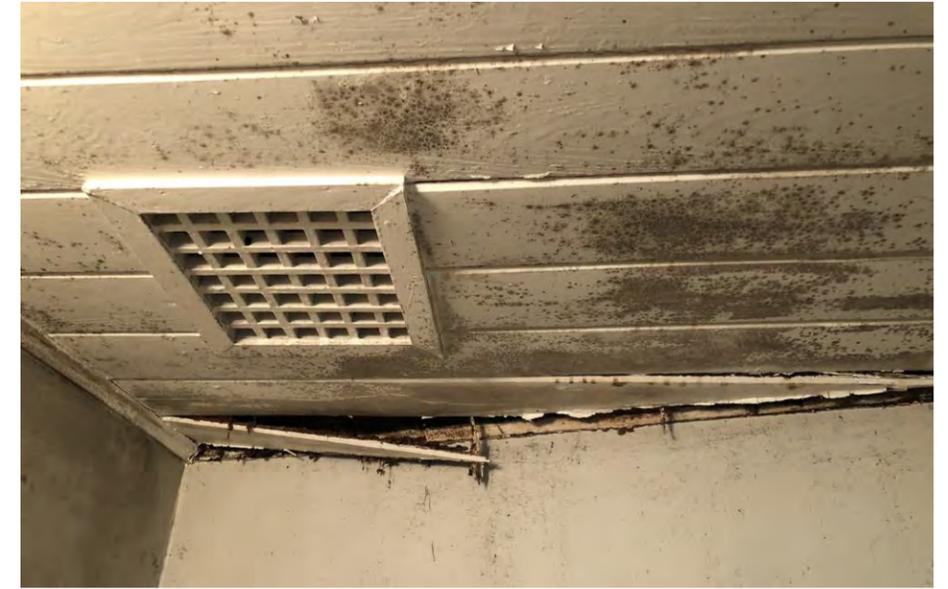
3. THE CEILING IN THE BATHROOM IS DETERIORATING AND MOLDING.

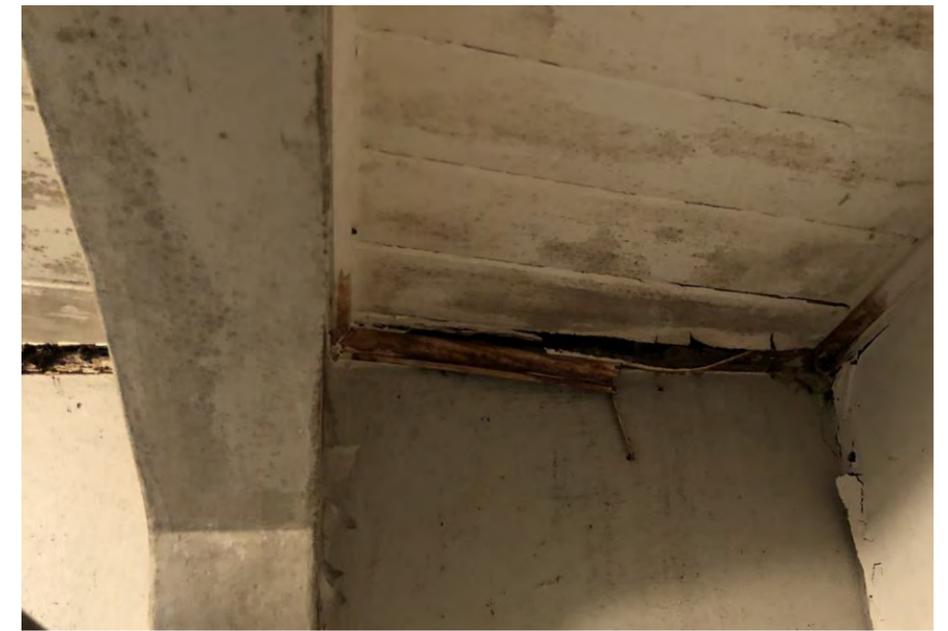
4. THE CEILING OVER THE BATHTUB IS DETERIORATING AND ALLOWING DEBRIS TO COLLECT IN THE TUB.

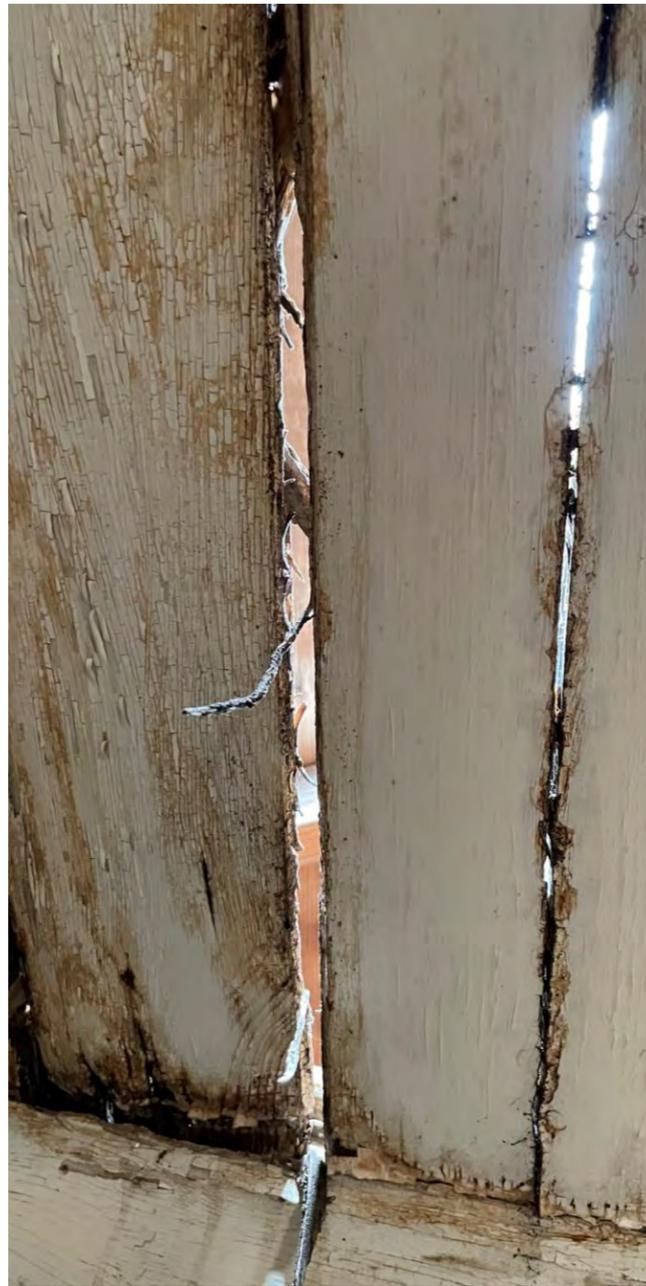
1. WOOD CEILING IS ROTTED, FALLING APART, AND SEPERATING.
2. CEILING FAILURE HAS OPENED THE INTERIOR UP TO EXTERIOR LIGHT, WATER, AND AIR. WATER DAMAGE CAN BE SEEN ON THE WALL AND CEILING.
3. THE KITCHEN CEILING AND STRUCTURE HAS DETERIORATED AND IS FALLING APART.

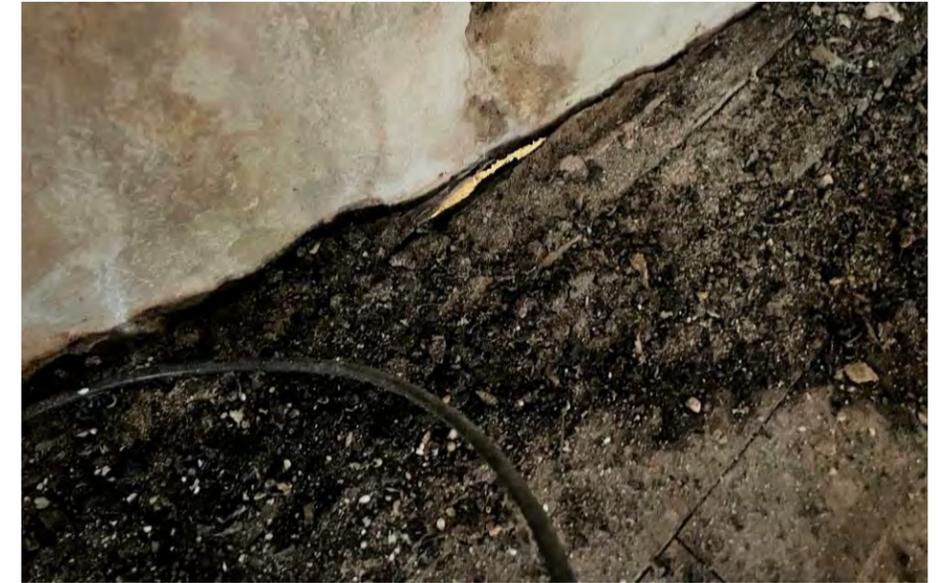
1. CEILING FAILURE HAS ALLOWED DEBRIS AND DIRT TO COLLECT INSIDE THE APARTMENT. THE WOODEN FLOOR IS CRACKING AND DETERIORATING FROM WATER DAMAGE.
2. THE WOODEN FLOOR IS FALLING APART AND SEPERATING FROM THE WALL.

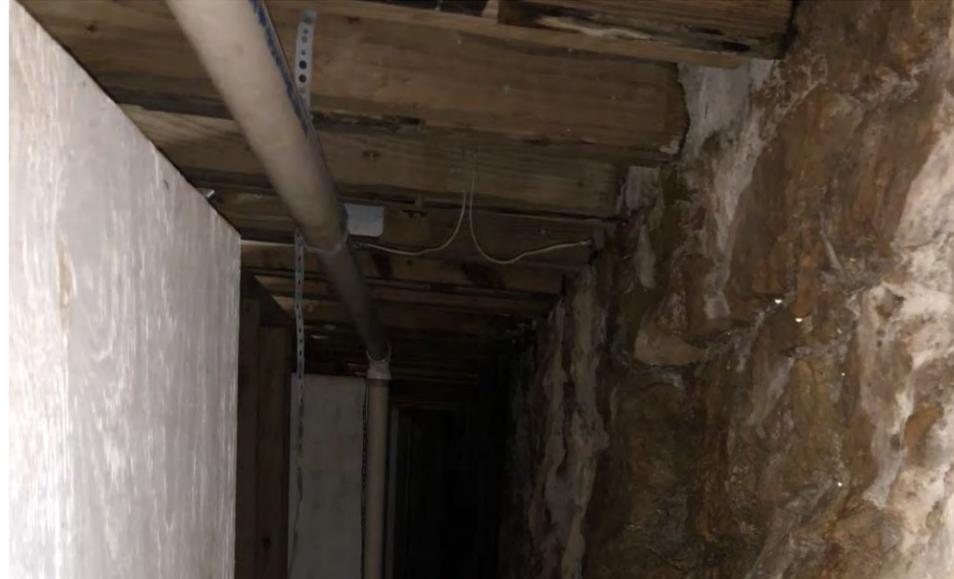
The existing floor joists are supported in slots gouged into the face of the exposed limestone cut (photo 1, page 16), which was leaching water (photo 3, page 16) during my visits despite no antecedent rainfall. The ends of the joists are spliced onto the original joists as part of a previous repair which was undoubtedly caused by previous similar rot. The splices are not adequate and show clear signs of deflection and distress. The repair ends are now showing signs of rot. These structural connections are inadequate and dangerous.

1. WATER IS LEAKING THROUGH THE RETAINING WALL AND INTO THE APARTMENT. WATER CAN ACTIVELY BE SEEN DRIPPING DOWN THE ROCK WALL.
2. IN ORDER TO HOLD UP THE SECOND FLOOR, RAILWAY TIES ARE USED AS STEEL BEAMS.
3. WATER IS DRIPPING DOWN THE ROCK AND FINDS ITS WAY TO THE STRUCTURE'S CONCRETE BASE.

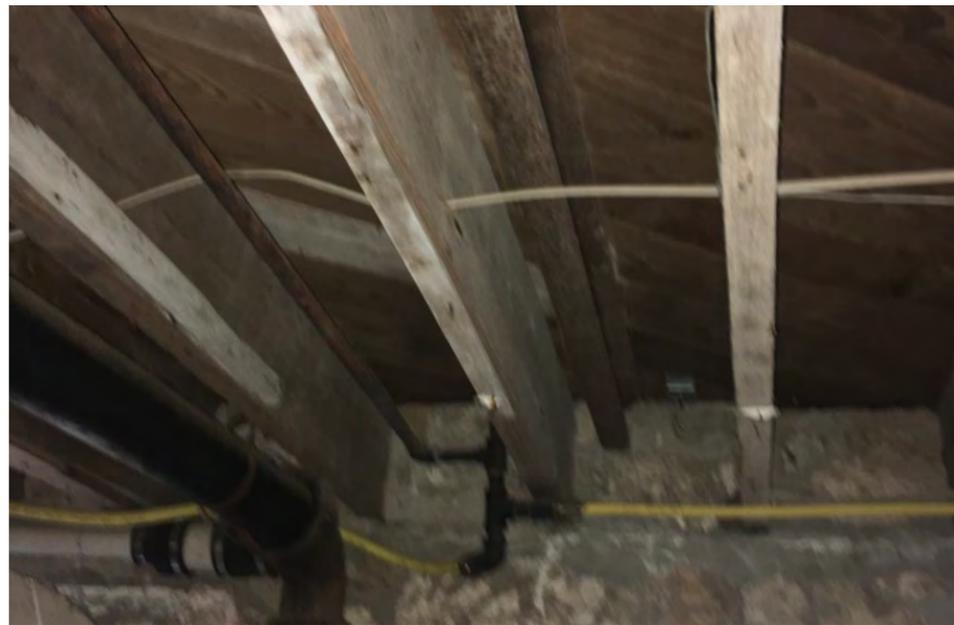
2.

The stone wall on the second floor is supported on an inverted steel railroad rail, which is not properly supported at points of bearing or against rotation. The elevated concrete slab over the garage also appears to use steel railroad rails as reinforcement, and the steel shows severe corrosion. Again, I recommend caution under and on this slab until it can be properly shored.

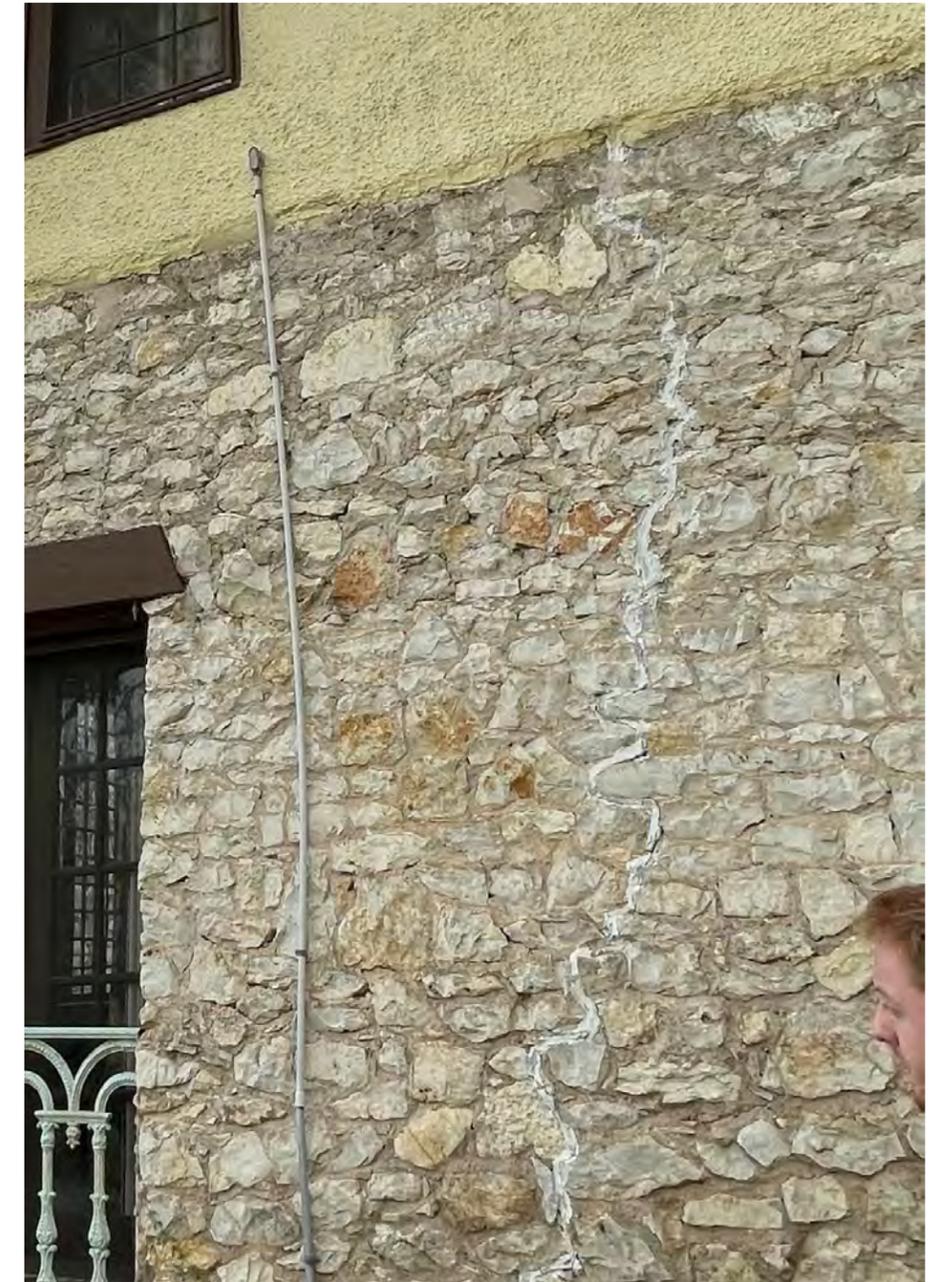
Additionally, the reuse of the existing masonry walls as non-load-bearing is not possible. The south wall has a significant crack (photo on page 19) that was previously patched and continues to move. This wall is noticeably out-of-square and out-of-plumb. Foundation movement is likely occurring. Further investigation will be required, but if the foundation is rubble, which is typical for the era, less invasive stabilization techniques will not be possible. The masonry walls will need to be removed so that the foundation can be rebuilt with reinforced concrete.

1. THERE IS A CRACK THAT STARTS AT THE ROOF, GOES THROUGH THE STUCCO SECOND FLOOR, AND CONTINUES THROUGH THE STONE WALL TO THE GROUND. IT HAS BEEN FILLED AND COVERED WITH PLASTER. THE BOTTOM OF THE STONE WALL SHOWS WATER DAMAGE.

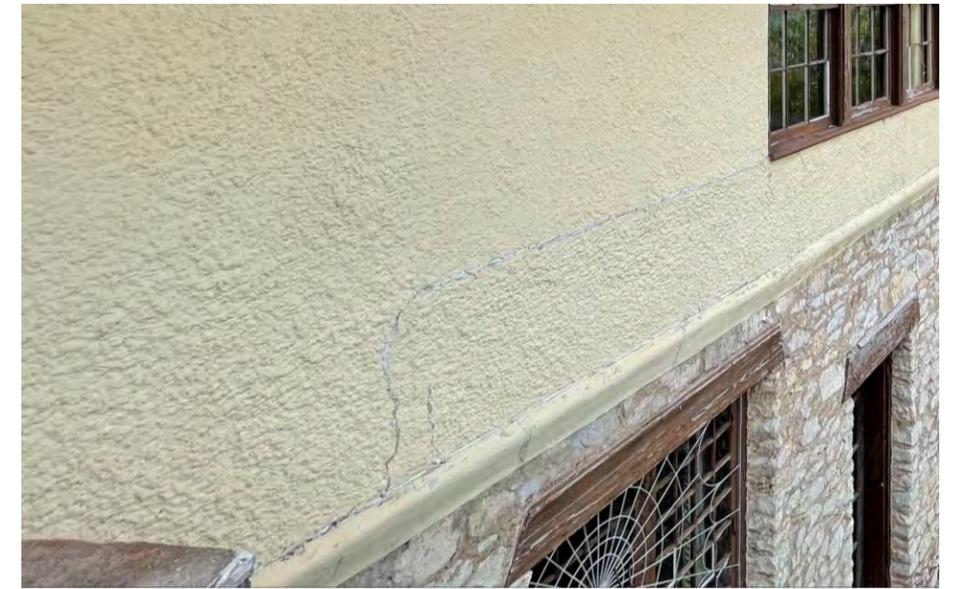
1. THERE IS A CRACK THAT STARTS AT THE STUCCO SECOND FLOOR WALL AND RUNS DOWN FROM THERE.
2. THE CRACK CONTINUES THROUGH THE ROCK FIRST FLOOR WALL. THE WATER DAMAGED STONE CAN BE SEEN AT THE BOTTOM OF THE WALL.

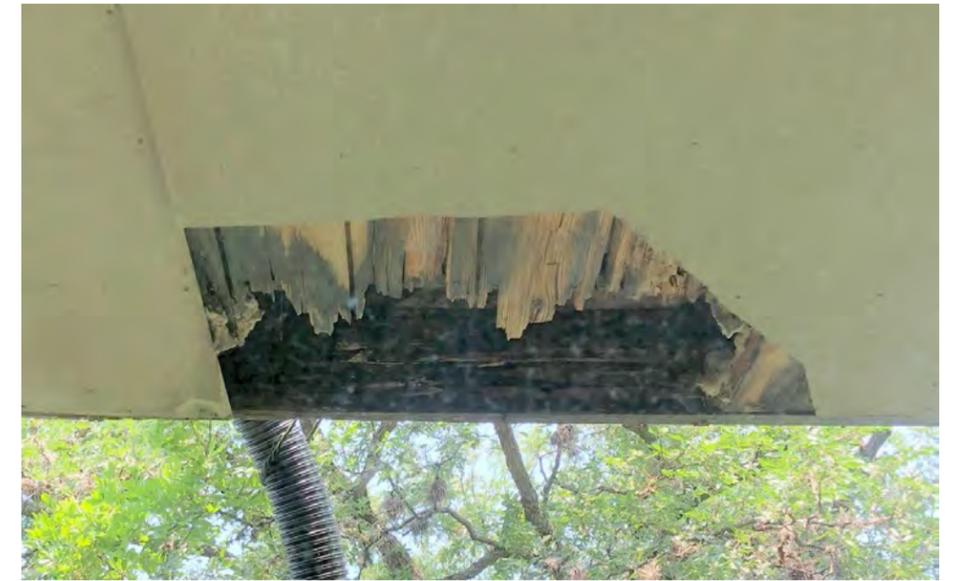
1. THE ROOF SOFFIT IS DETERIORATING AND FALLING APART.
2. THE WOOD STRUCTURE WITHIN THE ROOF IS EXPOSED.

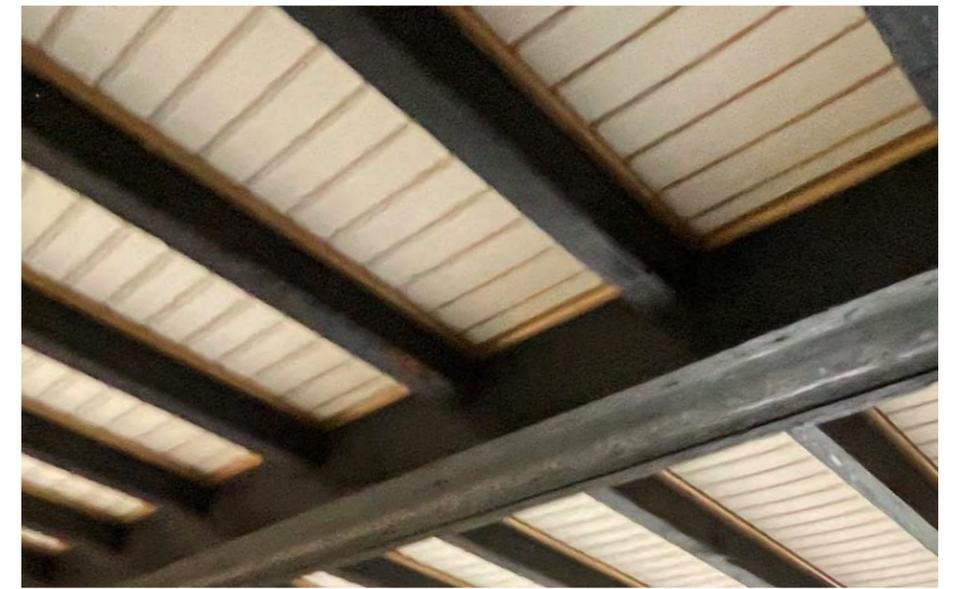
For the floor over the large room (photo on page 22), significant deflection is apparent from above and below. The beams and joists will likely need to be reinforced to support modern loads.

1. A STRUCTURAL ENGINEER HAS INDICATED THAT THESE BEAMS ARE INADEQUATE OF BEING STRUCTURALLY CAPABLE TO HOLD THE LOAD OF THE SECOND FLOOR.

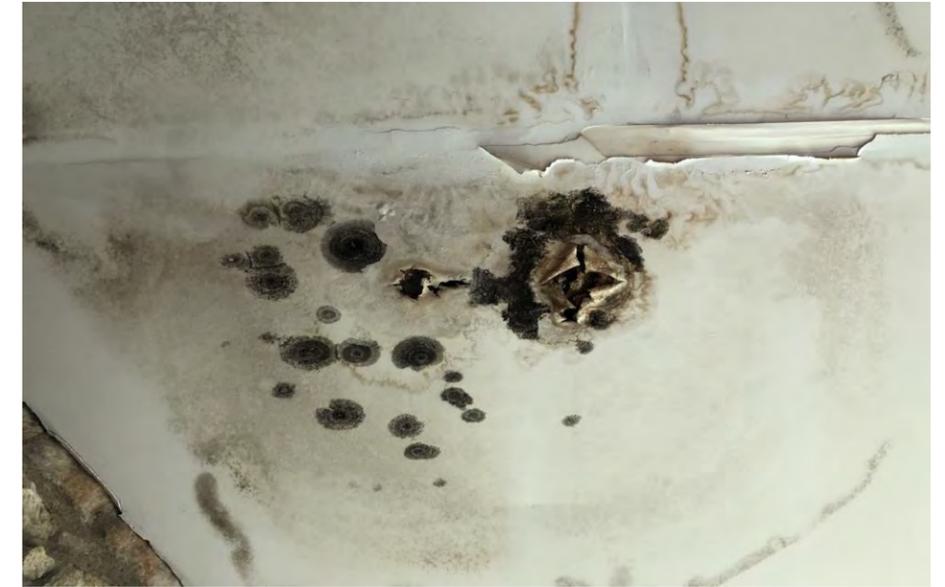
1. THE FLOOR IS DAMAGED AND FLAKING. ON THE EXTERIOR, THE HEIGHT OF THE GROUND IS HIGHER THAN THE HEIGHT OF THE WINDOW SILL, ALLOWING WATER TO FLOW INTO THE HOUSE.
2. WATER IS DAMAGING THE CEILING IN LARGE AREAS. BLACK MOLD IS EVIDENT IN MULTIPLE LOCATIONS.
3. IN THIS LOCATION THE WATER DAMAGE IS ESPECIALLY EVIDENT AND DESTRUCTIVE. MOLD IS A POTENTIAL HEALTH HAZARD AND WOULD REQUIRE AN EXTENSIVE MITIGATION EFFORT.

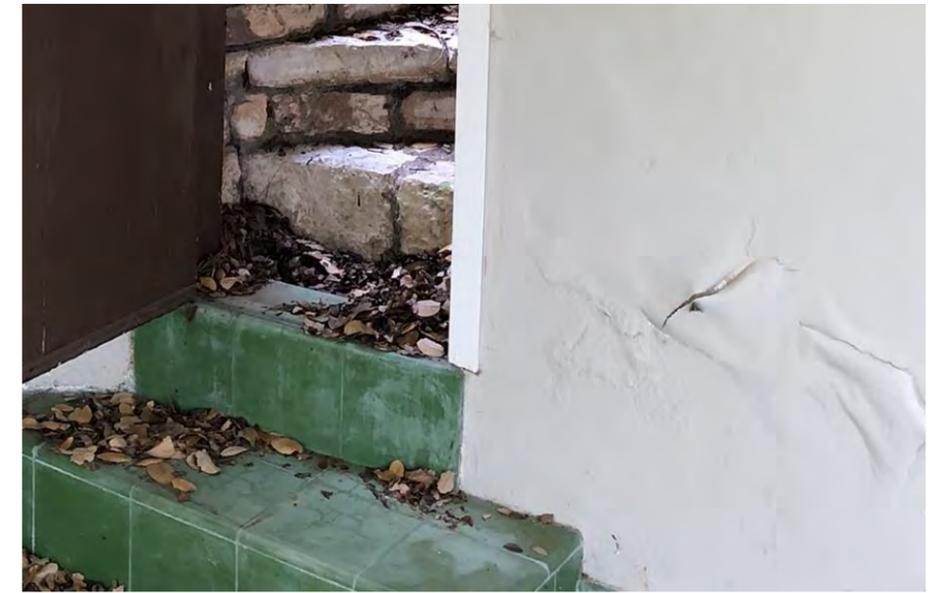
1. THE PLASTER DRYWALL IS FALLING APART AND CRACKING. THE DOOR IS TOO SMALL AND IS UP AGAINST STONE STAIRS.
2. THE PLASTER IS CRACKED AND FALLING APART.

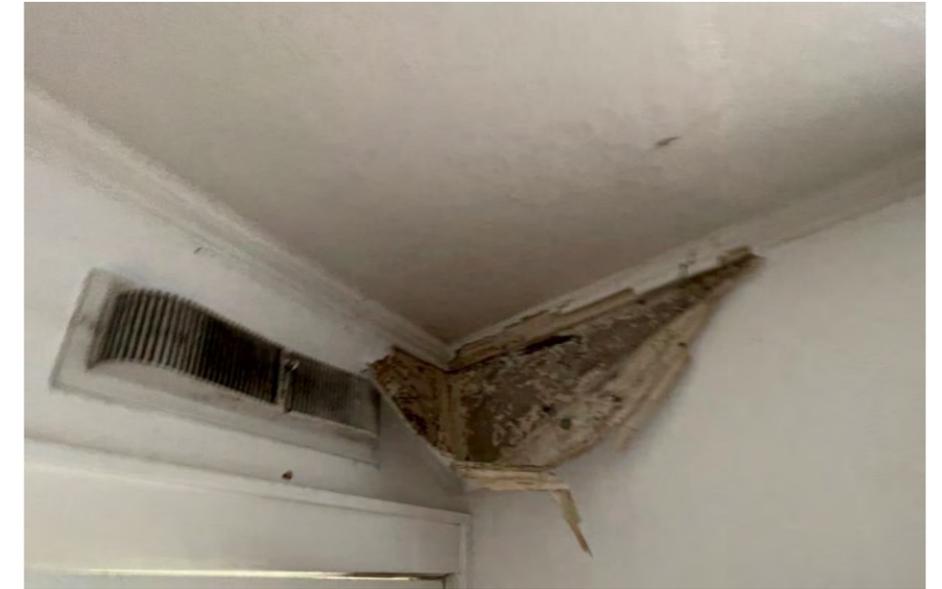
1. THE PLASTER AND THE TRIM ARE FALLING APART AND EXPOSING THE WALL BENEATH.
2. THE PLASTER IS CRACKING.

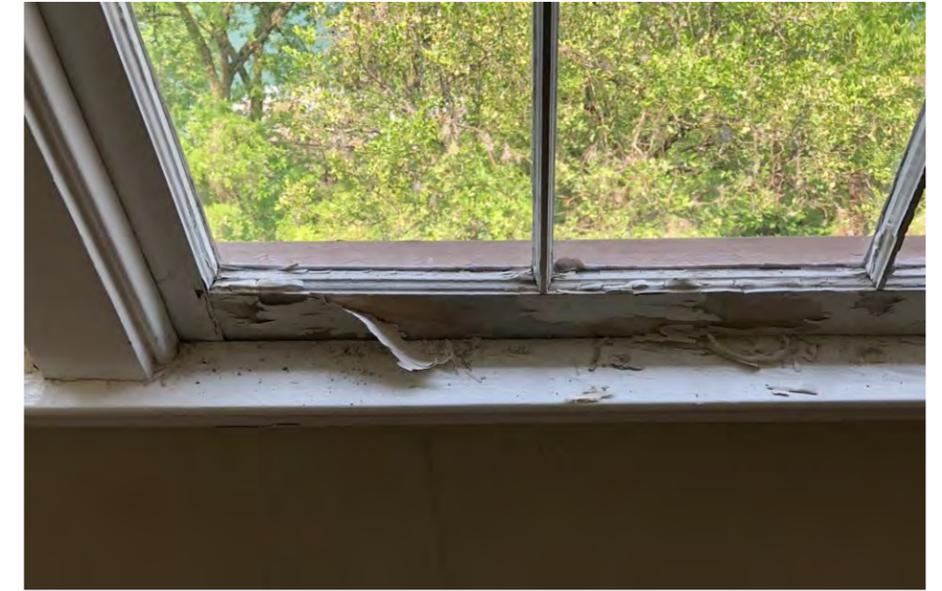
1. THE WINDOWSILL IS FALLING APART AND IS DROPPING DEBRIS ONTO THE WINDOW SILL AND FLOOR.
2. THE FLOOR IS BOWING DUE TO THE LACK OF STRUCTURAL SUPPORT BELOW.
