Memo

Re: Shoal Cycle Reasonable Use Memorandum

**Live Oak at 812 West 11th Street
Austin, TX 78701**

Tree Risk Assessment Report

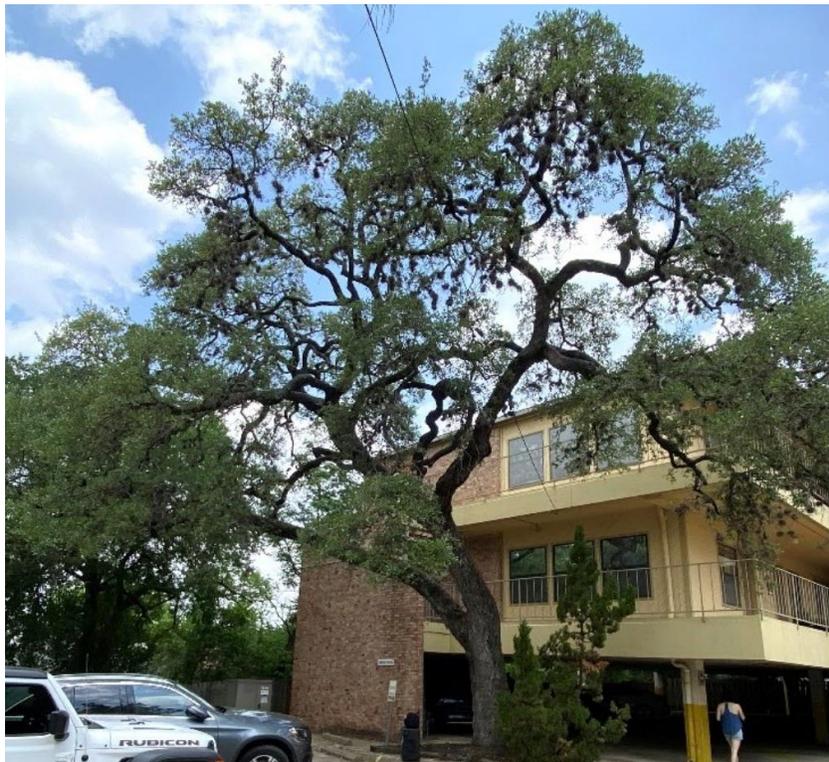
Exhibit D: 32-inch Live Oak

During the time when the transplant option was being considered, a level three advanced tree assessment was prepared for the 32-inch Live Oak by Michael Embesi of Bartlett Tree Experts on May 16, 2022. The tree was determined to be in fair condition. The report reflects that 95% of the critical root zone of the tree is covered by impervious surfaces (95% concrete coverage of the critical root zone is a significant barrier for tree viability and health), the tree is asymmetrical and leans over the parking lot, and that overhead utility service lines run through the tree canopy. Exhibit D below depicts an image of the tree and Exhibit E depicts existing conditions impacting the critical root zone. The asymmetrical canopy leans southwest as a result of the adjacent building and is characterized as “somewhat thin,” see Exhibit F below. 40% of the tree canopy is missing. Of the remaining canopy (60%); 20% of the foliage is missing. This equates to a tree that is only 48% of the leaf cover of a typical healthy tree.

The foliage appears both green (healthy) and chlorotic (yellow). 15% of the canopy is made up of “dead twigs and branches with a maximum diameter of 2-inches.”

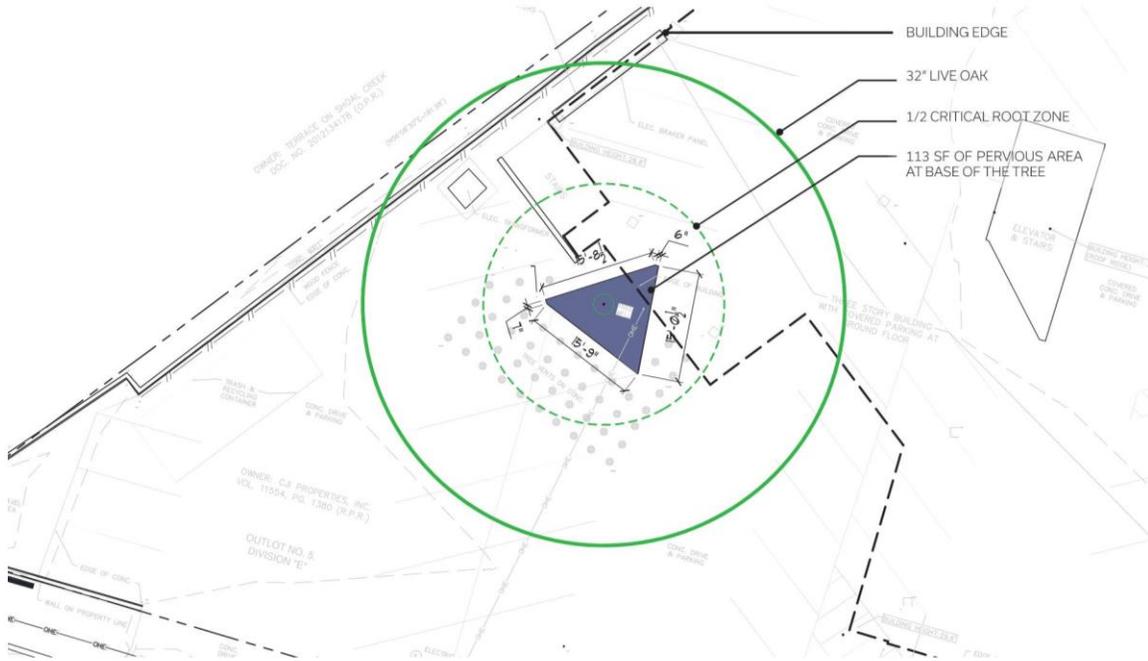
Exhibit E: Critical Root Zone Impact

If the tree were to remain, with its trunk location adjacent to the existing building and with 95% of the critical root system under pavement and most likely also under the structure, it is very risky to work around this tree and unlikely that the tree will survive the removal of pavement around it without ripping up the root system. A compromised root system for a tree in this state of poor health will further diminish the health and viability of the tree.

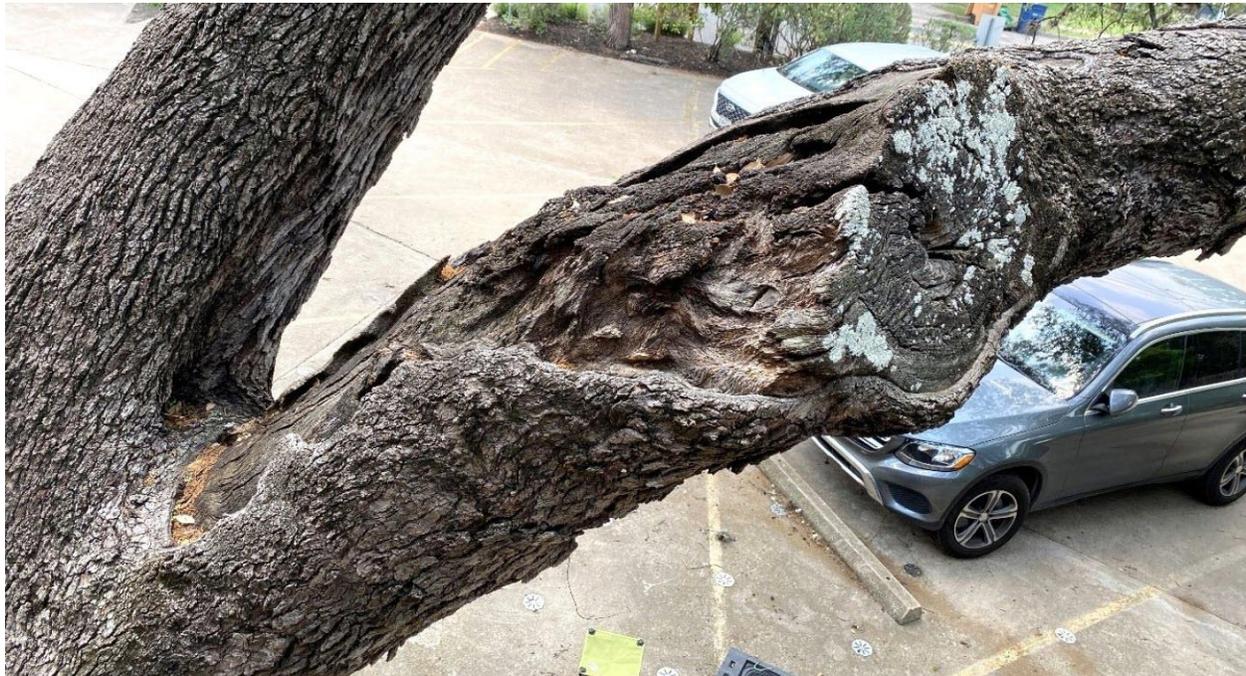
EXHIBIT G: West Stem Pruning Wound and Decay Exhibit

Additional significant decay is on the west stem limb shown in Exhibit G below. This limb is characterized by a large pruning wound of approximately 10 inches in diameter, and sapwood and heartwood decay, measuring 30 inches by 12 inches. This wound and decay area are noted to make up 1/3 of the circumference of the west stem with little response wood.

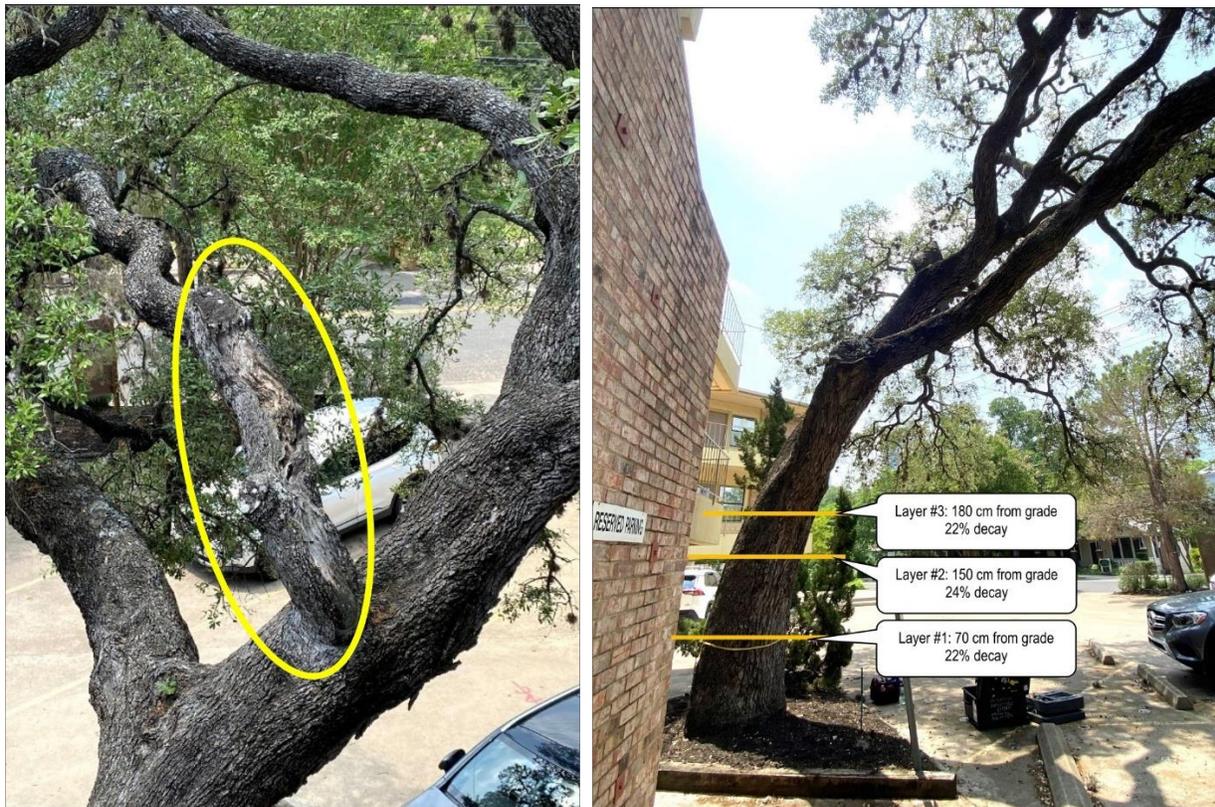
Exhibits H: East Stem Limb Decay / Exhibit I: Sonic Tomography Results

An 8-inch branch on the east stem of the tree is characterized by sapwood and heartwood decay located 25 feet above grade, see Exhibit H below. The size of this decay area comprised of 1/3 of the total circumference of the limb. Should this decayed limb, as referenced in Exhibit H, be removed, the current canopy would be further diminished by an additional approximately 15-20%, thereby reducing the overall canopy size to 28% of a tree in good health of similar size and species.

Sonic tomography was performed on the 32-inch Live Oak which indicated moderate decay at three different vertical planes within the tree: 22% decay at 70 centimeters from grade, 24% decay at 150 centimeters from grade and 22% decay at 180 centimeters from grade see Exhibit I below. Such measures of decay indicate 22-24% loss in structural integrity of the tree.

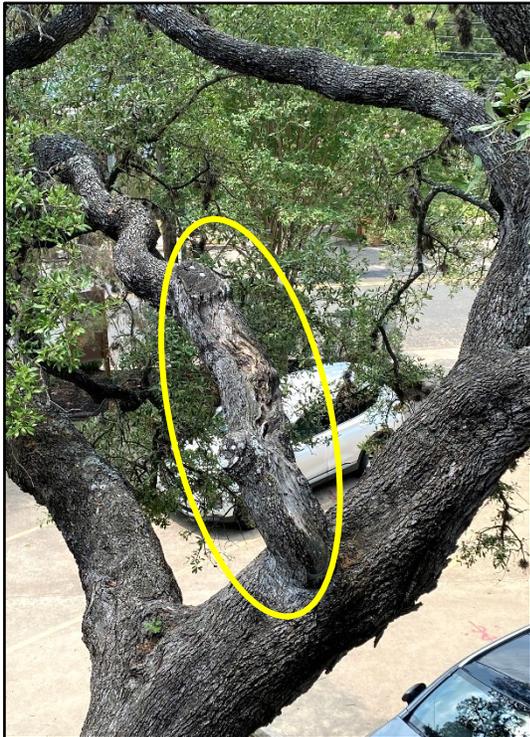
Image 2: Eight-inch branch arising from east stem had sapwood and heartwood decay (circled).

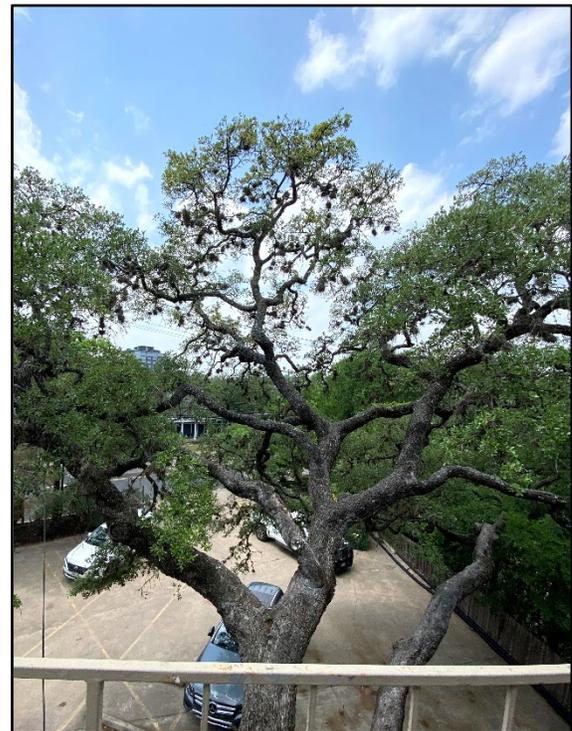
Image 3: Center portion of the canopy was thin and chlorotic. East stem is in the center of the image and the west stem is on the right.

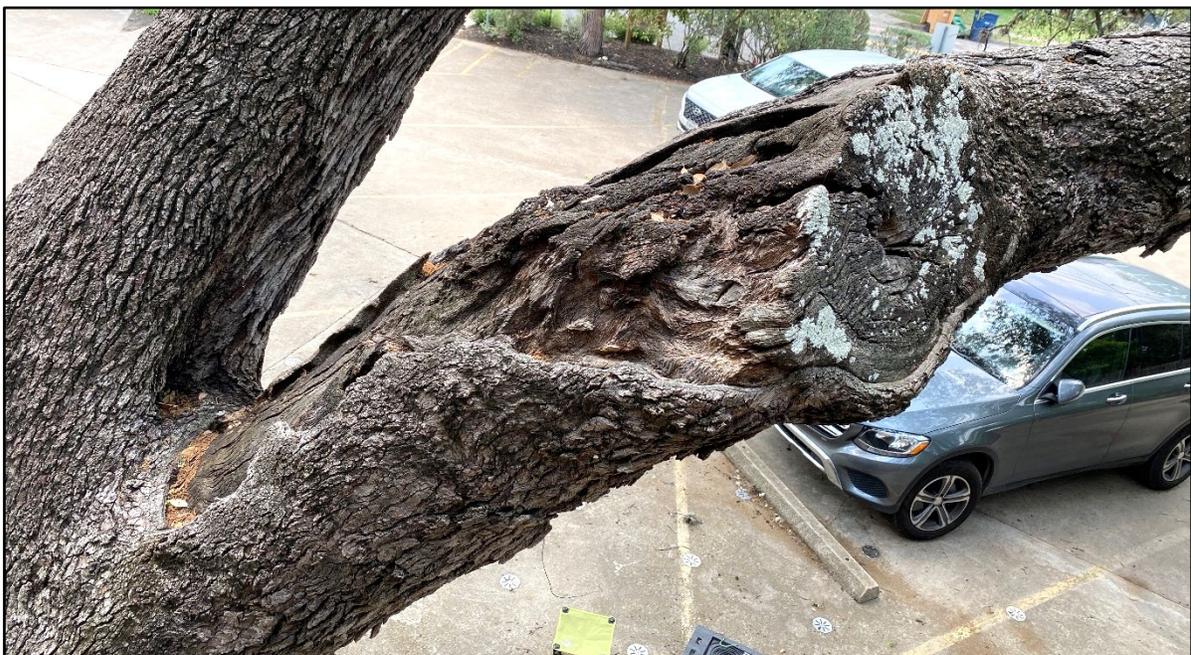
tree. The west stem was overextended. It had a large pruning wound approximately 10-inches in diameter. An area of missing sapwood was associated with this pruning wound that was approximately 30-inches in length and 12-inches in width. It comprised 1/3 of the circumference of the west branch. Very little response wound was present around the wound.

Image 4: Codominant union is on the left. The west stem arises from this union and has a large pruning wound approximately 10-inches in diameter. Sapwood and heartwood decay are present for an area approximately 30-inches in length and 12-inches in width. It comprises 1/3 of the circumference of the west branch with little response wood.

- Option One: Prune to remove 2-inch dead branches in the canopy. Removing dead branches will eliminate their residual risk.
- Option Two: Reduce weight of west branch and install cables to reduce the risk of branch failure. Pruning and cabling will reduce the residual risk of trunk, crown, and branch failure to low.
- Option Three: Remove the entire tree to remove the risk of root, root collar, trunk, crown, and branch failure. Grind the resulting stump and back fill the hole. There will be no residual risk for the trunk, crown, or branches, but there may be a tripping hazard with the remaining roots, stump, or grindings that you will need to address. The tree's risk may increase in the future as a result of not performing mitigation.

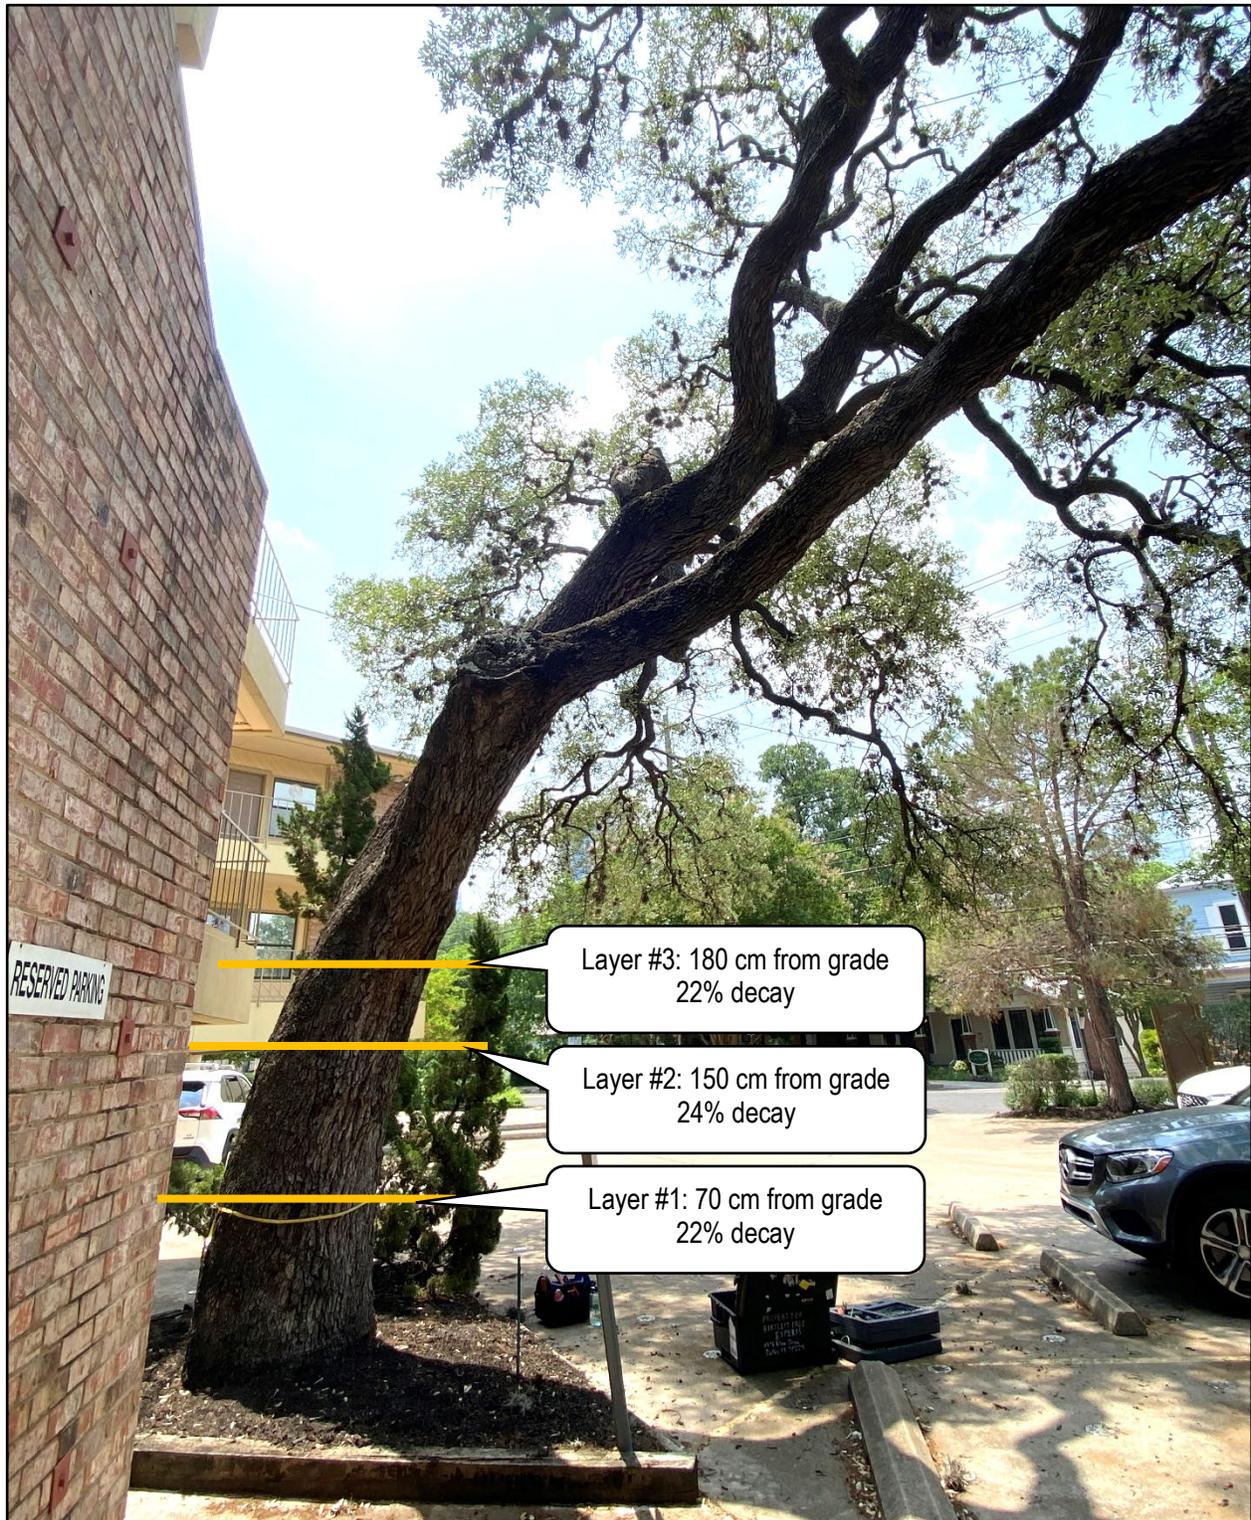
Image 5: Tree leans southwest over the parking area. Tree canopy is asymmetrical. Sonic tomography locations indicated by the yellow lines. A column of decay was located in the center of the stem. Pruning wound with decay on west stem is visible.

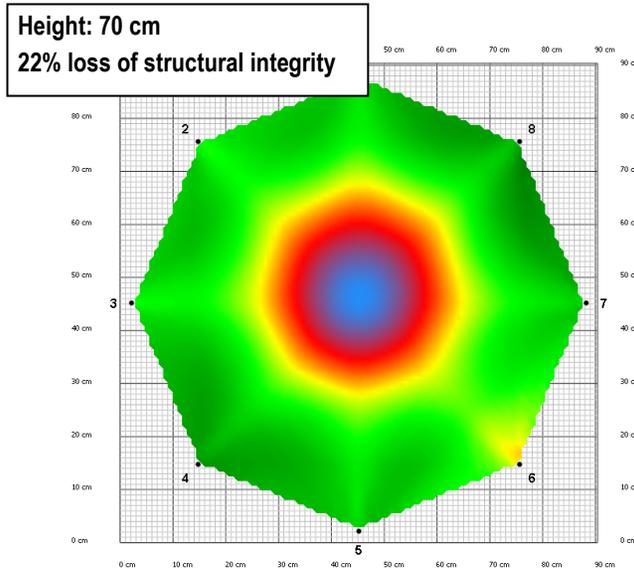
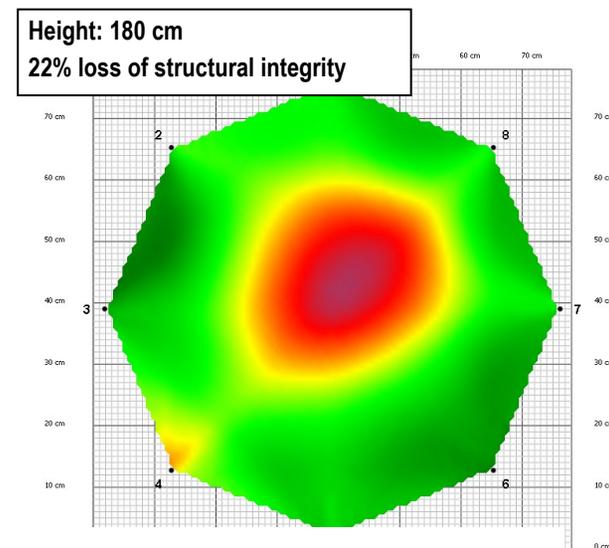
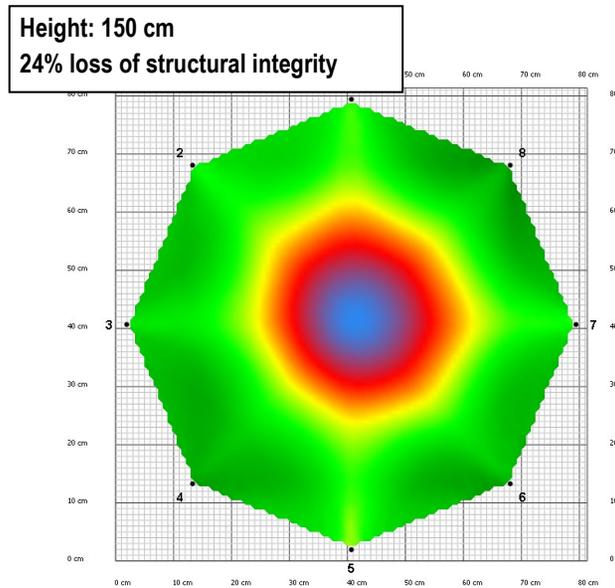
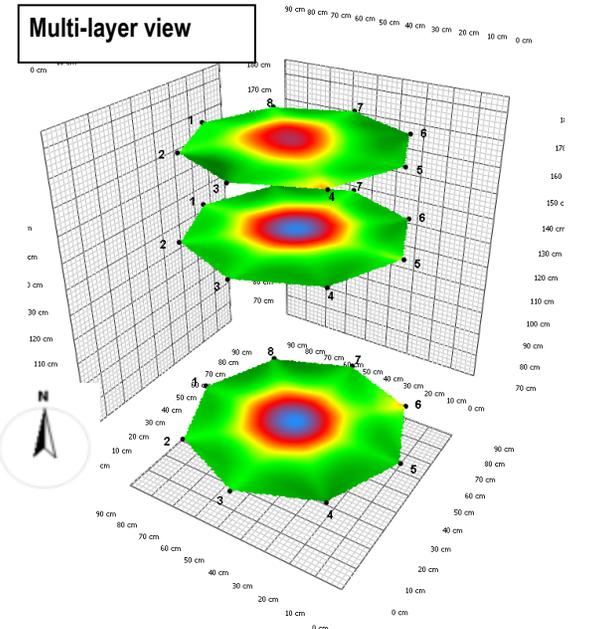
ArborSonic 3D™ Tomograms

Sonic tomography suggests moderate decay at three planes:

- 22 percent at 70-centimeters from grade
- 24 percent at 150-centimeters from grade
- 22 percent at 180-centimeters from grade.

The tree was in fair condition. There was 22 - 24% structural integrity loss suggested by sonic tomography imaging at 70, 150, and 180 centimeters from grade. The shell wall thickness appears adequate for trunk support; however, it is possible that the west scaffold branch will fail due to the codominant branch structure, sapwood decay, heartwood decay, and over-extended form. The origin of decay in the trunk may be due to the defects described on the west branch.

If the live oak should remain, I recommend a Level 3 Advanced Assessment to monitor internal decay every three years. In addition, a Level 1 Assessment should occur after major storm events. All recommended work should be performed by qualified arborists and in accordance with industry accepted standards and best management practices set forth by the *American National Standards Institute* and the *International Society of Arboriculture*.
