Public Works Department

Re: Zilker Botanical Garden
2220 Barton Springs Rd, Austin, TX 78746
Existing Roof Over Greene Room

This letter is in regard to the structural integrity of the existing roof over Greene Room at the Zilker Botanical Garden. A site visit was conducted on September 3, 2021, to perform a structural observation of the existing roof.

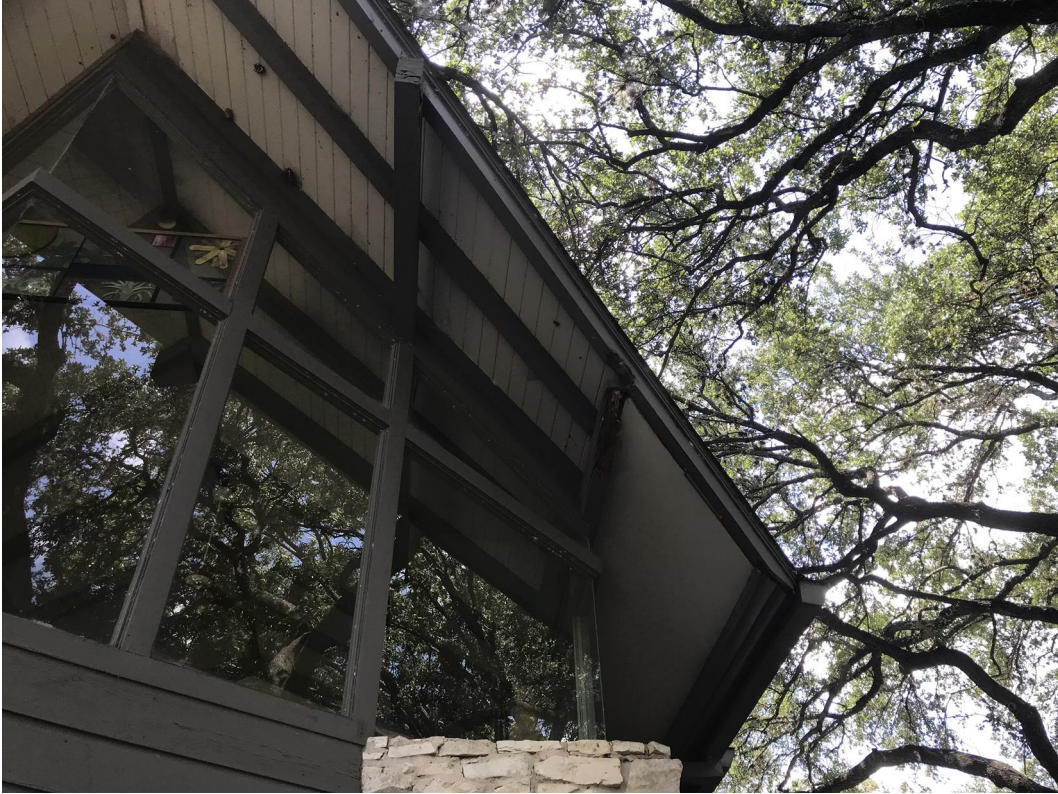
Photo A (Beams 1 and 2)

The exterior section of the Glulam beams have experienced structural damage due to weathering and wood erosion. See photos A, B, C, D and E. Beam 1 has lost a large section of beams cross-sectional area at the cantilever end that has reduces the structural sectional property of the beam which has affect the structural capacity of the member. This member has failed and needs to be addressed prior to any additional member loss. The fascia has been damaged and must be addressed. See photo B. Beam 2 shows signs of erosion, the extent of the damage is not clear at this time. The cross-sectional property at the cantilever end of the member has been compromised and must be addressed prior to any additional damage. See photo C. Beam 3 has experienced weathering and the cross-sectional property has been compromised at the cantilever end of the member. See photos D and E. Beam 4 appears to have been repaired, the extent of the repair is unknow and repair documents have not been reviewed. The repair material does not match the original wood member sizes of the Glulam and does not appear to be laminated.

The existing Glulam members have been compromised, creating imminent hazard and danger to the health, safety and welfare of the public. The existing wood roof needs to be addressed immediately to minimize any further damage. The room can be used at this time, continuous observation is required to help ensure safety. Roof access should be limited, no one should be allowed on the roof at the cantilevered ends.
