JUNE 28, 2022
22

RYAN STREET
ARCHITECTS

2002 SCENIC DRIVE RESIDENCE
Two Story House - Interior

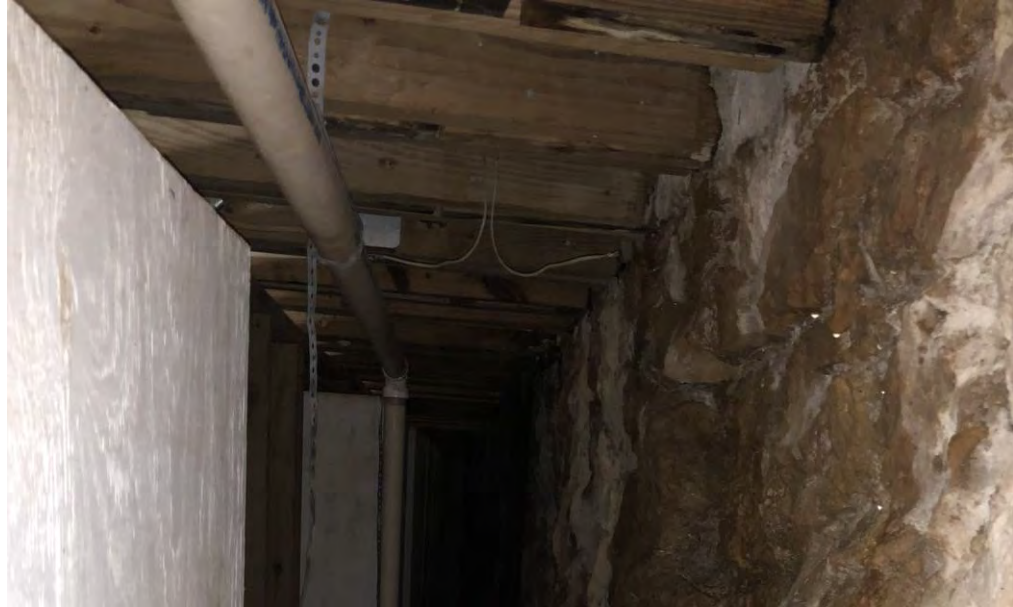
1. WATER IS LEAKING THROUGH THE RETAINING WALL AND INTO THE APARTMENT. WATER CAN ACTIVELY BE SEEN DRIPPING DOWN THE ROCK WALL.
2. IN ORDER TO HOLD UP THE SECOND FLOOR, RAILWAY TIES ARE USED AS STEEL BEAMS.
3. WATER IS DRIPPING DOWN THE ROCK AND FINDS ITS WAY TO THE STRUCTURE'S CONCRETE BASE.

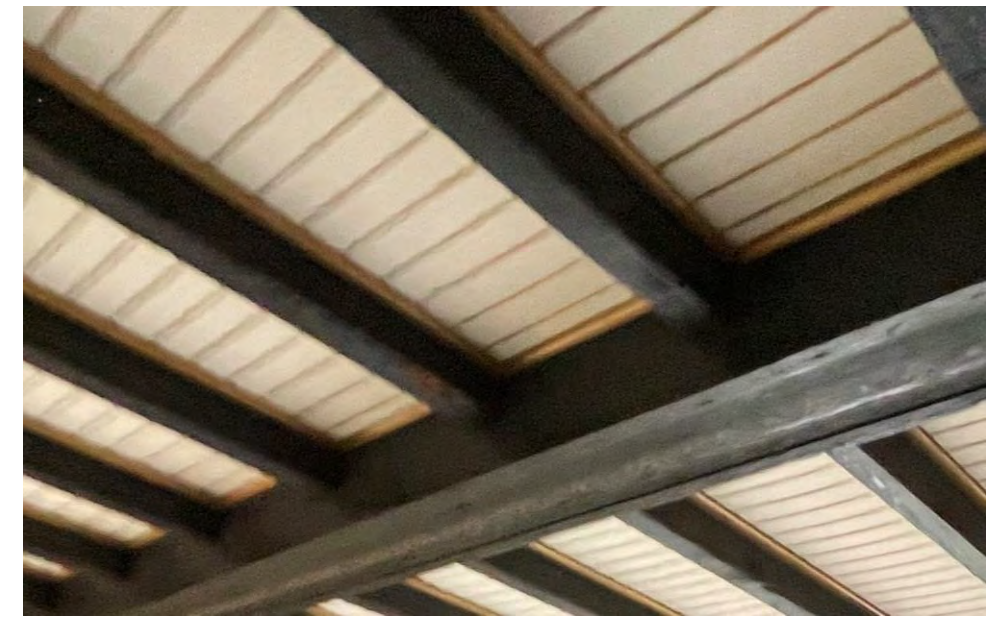
1. A STRUCTURAL ENGINEER HAS INDICATED THAT THESE BEAMS ARE INADEQUATE OF BEING STRUCTURALLY CAPABLE TO HOLD THE LOAD OF THE SECOND FLOOR.

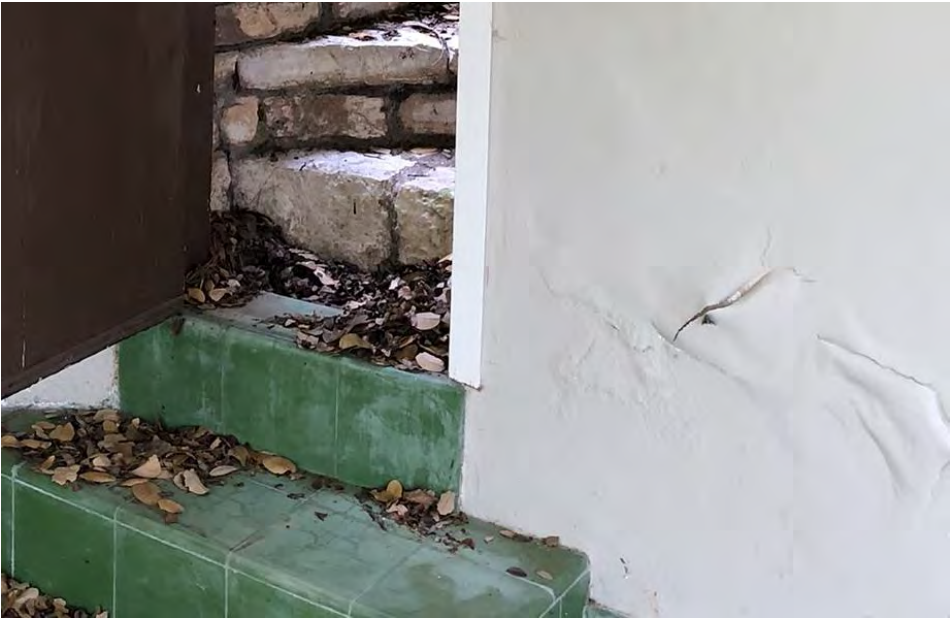
1. THE PLASTER DRYWALL IS FALLING APART AND CRACKING. THE DOOR IS TOO SMALL AND IS UP AGAINST STONE STAIRS.
2. THE PLASTER IS CRACKED AND FALLING APART.

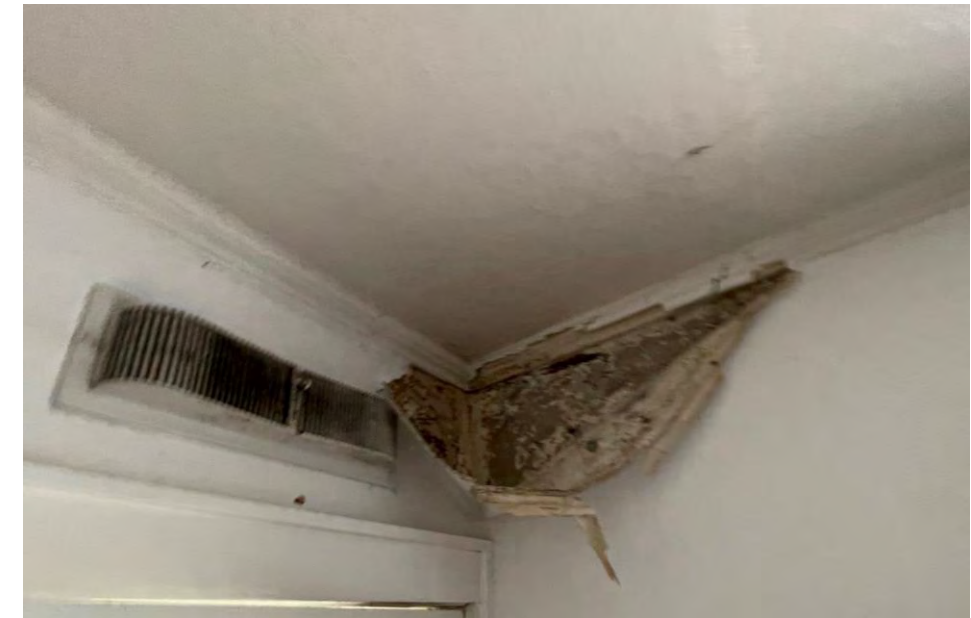
1. THE PLASTER AND THE TRIM ARE FALLING APART AND EXPOSING THE WALL BENEATH.
2. THE PLASTER IS CRACKING.

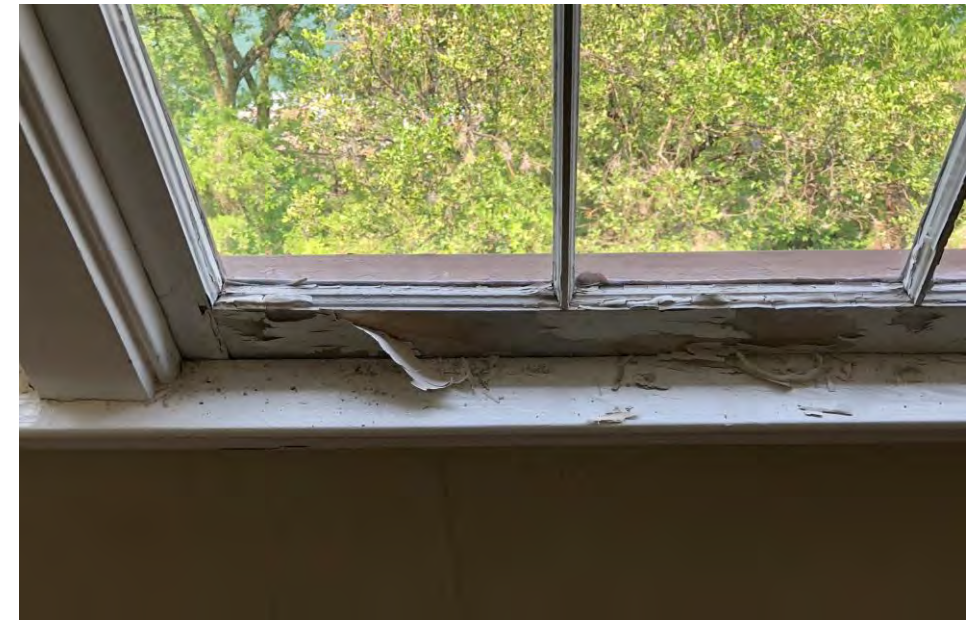
1. THE WINDOWSILL IS FALLING APART AND IS DROPPING DEBRIS ONTO THE WINDOW SILL AND FLOOR.
2. THE FLOOR IS BOWING DUE TO THE LACK OF STRUCTURAL SUPPORT BELOW.

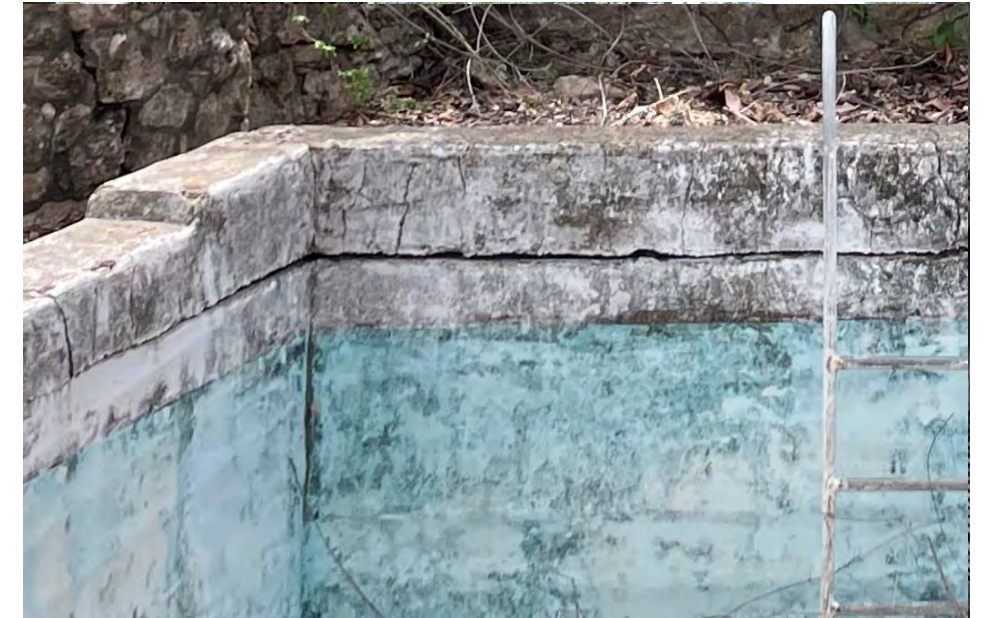
1. THE POOL'S STONE AND CONCRETE ARE SPLITTING APART AND CRACKING.

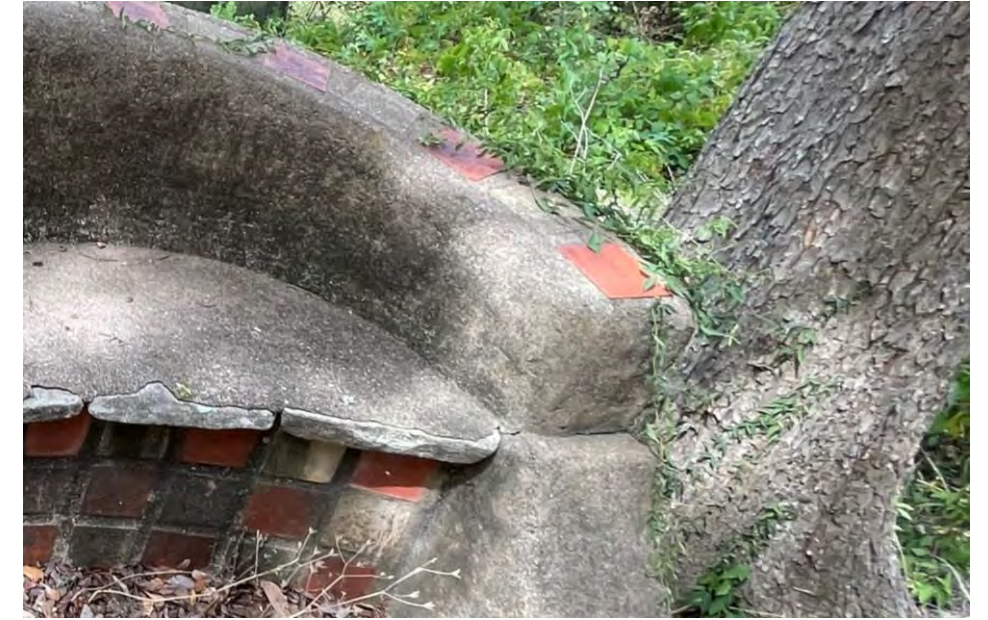
1. FRONT OF BENCH – THE FINISH OVER THE CONCRETE BENEATH IS PEELING OFF.
2. BACKSIDE OF BENCH – THE BENCH IS CRACKED AND IS IN DISREPAIR.

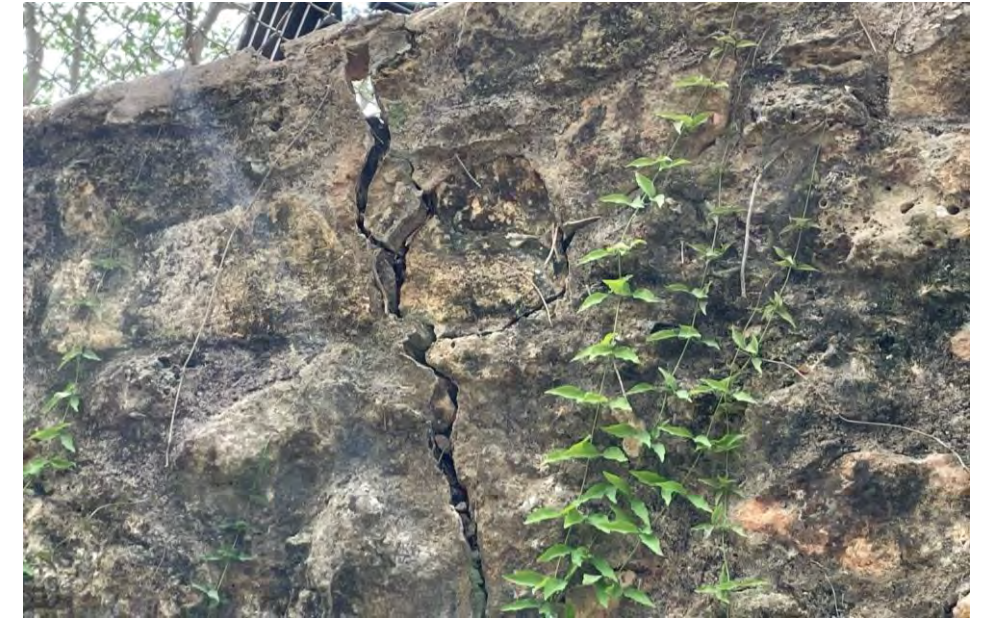
1. WALL IS CRACKING AND SPLITTING APART IN THIS LOCATION.

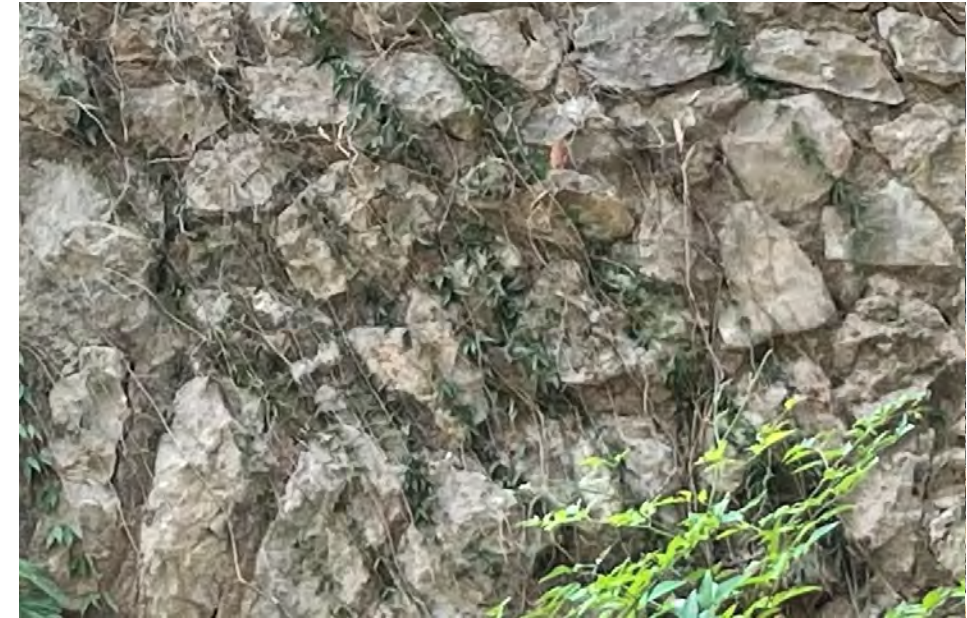
1. THE BRIDGE IS CRACKING AND IS UNSAFE TO WALK OVER.
2. THE WALL IS CRUMBLING APART IN SEVERAL AREAS.

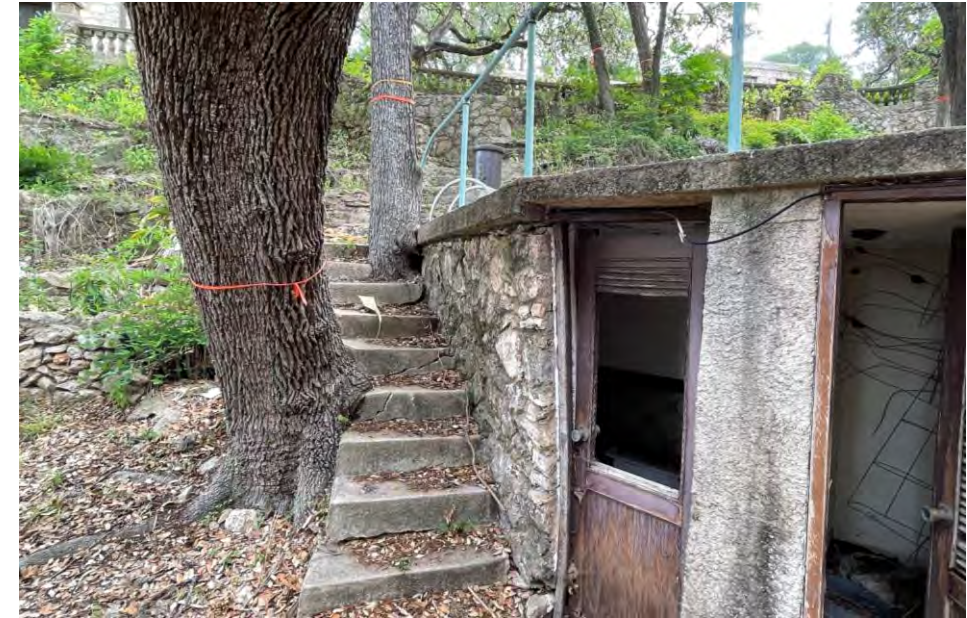
1. THE CONCRETE STAIRS ARE CONSTRICTING THIS SIGNIFICANT TREE.
2. THE STAIRS ARE CRACKING AND MOVING DUE TO THE TREE'S GROWTH.

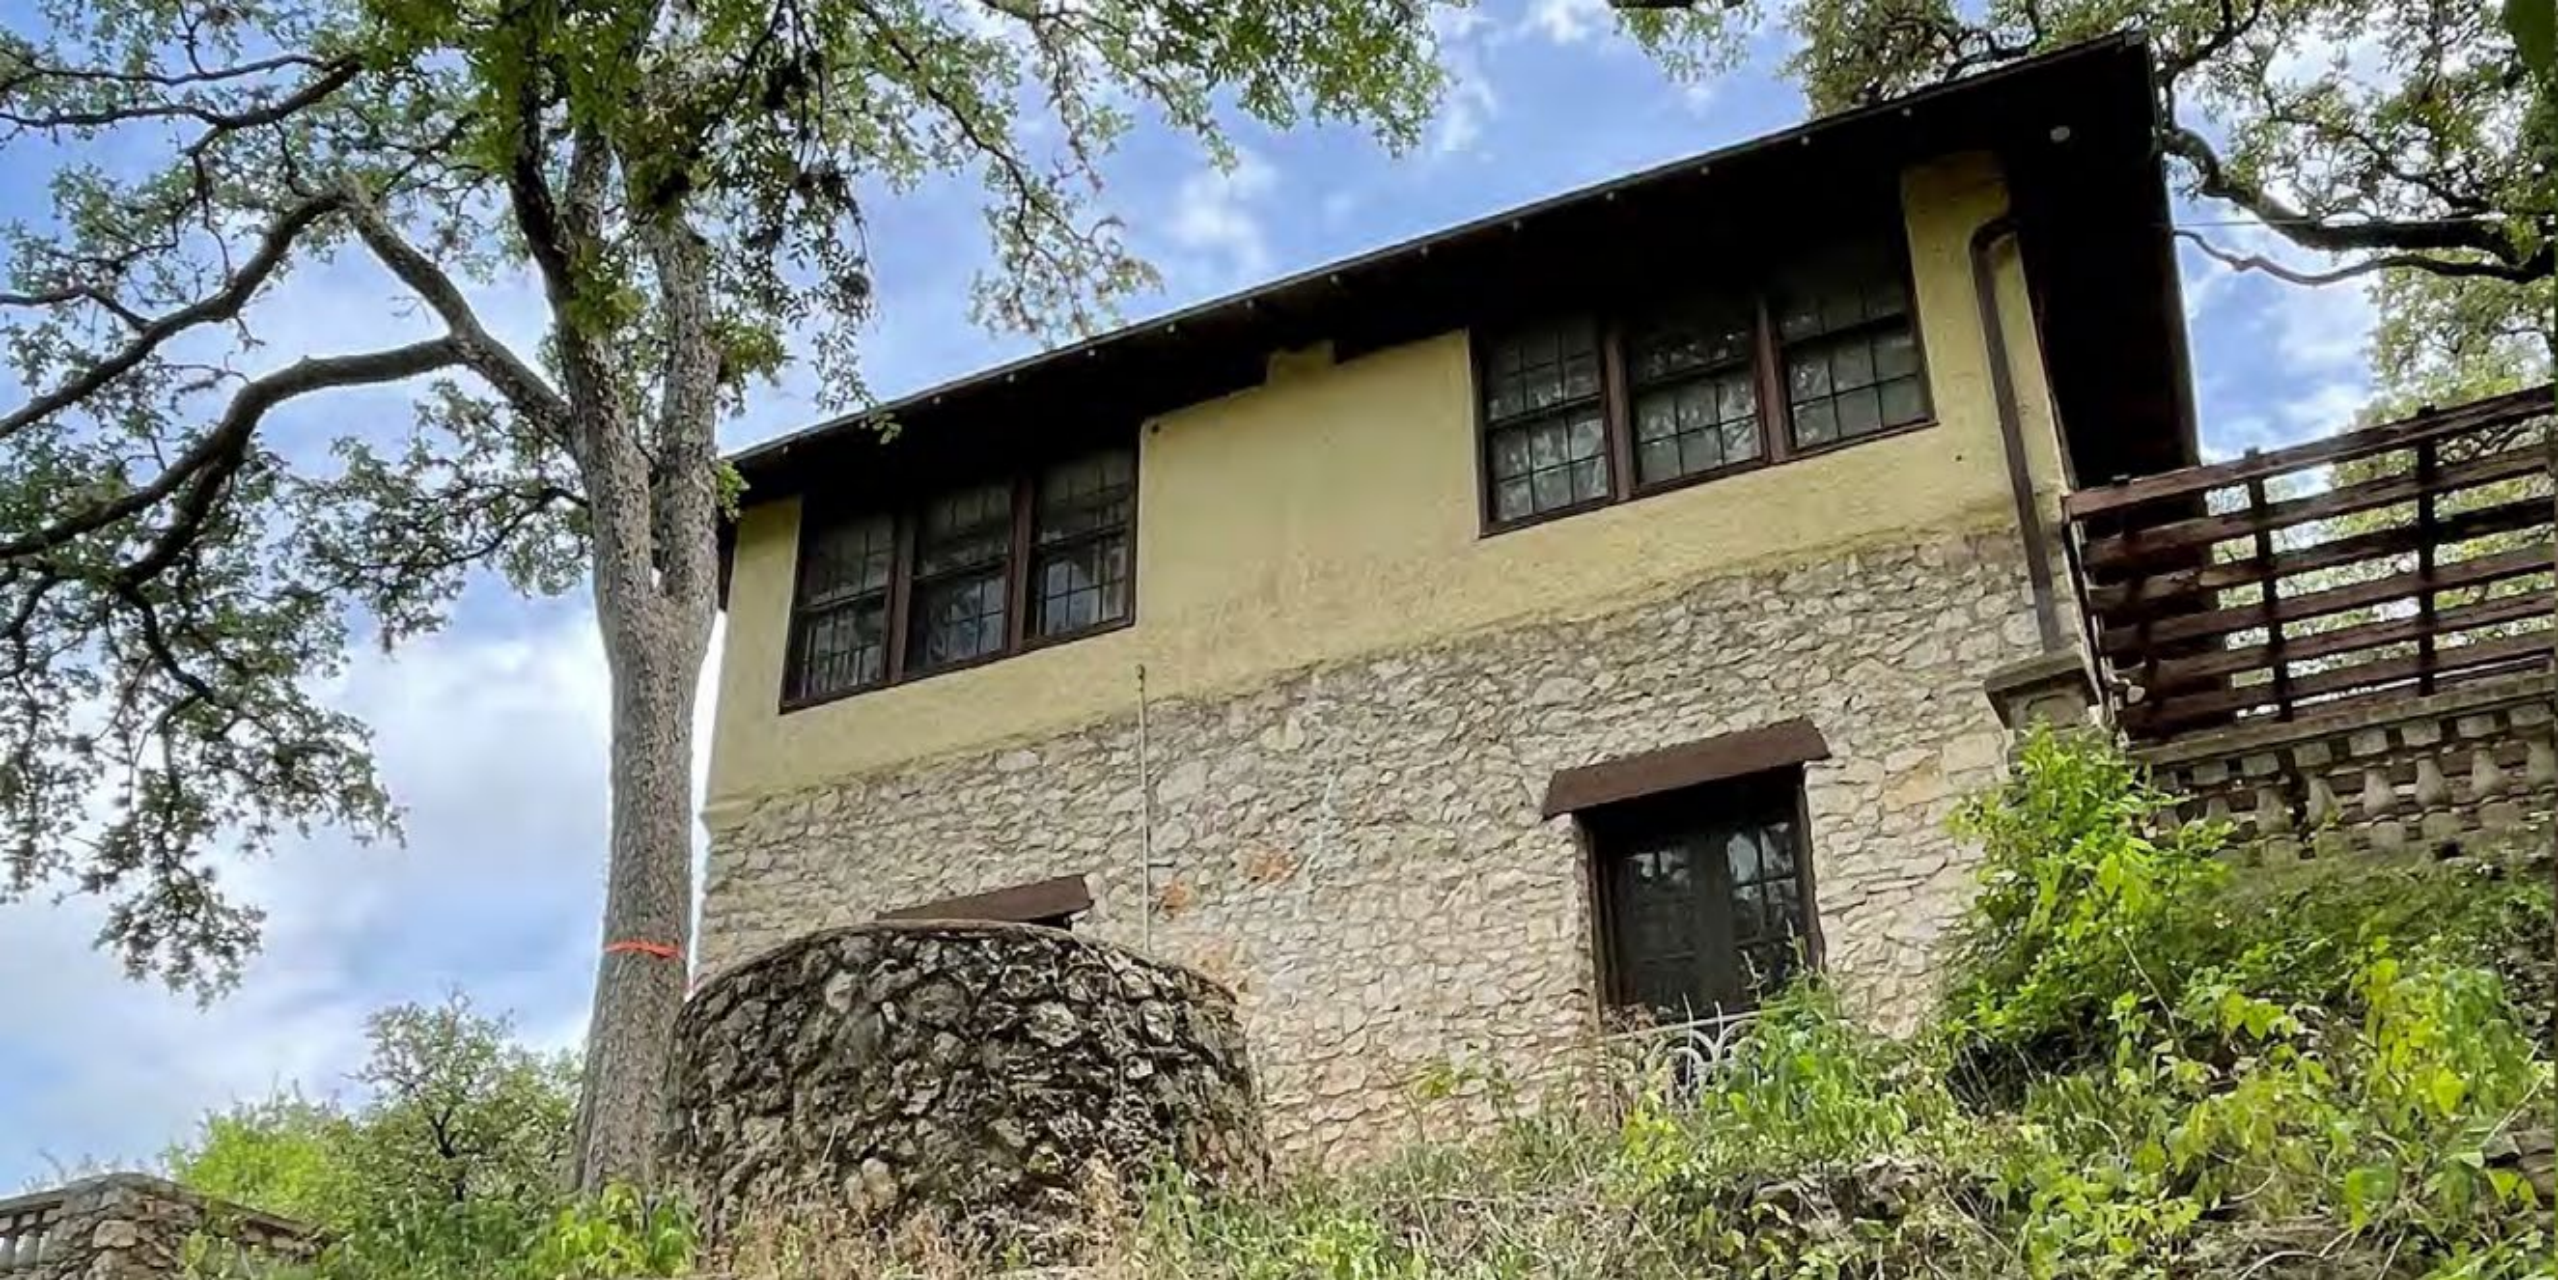
“The masonry walls are not adequate for load-bearing, and their reuse as a non-load-bearing veneer is not practical. The foundation is questionable and likely not adequate for reuse in an extensive renovation.”

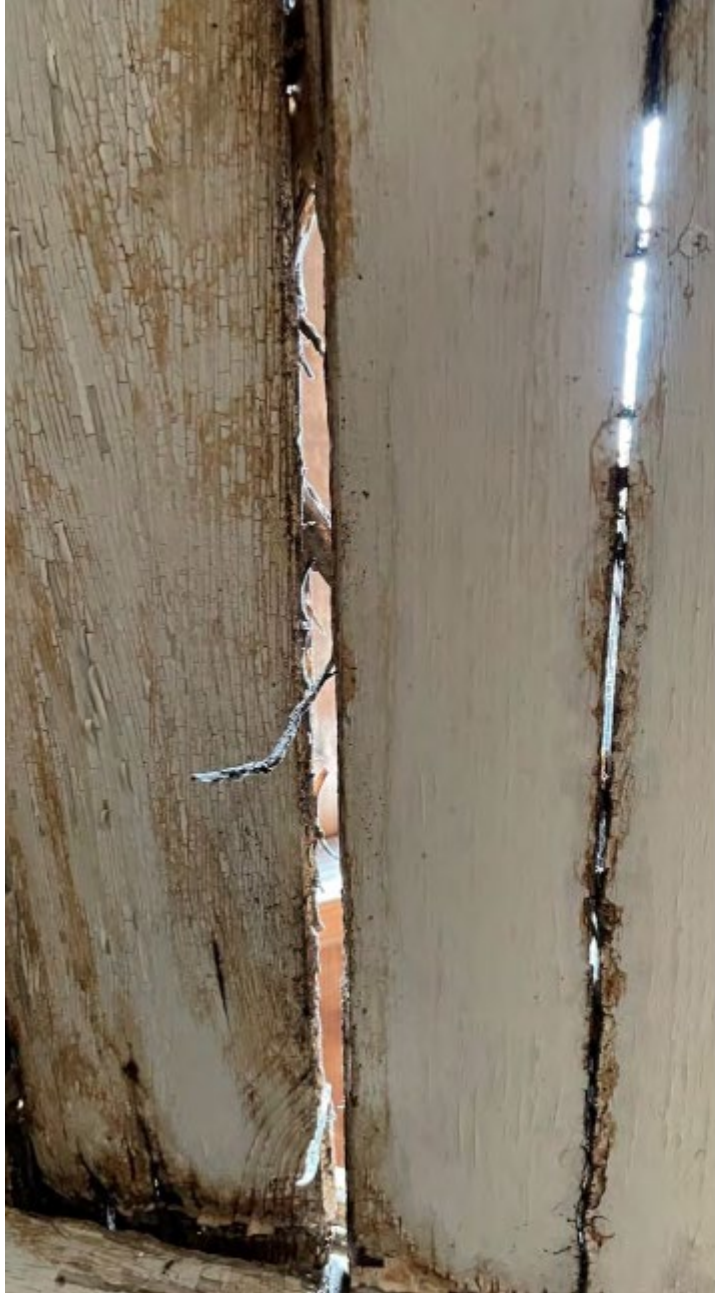
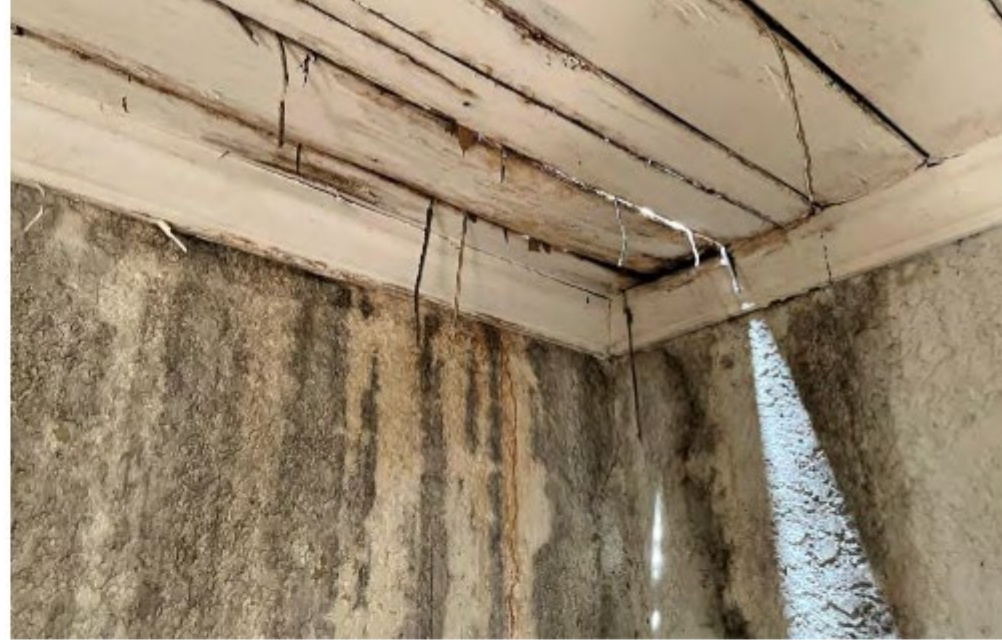
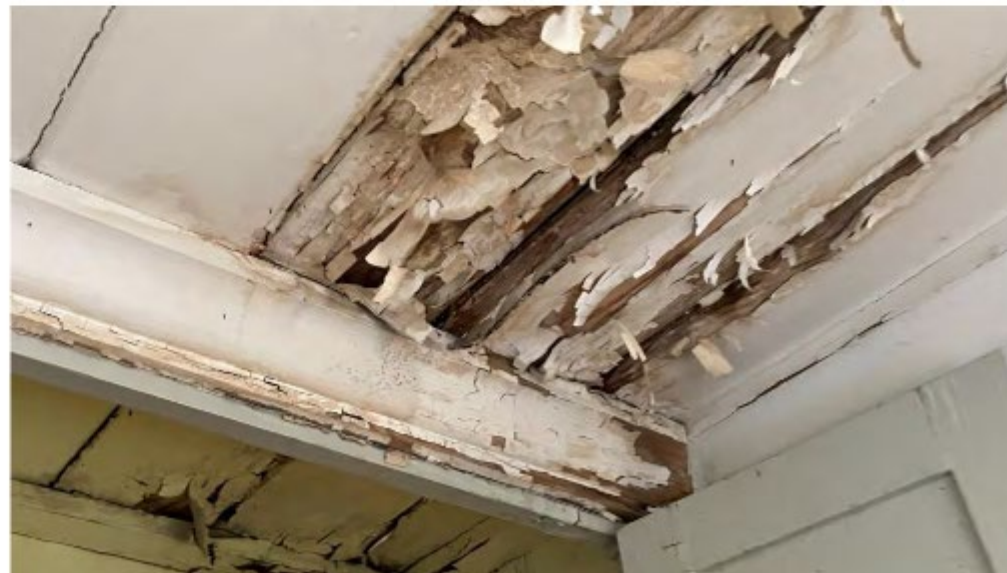
“The wood roof framing has obvious rot in areas exposed by holes, and I believe it is likely that further investigation will reveal that none of the roof framing is salvageable.”

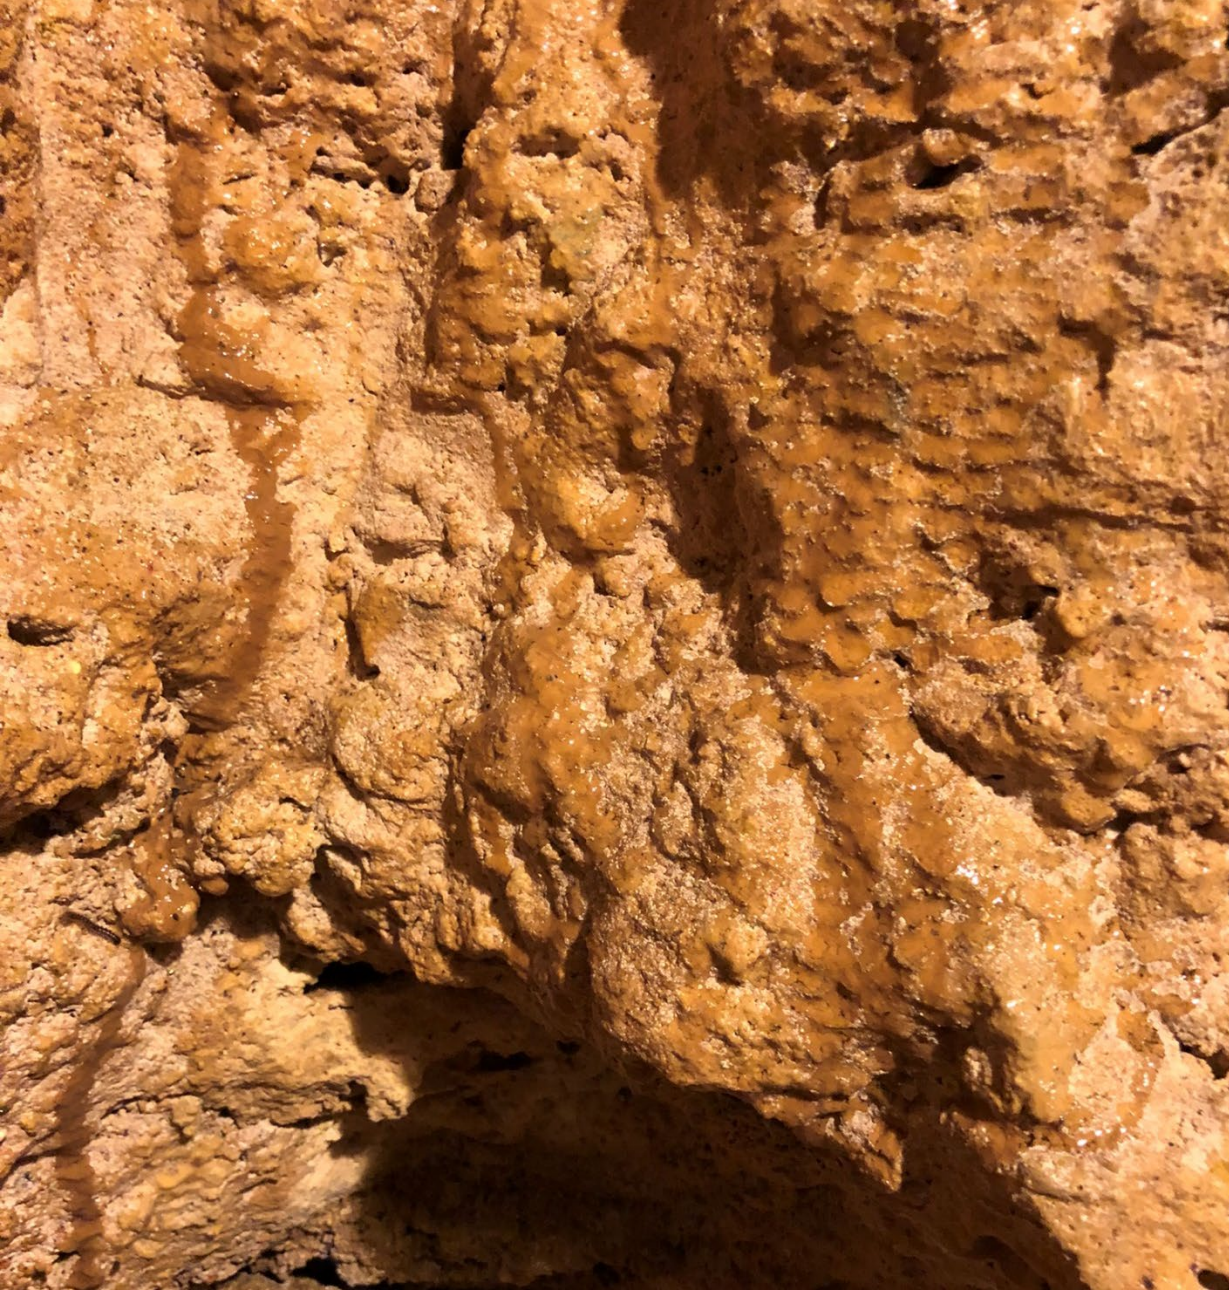
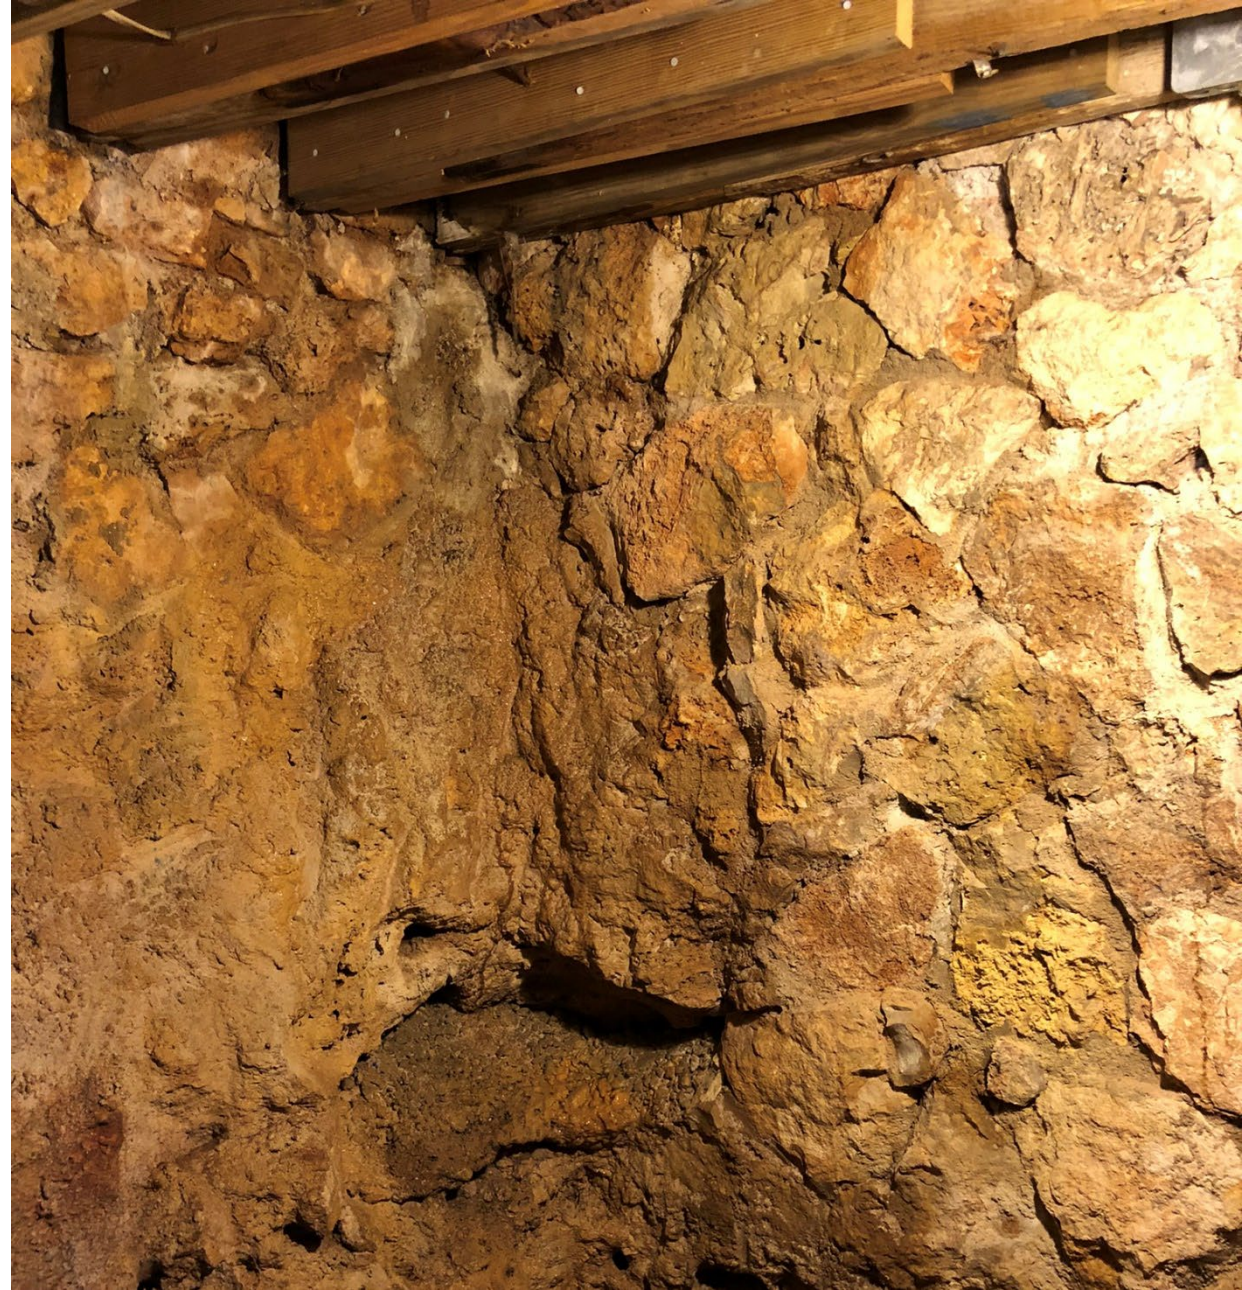
For the Apartment Unit: "These walls cannot be reused as load-bearing."

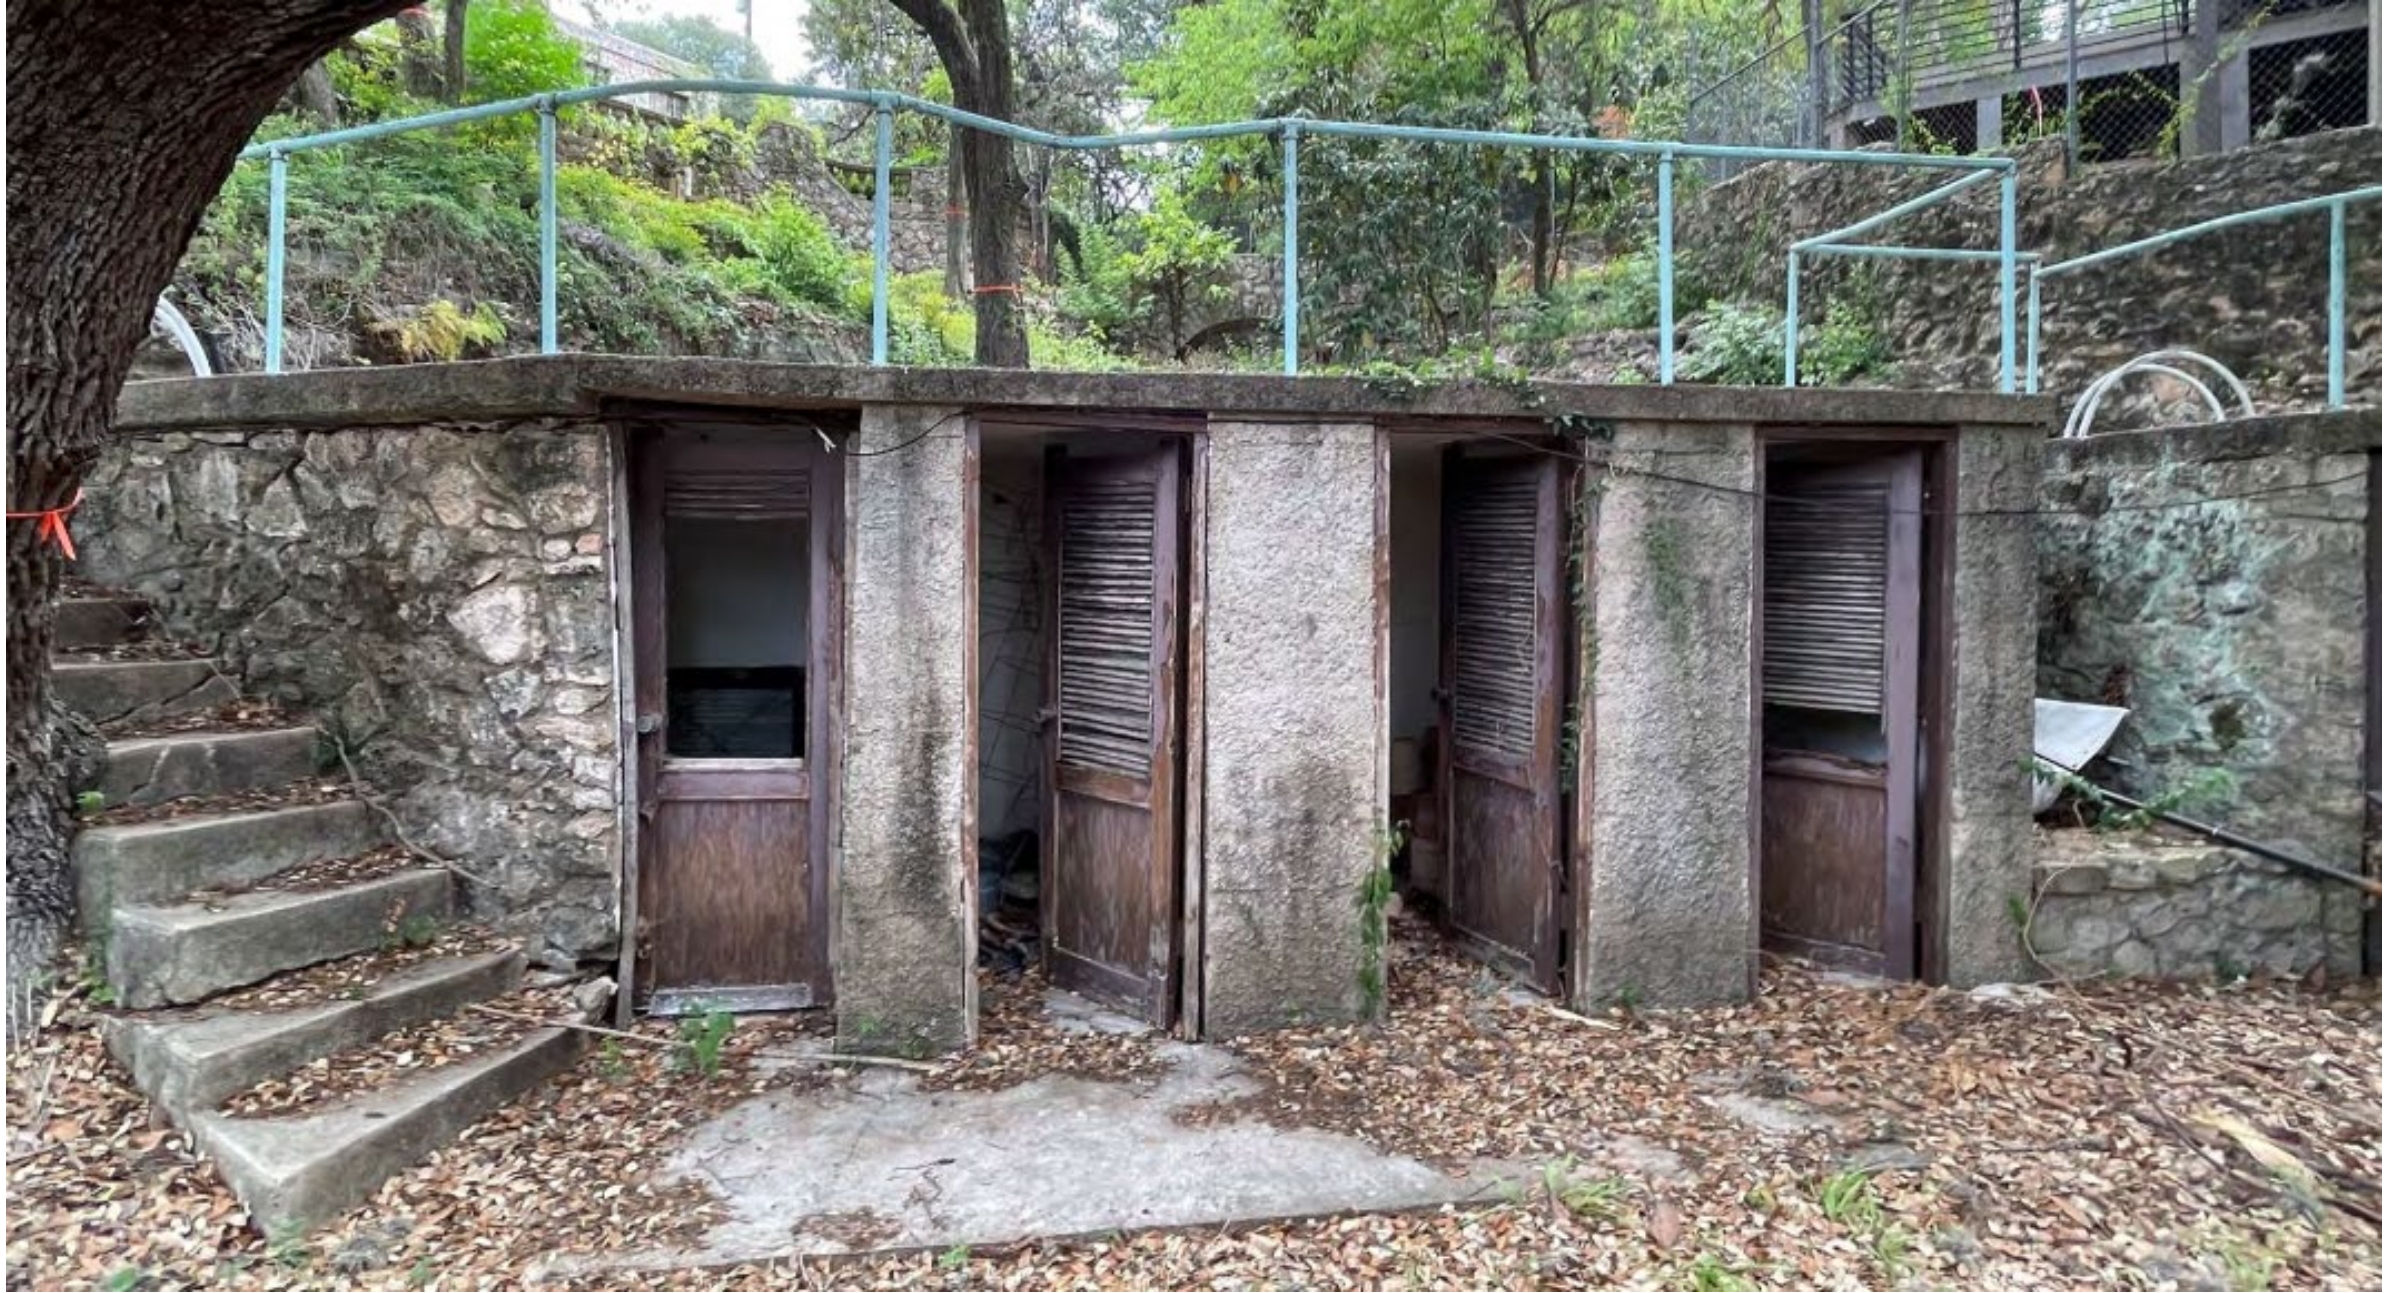
“These [pool] walls and slab have failed... The pool and deck are not suitable for reuse.”
