# City of Austin - Bridges and Culverts

# Critical Infrastructure Assessment – Bridges 2017

# Condition Report on the Emmett Shelton Bridge on Redbud Trail over Lady Bird Lake

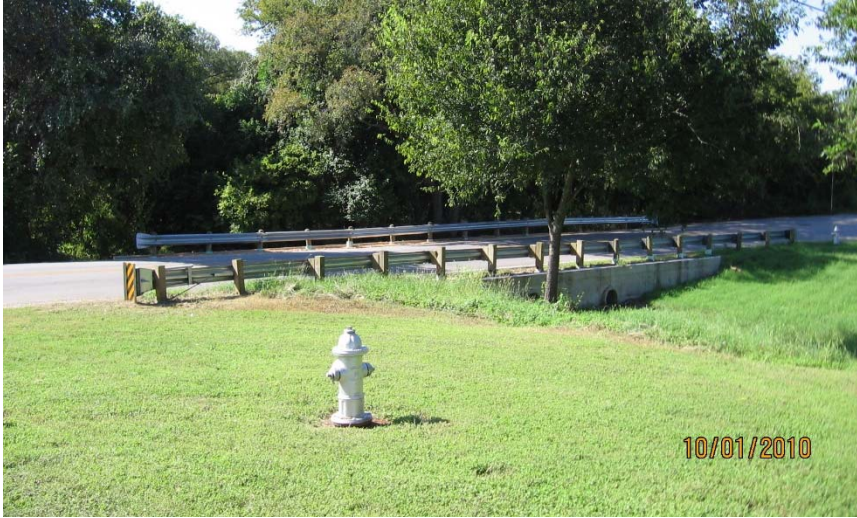
### Standard Culvert Crossing in Good Condition

Small multi-pipe crossing with headwalls, guardrailing, and SETs. Abrupt roadway edge drop-off condition, although relatively shallow, warrants guardrailing protection.

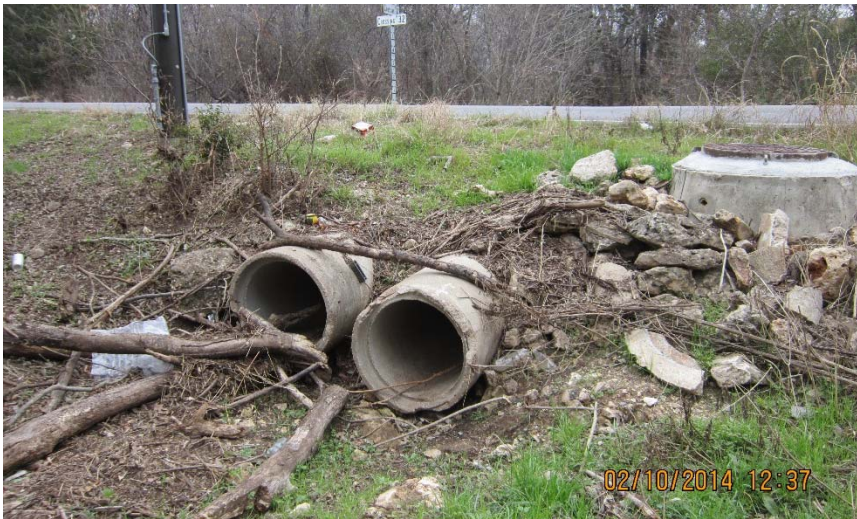
### Non-Standard Multi-pipe Culvert Crossing – Needs Maintenance

Small, extended multi-pipe crossing with no roadway elements at all. Pipe ends are far outside the roadway clear zone. Shallow bury, small diameter pipes only create a shallow edge drop-off which does not cause a concern for the roadway.

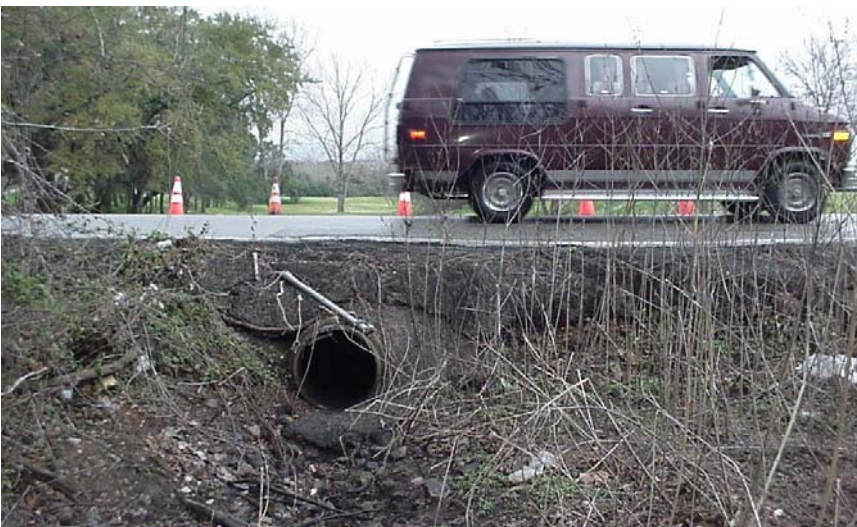
### Non-Standard Pipe Culvert Crossing – Needs Improvement

Small single pipe crossing with no roadway elements at all. Pipe end is within the roadway clear zone and should probably be protected or the slope extended and improved. Deeper small diameter pipe creates an edge drop-off which may cause a concern for the roadway.

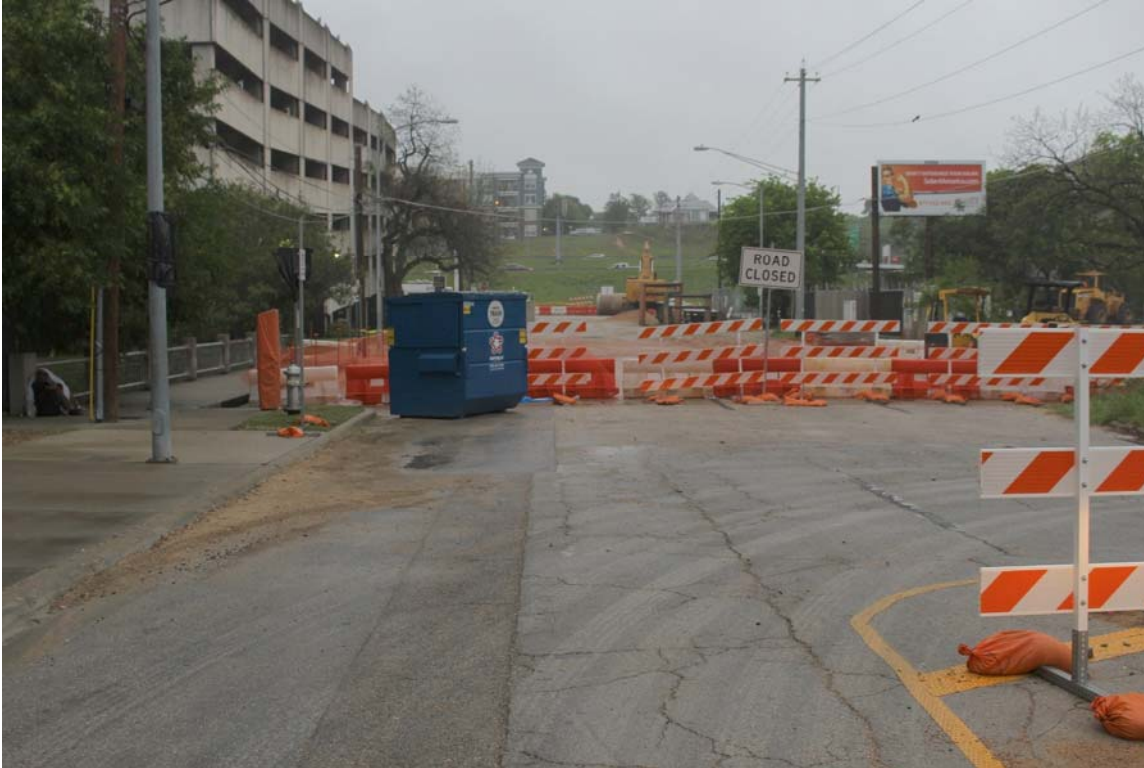
ROADWAY VIEW

NOTE: Bridge closed to house construction equipment for hotel construction at SE corner. Bridge open to pedestrian traffic.
