### I. Qualitative Analysis

**QUALITATIVE ASSESSMENT**  
**AUSTIN AQUATIC FACILITIES NEEDS ASSESSMENT**

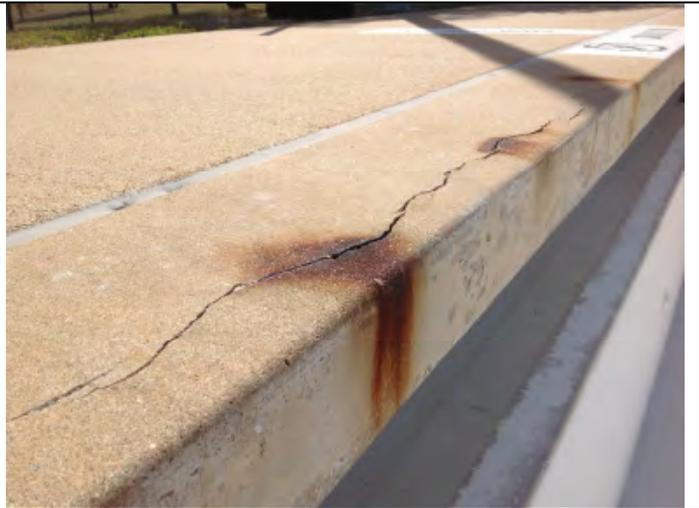
Pool Coping cracked – rebar rusting

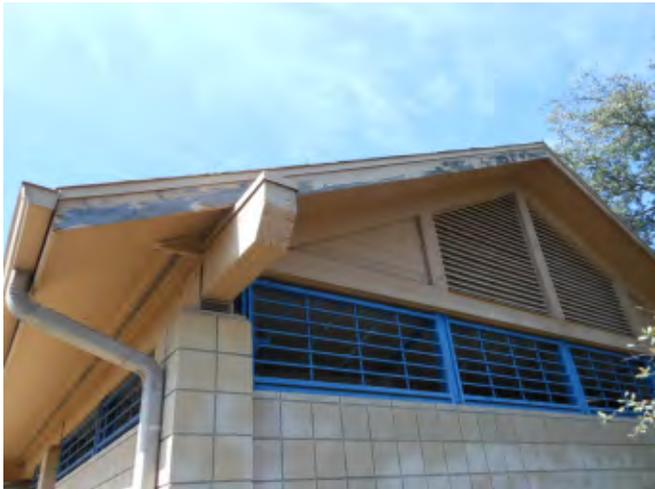
Paint at Fascia

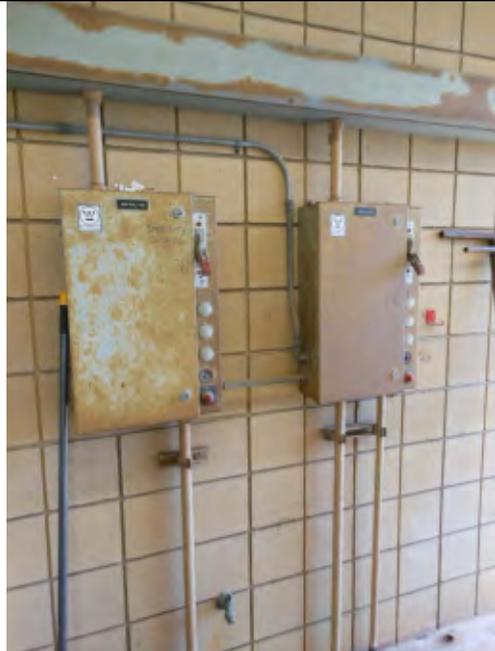
Rusted Electrical Panels

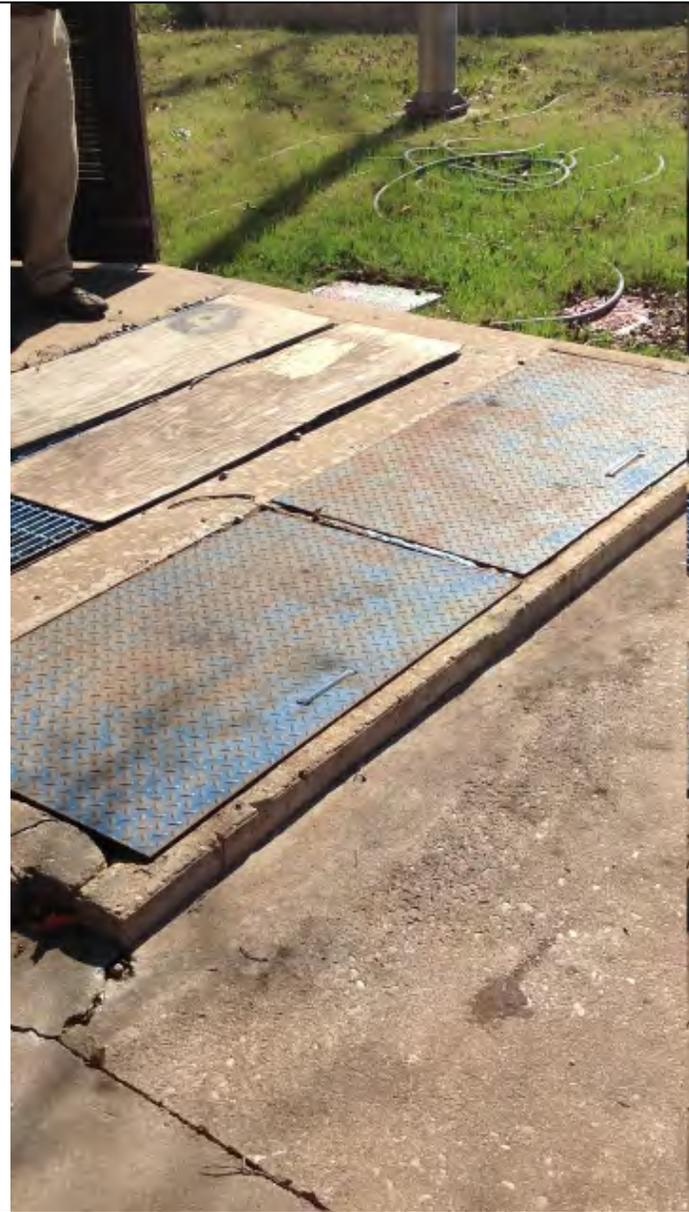
Steel Grates a hazard on the pool deck

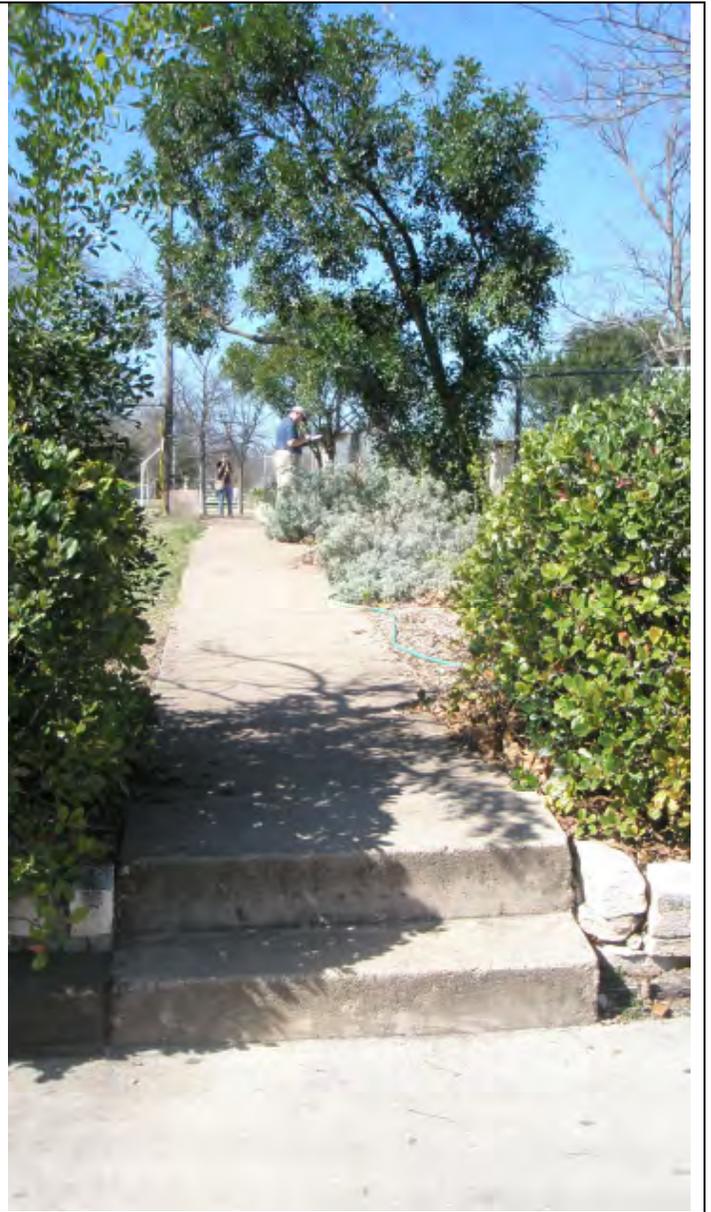
Access Issues

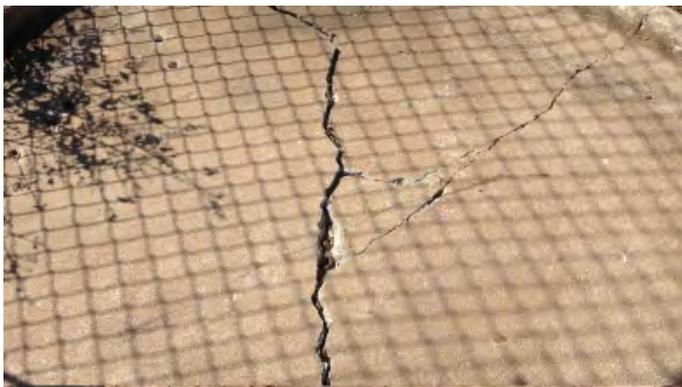
Failing Pool Deck

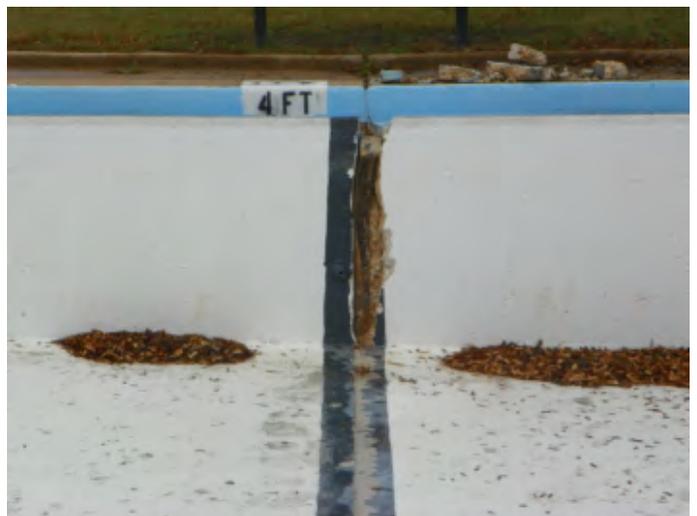
Cracked Control Joint

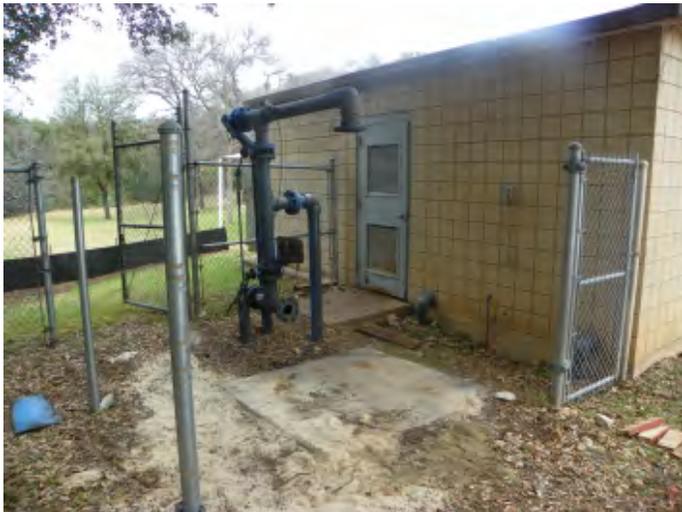
Pump House – Filter being replaced
