## *APPENDIX H: UT's Guadalupe Street Corridor Safety Study and Recommendations*

## FINAL REPORT

**DATE:** October 14, 2016  
**TO:** Mr. David L. Rea  
**FROM:** Brian D. Van De Walle, P.E. PTOE  
**JOB NUMBER:** 069225002  
**RE:** Safety Study  
Guadalupe Street Corridor

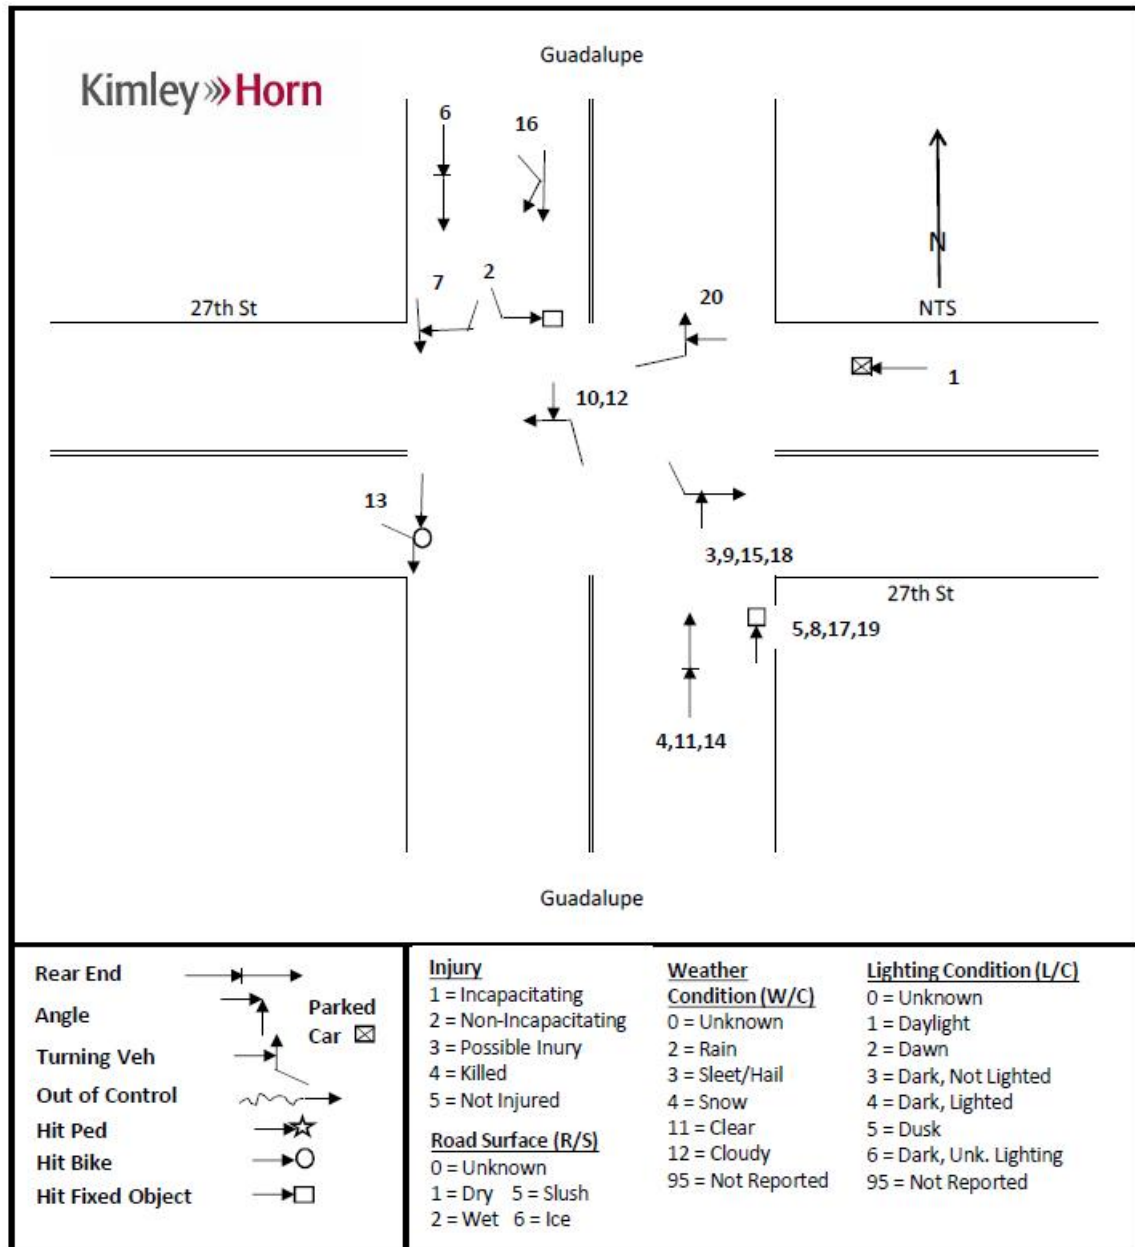
### 1. GUADALUPE AND 27<sup>TH</sup> STREET

Accidents occurring at the intersection of Guadalupe and 27<sup>th</sup> can be characterized as being caused by permitted left turns in the north and south direction, as well as rear ends and sideswipes from passing to move around turning and stopped traffic in the northbound and southbound directions. **1 bicycle** accident and **0 pedestrian** accidents were recorded at this location. The lone bicycle accident was caused by a right-turning wrong-way driver from the west on 27<sup>th</sup> Street.

- **Re-Stripe Crosswalks.** Because most accidents can be linked to the northbound crosswalk area, it is recommended that this crosswalk and westbound lanes be re-striped to improve visibility.

- **Northbound Right Turn Bay.** Consideration of a right-turn bay in the northbound direction could help mitigate rear end and angle accidents from southbound right-turners.

- **Modify Left Turn Signals (Flashing Yellow Arrow).** Changing the left-turn signal heads to flashing yellow arrows and increasing clearance intervals may help reduce accidents from left-turners.

- **Pedestrian Detection for Turning Vehicle Conflicts.** A possible innovative improvement at this intersection would be a pedestrian detection device that changes the left turn indication to a red arrow in off-peak traffic periods.

- **Advisory Speed Signs.** Sharp curves cause dangerous situations for pedestrians and cyclists on this part of Guadalupe, and a slower speed may help mitigate dangerous vehicular behavior. It is suggested to add an advisory speed sign of 25 mph through the curves.

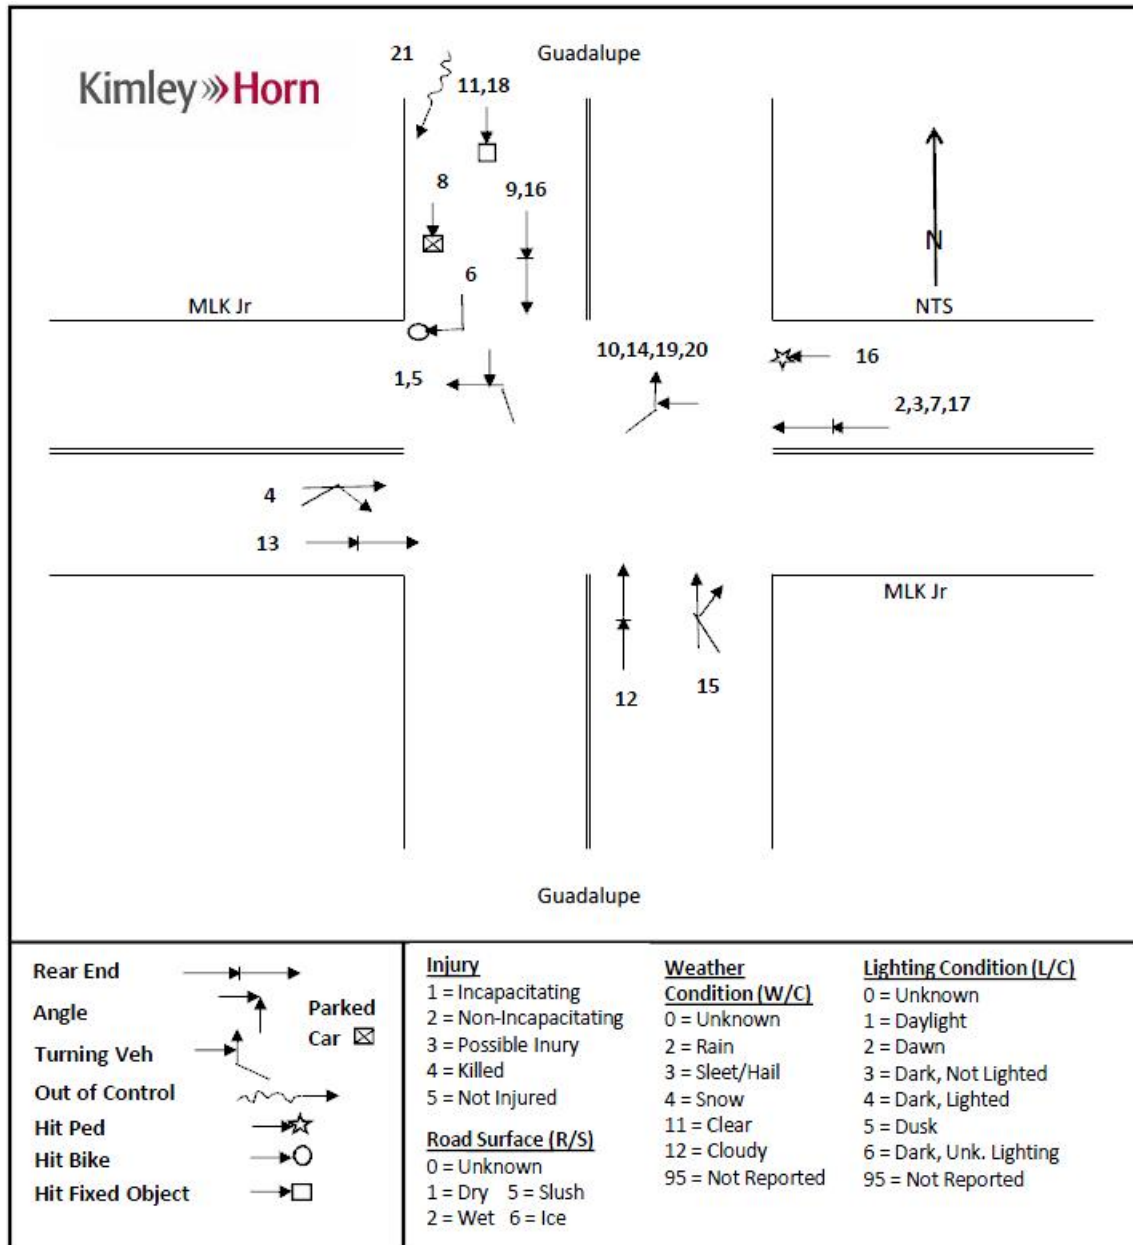
### 2. GUADALUPE AND MARTIN LUTHER KING, JR BLVD

Accidents occurring at the intersection of Guadalupe Street and MLK, Jr. Boulevard. can be characterized as being caused by left turns in the eastbound direction on MLK, right-turners not recognizing the early channelized left on westbound MLK, eastbound traffic turning from MLK onto northbound Guadalupe Street and trying to change lanes around buses or cars, and high activity areas on southbound Guadalupe Street north of the intersection with several parking maneuvers, backing vehicles, and a bike lane crossing at the entry to a channelized right. It was also noted that 10 of 22 accidents occur in the evening hours when it is dark. **1 bicycle** and **1 pedestrian** accident were recorded at the intersection. The bicyclist was hit by a southbound right-turning vehicle and the pedestrian was hit by a westbound vehicle while crossing the crosswalk on the east.

- **Improve Lighting.** It is recommended that a luminaire be installed on the northwest corner pole of the intersection.
- **Realign/Restripe Southbound Bike Lane/Travel Lanes.** To help reduce southbound accidents and increase cyclist comfort, it is recommended to move cyclist away from curb and adjacent to the outermost travel lane north of the driveway across from 20<sup>th</sup> street. Then, a larger area can be striped off for vehicles turning right in the southbound direction and the cyclists and backing vehicles can be in better view. Per the City of Austin staff, an improvement similar this to address the crossing issue is **in progress**.

- **Add Signage (“Yield to Bikes”).** Additional signage about the crossing traffic and backing vehicles may also be helpful to drivers, such as a “Yield to Bikes” sign. To mitigate accidents for left-turning vehicles in the eastbound direction, it is recommended to install a “No Right Turn on Red” sign in the westbound direction.

- **Change Signal Timing (Extend Clearance Interval).** To mitigate accidents for left-turning vehicles in the eastbound direction, it is recommended to extend the clearance interval.

- **Close Advanced Left Turn Westbound.** For westbound left-turners, pedestrians crossing in the eastbound direction and heading south should be moved to the intersection and cut through area near the island be closed off to traffic. This will help create a more familiar situation for drivers and will allow for safer travel for pedestrians in the area.

- **Adjust Crosswalk Location Southbound.** Lastly, the crosswalk in the channelized right-turn southbound should be pulled back from the intersection where most pedestrians coming southbound are crossing.

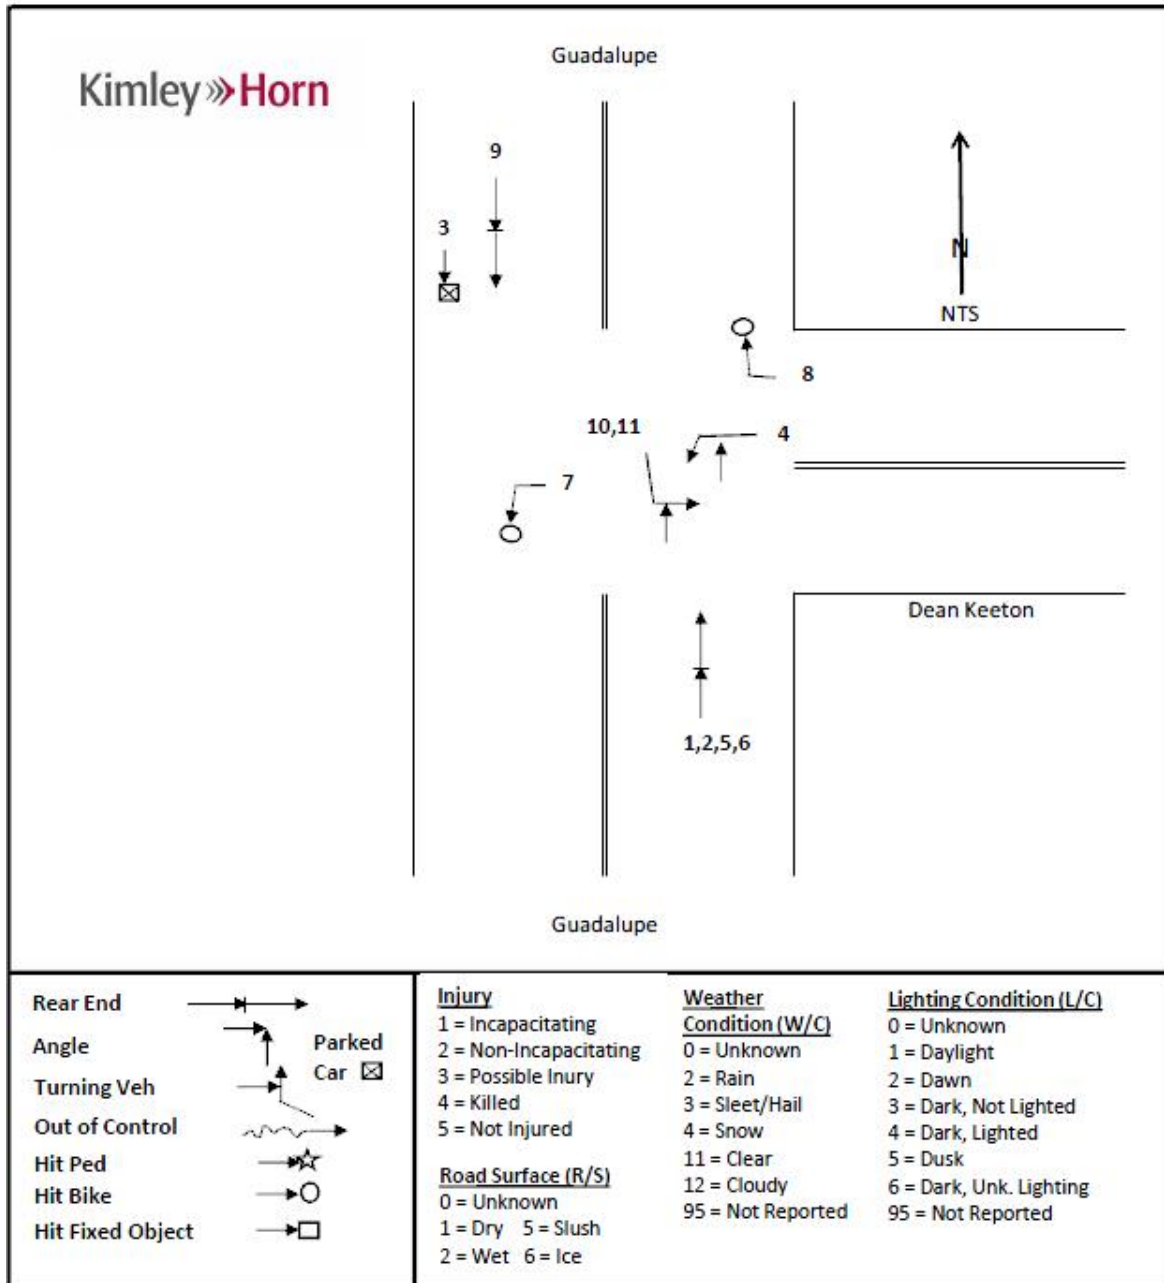
### 3. GUADALUPE AND DEAN KEETON STREET

Accidents occurring at the intersection of Guadalupe and Dean Keeton can be characterized as being caused by lane change movements and unexpected parking maneuvers at the intersection in the north and southbound directions, respectively. In addition, severe southbound left-turn accidents may be caused by the new dual-service southbound left-turn movement (both occurring after September 1, 2015). **2 bicycle** accidents and **0 pedestrian** accidents occurred at this location during the years 2013-2015. Both bicycle accidents involved turning vehicles (one left, one right) from westbound Dean Keeton.

- **Relocate Bus Stop.** To mitigate the most frequent accident (northbound rear-ends), it is recommended to move the bus stop to the far side of the intersection in the northbound direction. A large number of vehicles trying to turn right onto Dean Keeton are frustrated by long stacking buses due to multiple bus stops near this signal, causing aggressive behavior. The 640 university shuttle is the only observed bus turning left at this location, and can be serviced by a nearby stop south of Whitis on Dean Keeton. Coordination with Cap Metro will be required.
- **Re-time Off-Peak Signal Timing Plans (Extend Clearance Interval).** Both of the southbound left accidents occur during off-peak times, and may result from an issue with signal timing, and should be further investigated for the off-peak timing plan.

**Remove/Reduce Commercial Parking Space.** Due to the lane shift and far-side parking on the southbound Guadalupe approach at Dean Keeton, a dangerous situation was observed in the field where the two receiving lanes were too narrow for 2 vehicles to fit through, causing braking and near accidents. It is recommended that the parking for commercial vehicles be eliminated until a full lane width for the outside lane is available next to parking, and to shift deliveries to the rear of the building where there is access. Per the City of Austin staff, an improvement to address the issue is **in progress**.

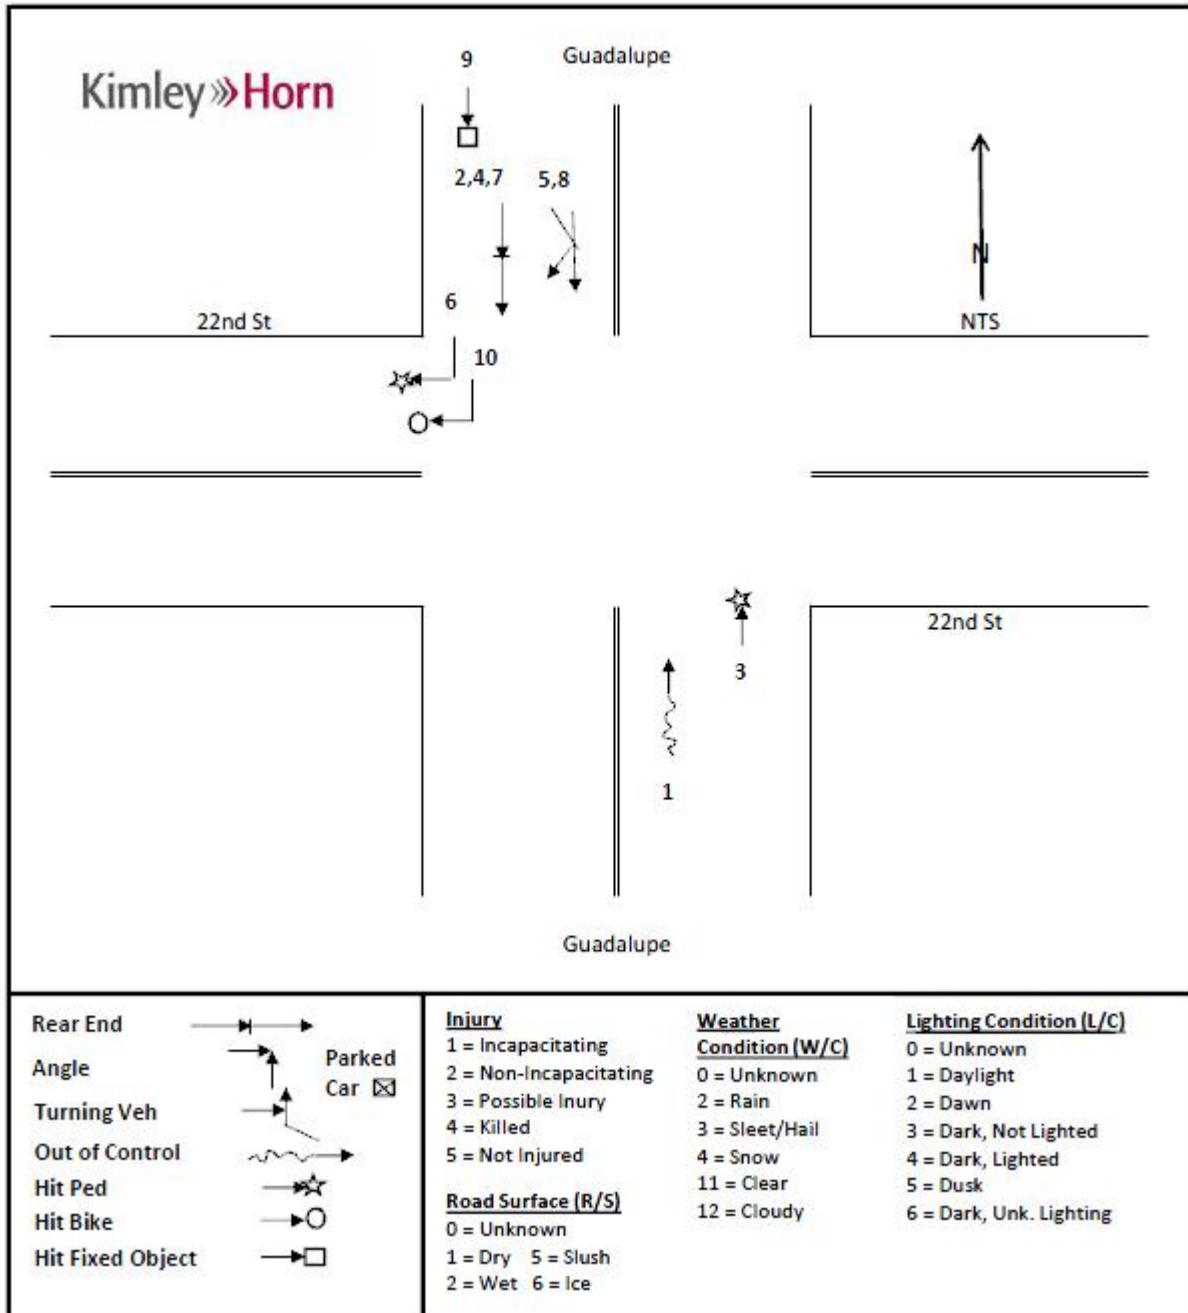
### 4. GUADALUPE AND 22<sup>ND</sup> STREET

80% of the accidents at the intersection of Guadalupe and 22<sup>nd</sup> street occur on the southbound approach to the intersection. The other 20% of accidents at the intersection occur in the northbound direction. 1 **bicycle** accident and 2 **pedestrian** accidents occurred at this location. One of the pedestrian involved accidents resulted in an incapacitating injury to the pedestrian, occurring in the morning off-peak hours. The incapacitating accident occurred due to a vehicle hitting a pedestrian in the crosswalk on the south side of the intersection. The two other accidents involving bicyclists and pedestrians resulted in non-incapacitating injuries due to right turning vehicles headed southbound.

- **Change signage (“Yield to Bikes” sign).** For the accidents in the southbound direction, it is recommended that a sign with “Yield to Bikes” be placed in a visible area as the intersection at 21<sup>st</sup> also has currently installed. The amount of signs at the intersection are overwhelming and could be consolidated to simplify messages to automobiles.

- **Prohibit Southbound Right Turns.** Prohibiting vehicular right turns may be best at this location, as the visibility of pedestrians crossing is occluded due to parked cars and heavy amounts of pedestrians waiting in the corners.

- **Prohibit Westbound Left Turns.** Prohibiting left turns from Inner Campus Drive onto Guadalupe will help reduce pedestrian and bicycle crossing conflicts where there is currently an unprotected turn movement.

- **Add Leading Pedestrian Interval (LPI).** Adding an LPI will help move pedestrians into the crosswalk prior to a signal green phase to make them more visible to vehicles. This is a possible alternative if prohibiting southbound right turns is not possible.

- **Expand Pedestrian Space.** Crowding of the corners is especially present on the University side (east side) of the intersection, where significant improvements can be made by pulling back the architectural walls and widening sidewalks through the area. It was observed and noted by University employees that the level of pedestrian and bicycle traffic has increased dramatically as student housing development has accelerated in the “West Campus” area, causing problems for eastbound and westbound turners who do not have time during signal cycles to make a safe movement.

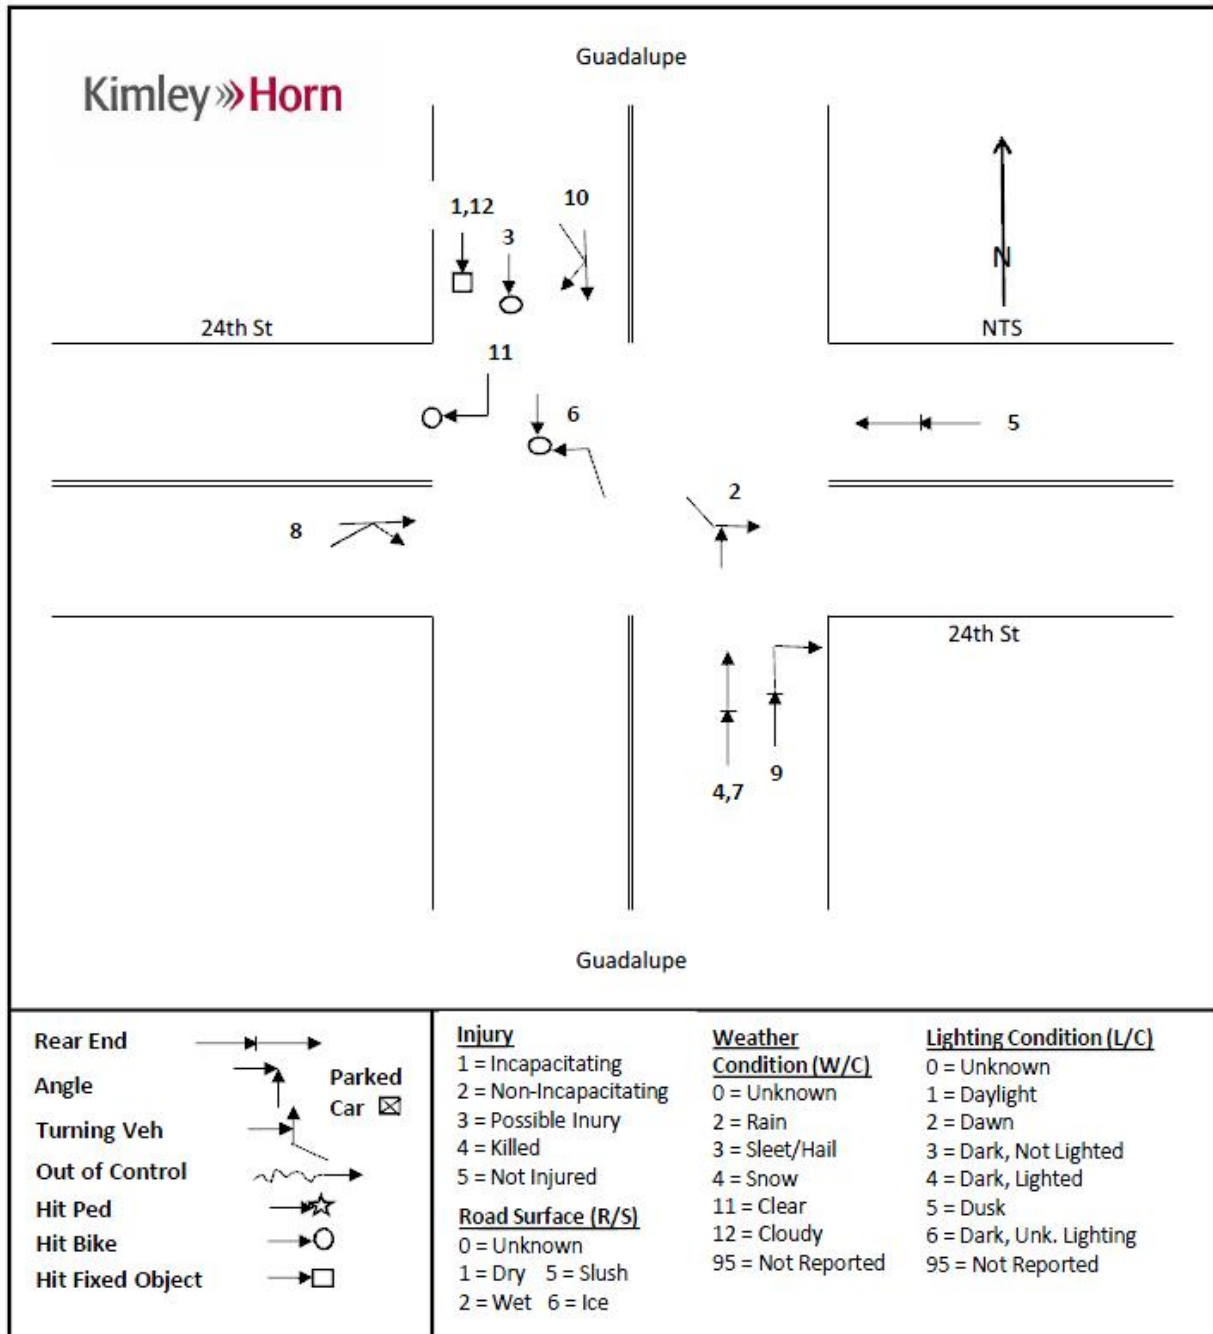
### 5. GUADALUPE AND 24<sup>TH</sup> STREET

As with Guadalupe and 22<sup>nd</sup>, accidents occurring at the intersection of Guadalupe and 24<sup>th</sup> Street are primarily occurring in the southbound direction, and secondarily in the northbound direction, likely attributed to aggressive behavior for lane changing due to buses, or unexpected pedestrians in the crosswalk. **3 bicycle** accidents and **0 pedestrian** accidents occurred at this intersection. 25% of the accidents at this location involved bicycles in the southbound direction, suggesting that visibility of bicycles to motorists may be an issue. One accident involved an illegal left turn in the northbound direction around the time of the morning peak on a Friday.

- **Relocate Bus Stops.** It would be beneficial to move near-side bus stops to the far side of the intersection, especially in the southbound direction, as buses stop a few hundred feet from the intersection and bikes squeeze by on the outside lane to the beginning of a bike lane, occluded from view from motorists. Moving the bus stop on the northbound side to the far side of the intersection will hopefully help mitigate accidents at this location.

- **Re-stripe Southbound Approach (add Bike Box).** The lane width of the southbound right turn is below the acceptable minimum lane width at 7.5' wide. It is suggested that a sharrow pavement marking (as on Guadalupe between 27<sup>th</sup> and 29<sup>th</sup> Streets) replace the bike lane with a bike box in front of the stop bar for safer operation.

- **Expand Pedestrian Space.** The architectural wall on the southeast corner could be moved back to improve visibility of pedestrians for right turners.

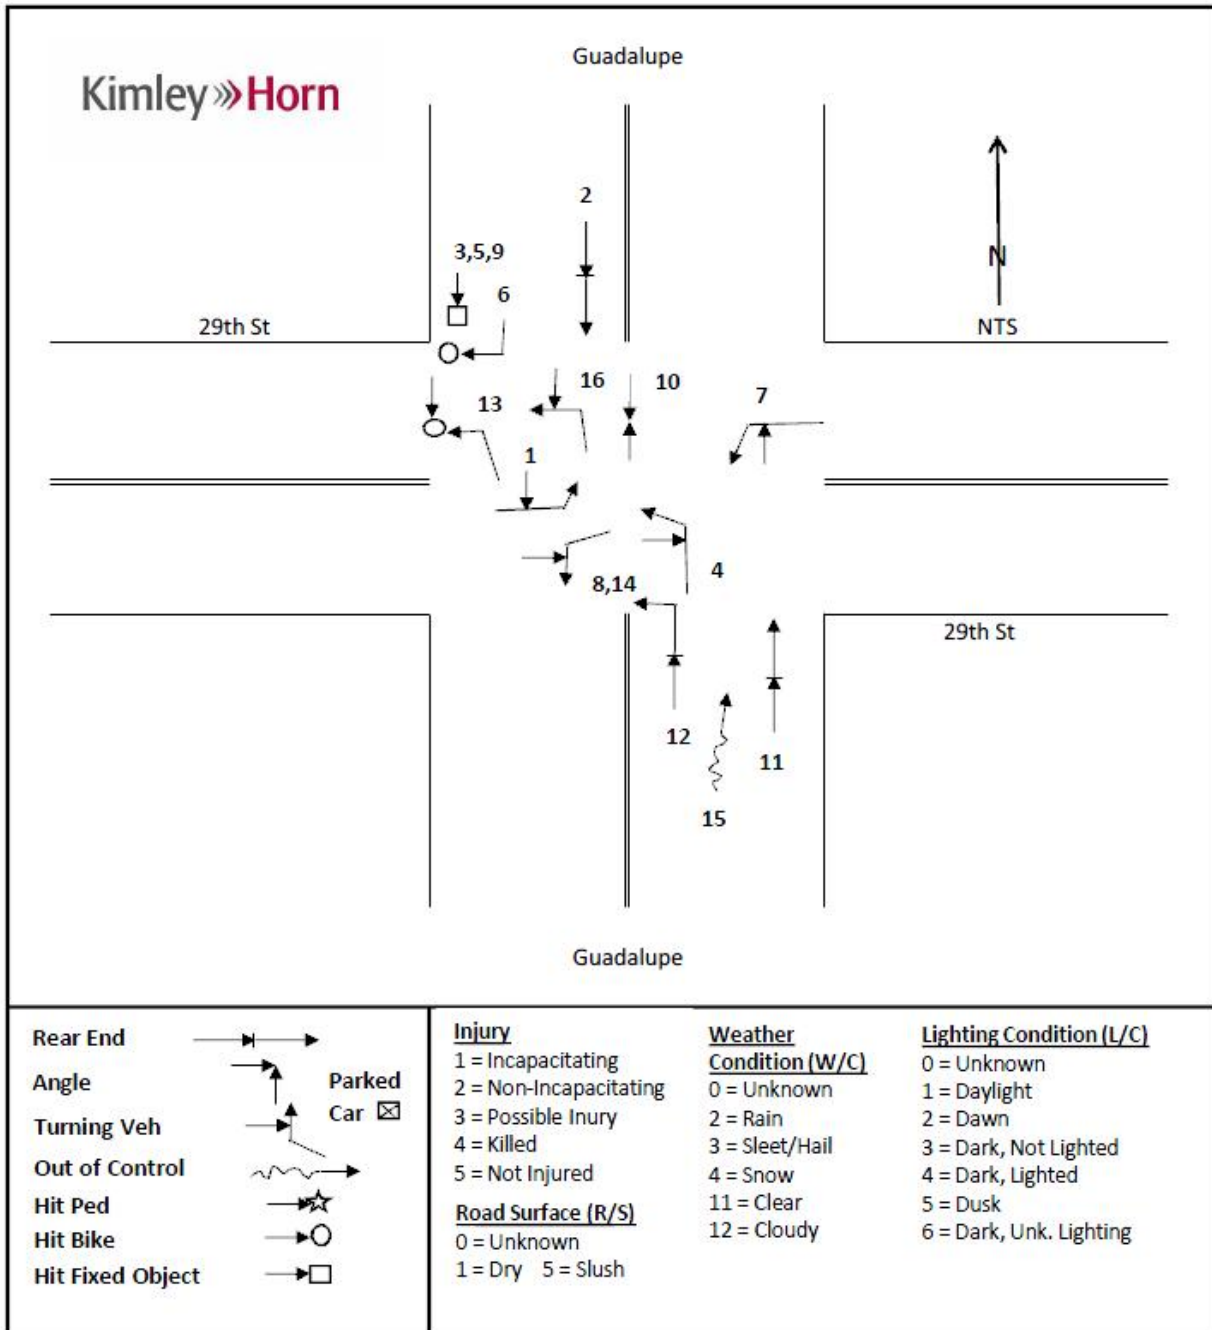
### 6. GUADALUPE AND 29<sup>TH</sup> STREET

At the intersection of Guadalupe and 29<sup>th</sup>, accidents occur primarily in southbound direction (over 50%) and almost 50 percent of all accidents are left turns, many of which occur in the off-peak period. In addition, 5 of 16 accidents occur after midnight. It appears that most accidents could be attributed to high speeds and poor sight distance due to the curvature of Guadalupe at the intersection as well. **2 bicyclist** accidents and **0 pedestrian** accidents occurred at this intersection. Of particular concern is bike accidents and vehicles hitting "fixed objects" which has been previously mislabeled in a report for a cyclist, but could also be a stopped vehicle, such as the buses at the southbound bus stop.

- **Advisory Speed Signs.** Sharp curves cause dangerous situations for pedestrians and cyclists on this part of Guadalupe, and a slower speed may help mitigate dangerous vehicular behavior. It is suggested to add an advisory speed sign of 25 mph through the curves.

- **Relocate Bus Stops.** It is suggested to move the bus stop to a more advantageous location away from the intersection, either further back on the segment at 30<sup>th</sup> street or to the far side.

- **Improve Lighting.** Lighting should be improved at the northeast corner of the intersection where there is no luminaire and the existing pole has enough height for an arm to be added.

- **Add Protected Left Turns (Eastbound/Westbound).** Consideration should be given to adding a protected left turn in the east and west directions during the off-peak.

- **Restripe Crosswalk and Replace Ramps.** The southbound pedestrian crosswalk can also be repaired by placing ADA compliant ramps that are perpendicular to the curb, rather than diagonal, and restriping the crosswalk with high-visibility continental (bar) style pavement markings.

- **Reconstruct Southwest Corner (Curb Extensions).** Right turners from the eastbound direction can also be coerced to reduce speed by extending the curb to the north and east at the southwest corner of the intersection. This will also help reduce the crossing distance for pedestrians and provide space to stand.

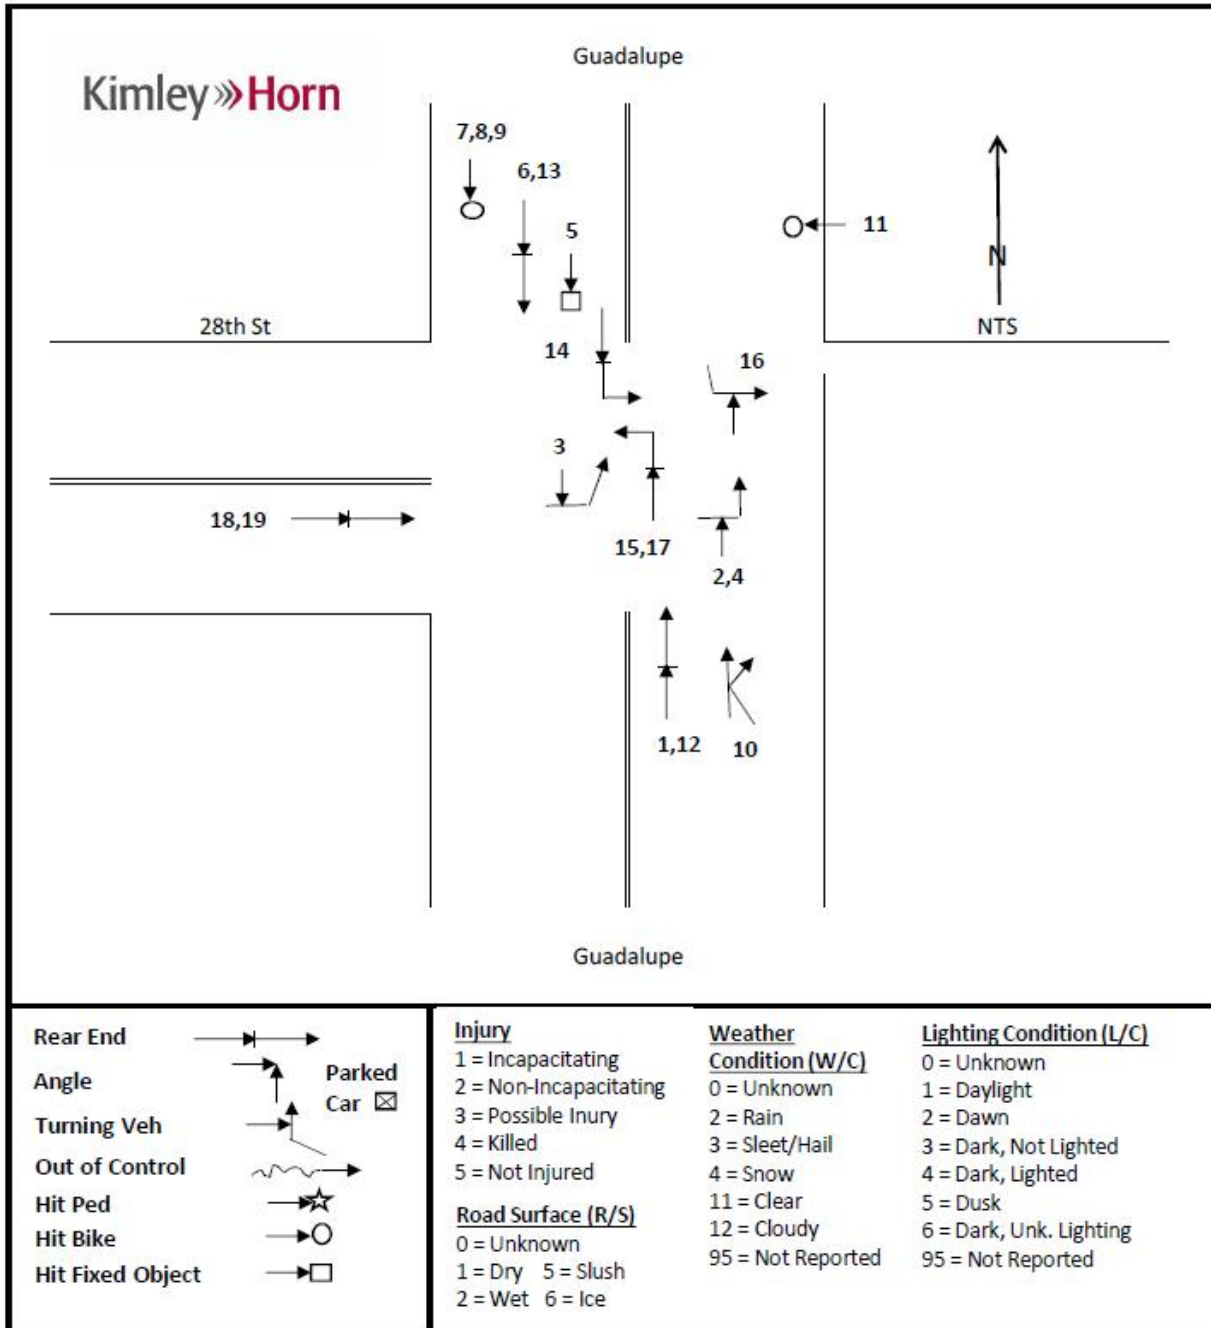
### 7. GUADALUPE AND 28<sup>TH</sup> STREET

Although the intersection of Guadalupe and 28<sup>th</sup> Street was not one of the 6 hot spots, it did have the highest number of accidents at 19, and is thus being included as a “hot spot” for countermeasures. **4 bicyclist** accidents and **0 pedestrian** accidents occurred at this location. The bicycle accidents can likely be attributed to high speeds in a shared lane in vicinity of this intersection, as well as many unprotected left and right-turning vehicles trying to access businesses along the segment. In addition, backing traffic from the east side where there is a 220' stretch of no curb results in dangerous backing maneuvers onto Guadalupe from pull-in spots.

- **Add a Pedestrian Hybrid Beacon (PHB).** A PHB near the intersection would be helpful, but it would require a ramp and curbed area to be installed on the east side where there is currently no curb. Per the Guadalupe Corridor Plan, not yet finalized, the intersection at Guadalupe and 28<sup>th</sup> or Guadalupe and Nueces may become signalized, allowing for a pedestrian crossing at one of those locations in the long-term.

- **Re-Route Cyclists.** Bicyclists could benefit from not having a shared lane and being pushed onto either Nueces Street going southbound or onto Hemphill Park going northbound for detour routes.

- **Prohibit Left-Turns.** Left turns could also be prohibited at 28<sup>th</sup> street by adding a sign on the east side of Guadalupe near the intersection.

- **Improve 28<sup>th</sup> Street Crossing (Pull in Curbs).** To improve the crossing of 28<sup>th</sup> on the west side of the intersection, pulling in curb radiuses would slow down eastbound right turners and shorten crossing distance for pedestrians. This could also be aided by a stop bar and striped crosswalk.
