Existing Conditions Assessment for the Dougherty Arts Center

prepared for the
City of Austin
Parks and Recreation Department
15 September 2010

Existing Conditions Assessment for the **Dougherty Arts Center**

DOUGHERTY ARTS CENTER
GENERAL STRUCTURAL ASSESSMENT

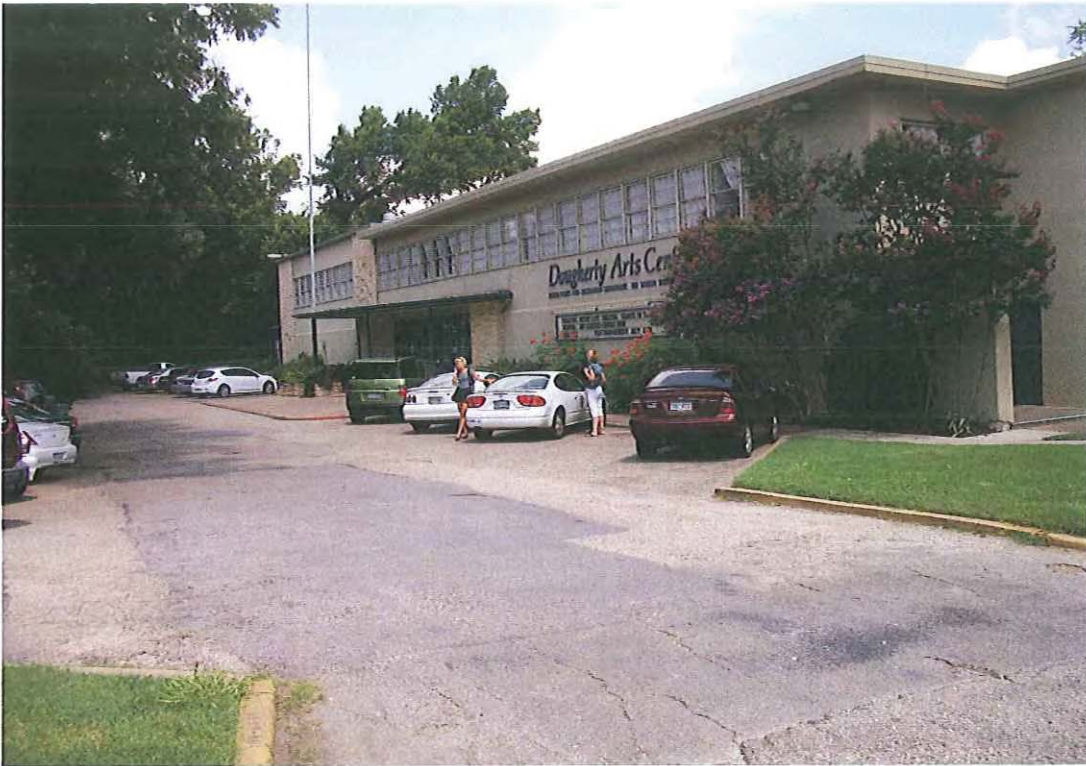
1. South façade of the Dougherty Arts Center, facing Barton Springs Road. In general, this façade preserves the original appearance of the 1947 Naval and Marine Reserve Center.

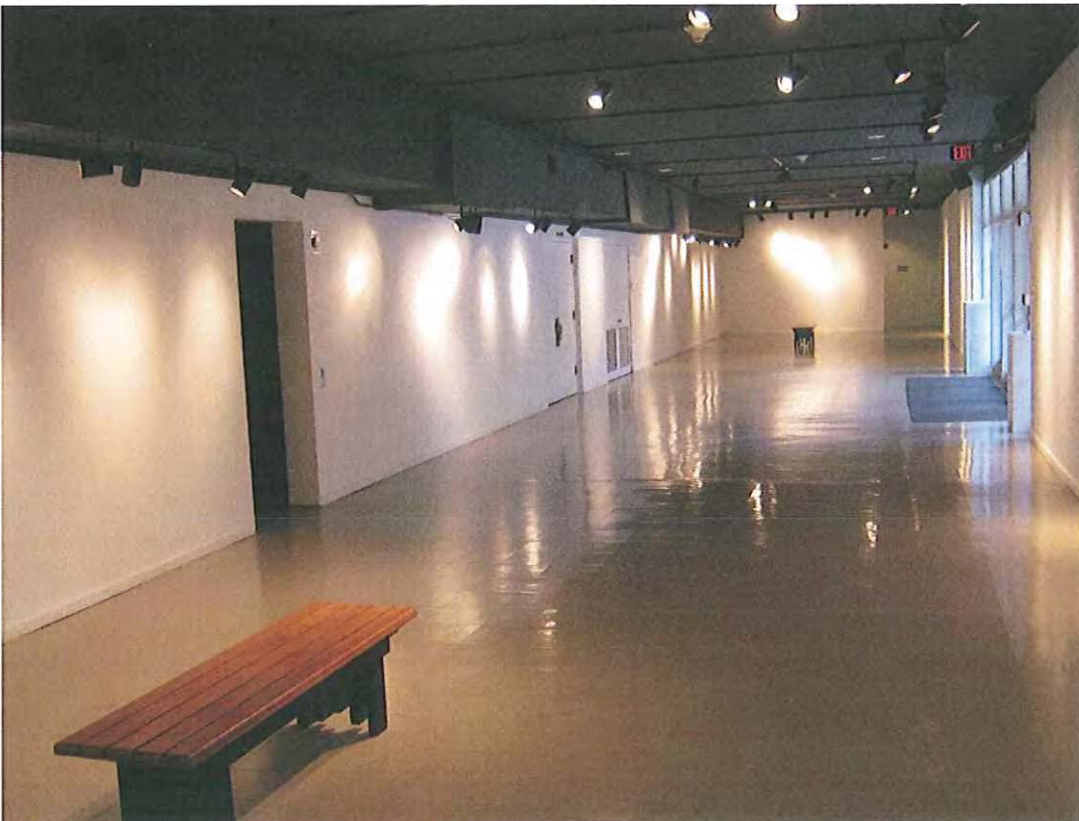
2. The Julia C. Buttrick Gallery on the ground floor of Area A: combined vestibule, lobby, corridor, and exhibition space.

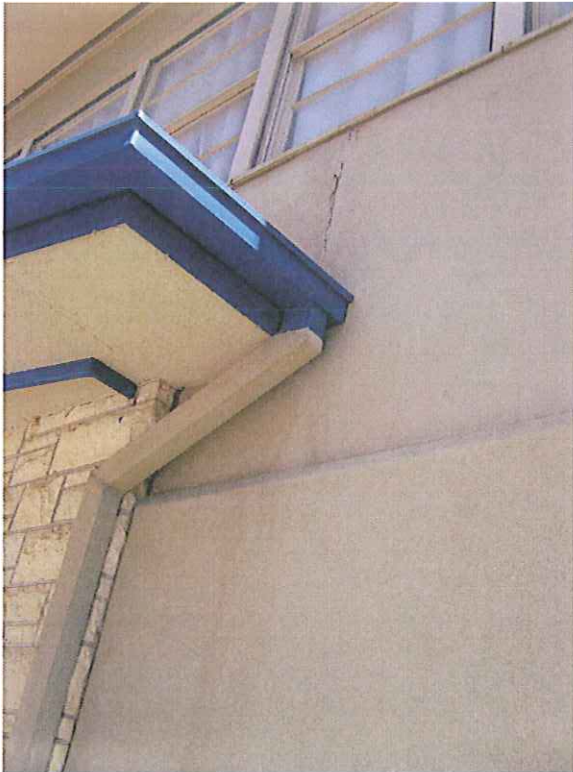
The plaster surface of Area A were not installed in accordance with the current standards of the Portland Cement Association, as codified in the *Portland Cement Plaster/Stucco Manual* per ASTM C1063, *Standard Specification for the Installation of Lathing and Furring to Receive Interior and Exterior Portland-Cement Based Plaster*. The absence of control joints as recommended by these publications is likely contributing to the stressing and fragmentation of the stucco veneer.

3. Failing plaster installation at Area A.

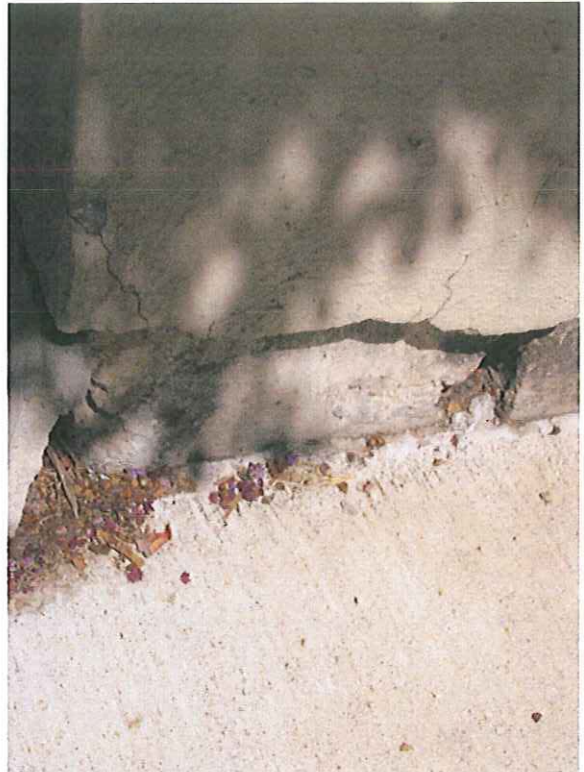
4. Delaminating plaster at Area A.

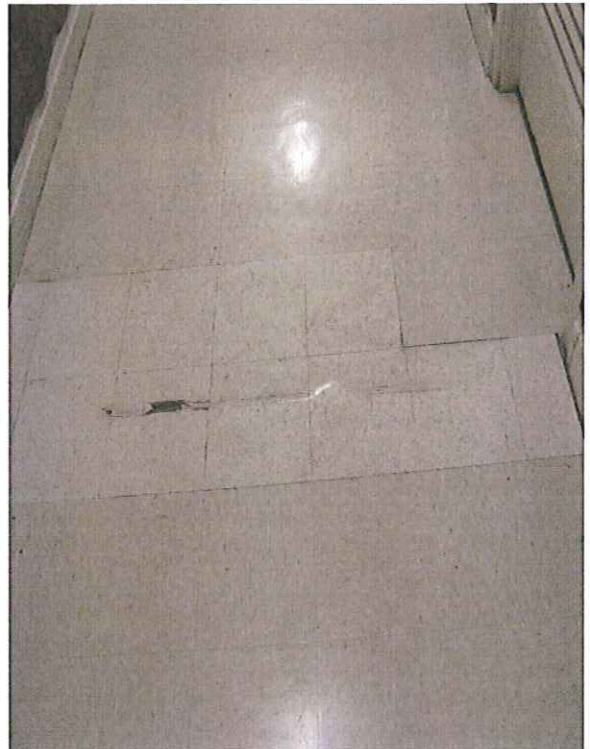
6. Tile condition at connection between Areas A & B.

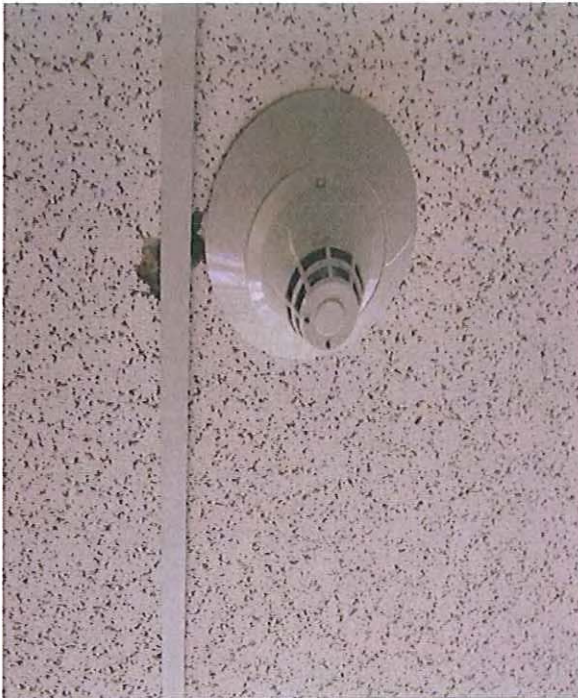
7. Evidence of raccoon infestation in Area A (202W).

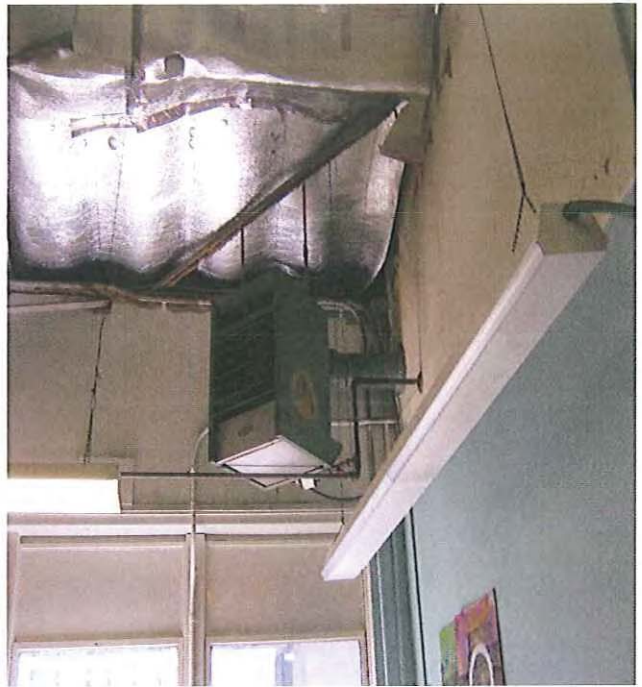
8. Ceiling/roof condition in Area B (5W).

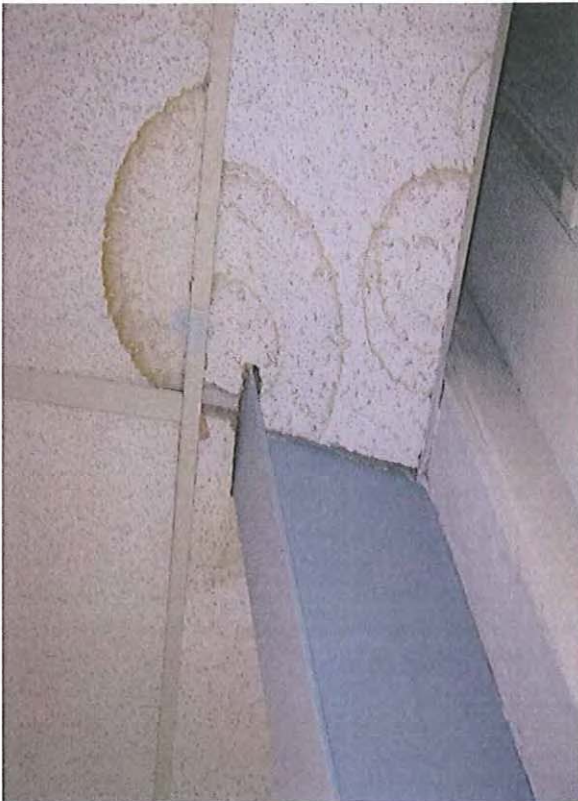
9. Evidence of roof membrane failure in Area B (4W).

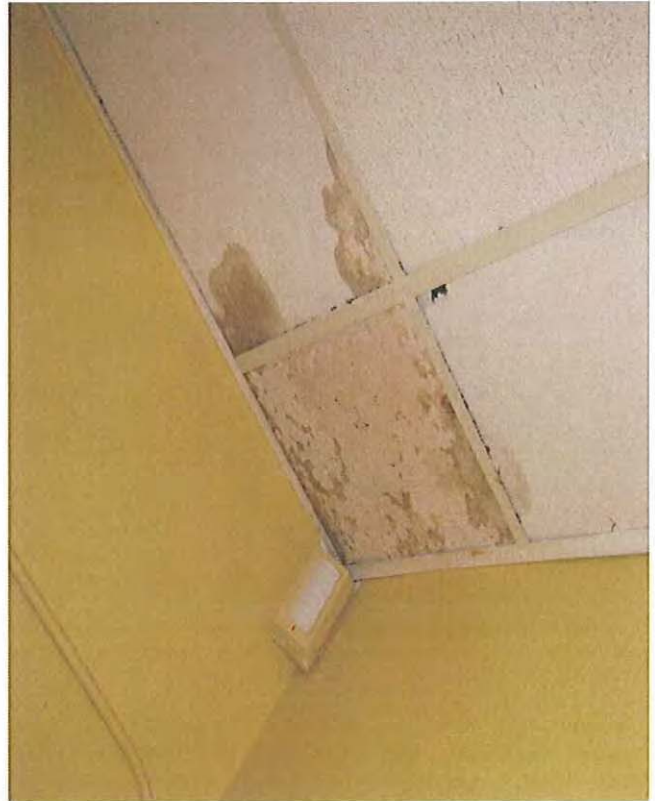
10. Evidence of roof membrane failure and potential mold growth in Area B (2W).

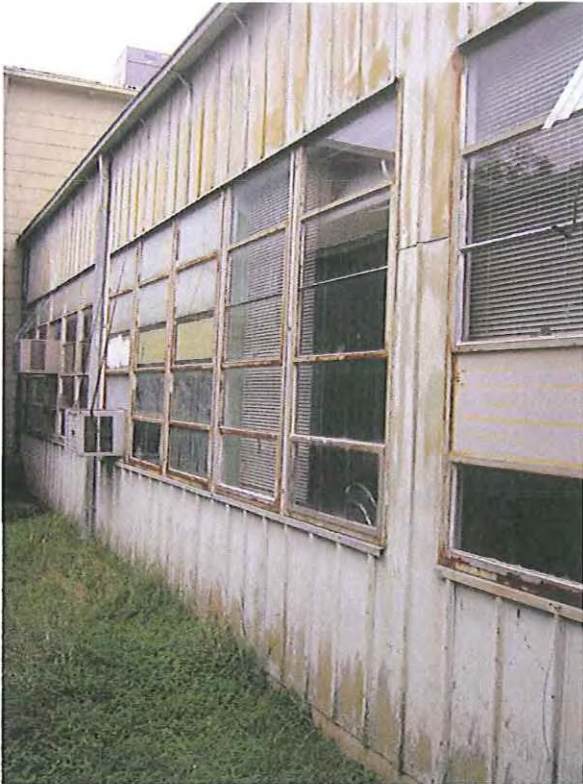
The majority of the windows in Area B appear to be original to the building. The 1998 Condition Report noted “Many of the exterior windows are badly rusted with some unable to close due to broken parts or other problems. Various window panels are broken and have been filled in with a variety of inappropriate products including cardboard and plywood.”¹⁵ The photograph of the east wall of Area B that accompanied this comment in the 1998 Condition Report documents that only limited and discrete improvements to the existing windows were made over the following twelve years. The windows in Area B are, essentially without exception, economically unserviceable. In addition to their conspicuously poor present condition, these windows, constructed from non-thermally-broken steel frames single-glazed with clear float glass, with fault prone operators and with gaskets and weather seals long since perished, provide an appalling degree of thermal inefficiency, with a corresponding impact on both occupant comfort

11 A/B. Exterior of East and West side of Area B. Presumed original metal windows and wall panels installed in 1947.

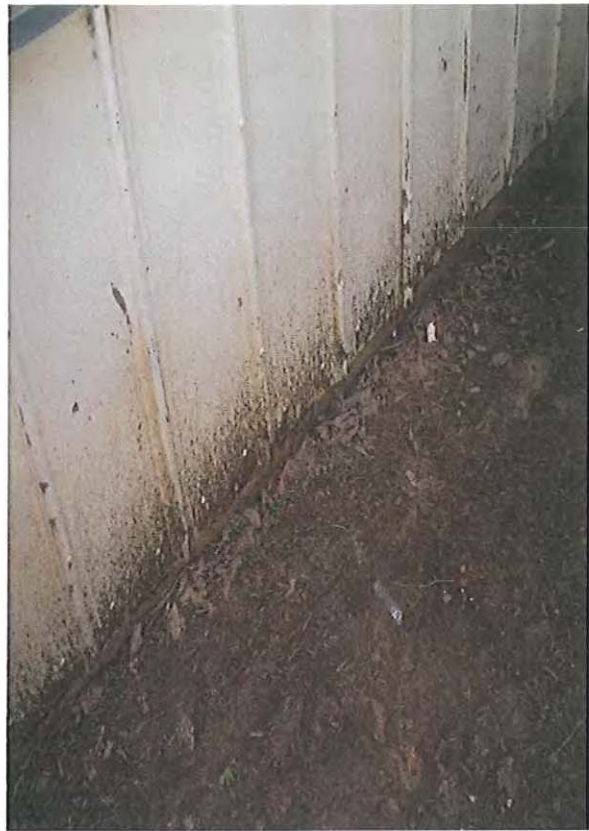
12. Typical asbestos wainscoting in Area B.

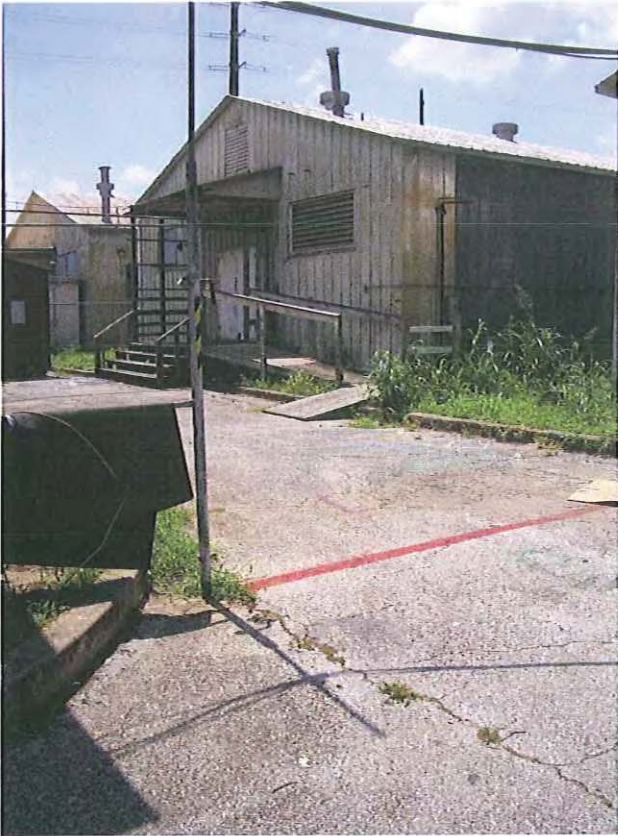
14. Exterior condition of Area C, emphasizing distinction between original and replacement wall panels.

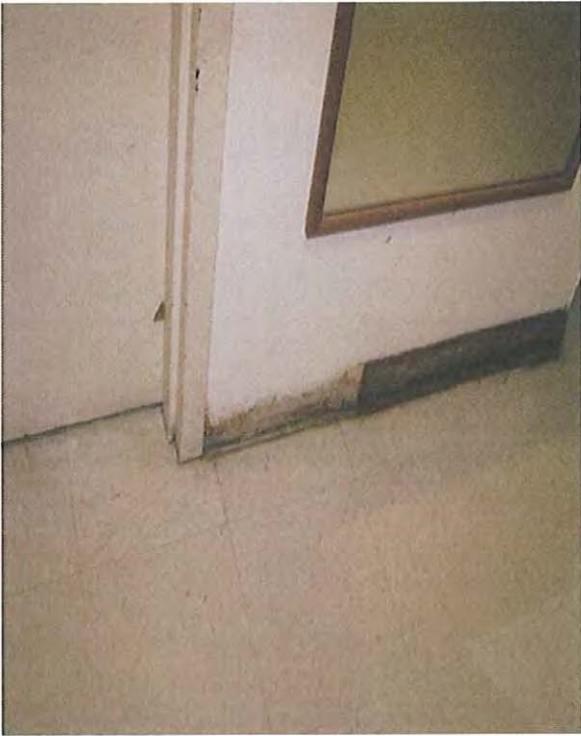
15. Base conditions in Area C.

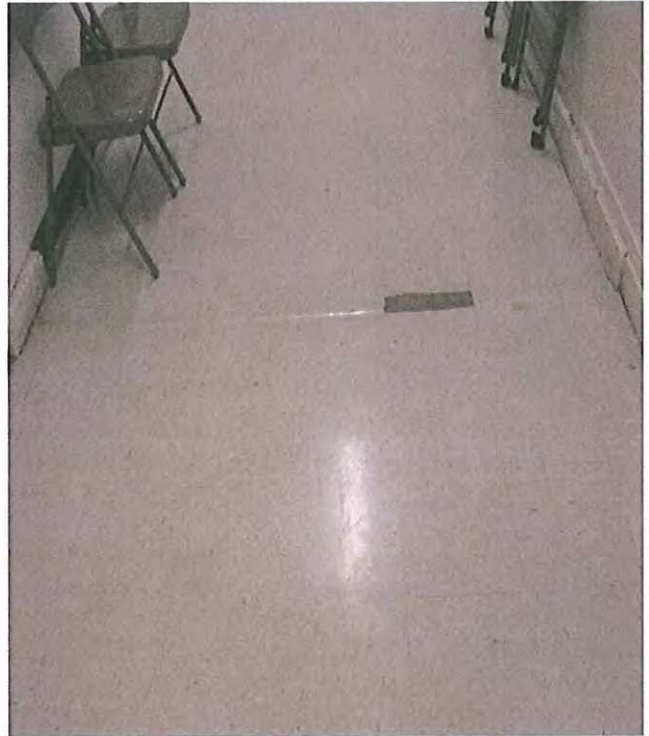
16. Tile at joint between Areas C & D, indicating evidence of differential slab movement.

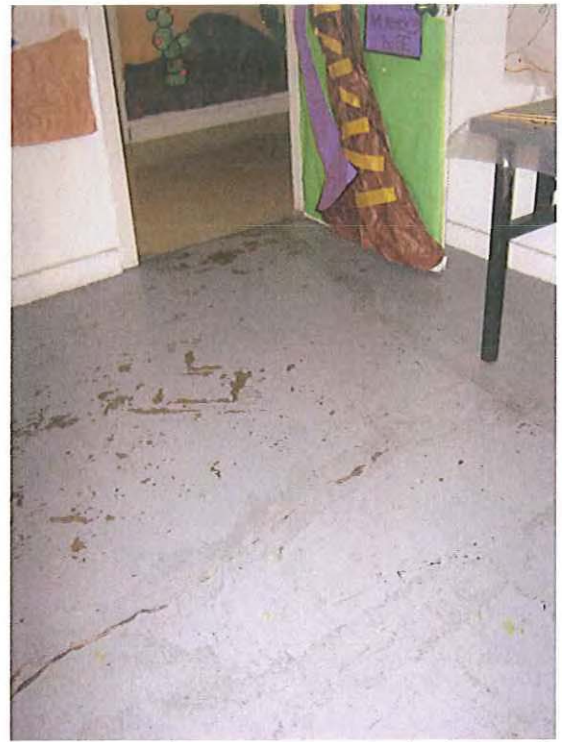
18. Evidence of past concrete repairs in Area D (8E).

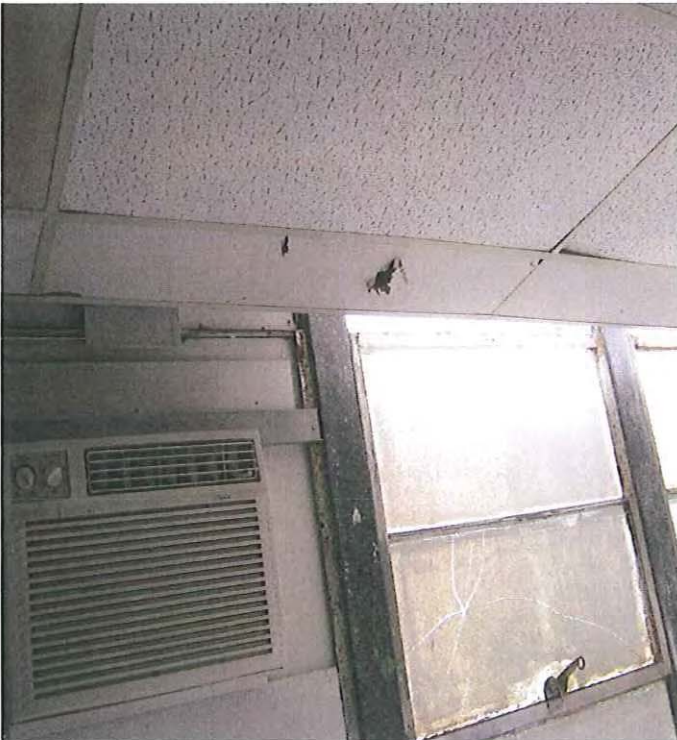
19. Evidence of vermin infestation and window failure in Area D (10E).

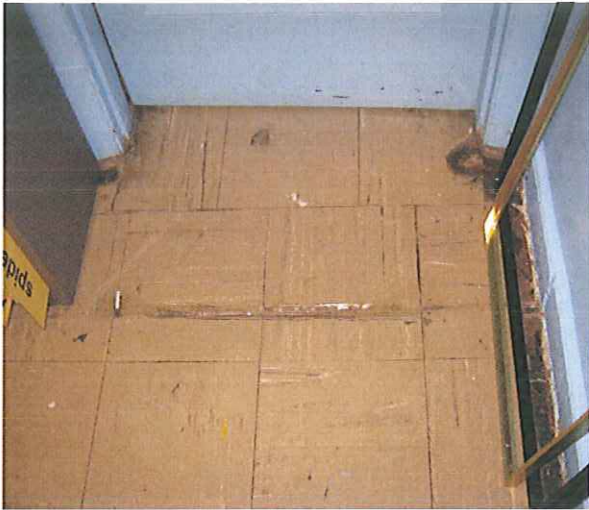
20. Slab and tile conditions in Area E (13N).

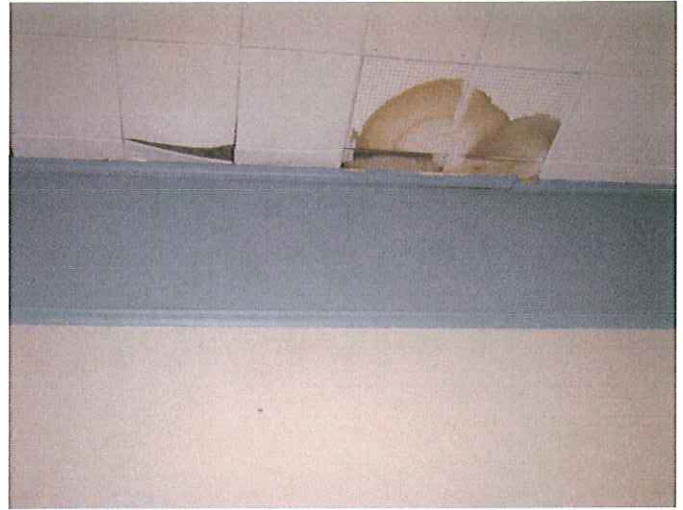
21. Evidence of roof leak in Area E (13N).

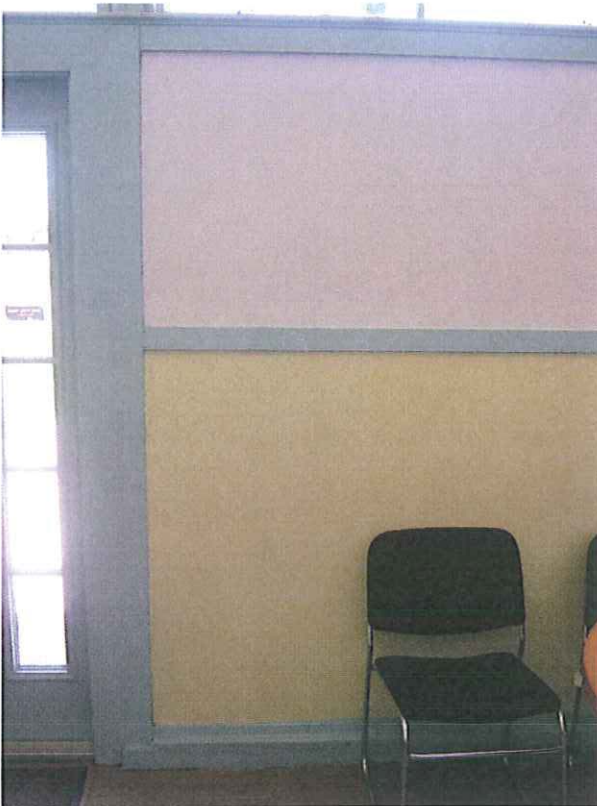
22. Interior conditions in Area E.

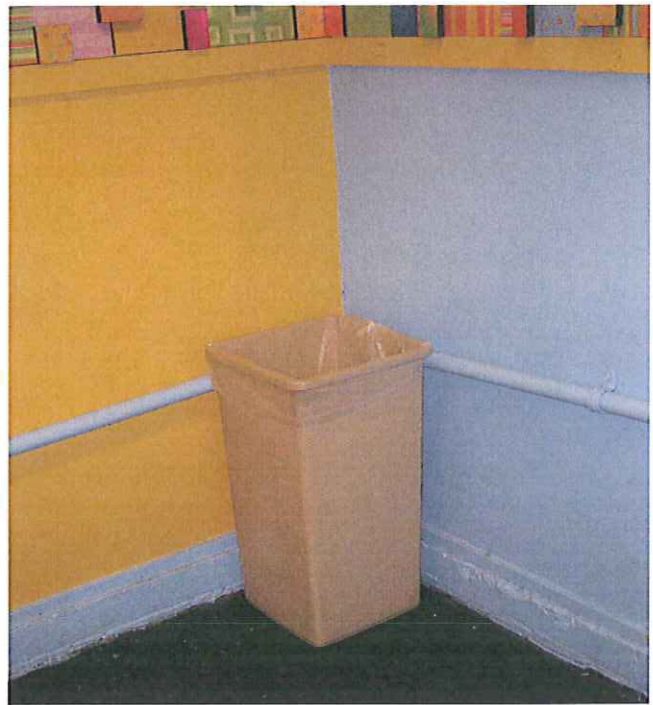
23. Interior conditions in restrooms in Area E.

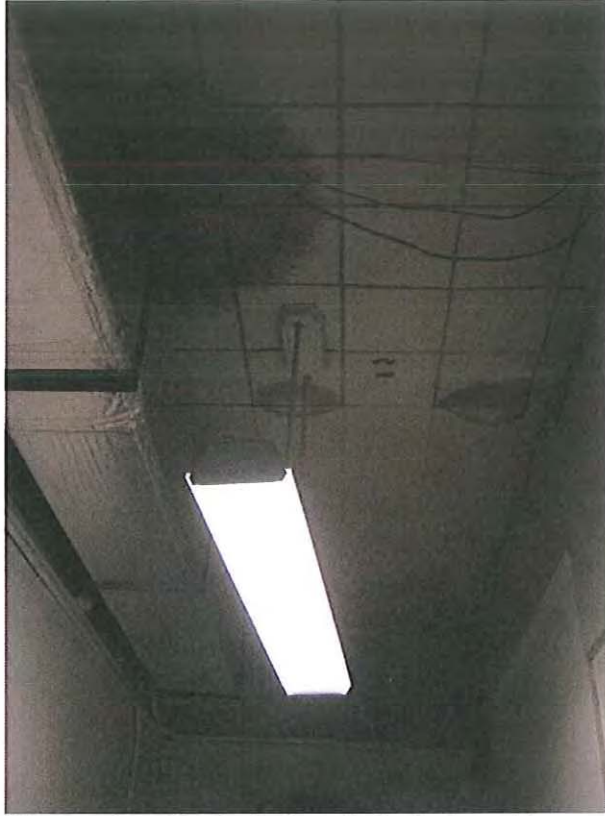
24. Evidence of roof leaks in Area E: typical corridor.

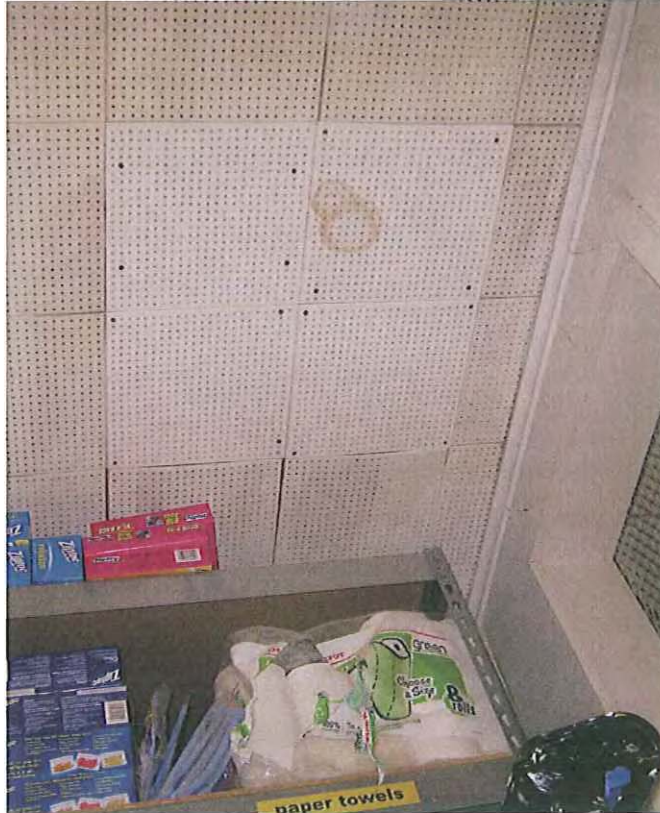
25. Evidence of roof leaks in Area E.

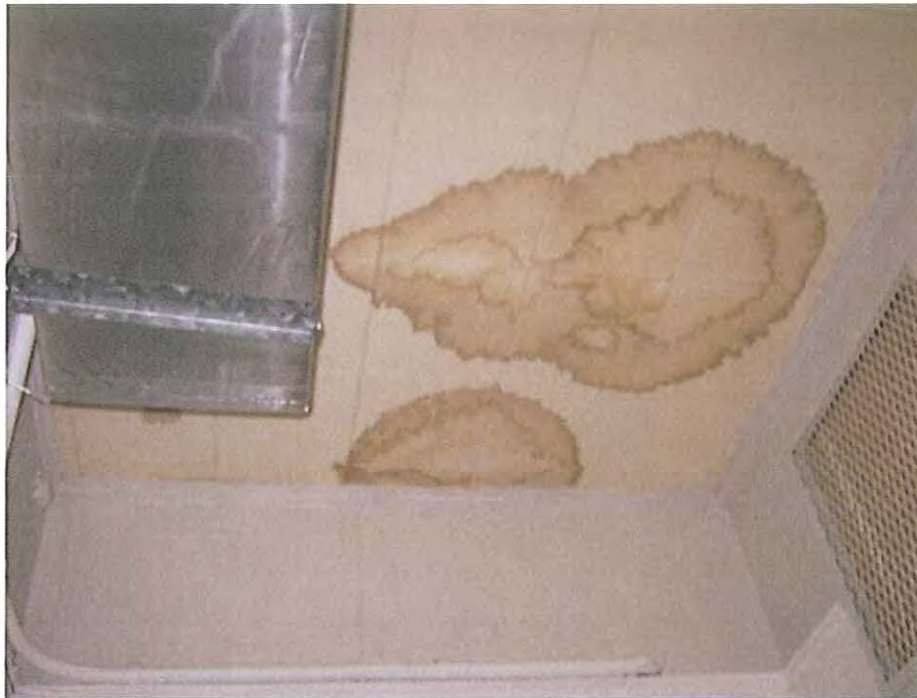
26. Evidence of roof leaks in Area E.

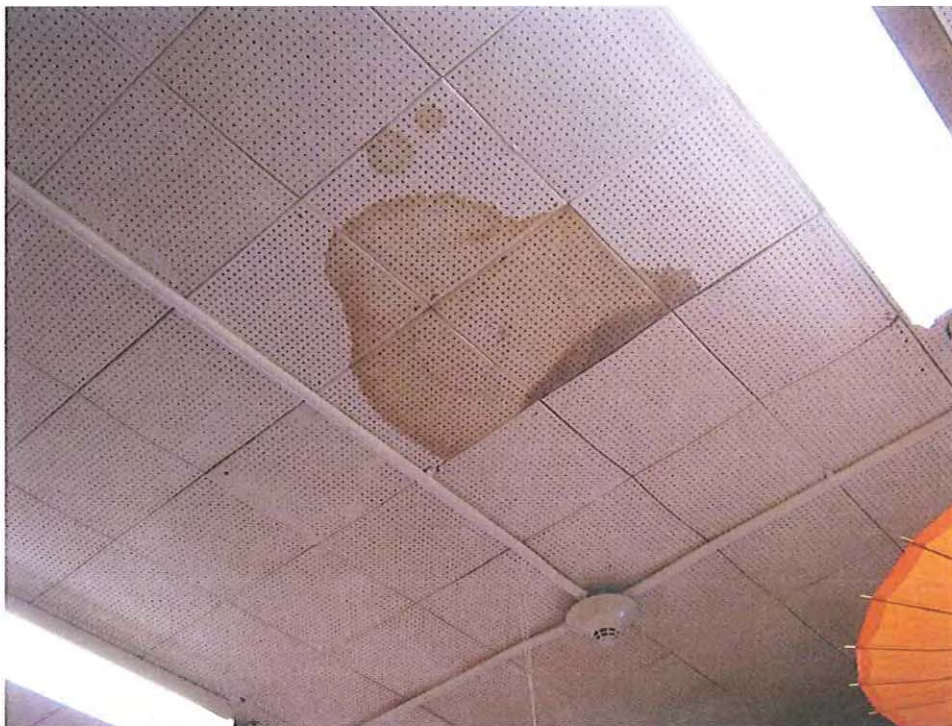
27. Evidence of roof leaks and pervasive water damage in Area E.

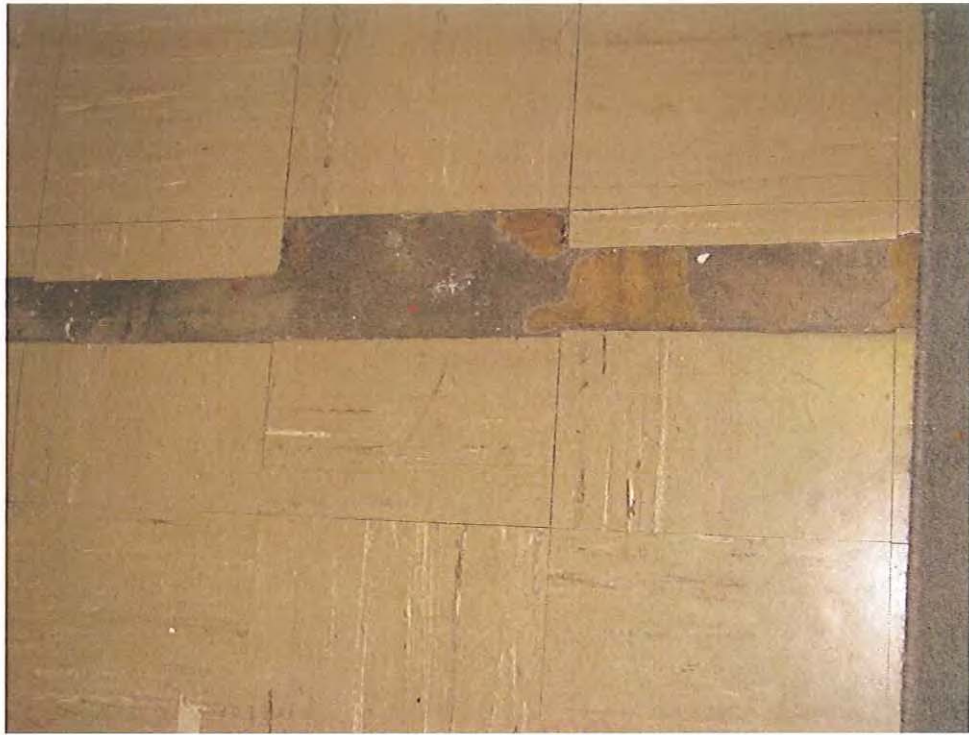
28. Typical tile conditions throughout Area E

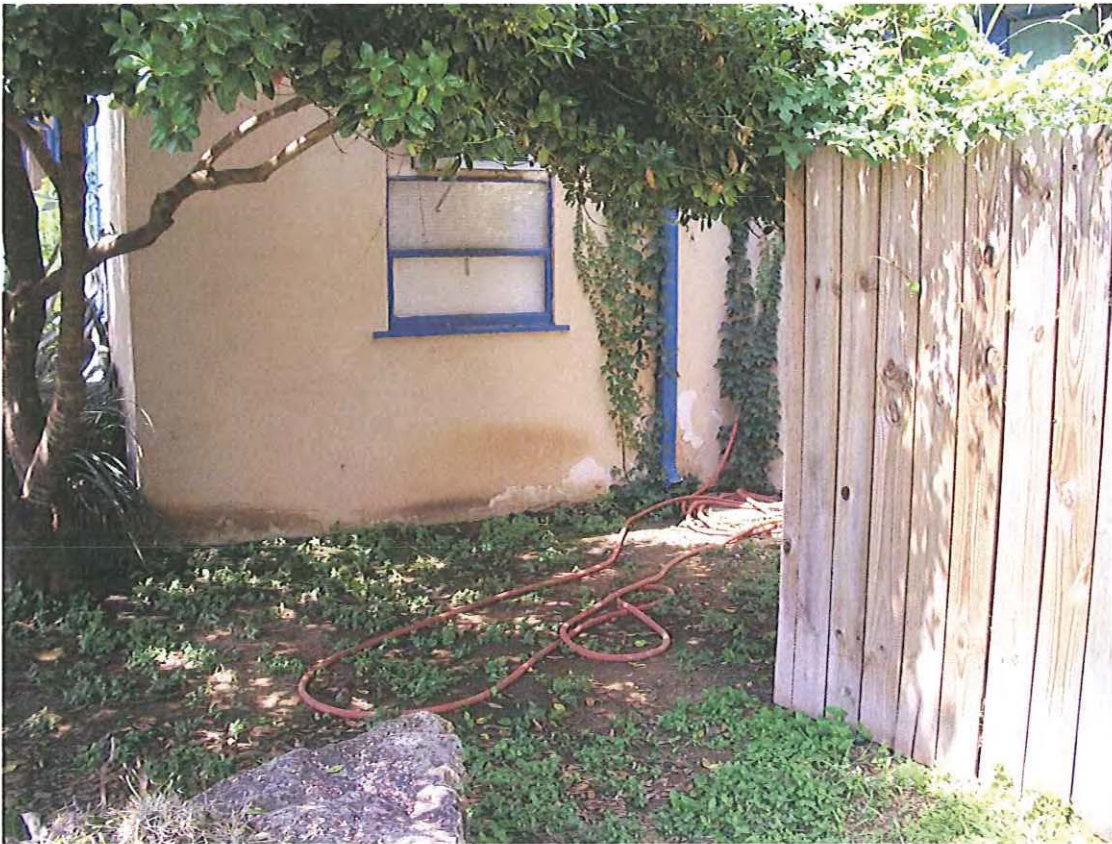
29. Typical exterior conditions of Area E.

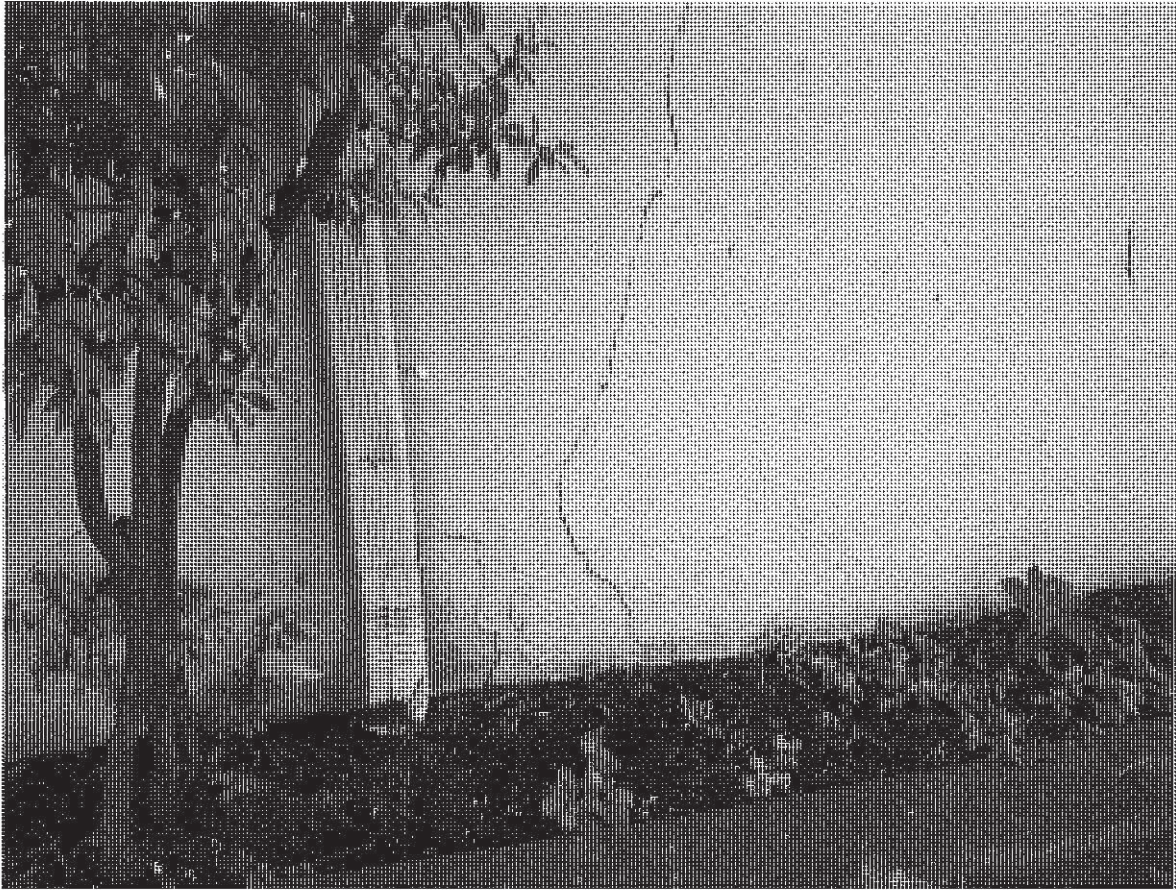
30. Typical exterior conditions of Area E.

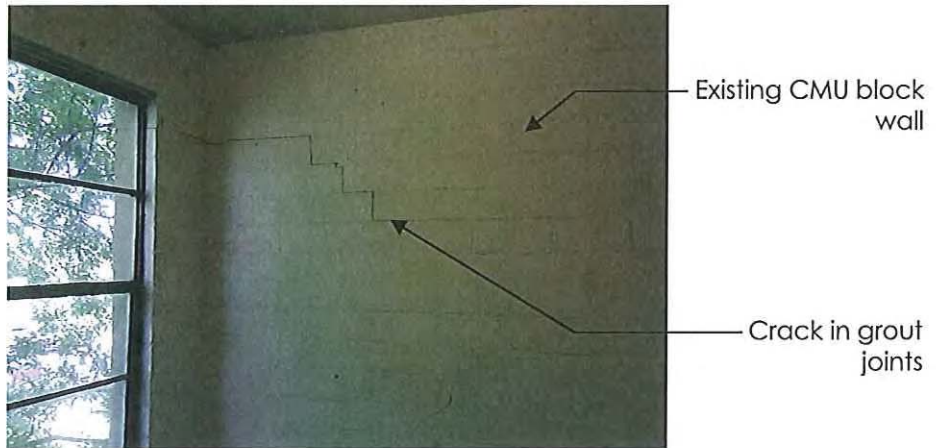
Photo 4: Cracks in CMU wall at east staircase

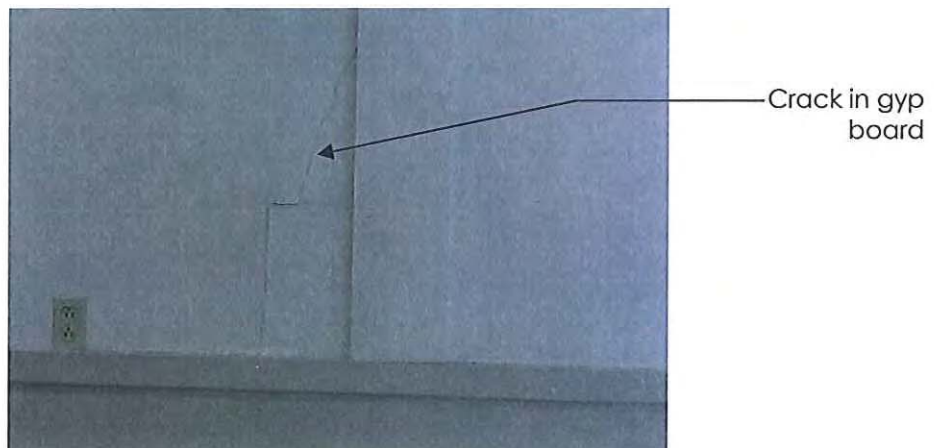
Photo 5: Cracks in gypsum board

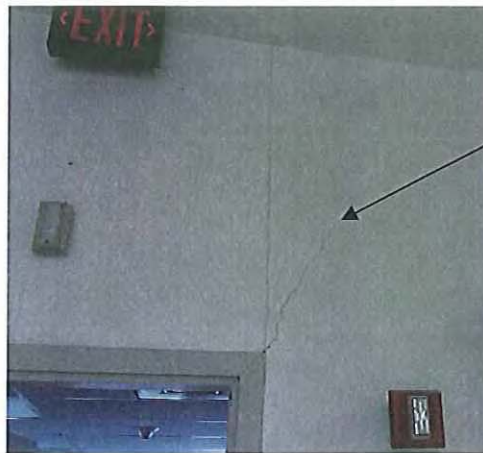
Photo 6: Cracks in gypsum board

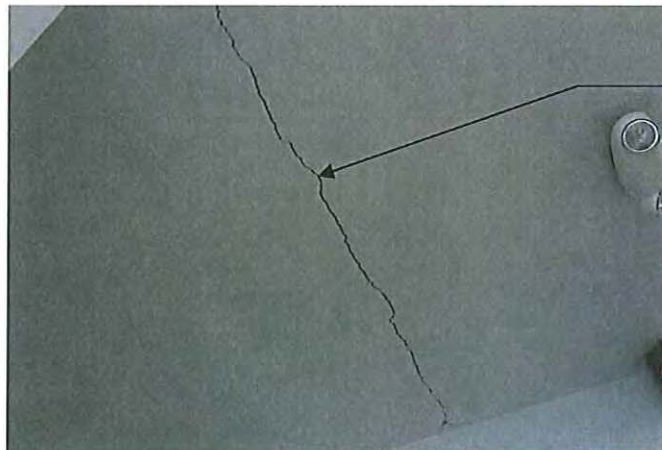
Photo 7: Cracks in gypsum board

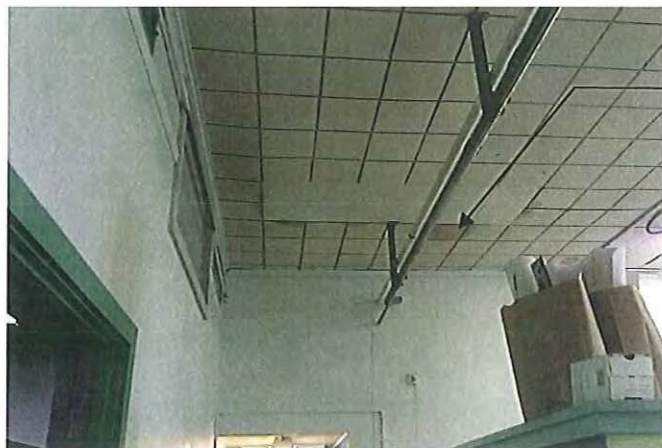
Photo 8: Water damage in ceiling

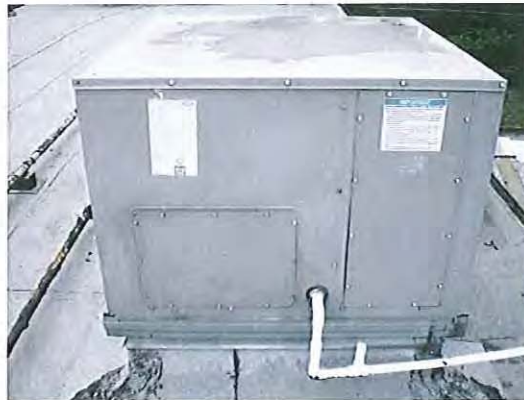
- 1.1 The mechanical systems are maintained based on an effort to minimize complaints from the customers who use this space. The front wing that faces Barton Springs Road was partially destroyed in a fire and rebuilt, and thus has packaged HVAC units on the roof dating from the 1991 remodel.

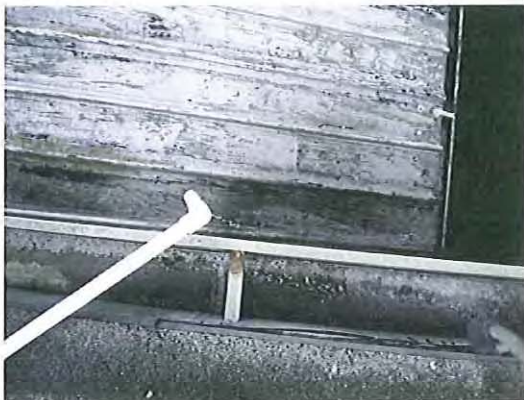
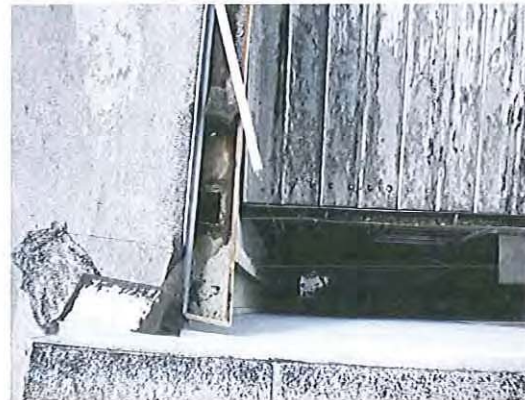
- 1.2 The condensate drainage from the rooftop units on the 1991 front remodel drains over the edge of the roof onto the ground, ponding in a corner. This is in violation of current code requirements and makes a problem on the ground, with standing water.

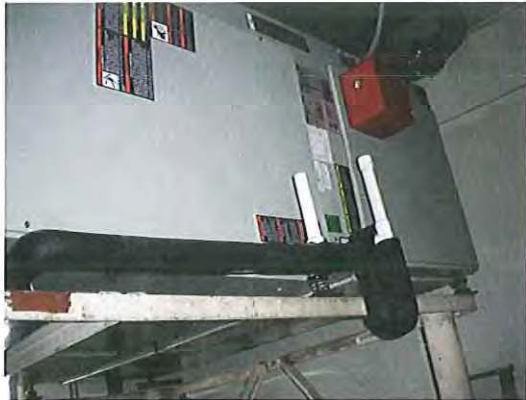
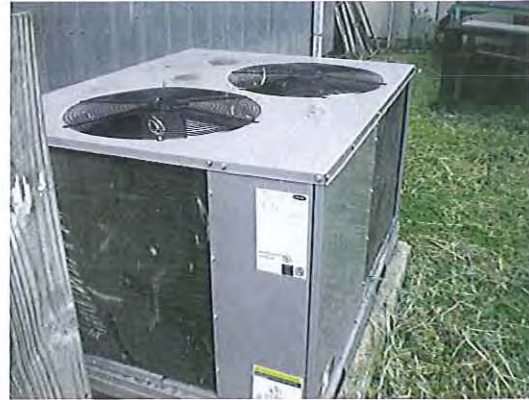
1.3 The auditorium units are several years old but in working condition. The large units serving the classroom areas are approximately 10 years old and appear to be in working condition.

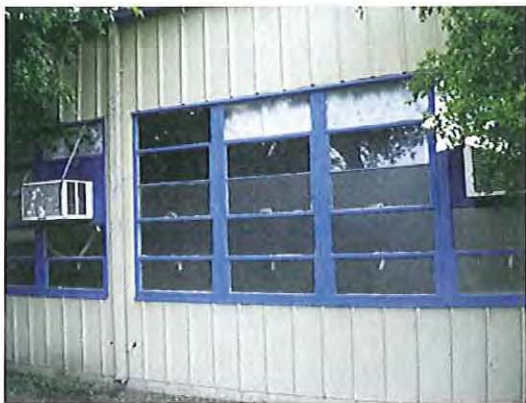
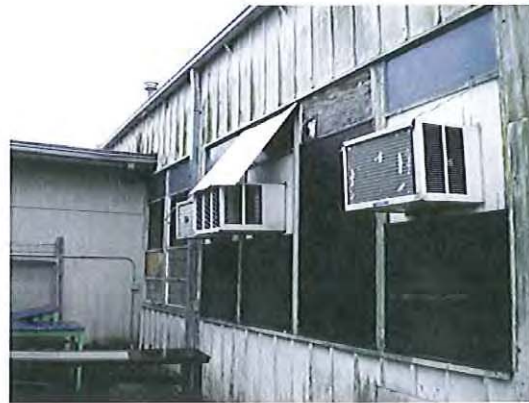
1.4 Many of the offices and classrooms have through-the-wall units. The condensate drainage from these units doesn't meet current City of Austin ordinance requirements, and the units are of various ages.

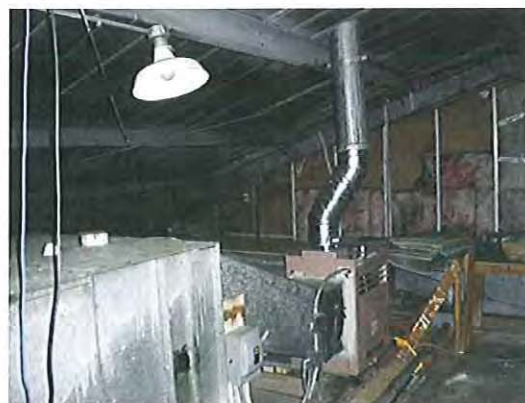
1.6 Some of the heating is served by gas fired unit heaters. These have standard flues through the roof, but no dedicated provision for combustion air, instead obtaining their oxygen for combustion from the classroom space. This is a relatively dangerous setup. It is relieved somewhat by the large amount of leakage apparent from the 63 year old building.

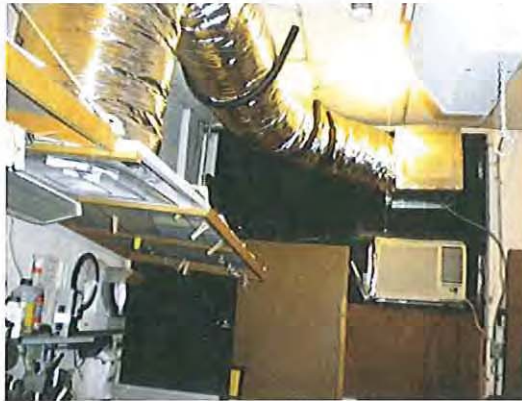
- 1.7 The darkroom HVAC is a clever hodgepodge of available parts, but doesn't meet current code requirements for ventilation and exhaust air.

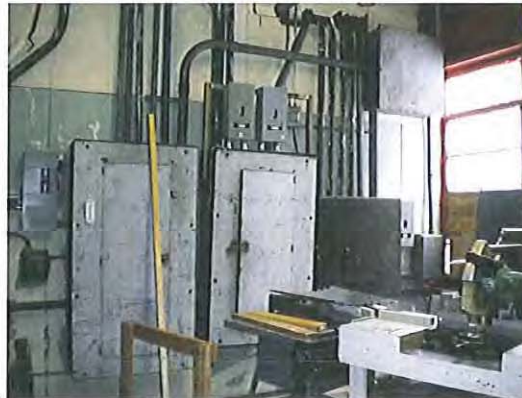
- 2.1 Some of the original electrical panels, installed in 1947, remain, but none are in use. It appears that much of the electrical systems were replaced in the 1980s

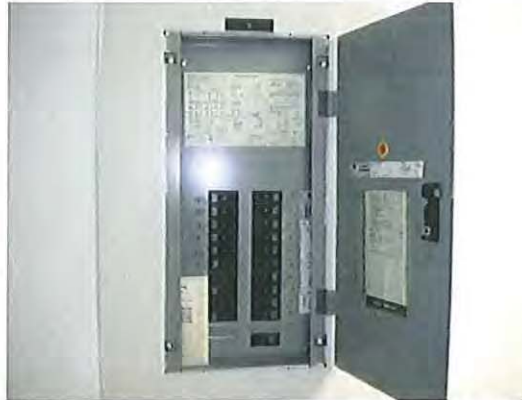
- 2.2 The front wing was remodeled in 1991 and the electrical gear in that area dates from that time.

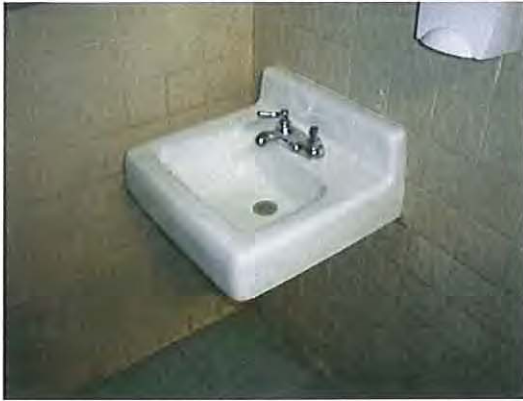
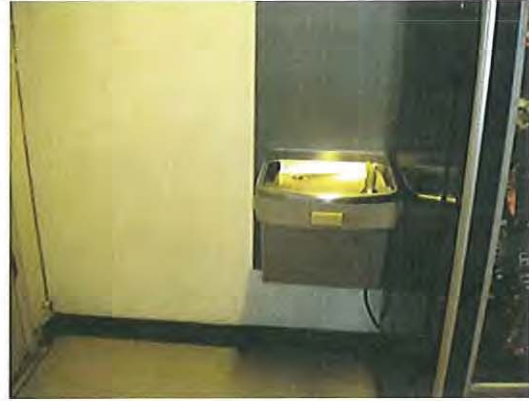
3.1 The plumbing fixtures appear to mostly be original, except for the 1991 remodel. There are very few ADA-compatible drinking fountains in the building.

3.2 There are newer types of plumbing fixtures that use less water than even the fixtures available in 1991, so it would be our recommendation to replace all plumbing fixtures in a full remodel project.

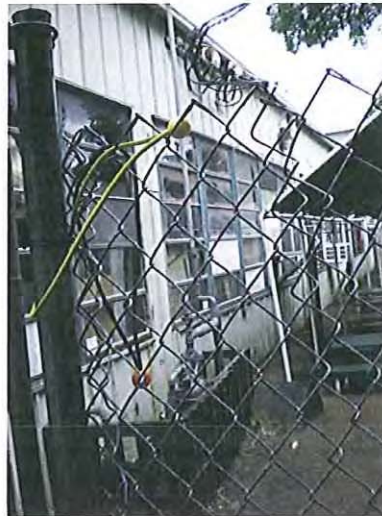
3.4 The gas meter location is too close to operable windows, so it doesn't meet the gas utility's requirements.

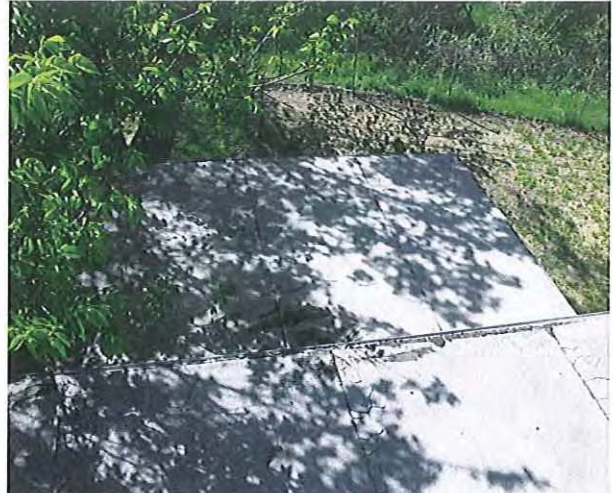
Photo A-1.2 Looking west. Damage at roof edge.

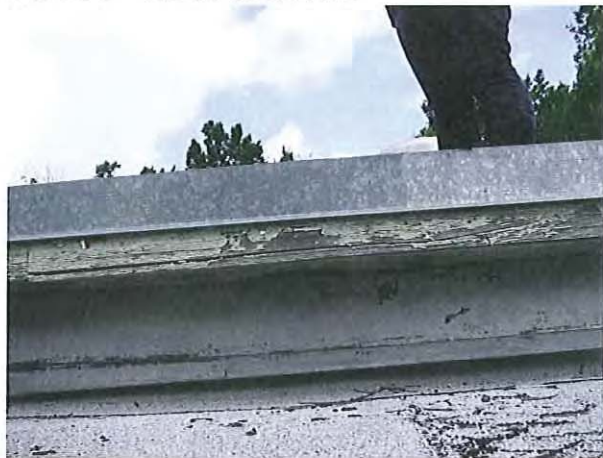
Photo A-2.1 Roof edge w/ weathered fascia.

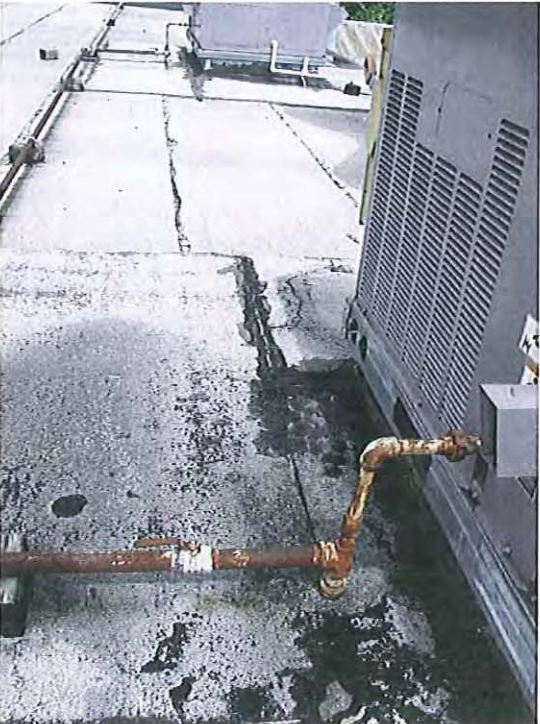
Photo A-3.3 Membrane decay at RTU.

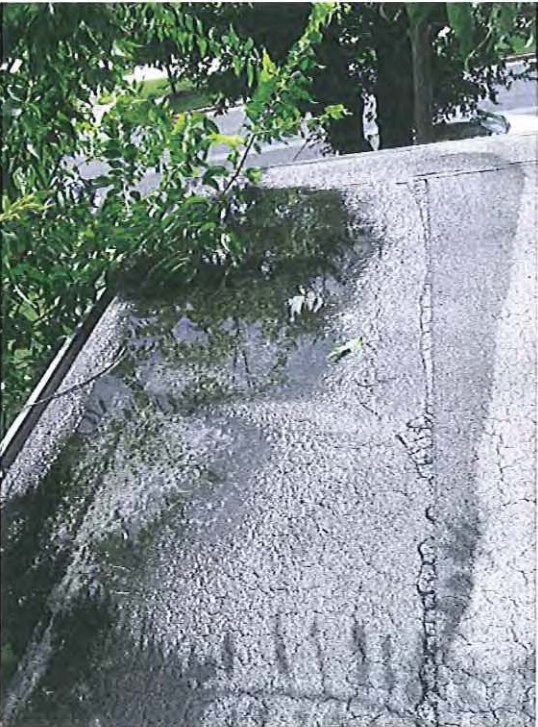
Photo A-3.4 Ponding at NE corner.

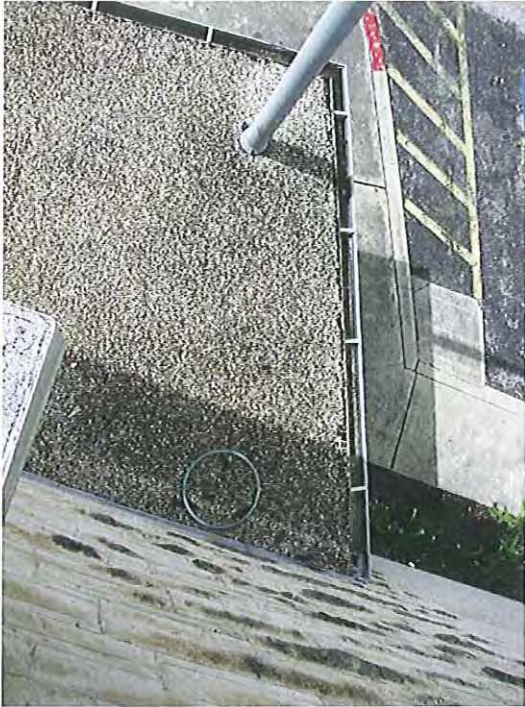
Photo A-4.1 West end of A4, gravel loss noted.

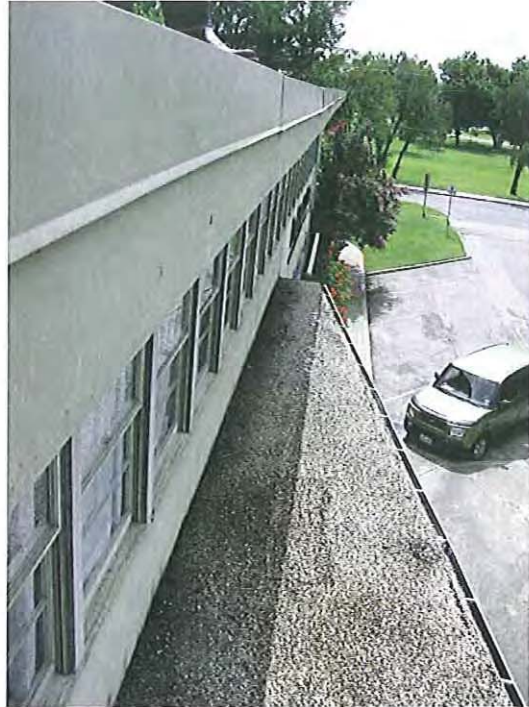
Photo A-4.2 East end of A4, gravel loss noted.
