Existing Conditions Assessment for the Dougherty Arts Center

prepared for the
City of Austin
Parks and Recreation Department
15 September 2010

Existing Conditions Assessment for the **Dougherty Arts Center**

DOUGHERTY ARTS CENTER
GENERAL STRUCTURAL ASSESSMENT

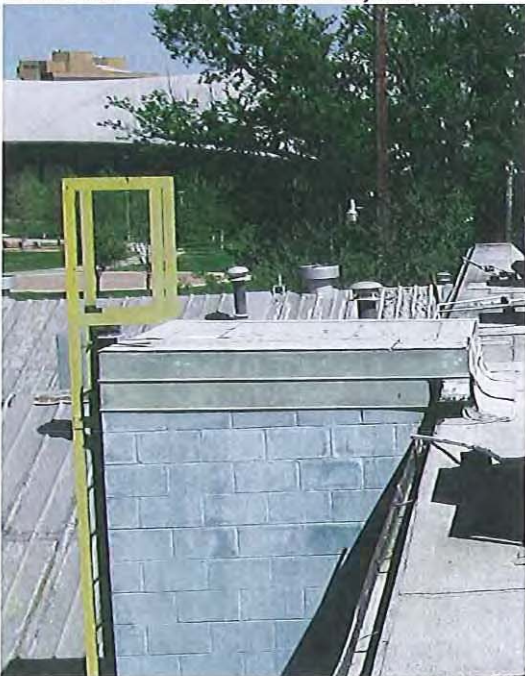
Photo A-5.1 Flashing weathered, but functional.

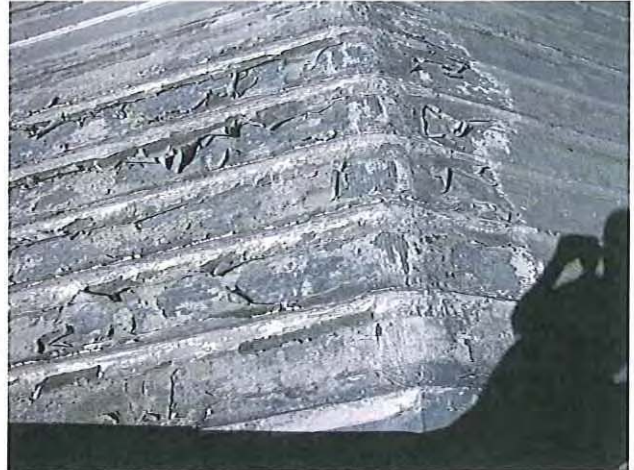
Photo B-1.2 Decayed roof patching.

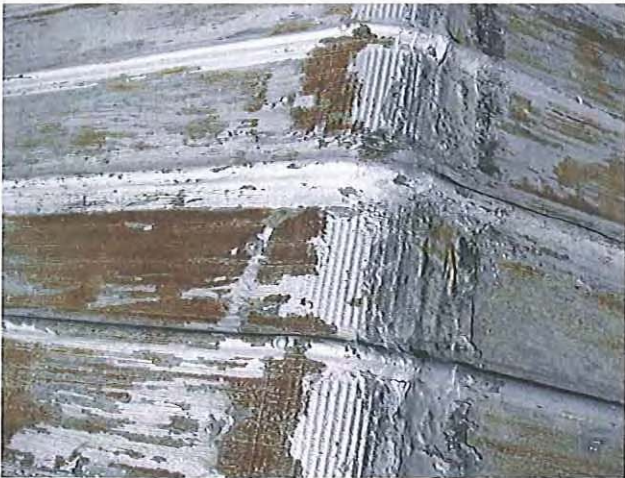
Photo B-1.3 Rusted panels, worn ridge sealing.

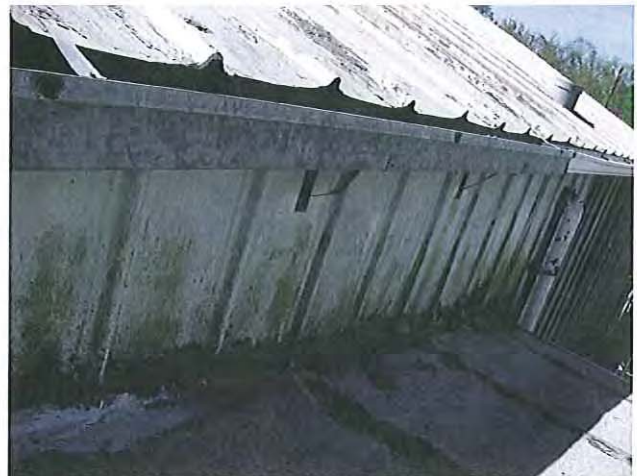
Photo B-1.4 Patchwork gutters – some sections are still serviceable; others are failed.

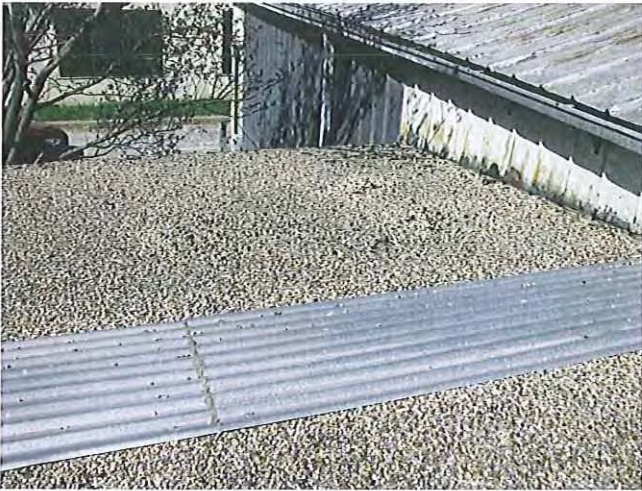
Photo B-3.1 Gravel loss noted.

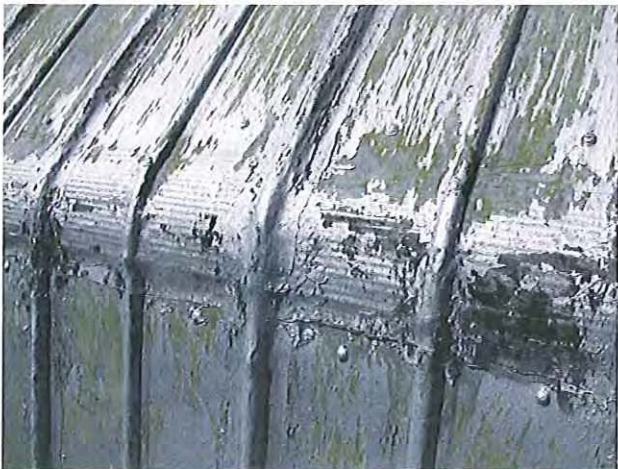
Photo C-1.3 Failing ridge patch.

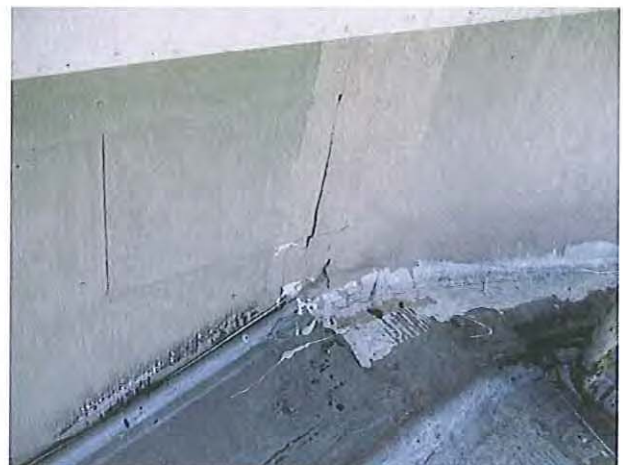
Photo C-1.4 Failing wall flashing.

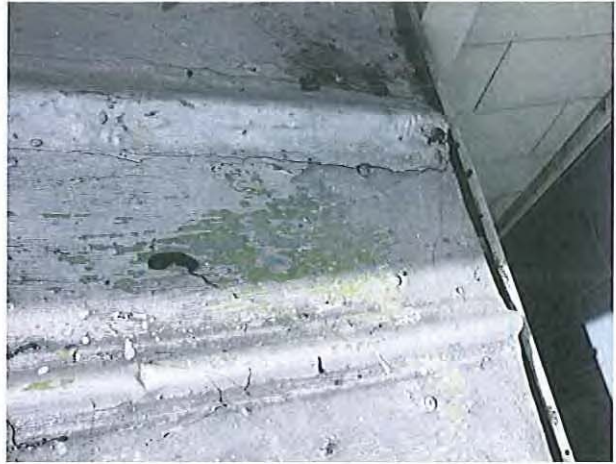
Photo D-1.2 Degradation at roof edge.

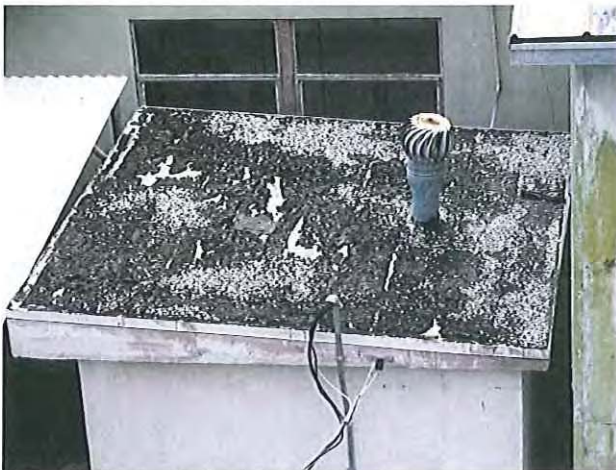
Photo D-2.1 Failed Membrane.
