Bartlett Tree Experts

Tree Risk Assessment

Cottonwood Tree at Lou Neff Point, Zilker Park

February 29, 2012

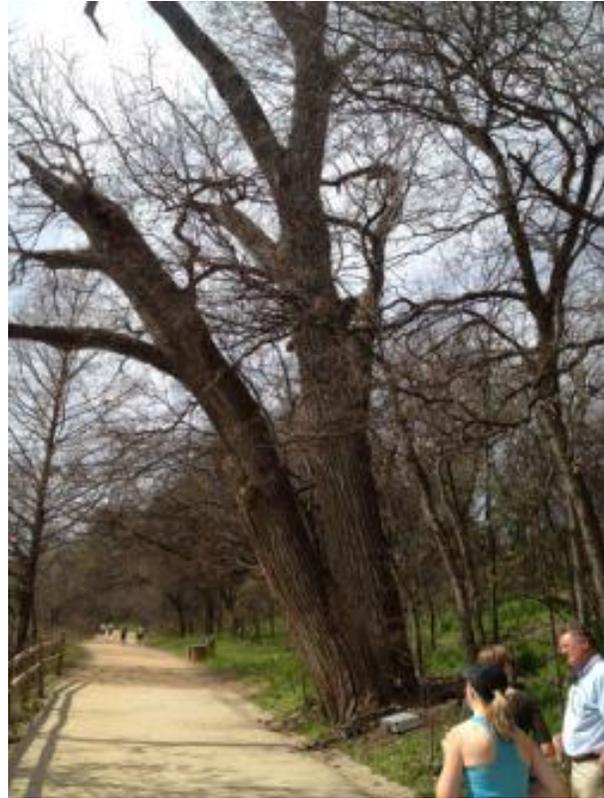
The subject tree is located two feet to the uphill (NW) side of Lady Bird Lake Trail, a recreational trail made of concrete and installed roughly five years ago. Barton Creek runs adjacent to this trail and is within the fall zone of the tree. Just in the time we visited the site, a near constant procession of joggers, bicyclists, walkers, and mothers pushing babies in strollers passed us on the trail. The creek is also frequently host to people in canoes and kayaks. Figure 1 shows the tree's close proximity to the trail. Figure 2, obviously a winter view, shows a fairly steady stream of people enjoying the trail. Presumably, this traffic would increase in spring.

FIGURE 1: The subject tree leaning over the trail and toward the creek (not shown).

The subject tree should be removed as soon as possible.

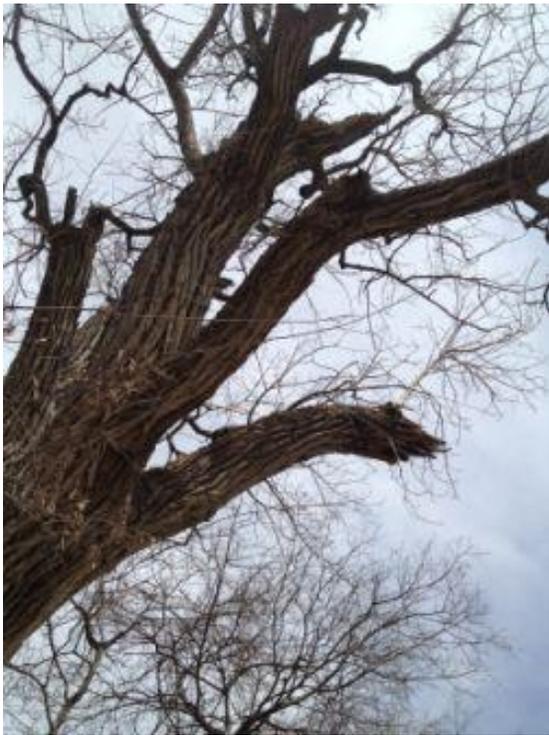
This cottonwood is a very mature tree and quite large at 65 inches DBH, 75 feet in height, and a canopy spread of 50 feet. Seven broken stubs appear in the canopy, indicating past limb failures. Cavities at old wounds are visible in various locations in the crown. The main **stem**² bifurcates at eight feet into **codominant stems** of approximately 33 inches diameter each. Some bark disturbance appears near the crotch, possibly from an old wound, and evidence of borer activity is visible in this area and elsewhere on the main stem. The tree leans 25-30 degrees over the recreational trail. A **fungus fruiting structure** is visible at the tree's base. The **root collar** is exposed. Figures 3-6 show examples of defects in this tree.

FIGURE 3: Multiple stubs show evidence of previous failures.

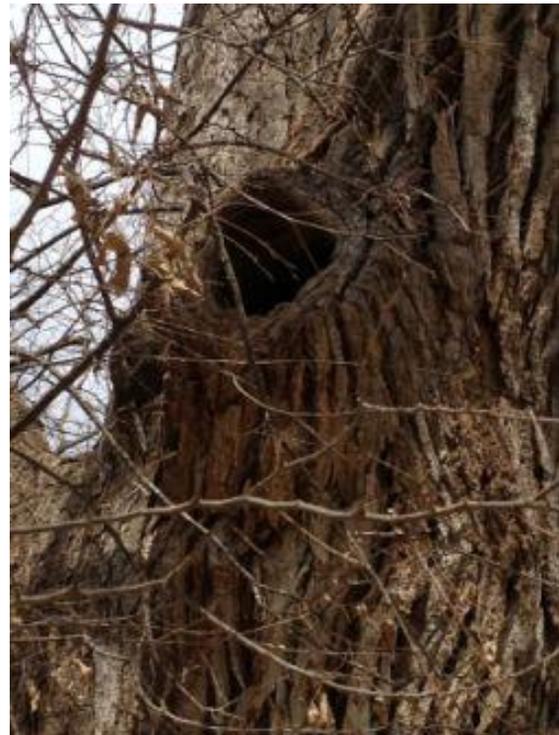
FIGURE 4: Example of decay cavity visible in tree.

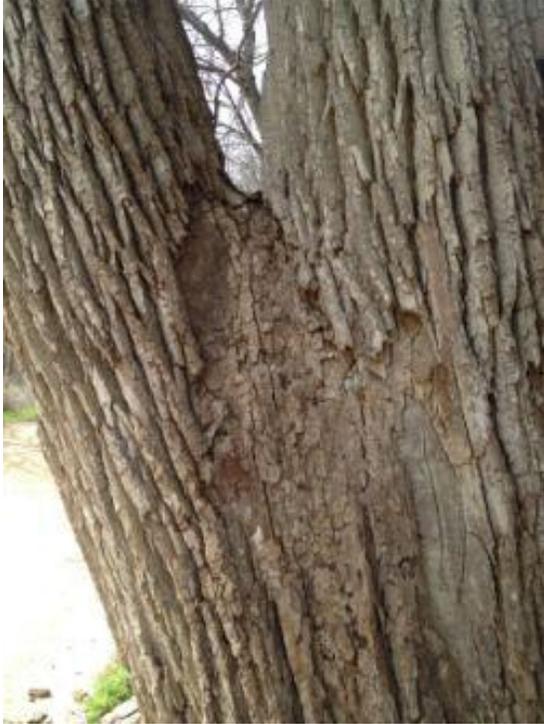
FIGURE 5: Detail of crotch at codominant stem.

While codominant stems are common in trees, and more so in certain species, this structure is less desirable than one in which a central leader exists with well-spaced, appropriate-sized branches growing from it. In the case of the subject tree, each codominant stem is quite large and poses additional hazard potential, should weakness be present at the crotch, as suggested by the bark disturbance, borer evidence, and the Resistograph reading that indicated decay at 10.5 inches on the stem leaning over the trail.

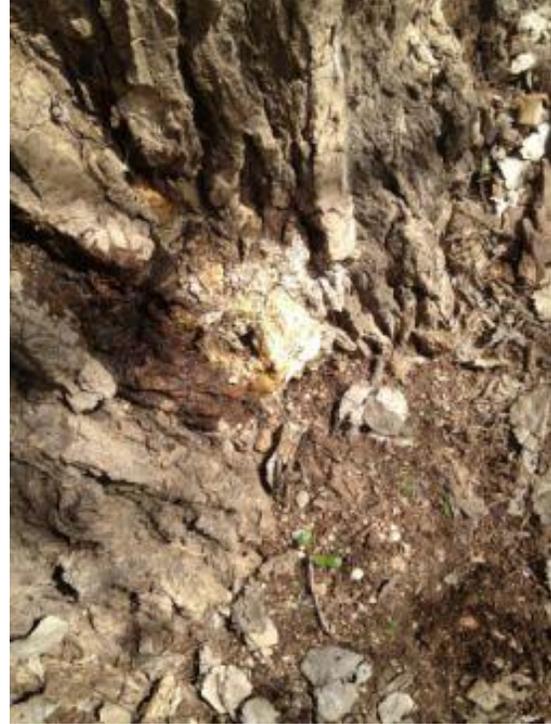
FIGURE 6: Fungal fruiting structure at tree base.

Fungal fruiting structures in the area of the root collar are positive indicators of root decay (Smiley, Matheny and Lilly 2011). In this declining tree, especially in this species, root disease would not be surprising. Furthermore, it is possible that disturbance from construction of the concrete trail within two feet of the stem might have advanced any root decay already occurring in this aging tree. Notwithstanding the presence of a fungal fruiting body at the tree's base, we did not perform additional assessment of the root collar or **root plate** because so many other factors are present to evaluate the hazard potential of this tree.

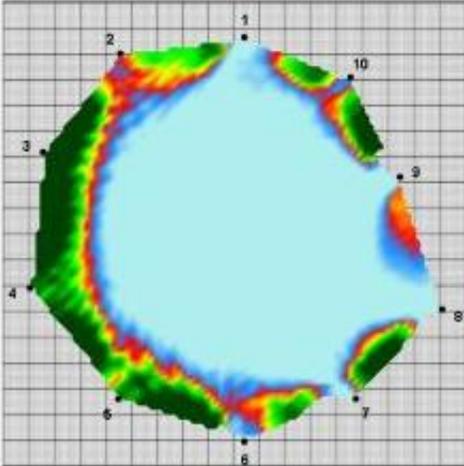
Research shows a high degree of accuracy in sound-wave assessment of internal wood density in trees (Gilbert and Smiley 2004). We used the ArborSonic 3D Acoustic Tomograph to evaluate wood density at nine inches above grade. The resulting image (Figure 7) represented 75% decay at that location. The ArborSonic instrument may represent some decay at the sensor points that slightly over-states the percentage of decay in a particular location, but the results should be reliable within a few percentage points. For this reason, even adjusting to 70% decay puts this tree at high risk of failure, especially taking into account the other defects and factors that add to the risk profile.³ To provide confirming data on this result, we also performed a drilling evaluation, as detailed in the next section. (A description of how the ArborSonic works is included in the Appendix.)

FIGURE 7: ArborSonic image at nine inches above grade, showing 70% decay.

In addition to visual evidence that decay exists throughout the tree, that failures have already occurred, and that root decay is likely, the sound-wave and resistance-recording drilling confirm that a significant area of decay exists in the lower stem. This increases the risk that the tree could fail at the base.

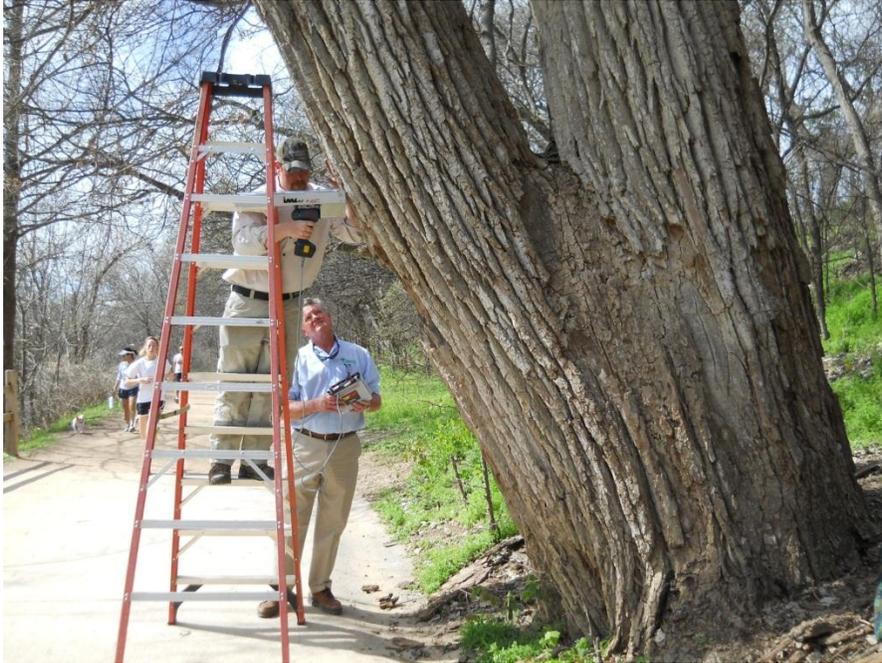
Although we were satisfied that both advanced assessments of the lower stem – a critical area for tree stability – provided adequate information to help us evaluate risk potential, we decided to take one more Resistograph reading at about nine feet, approximately level with the stem crotch. The result was 10.5 inches to decay, and, again, the resistance through that distance was atypical, suggesting early-stage decay. Figure 8 shows the location of that drill point and provides a better idea of tree size, lean, and location.

FIGURE 8: James Dossett takes additional resistance-recording reading at approximately nine feet above grade. This photo also provides a better view of the disturbed area at and below the crotch that showed evidence of borer activity.

Borers are usually secondary invaders; they like to inhabit trees already stressed by primary causes, such as drought, construction damage, over-pruning, or loss of vitality. The subject tree is old, has lost its vitality, and is giving in to species susceptibility for failure and decay. Presence of borers in this tree emphasizes its poor condition.
