Tree Assessment and Recommendations

Duncan Park BMX Trail Area

Developed by PARD Urban Forestry Program Staff:

July 14, 2011

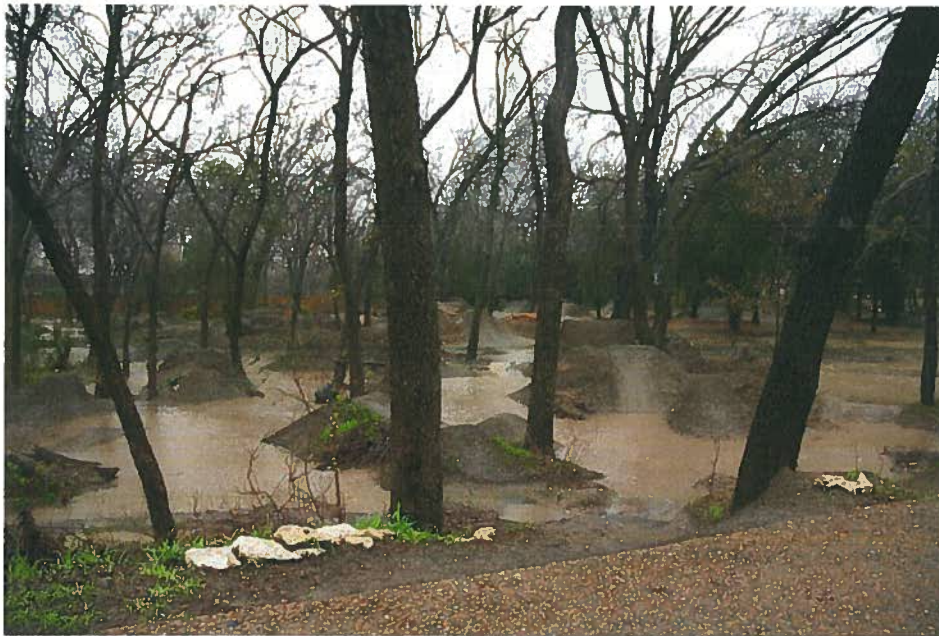
Flooding of BMX trails

The construction of the BMX trail features involves the excavation, movement, and piling of soil. Because this area contains un-stable soil and because of the area’s close proximity to Shoal Creek, soil erosion into the creek is a water quality concern. As shown in the photo below, taken from 9th street, the area is prone to flooding.

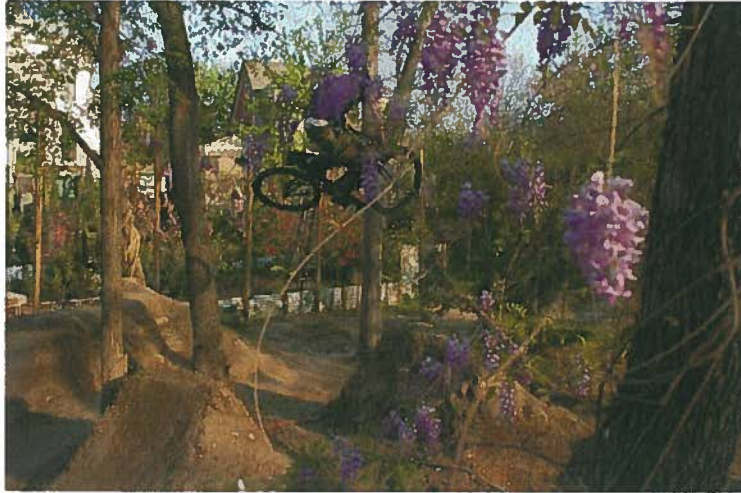
Example of Soil Modification

The construction of the BMX trails has created some environmental concerns, namely soil erosion in close proximity to Shoal Creek and soil grading within the critical root zones (CRZ) of trees on the BMX site.

The photo below shows an example of the type of soil modification within the CRZ's of trees that is common in the BMX trail area.

- A. Restore the original grade of the soil based on the depth of each tree's root flare
- B. Provide mulch and/or supplemental water to the CRZ's of trees where possible
 - a. Place mulch in areas where it will not impact the use of the BMX trails
 - b. Place mulch in areas where slope will not cause it to migrate
- C. Continue to assess tree health, impact, and soil compaction of the 115 trees on an annual basis
- D. Continue to monitor trees and remove and prune trees as they become hazardous

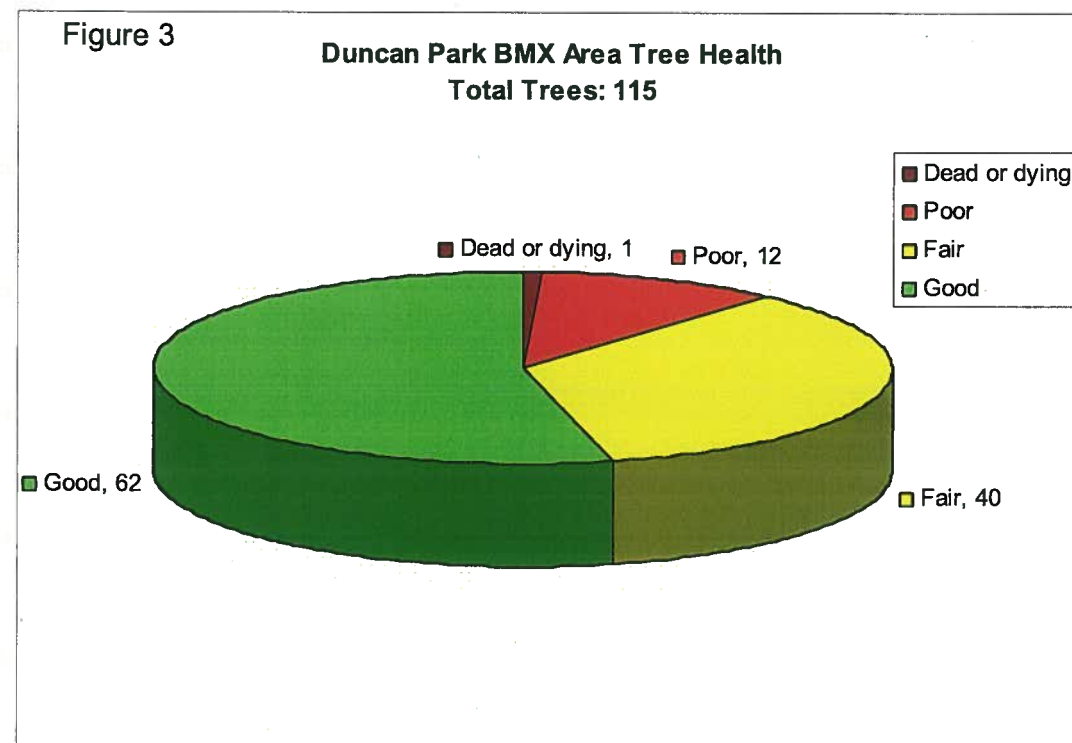
The majority of the trees on site were in good or fair health. They showed little to moderate signs of water stress, chlorosis, insects/disease, decay, and/or other signs of stress. American elm trees were in the poorest health overall.

Table 1 and Figure 3 show the health of the trees on site as well as a health rating by size class. Also see Appendix Map 1 for a spatial representation of this data.

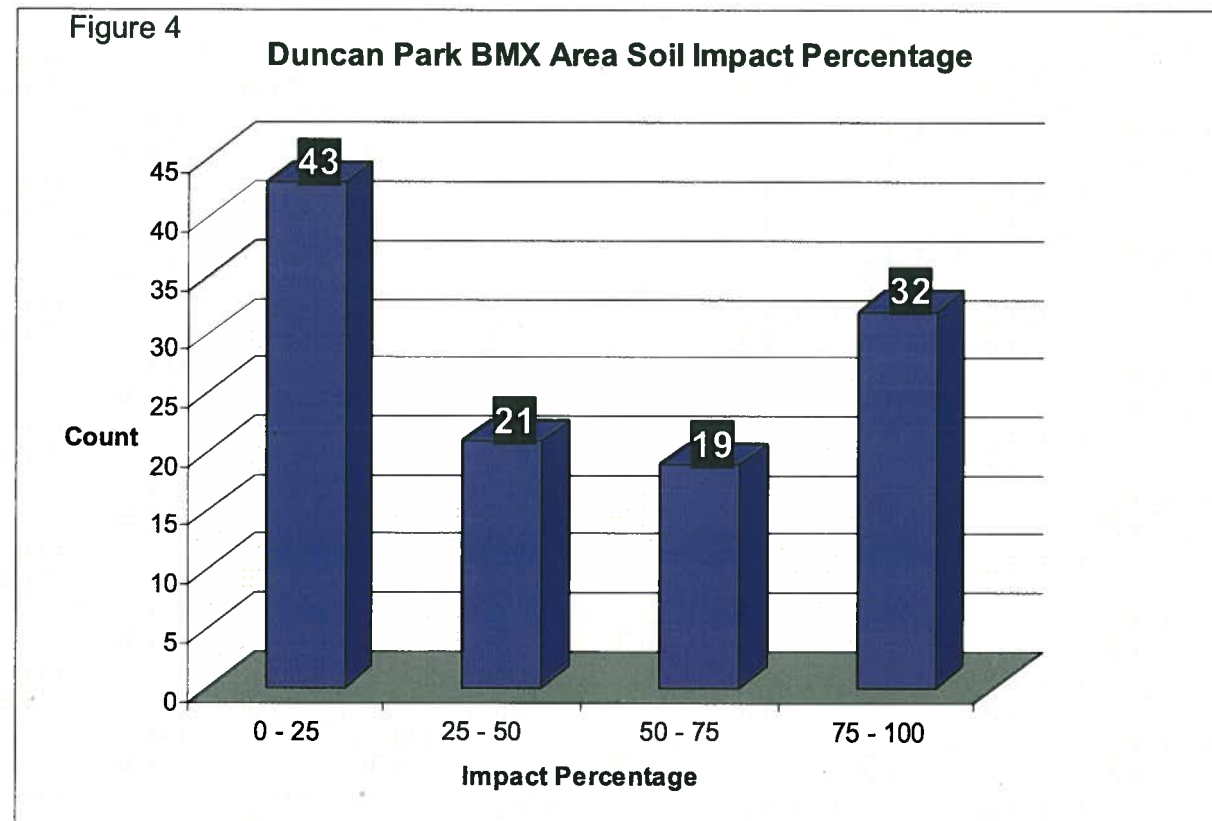
Each tree was assigned a value based on the amount of soil area within the CRZ that had been adjusted from original grade by BMX trail construction. There are over 100 soil mounds or holes that were created to provide “jumps” for BMX trail users. The impacts consisted of soil removal up to 5 feet deep or soil filling up to six feet high within the CRZ. In some instances, soil was mounded against the trunks of trees up to several feet from original grade. Table 2 and Figure 4 display a count of the trees whose CRZ's were impacted by BMX trail soil grading. Four categories were used to assess the amount of impact: 0-25%, 25-50%, 50-75%, 75-100% based on the amount of each tree's CRZ that contained soil modification. Also see Appendix Map 2 for a spatial representation of this data.

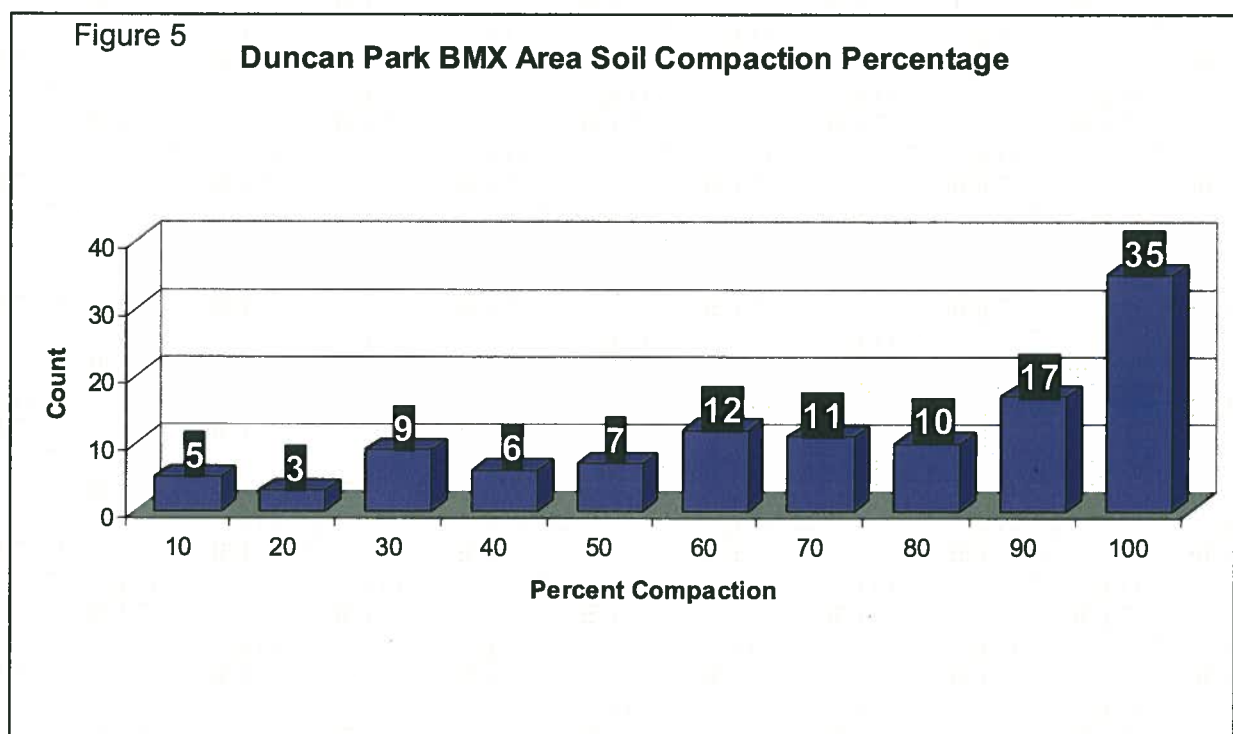
Each tree was also assigned a value based on the amount of its CRZ that was compacted. The intent of this category of data is to capture impacts to CRZ's that were not necessarily caused by soil excavation but by frequent use by BMX trail users. Often, areas of soil within CRZ's that remained at original grade were still impacted because a flat portion of a BMX trail crossed through the CRZ. Each tree was given a value between 0-100%, in 10% increments, based on the amount of CRZ that was compacted due to trail use. Table 3 and Figure 5 summarize the data. Also see Appendix Map 3 for a spatial representation of this data.

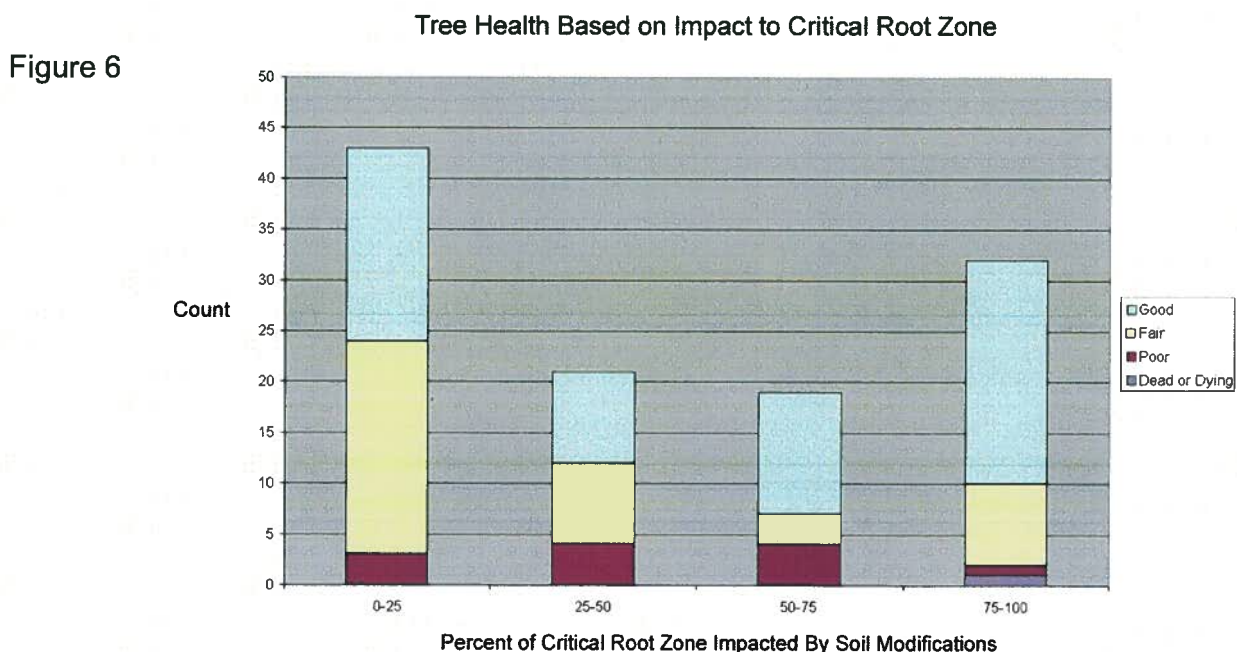
The two methods of correlating the data do not show a statistically significant correlation between Tree Health and either Impact or Compaction—the coefficient values are too close to 0 to be attributed to a correlation, they are simply due to variation in the data.

Figure 6 shows tree health based on the amount of impact within the CRZ of each tree.
