# Barton Springs Municipal Pool

## Pecan Tree Risk Assessment Report

Submitted on August 29, 2023

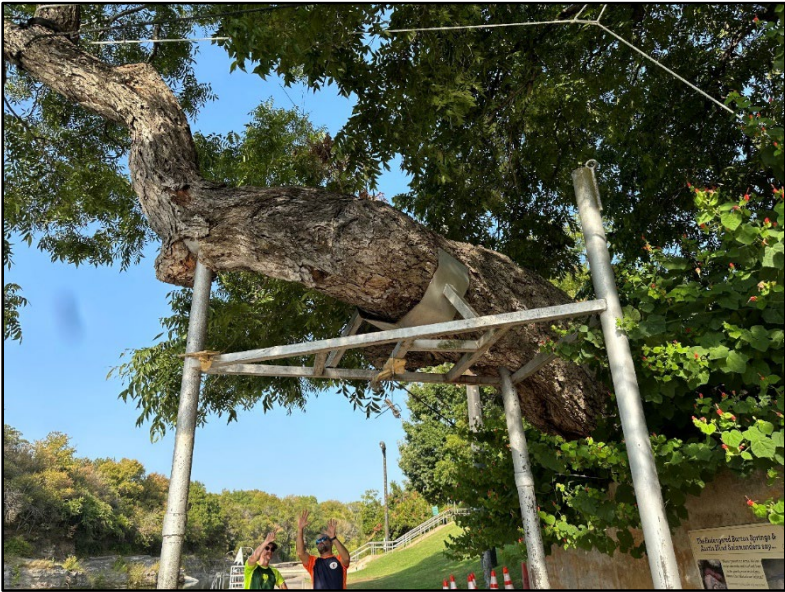
The large cavity in the main stem began at grade and extended to 9 feet; the cavity widest at the base and tapered as it extended up the stem. The bark was absent on the top portion of the stem up to 9 feet and mostly detached underneath the cavity. It appeared that the main stem was not wood, but rather held in place by the concrete poured as a foundation and up through the stem. I noted the presence of large cavities on both the east (18 inched depth) and west 17 inches depth) of the main stem where it was in contact with the soil at the edge of the wall. One foot from the trunk on the east was a pop-up irrigation sprinkler head. I measured the available soil moisture using a 15-inch soil probe and incorporated the USDA NRCS “feel and appearance” method to be in the 0-25 % range. A pop-up irrigation sprinkler head that had been broken was located 17 inches from the base of the stem to the west. The available soil moisture on that side of the tree was in the lower 25-50% available soil moisture range. It may be that the base of the tree was in the direct line of the water distribution area. Just beyond the wall on the lower portion of the stem was evidence of fungi that was previously identified as *Kretzschmaria deusta*– a wood decay fungus also known as brittle cinder fungus. The fungus was growing in what appeared to be an old wound that was approximately 4 to 5 feet in length. The fungus was sampled by the City of Austin and sent to Texas A&M University, where they diagnosed the pathogen.

**Image 1:** View from the sidewalk under the pecan. Previously installed props and a soft “cabling” system pictured.

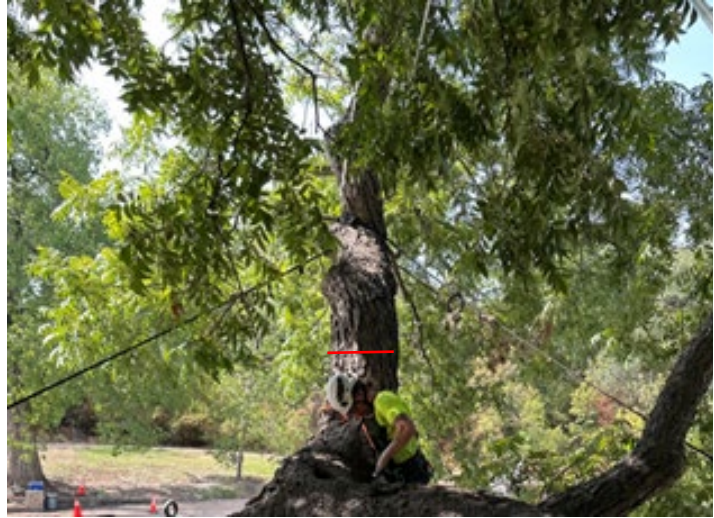
Image 3: Approximate location of drilling plane (red line) on the north side of the lower stem. Drillings at 216 inches (18 feet). The drilling sites at 216 inches were made above the scaffold branch.

(18 feet) above grade just above the attachment of the large scaffold branch. The drilling data at 216 inches indicated significant wood strength loss on the north, east, and west side.

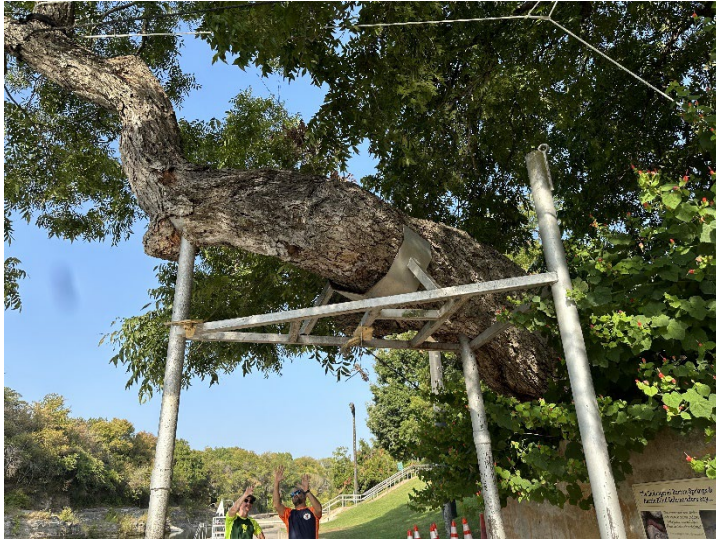
**Image 4.** Previously installed props used to support weight of the pecan's leaning stem.

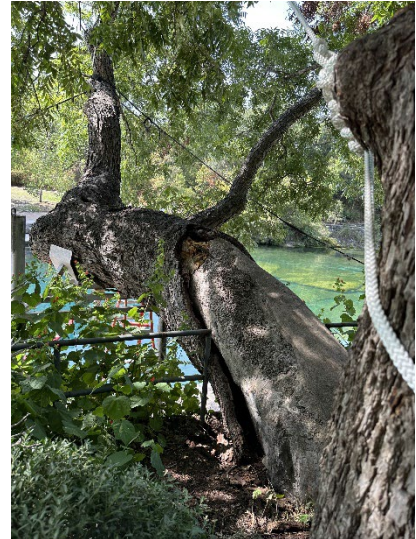
**Image 5.** Concrete filled cavity leaning over guardrail and sidewalk below. Rebar and expanding foam was also observed.

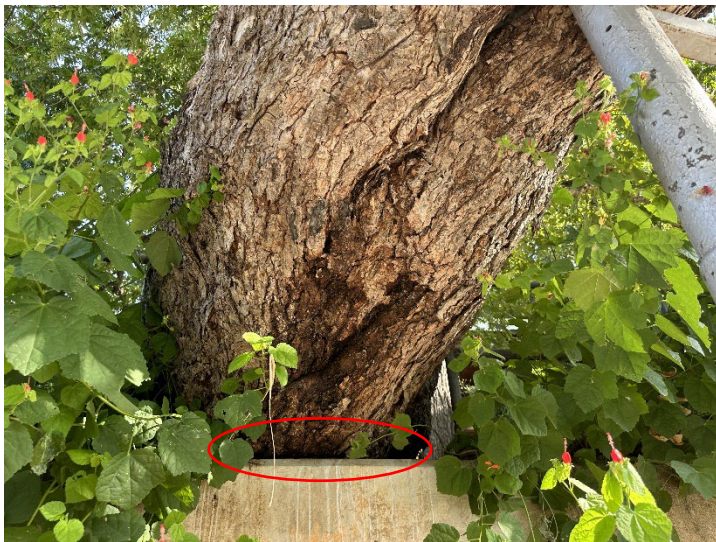
**Image 6.** Area where *Kretzschmaria deusta* was confirmed. This is the largest area of intact wood and live tissue throughout the stem.

<p><b>Diagnosis/Recommendations</b></p> <p><b>Diagnosis:</b> Brittle Cider Fungus (<i>Kretzschmaria deusta</i>)</p> <p><b>Category:</b> FUNGAL</p> <p><b>Comments: LAB SUMMARY:</b></p> <p>Upon examination of fungal mat submitted, it appears the tree is infected with brittle cider fungus, Brittle cider fungus, or <i>Kretzschmaria deusta</i>, appears at the bases of trees and roots as a white or gray fungal mat. As it ages, it turns black and starts to resemble burnt bark. This pathogen infects many hardwood trees through open wounds and other stress factors. <i>Kretzschmaria deusta</i> will eventually break down the cellulose and lignin of the tree causing wood decay/rot.</p> <p><b>Management:</b></p> <p>Currently, there are no effective fungicides to control brittle-cider fungus. Maintaining a sound tree maintenance program that promotes good vigor can help minimize infections, such as utilizing proper fertilization, pruning, and mulching practices. Trees in which the infection has already progressed extensively have little to no significant structural integrity and should be considered for removal to avoid damage to property or life.</p>

I recommend Option One. With the confirmation of a wood-decaying fungus, as well as the presence of several support systems and its location within a high-use area, I do not believe this tree is a good candidate for continued preservation.

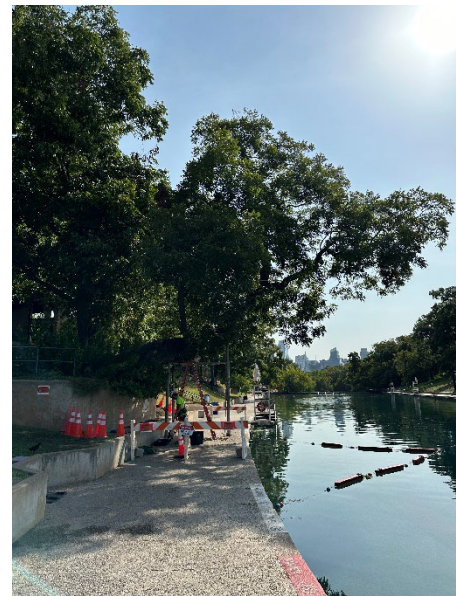
**Image 7.** Overview of pecan and its lean over the pool and walkway.
