**Tree assessment:  
Barton Springs Pool's "Flo" Pecan. Austin Tx 78704. 08/25/2023**

Site visit 08-25-2023.

Scope: assess leaning Pecan tree.

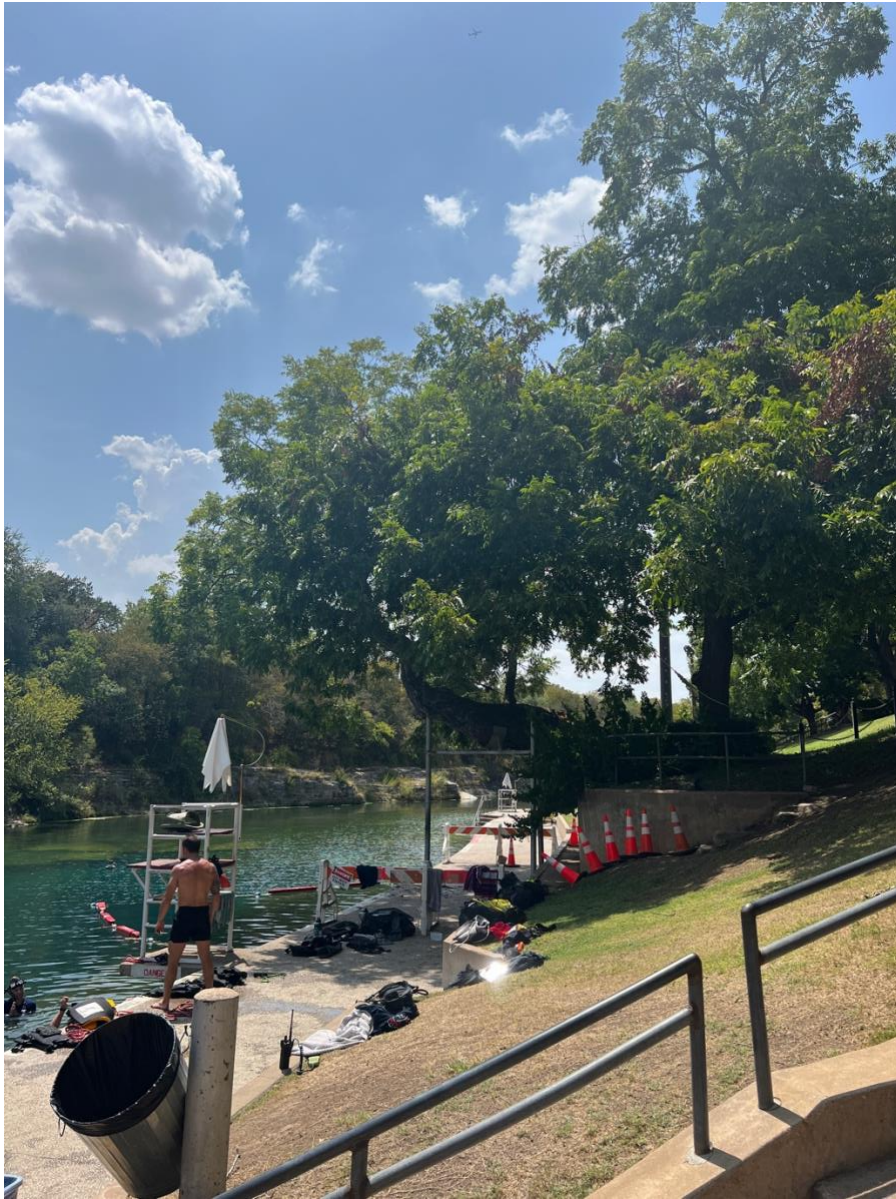
*4 target area and showcasing the lean*

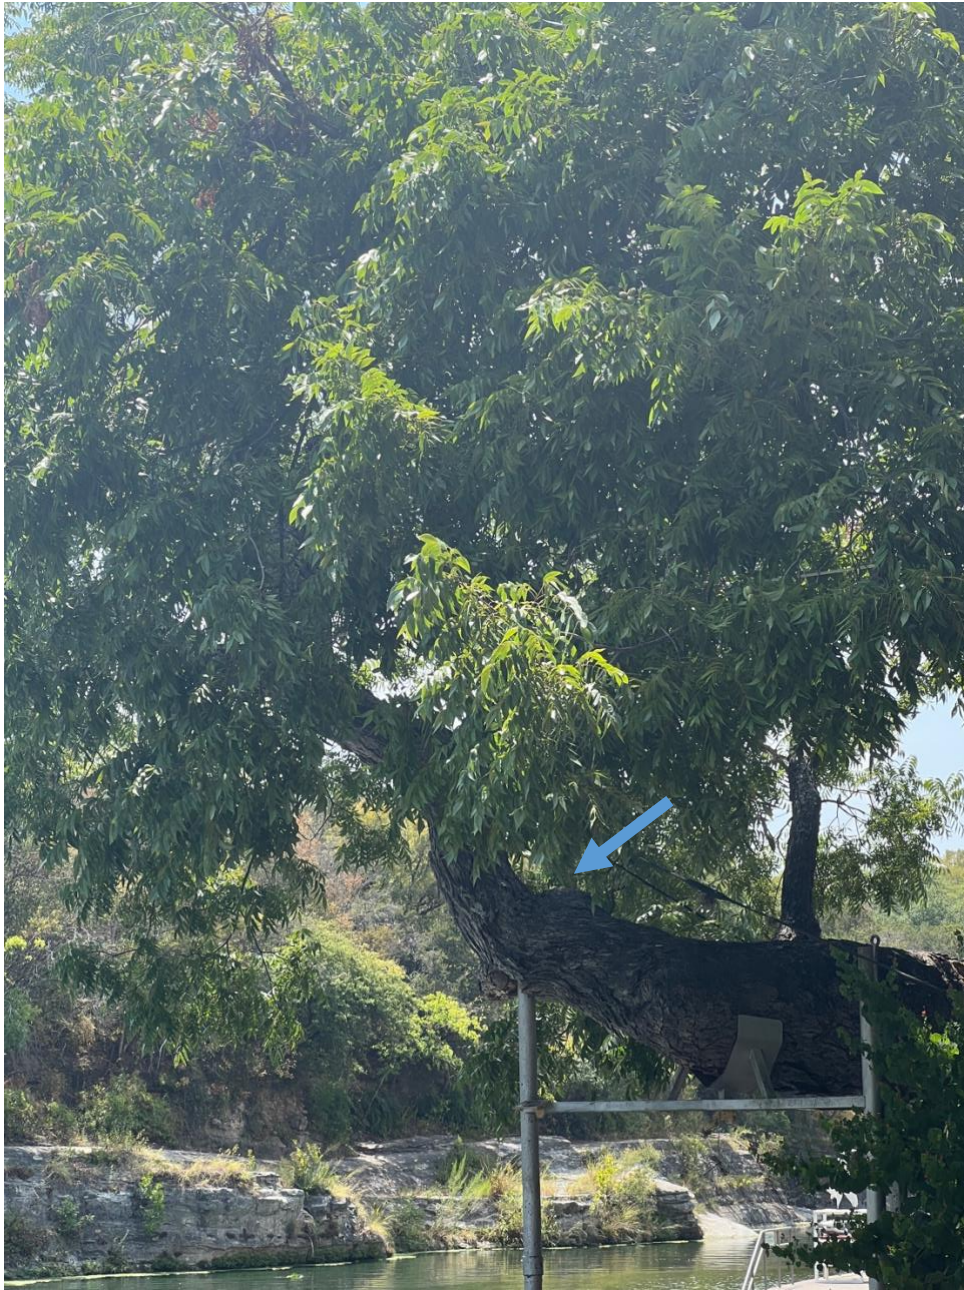
**2: Main stem beyond the second support beam:** Per personal communication from the urban forestry program manager, the existing historical cavity has already been investigated 2 or 3 years ago due to the concern of potential failure of the canopy over the pool area. We have not been provided the results of this investigation. We share that concern seeing as the cavity is significant and could run well beyond the support point.

*5: second support, defect location, and size of part of concern*

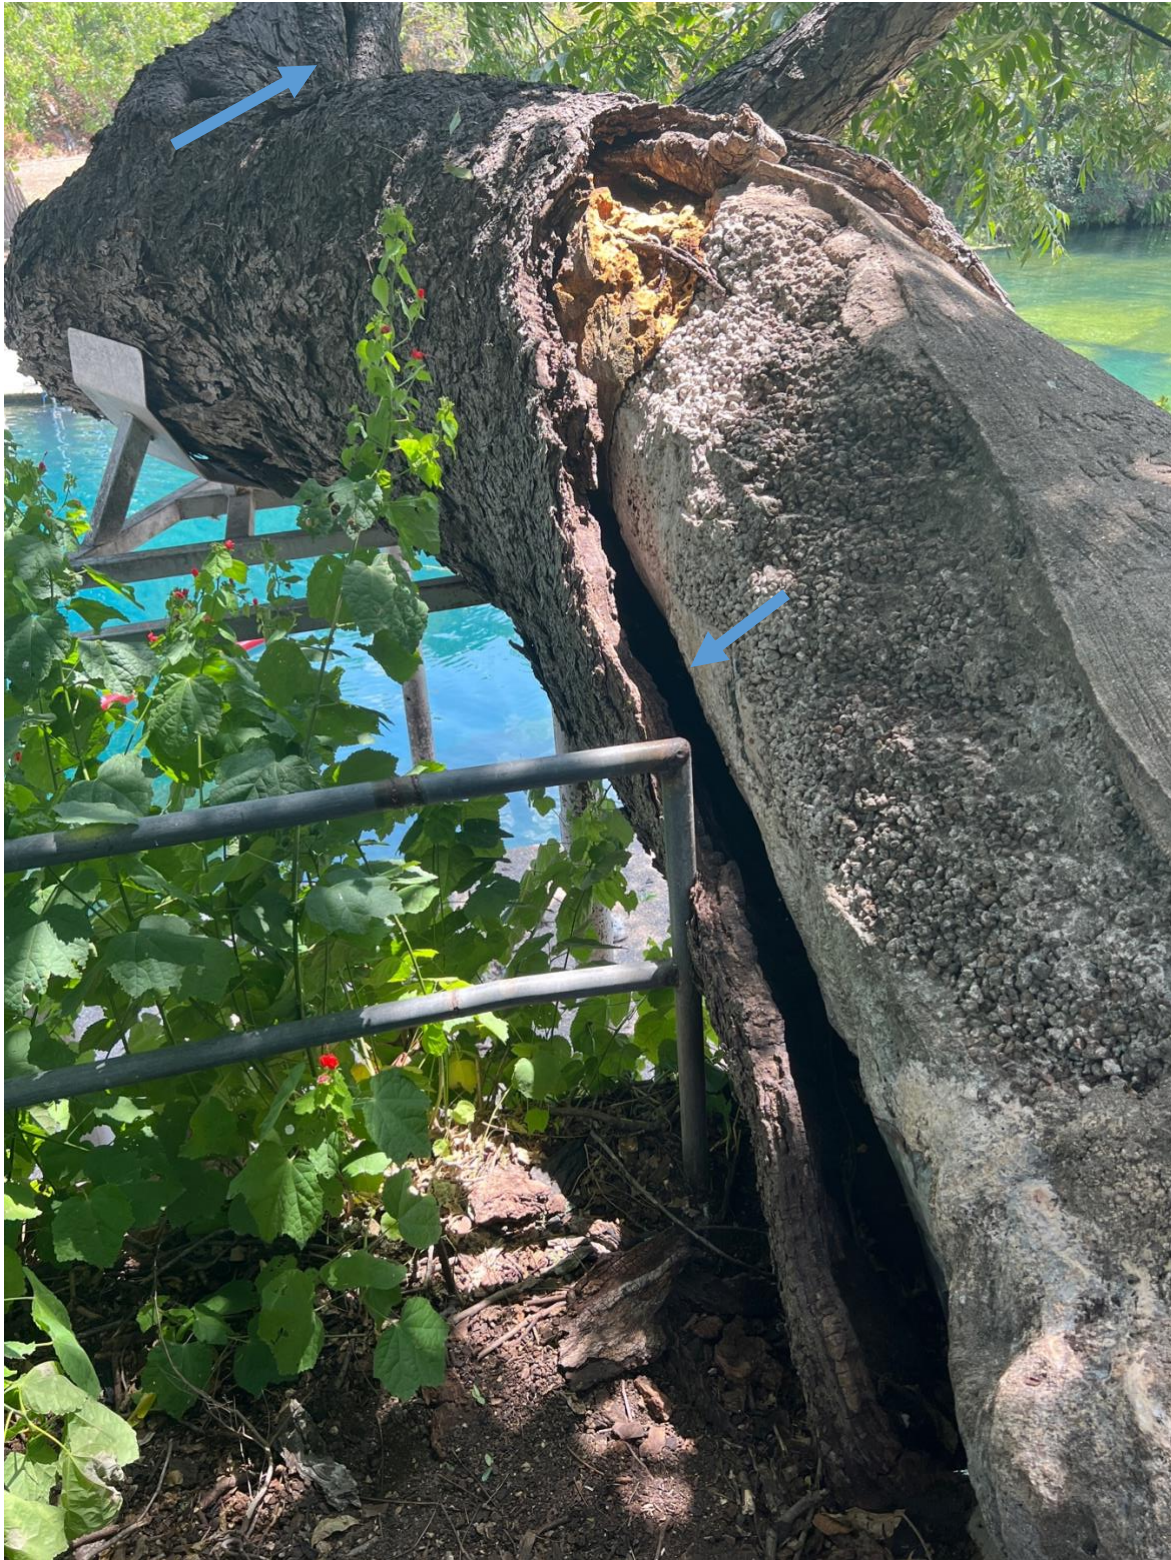
6: extend of heartwood loss, alternate view of defect at second support point.

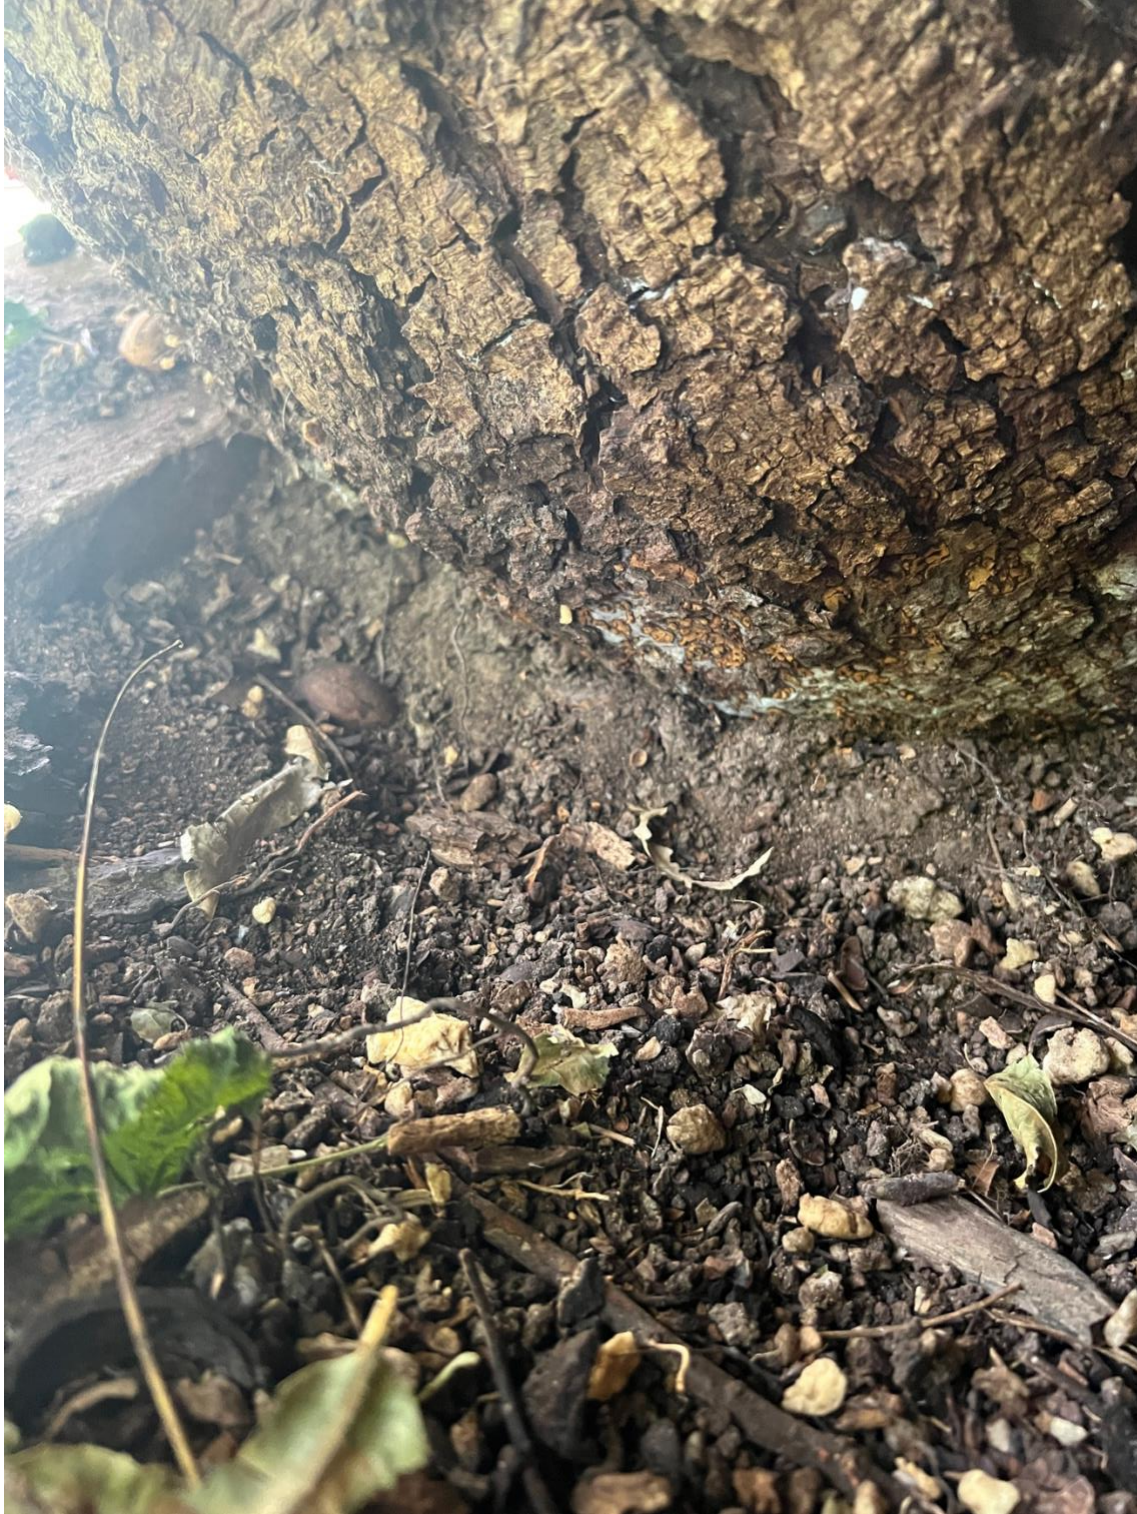
*7: root flare on north side, showcasing difficulty of inspection as well as the bark texture change hinting at declining sapwood.*

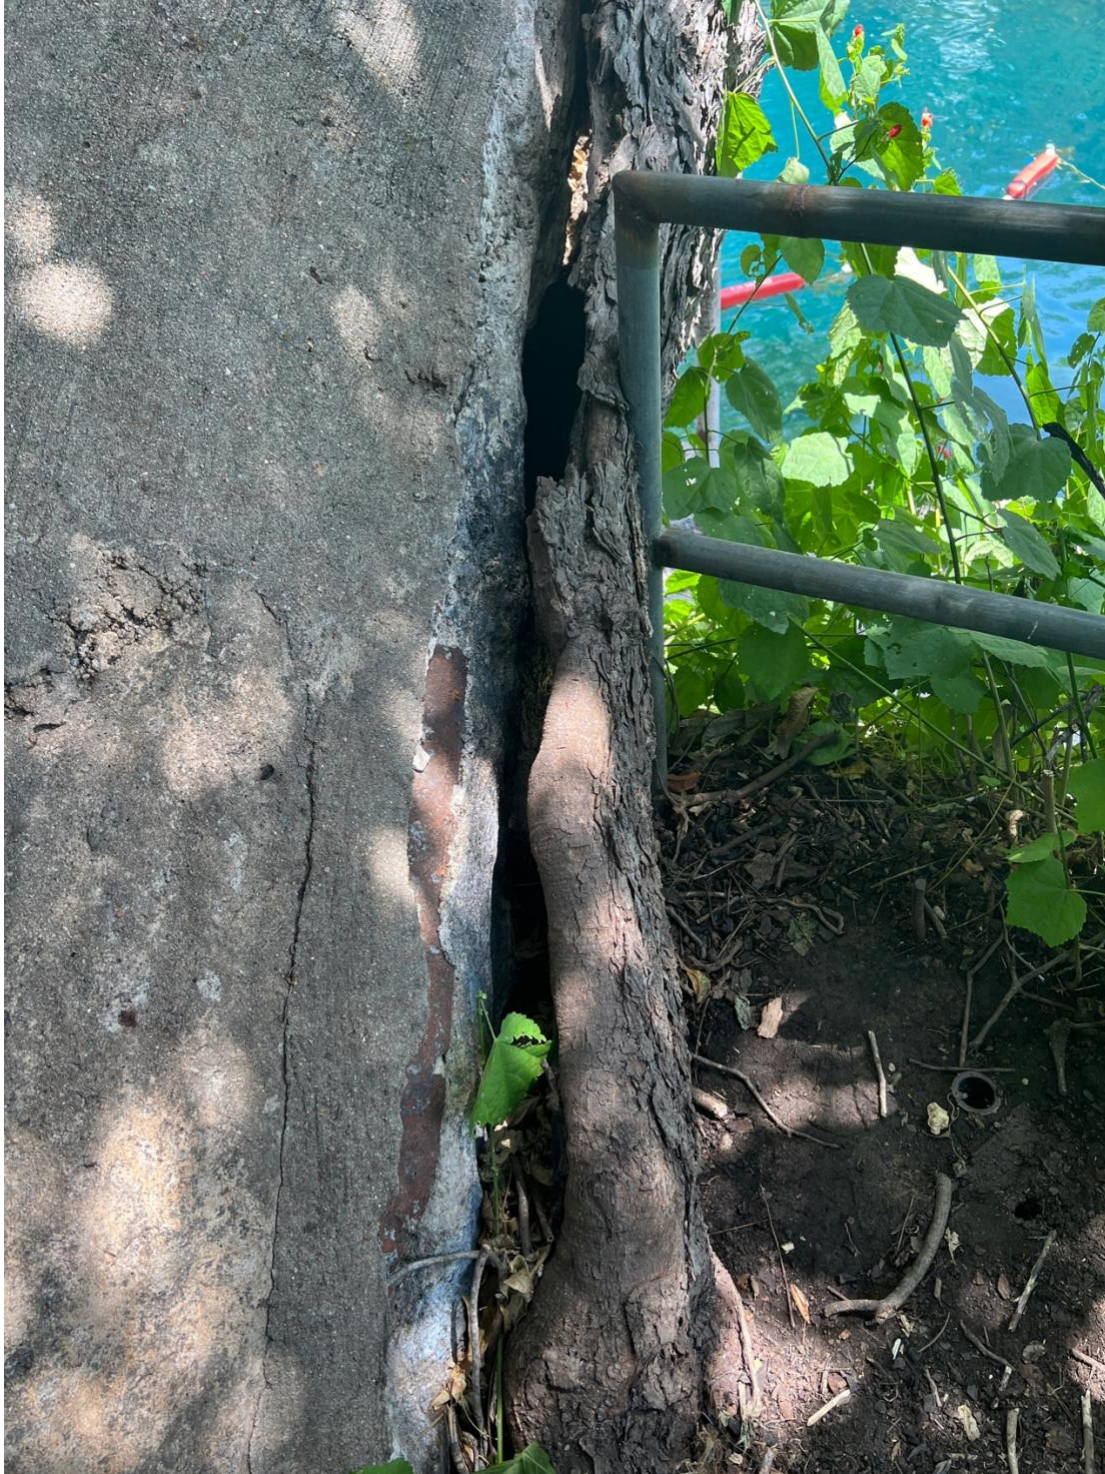
*8: opposite side of main stem: no remaining heartwood.*
