Hope all is well. The following was observed during our site visit this morning at Barton Springs to observe the structural condition of Flo:

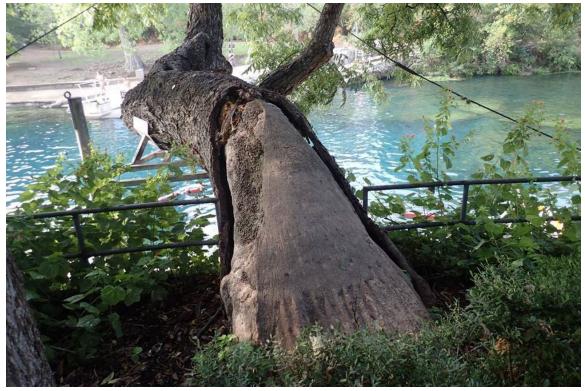
Photo A

- The existing concrete base is no longer engaged or attached to the base of the existing tree.
 There are voids on both sides of the concrete base. See Photo A, B and C. The concrete base is acting as a counterweight to the remaining section of tree that is along the underside of the existing concrete base.

Based on the information above, the existing tree is not structurally sound resulting in imminent failure. This has created a life and safety risk for the public and must be addressed in a timely manner to reduce any damage or harm to those in the area. Access under the tree extending into the water must be restricted, this will affect ADA access in the area.

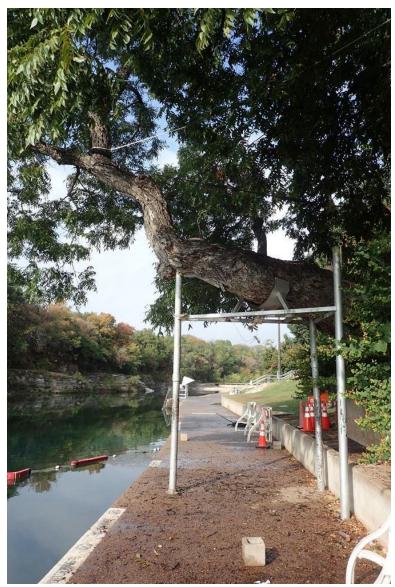
Photo D

- There are currently two types of cable supports that are attached to the cantilevered section of the tree. See Photo D. The primary purpose of this system is to help mitigate the cantilevered section of the tree from swaying back and forth due to wind loading. It is not designed to support the weight of the tree.

- There is an existing steel frame supporting the tree over the sidewalk. See Photo D. The steel
 frame system does not appear to be adequately designed to support the dead load of the tree if
 it was to fall onto the sidewalk. A failure of the tree could potentially damage the sidewalk and
 any infrastructure under the sidewalk, access in this area must be restricted due to life safety
 concerns.
