Barton Springs Sunken Garden

Sunken Garden Improvements Phase I

Preliminary Engineer's Report

October 29, 2013

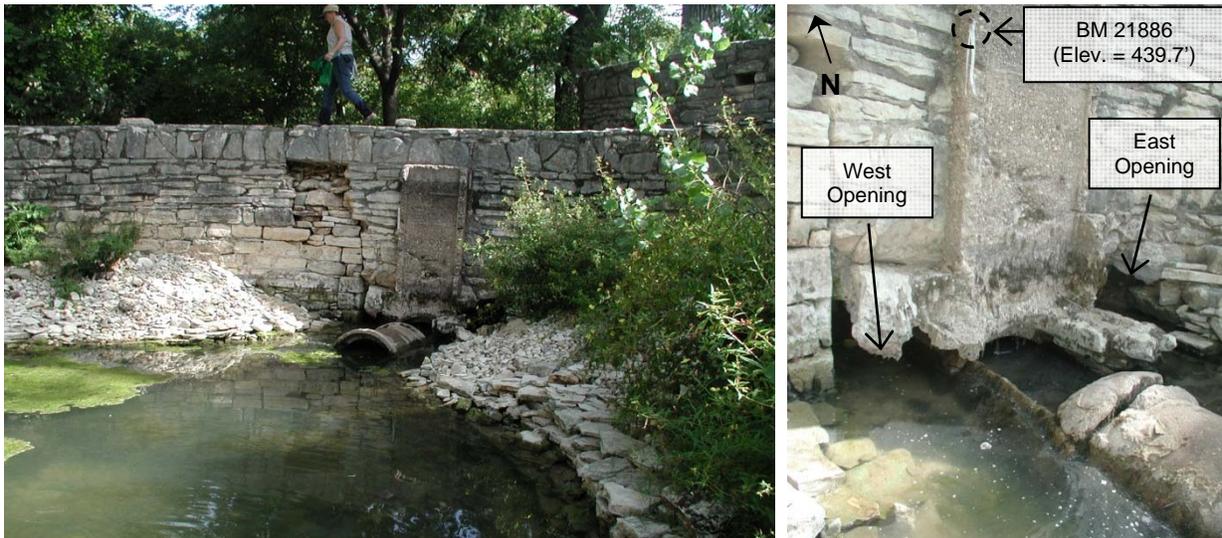
PESC visited the Sunken Garden site on August 28, 2013. Standing, stagnant water was observed both within and outside the existing stone wall enclosure at the time of our visit (Figures 2.1.1 and 2.1.2). Water was being re-circulated within the enclosure with a pump and hose, to help aerate the still water and improve habitat conditions. The base of the existing stone wall to the north was penetrated by a plugged concrete pipe and loose concrete debris. Because the plugged concrete pipe has been blocking the natural flow of water exiting the enclosure, the base of the wall on both sides of the plugged pipe has deteriorated, creating self-made openings in the wall to the west and east of the concrete pipe.

Figure 2.1.1: Outflow Exit Location – Views from within Enclosure
Overall View (Left) and Close-up of Wall Openings (Right)

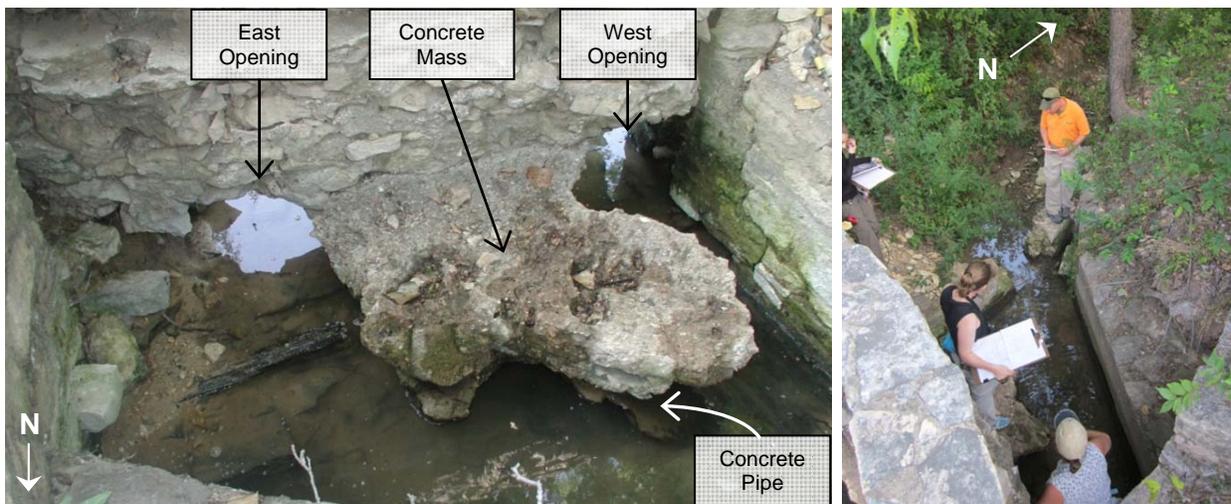
Figure 2.1.2: Outflow Exit Location – Exterior View

At the time of our visit, it was determined that the depth to the bottom of the existing concrete pipe at the enclosure exit (18" ± below the current water level) was the preferred flow line elevation. While this elevation would ideally be the highest flow line elevation between the enclosure and Barton Creek, we observed that the pool of stagnant water continued beyond the enclosure and was blocked by a highpoint in grade near the beginning of the channel (See Figure 1.2.4). The remainder of the channel leading down to Barton Creek was dry (Figure 2.1.4).

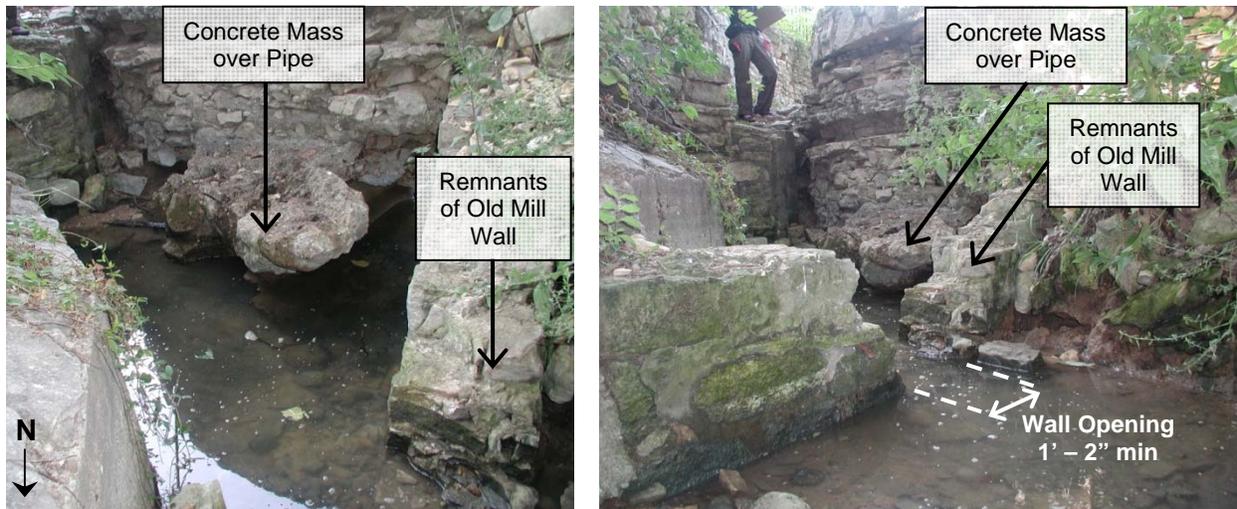
Further impediment of spring outflow appears to be caused by a portion of the historic mill wall that crosses the path of exiting spring water several feet outside of the enclosure (Figure 2.1.3). The old wall is in poor condition and an "opening" has formed for water flow to pass from the enclosure to the channel. At the time of the site visit, the bottom of the wall opening was approximately 2 inches below the top of the standing water.

Figure 2.1.3: Standing Water Outside Enclosure

- Retrofit the old mill wall so that opening is wider and deeper, to accommodate same flow volume as new opening in stone wall and not impede water flow to the channel.
- Line the channel with a cobble stone bed to provide new/better habitat for the salamander. This item is discussed further in the civil section.
- Improve the channel by increasing slope and providing cobbled habitat in the bottom of the channel bed, to provide a pebbled running water condition preferred by salamander. This item is discussed further in the civil section.
- Retrofit the stone boulder drop structure at the end of the channel to accommodate a lower channel elevation.

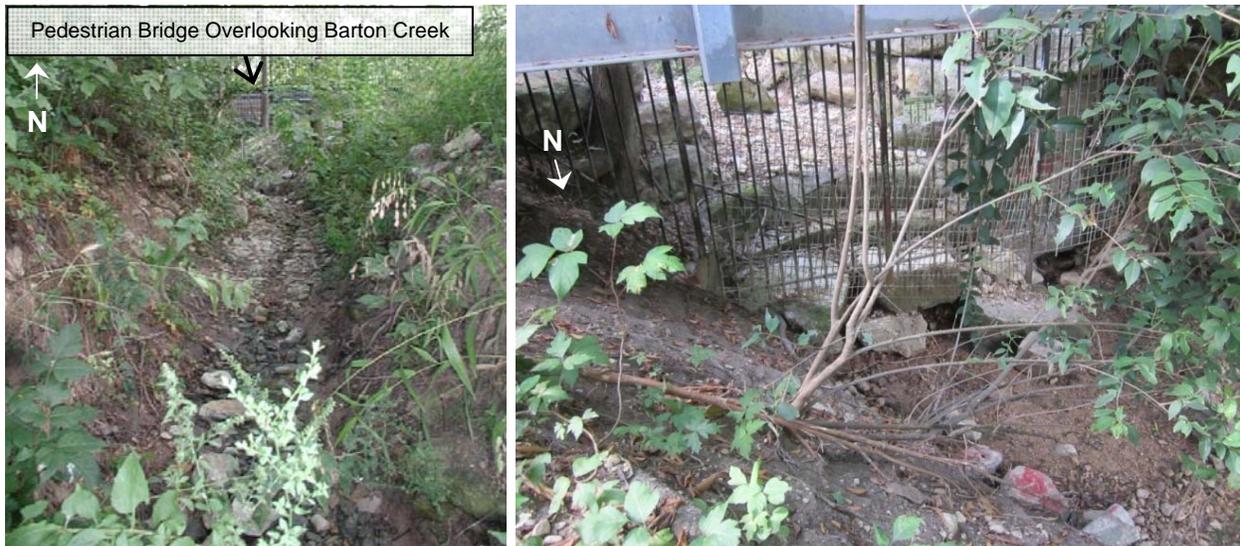
Figure 2.1.4: View of Channel

Channel Looking Towards Barton Creek (Left) and Boulder Drop Structure at Channel End (Right)

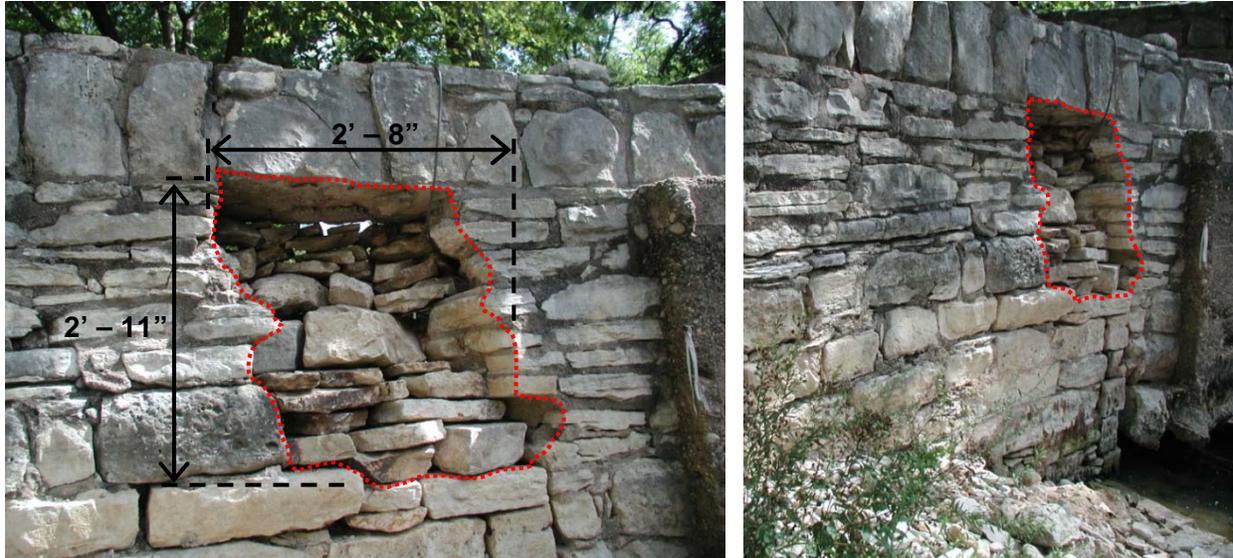
In addition to the wall opening deficiencies observed, we observed a several locations where the stone enclosure wall has experienced significant damage and/or deterioration. Damage nearest to the wall opening location consists of a square-ish-shaped section of wall that had been completely knocked out and is currently filled with dry-stacked pieces of loose stone with no binding mortar (Figures 2.1.5 and 2.1.6).

Figure 2.1.5: Portion of Wall with Dry-Stacked Rubble – Views from within Enclosure
Straight-on View (Left) and Oblique View (Right)

The portions of the enclosure wall that are damaged or in a state of disrepair (see Section 2.1) require restoration, including the repair or reconstruction of deteriorated portions of the stone wall and replacement of degraded mortar to ensure that the wall will continue to support itself and so that further deterioration is prevented. It may also be necessary to repair portions of the wall beyond the extents of obvious damage.

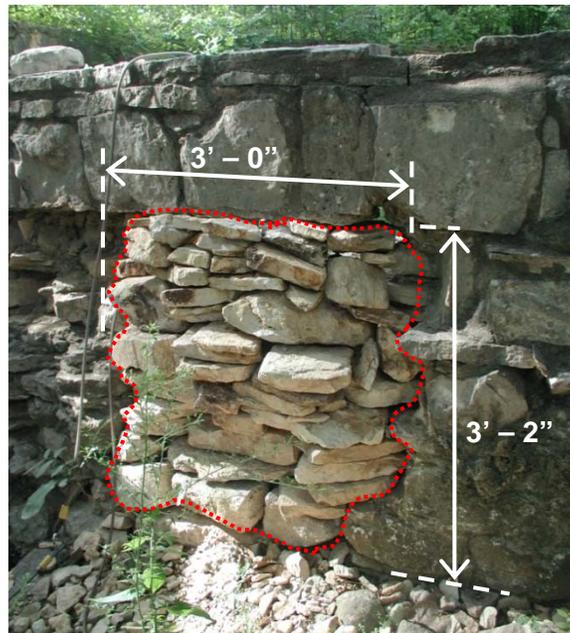
Figure 2.1.6: Portion of Wall with Dry-Stacked Rubble – Exterior View

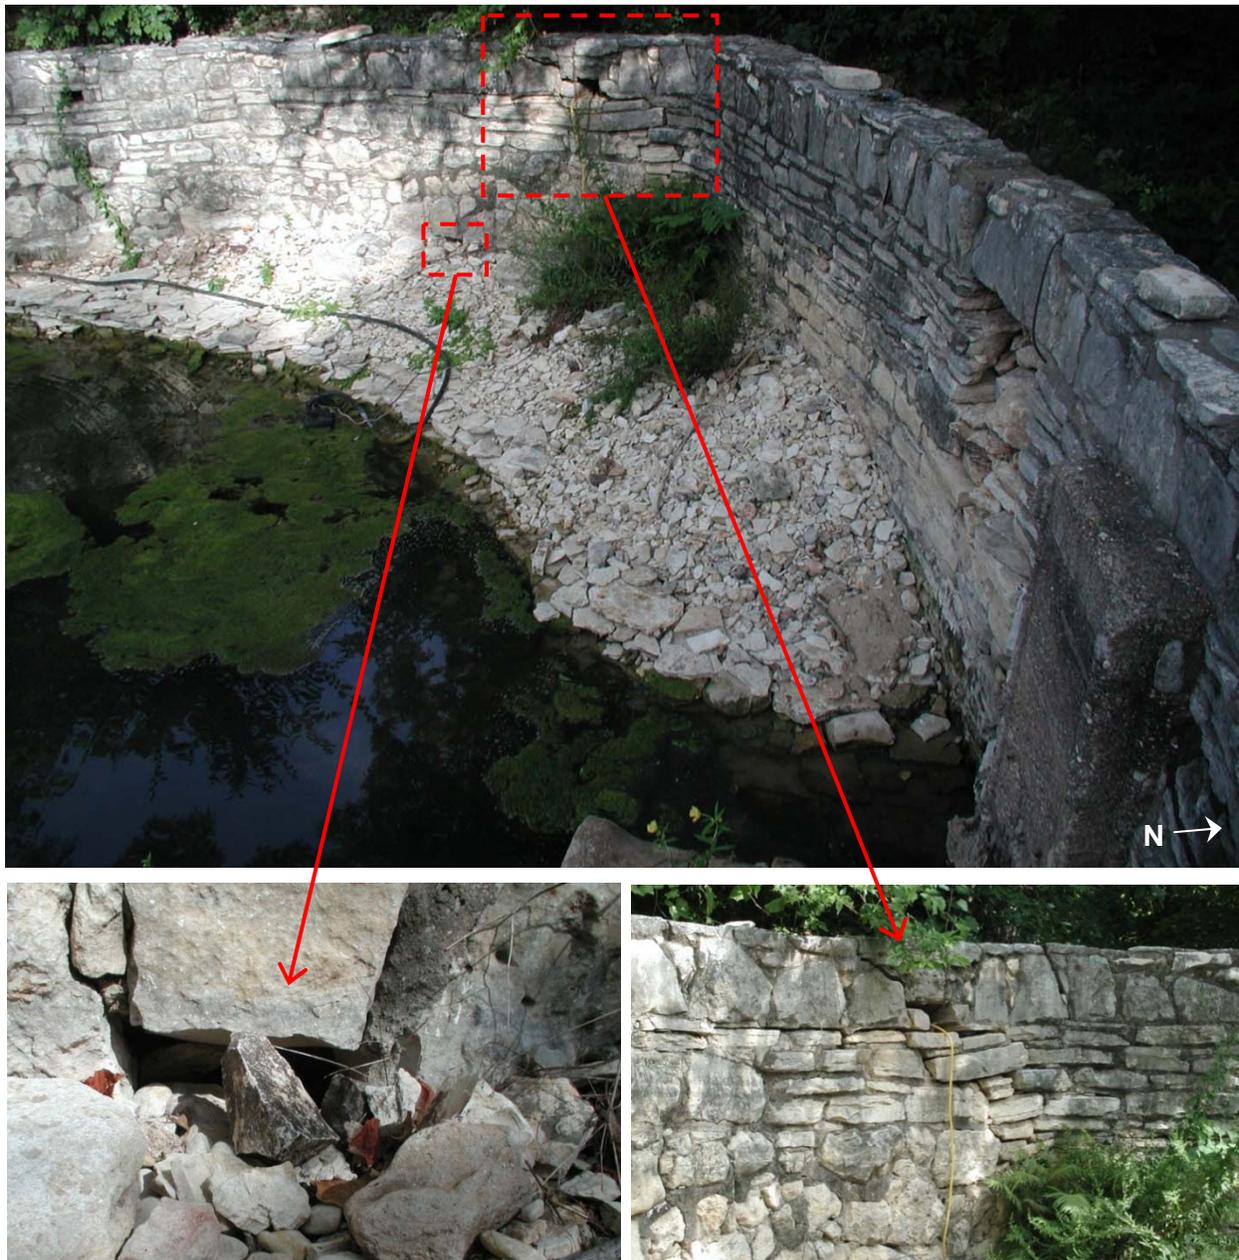
To the west of the area with dry-stacked stones, there is a large diagonal crack in the wall and a hole at the base of the wall that is known to allow water to pass freely through the enclosure wall when the spring pool water reaches the height of the hole (Figure 2.1.7). Due to overgrown vegetation on the backside of the wall, this area was inaccessible for investigation and photographs are not available for the exterior side of this portion of damaged wall.

Figure 2.1.7: Damaged Areas of Stone Wall

Overall View (Top) and Close-ups of Hole at Base (Bottom Left) and Diagonal Cracking (Bottom Right)

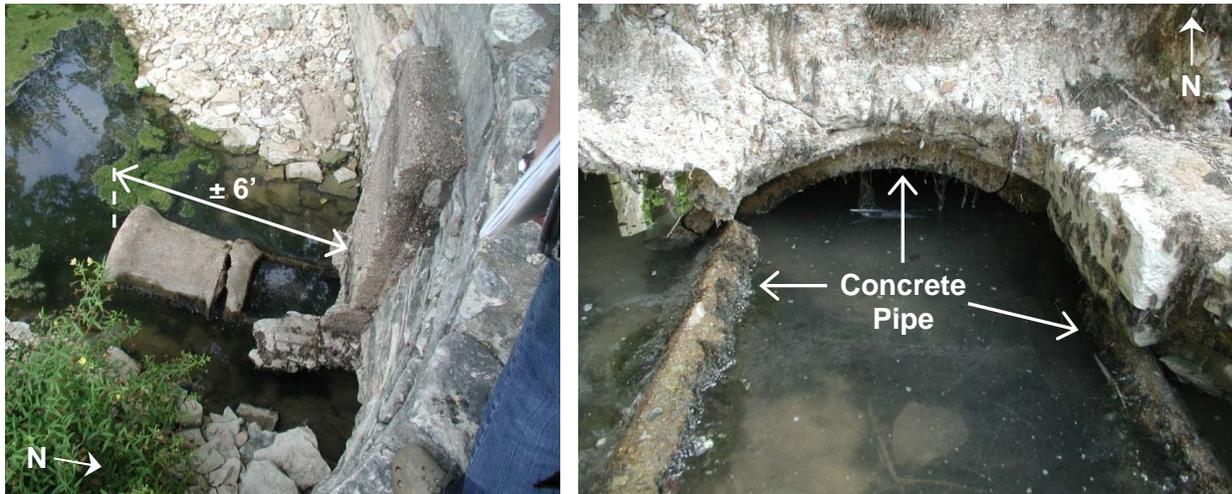
The plugged concrete pipe remnants and the loose concrete debris beneath and around the wall opening need to be removed. The concrete pipe extends approximately 6 feet inside the enclosure and penetrates through the existing wall opening (Figure 2.2). Remnants of the pipe are also present on the exterior side of the wall under a mass of old concrete (Figure 2.1.2, in previous section).

Figure 2.2: Concrete Pipe Blocking Water Flow Below Wall

View of Pipe within Enclosure – from Top of Wall (Left) and Close-up of Pipe Under Wall Opening (Right)

- Remove the existing concrete pipe and concrete debris from under the wall.
- Temporarily remove the stone wall above the new opening, and then reconstruct on top of new opening frame
- Construct a new opening in the wall. New opening shall be sized for worst-case hydraulic conditions. Opening will have a concrete frame and spread footing foundation.
