Table of Contents for Bowie Street Tree Permit
Heritage Tree Variance Package

**ADDRESS
OF PROPERTY:** 311,313,315 Bowie Street

TREE PERMIT: 10617196

Tree Assessment Report

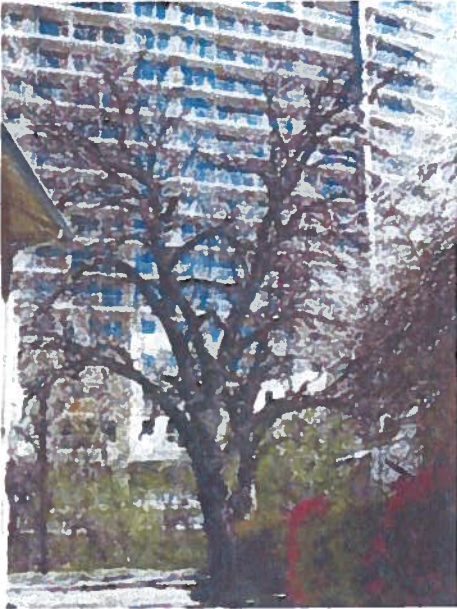
Located at the right rear of the Consort office, this tree stands approximately 60 feet in height. The stem leans 5 degrees toward the north, but the tree architecture is balanced. The crown is medium for stem size and has approximately 5% dead branches with a maximum size of 5 inches. The branch ends are dense and heavy. Two abrupt bends and a sweep are visible in the scaffold branches. A previous failure of a 6-inch limb is visible. The root flare is mostly exposed, and no evidence of root decay was visible upon excavating the south and east sides of the root collar. The root space is limited.

Tree #6805 is a stable, attractive tree with minor flaws that are typical of older pecans in urban settings. One question on the property is the suitability of this tree to be transplanted. In our experience, large pecan trees are not good candidates for relocation. As pecan is a bona-fide tap root species, transplanting large specimens in deep soils will sever this large root and eventually lead to decay and tree failure. This is due to the difficulty in capturing a deep enough root ball and the associated weight of the transplant.

Left photo – structure of Tree #6805.

Tree #6805, however, is a quality tree in good condition. Relocation of this tree is problematic due to the depth of the root ball needed for a successful transplant and the urban nature of the site. Unless an unusually large root zone were left for this tree, development around this large riparian tree would likely cause enough site disturbance and internal soil drainage changes to cause the tree to decline.

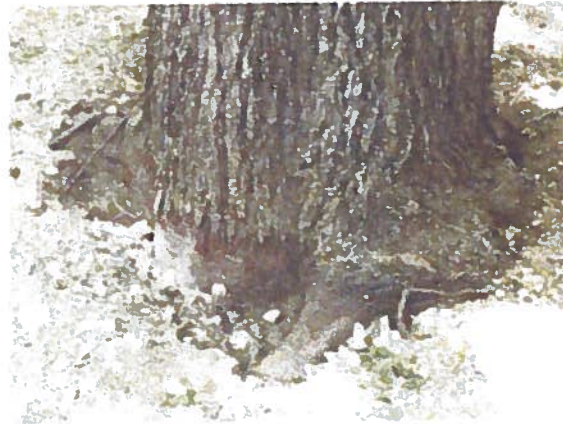
Photo above – root collar of Tree #6805.

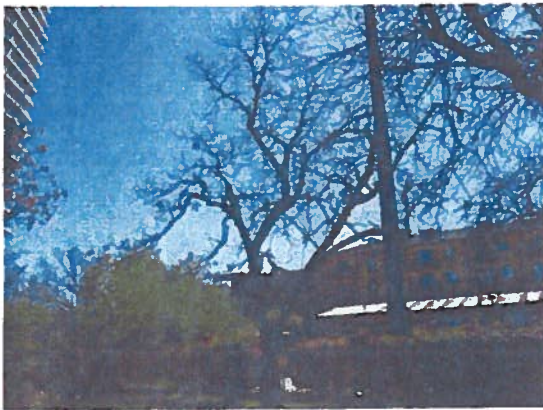
This tree is located at the right rear of the Consort parking lot and stands approximately 55 feet in height. The crown is medium for stem size, and the tree architecture is balanced. About one percent of the branches in the crown are dead with a maximum size of 3 inches. Branch ends are dense and heavy. Five abrupt bends and several previous branch failures are visible. This tree has a codominant-stem structure with a crotch at 8 feet. The codominant stems measure each approximately 19 and 24 inches in diameter. The stem growing to the west displays a 9-inch cavity just above the crotch, and the stem growing east displays a decay column of approximately 12 feet in length and up to 8 inches wide. A crack and borer gallery extend the length of the decay column. A 2" x 10" cavity appears at approximately 4.5 feet on the main stem. Excavation of the south and east sides of the root crown revealed that the root flare is buried with 32 inches of rocky fill, stone, and brick. The excavation did not reveal evidence of decay in the area excavated. The root space is very limited.

Tree #6806 displays numerous problems. Although the canopy gives the appearance of a healthy tree, the structure of the tree has fundamental problems. The east stem is decayed and cracked and highly likely to fail. Abrupt bends in the scaffold branches, previous failures, persistent dead wood and cavities add to the declining and hazardous condition of this tree. The buried root collar and limited root space have likely contributed to the declining condition of the tree and would likely contribute to further decline of this tree over time.

Left photo – structure of Tree #6806.

With regard to tree # 6806, incumbent decay, root collar disorders, and accumulated stress coupled with high traffic in this area and high pedestrian presence make this tree an unreasonable hazard. Removal of this tree is the recommended before development.

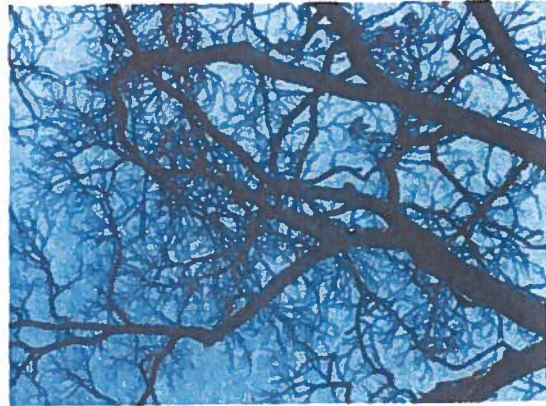
Right photo – abrupt bend in the crown of Tree #6806.

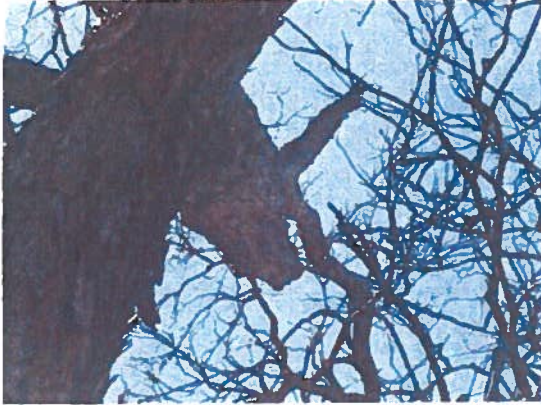
Left photo – decayed east stem and previous storm damage on Tree #6806.

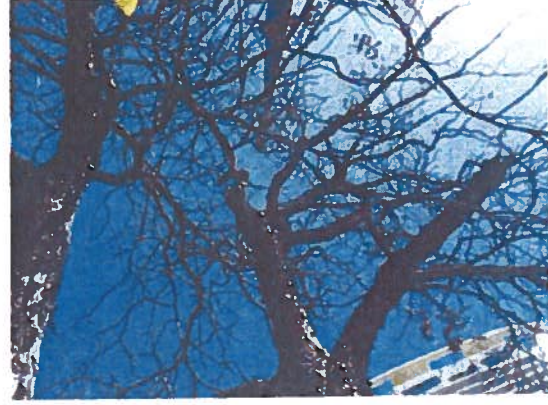
Right photo – broken stubs in Tree #6806 from previous storm damage.

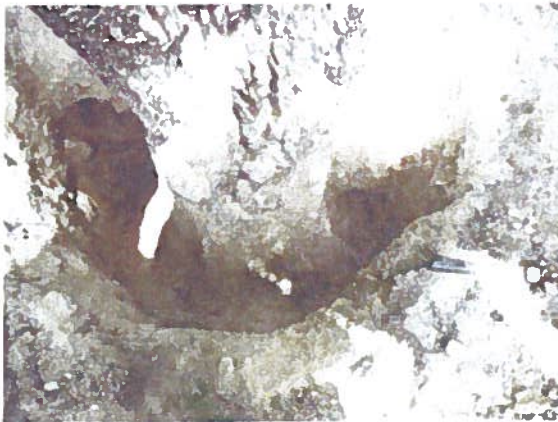
Left photo – view of exposed root collar on the south side of Tree #6806.

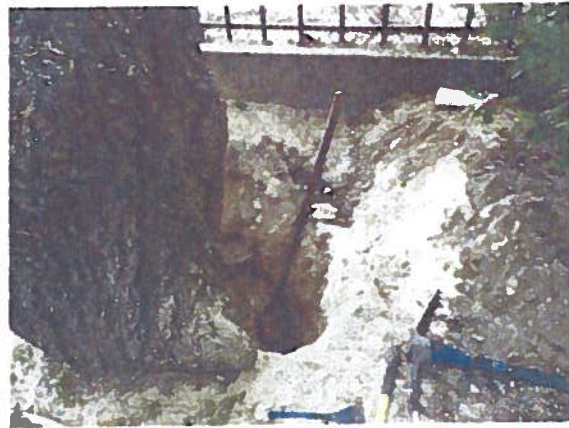
Right photo – view of fill depth (32 inches) over the root collar of Tree #6806.

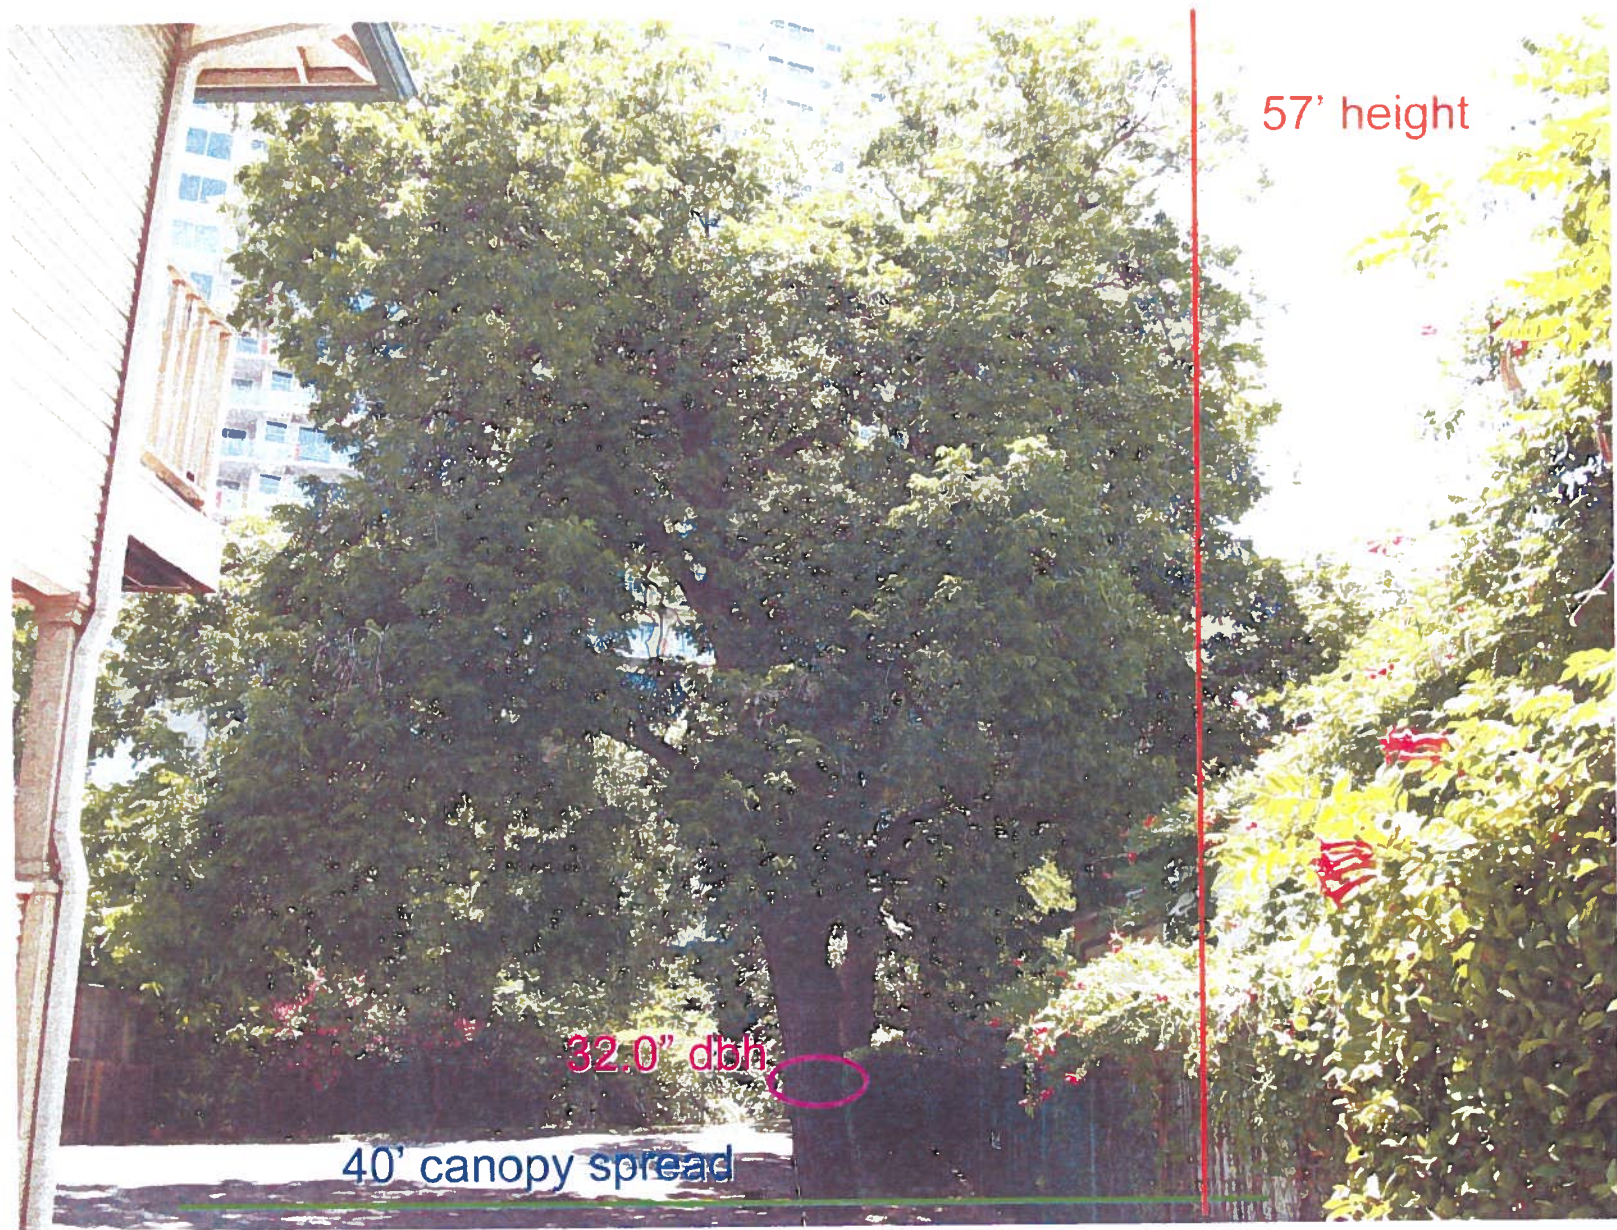
Exhibit 2

The subject tree is a 32.0 inch diameter at breast height (dbh) Pecan (*Carya illinoensis*). The tree height is 57 feet and the canopy spread is 55 feet (Exhibit 2). The canopy is generally symmetrical exhibiting less than five percent deadwood with minimal structural defects (Exhibit 2). Dense, heavy branch ends appear to be the only visible evidence for potential branch failure (Exhibit 3). Storm damage is evident by the presence of broken stems, though no noticeable decay or structural weaknesses are present (Exhibit 4). Subsurface conditions are characterized by greater than 90 percent impervious cover over the root system, compacted and consolidated soil, and fill material that has partially buried the root flare (Exhibit 5). Rainfall catchment area is limited by the extent of impervious cover though it is likely shallow groundwater is influencing soil moisture in the rhizosphere (interface between root system and soil). Decay is not apparent and unlikely since the soil is principally composed of abiotic minerals as opposed to organic soils. Given the aforementioned conditions, the subject tree is rated 'good' per the City Arborist tree evaluation (Exhibit 6).

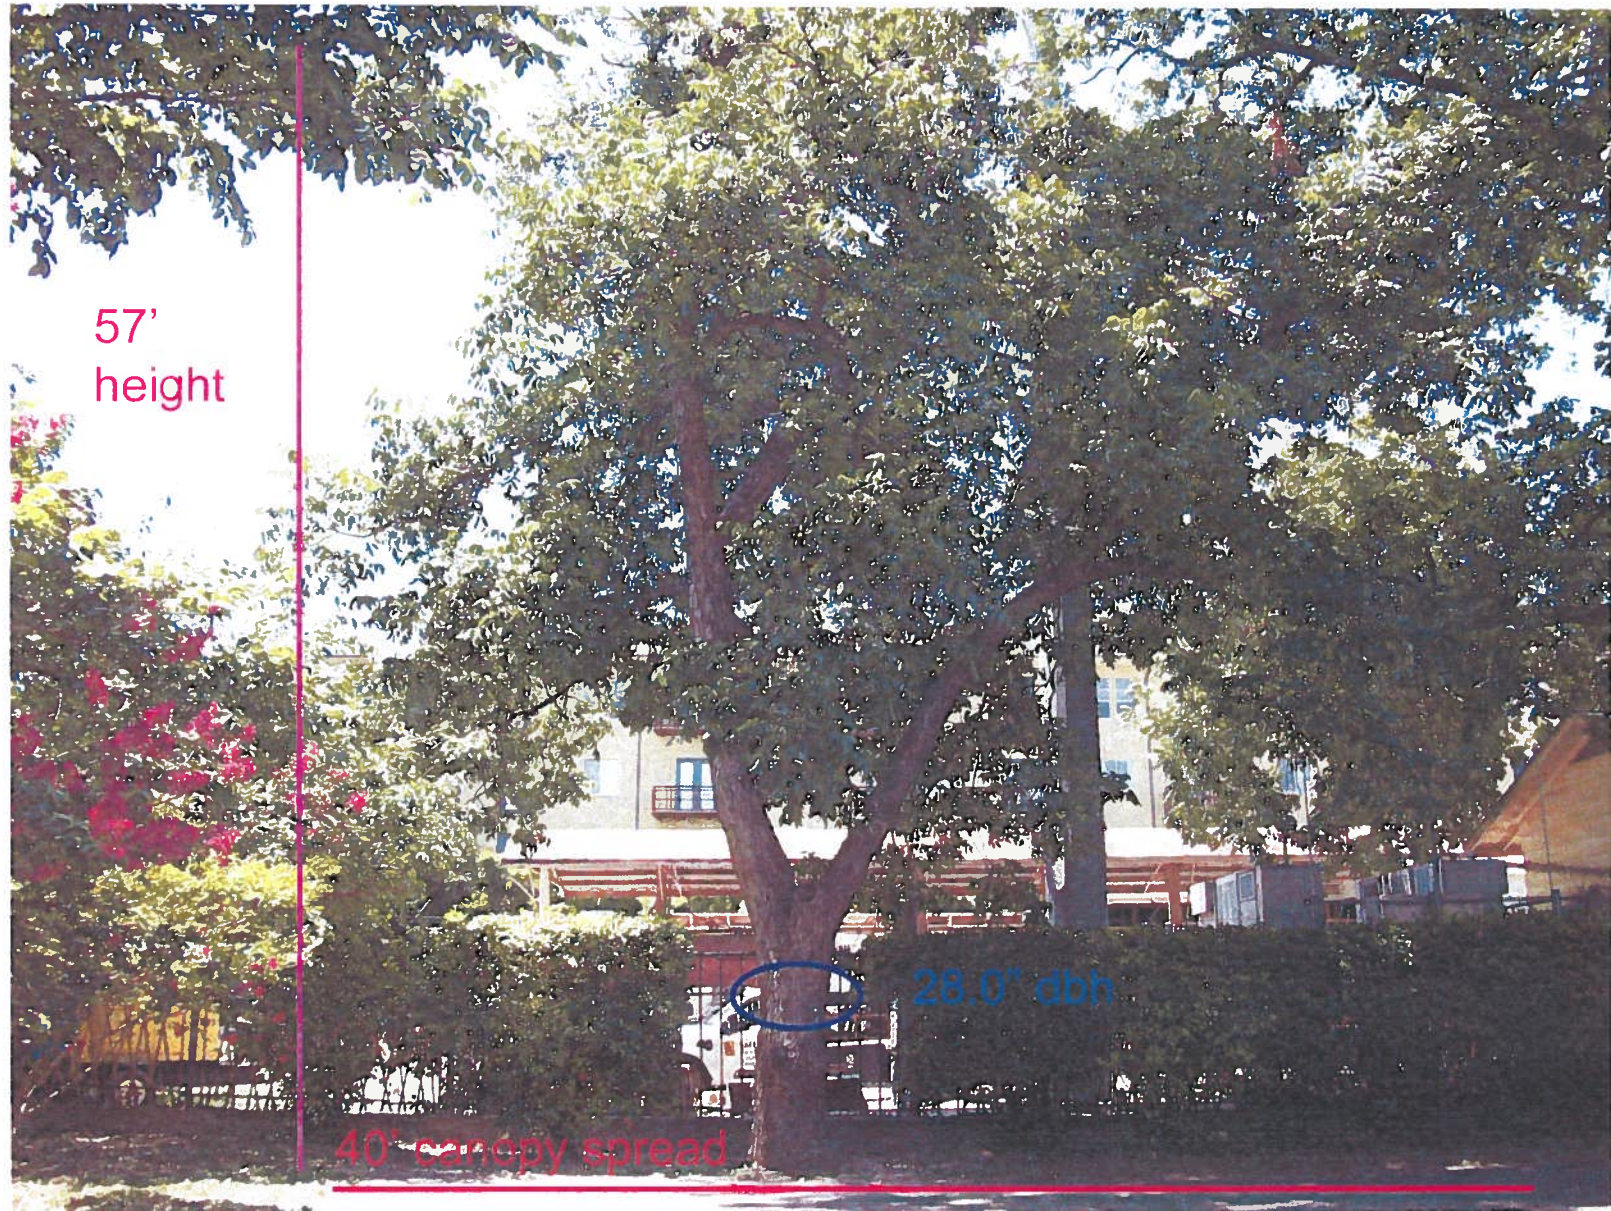
Exhibit 7

There is also a 28.0 inch diameter Pecan onsite that is proposed to be removed (Exhibit 7). This tree displays severe structural defects. There is a 2" x 10" cavity that exhibits

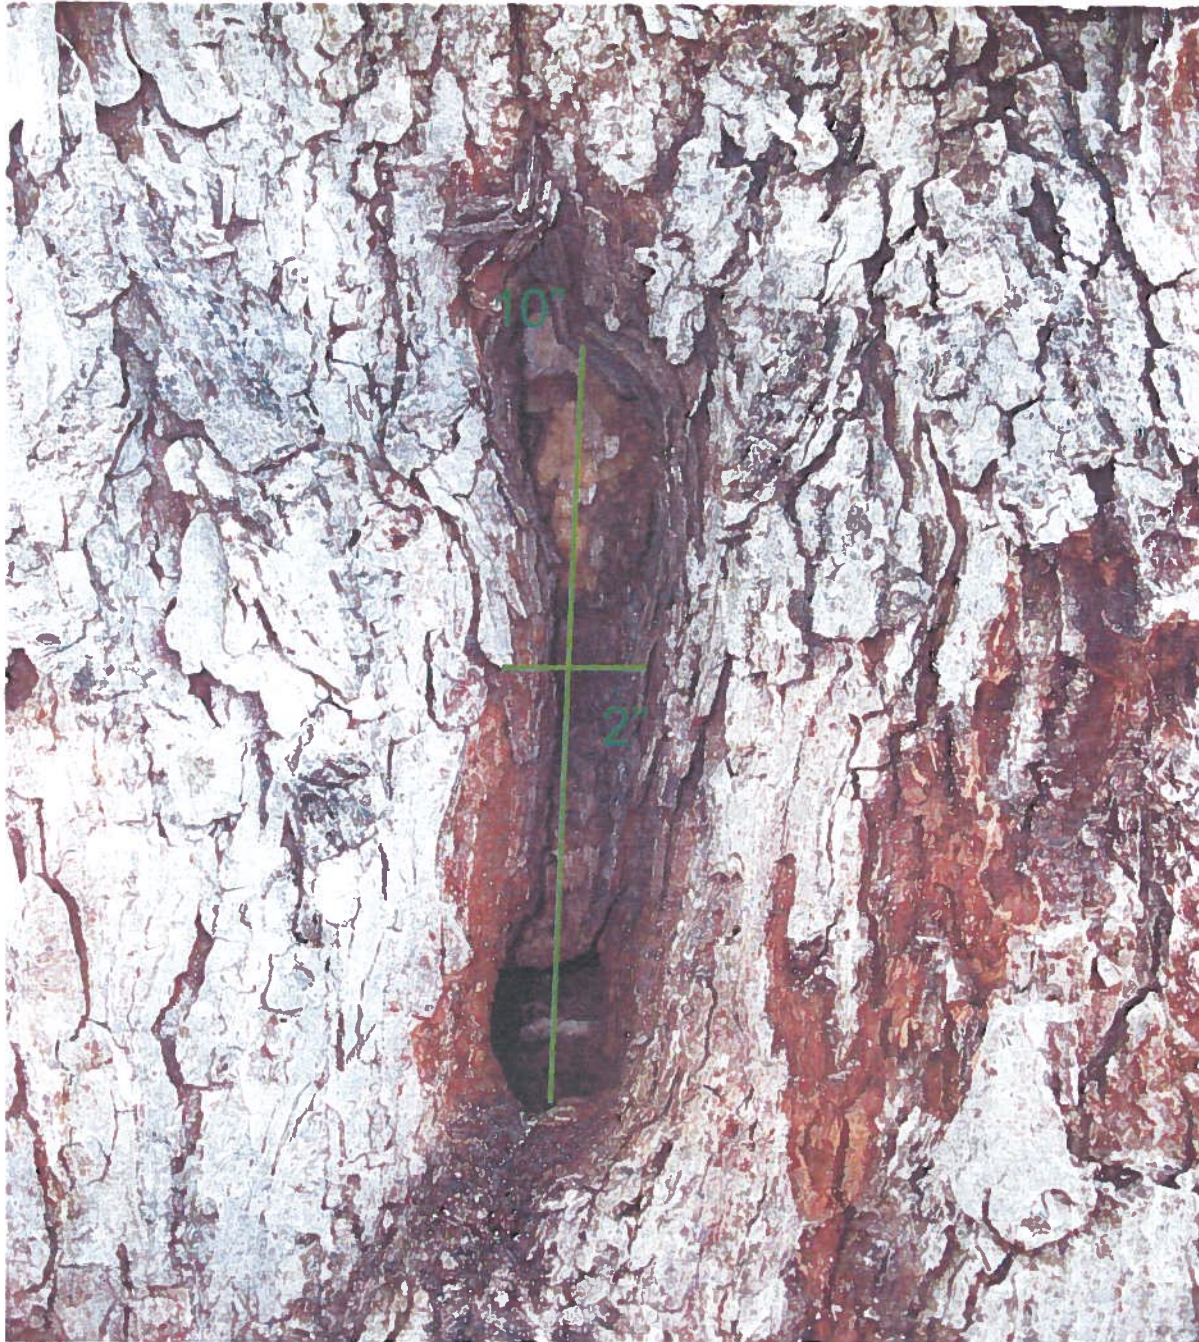
Exhibit 8

significant decay as evidenced by the ~200 in³ of void space (Exhibit 8). There is also a 8" x 12' decay column in the east stem (Exhibit 9). Further, the root flare has been buried 32 inches with rock, fill, stone, and brick (Exhibit 10) per the Bartlett assessment included in the applicant's memorandum. Given the aforementioned reasons both the City Arborist's assessment (Exhibit 11) and the Bartlett assessment concur that the subject tree is hazardous. The subject tree meets the criteria for administrative criteria for removal per both LDC 25-8-624(5)(a), diseased and restoration is not practicable, and LDC 25-8-624(A)(3) imminent hazard; thus the City Arborist will allow the subject tree to be removed and is not considered part of the variance request before the Environmental Board and Planning Commission.
