Historic Landmark Commission
September 26, 2011
Permits in National Register Historic Districts
NRD-2011-0079
West Austin Park – Shelter House
1317 W. 10th Street

**SUBJECT: Updated: Back-up information for National Register Permit:
West Austin Shelter House Improvements**

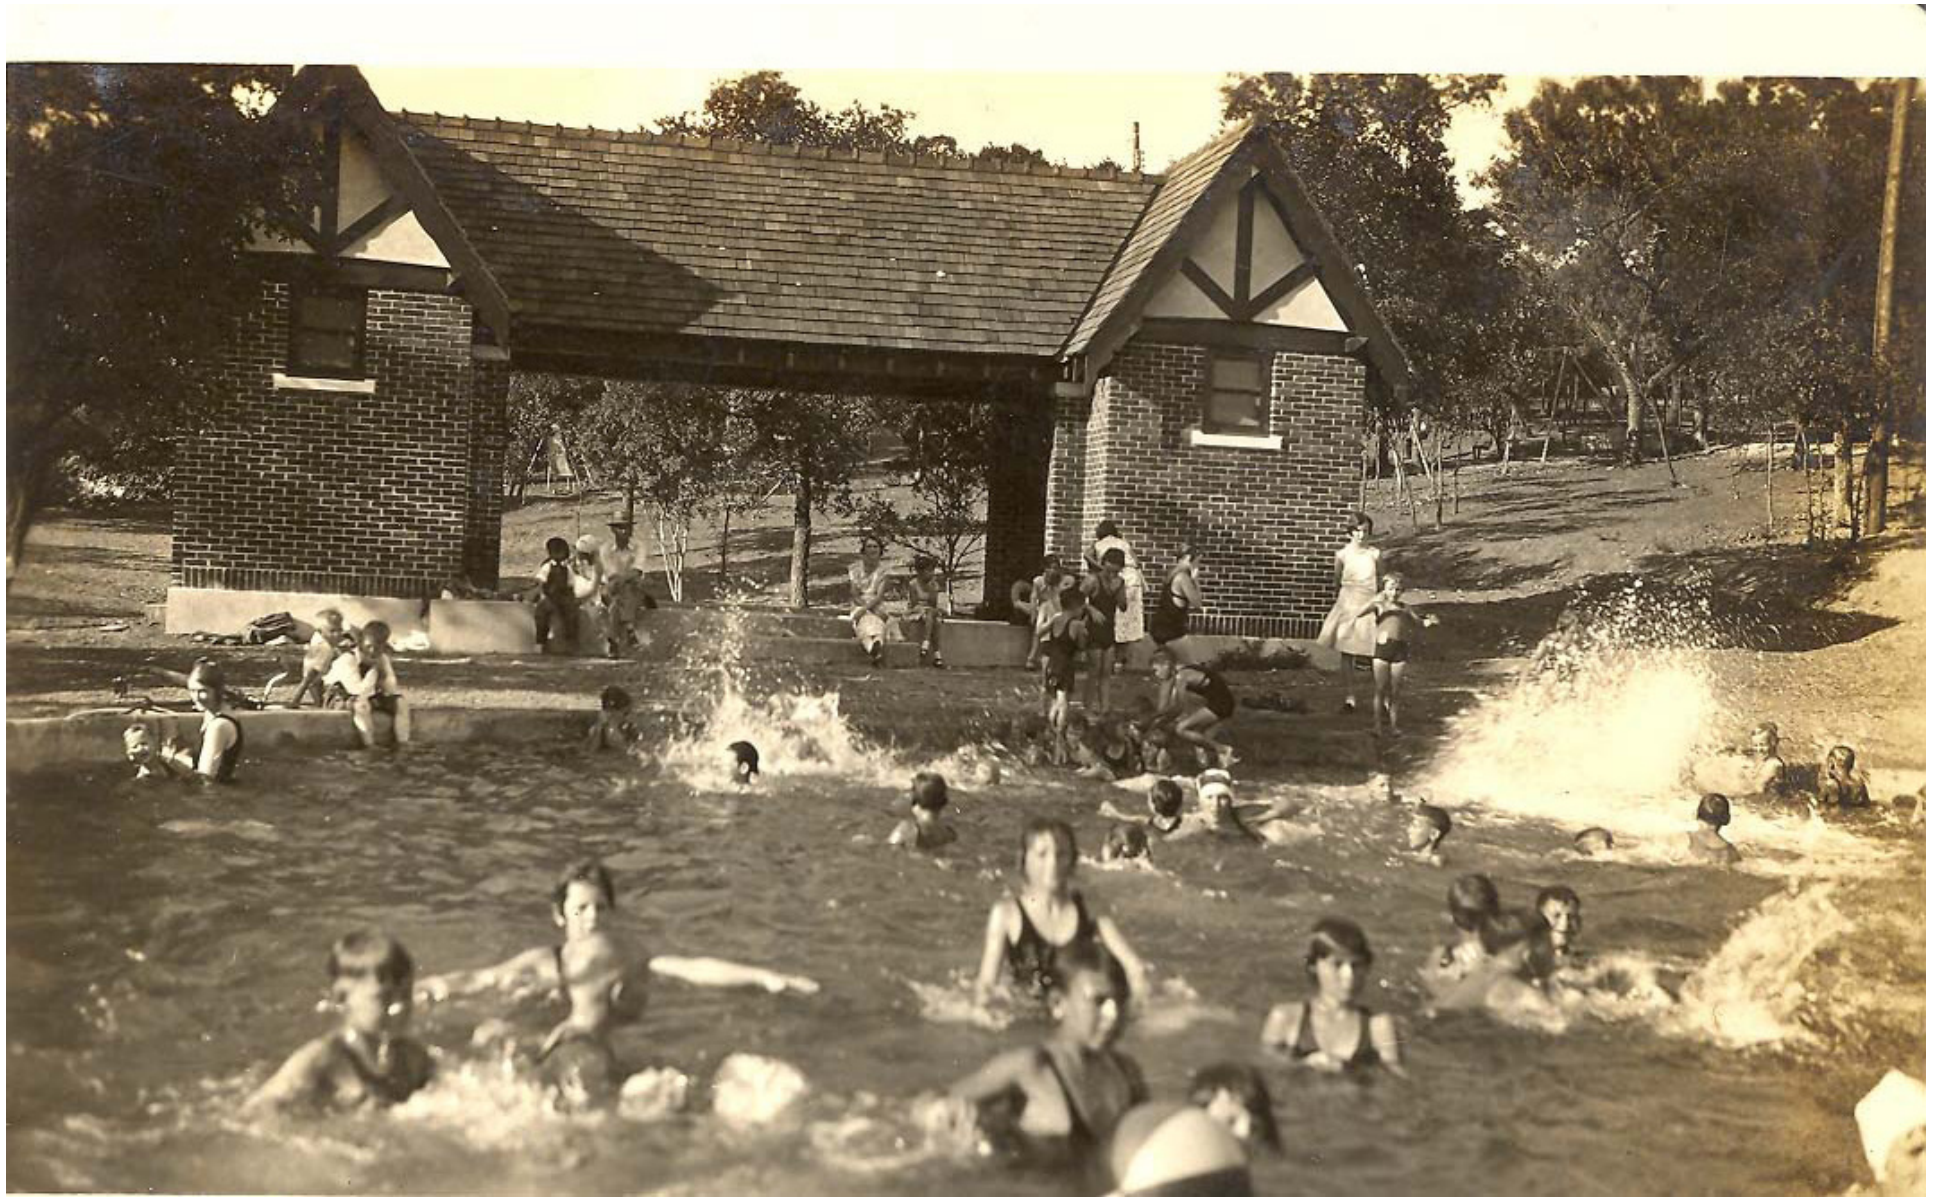
- b. The grant proposal specifies acrylic block as the replacement material.
 - c. Considerations: Historic photographs show that the windows were originally 1:1 wood sash windows (Fig. 1). In many conversations with representatives of West Austin Park as well as PARD staff, it was decided that the replacement windows will be 1:1 wood sash windows with tempered glass. Should further protection be necessary, a “screen” can be constructed using Lexan or a similar material. This treatment is used at both the Lions Municipal Golf Course Club House and North Austin Substation at Sparky Park. For ventilation, a passive vent system incorporating electric bath fans will be installed in each restroom. A low-profile square vent will be installed on the back side of the roof (apx. 4" x12"x12").

Figure 1: Historic photo of West Austin Shelter House, constructed in 1930.

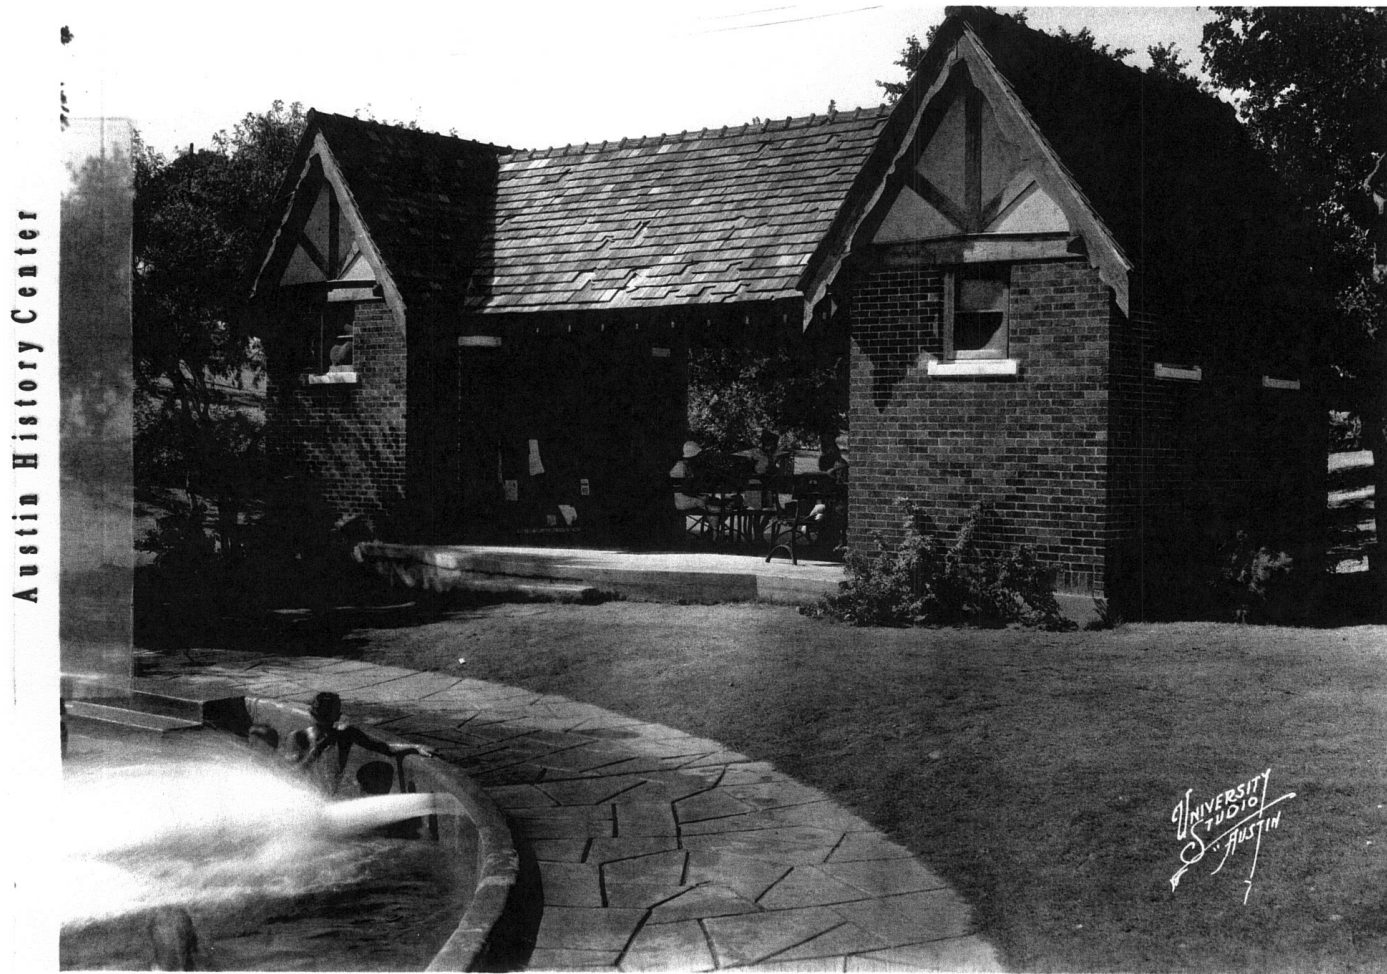
as the part of the re-roofing as are decorative bargeboards that are shown in Figure 3. Flashing along the valleys of the roof should be sensitively installed.

Figure 3: Historic photo of West Austin Shelter House constructed in 1930. Note decorative bargeboards and wooden ridge cap shingles.

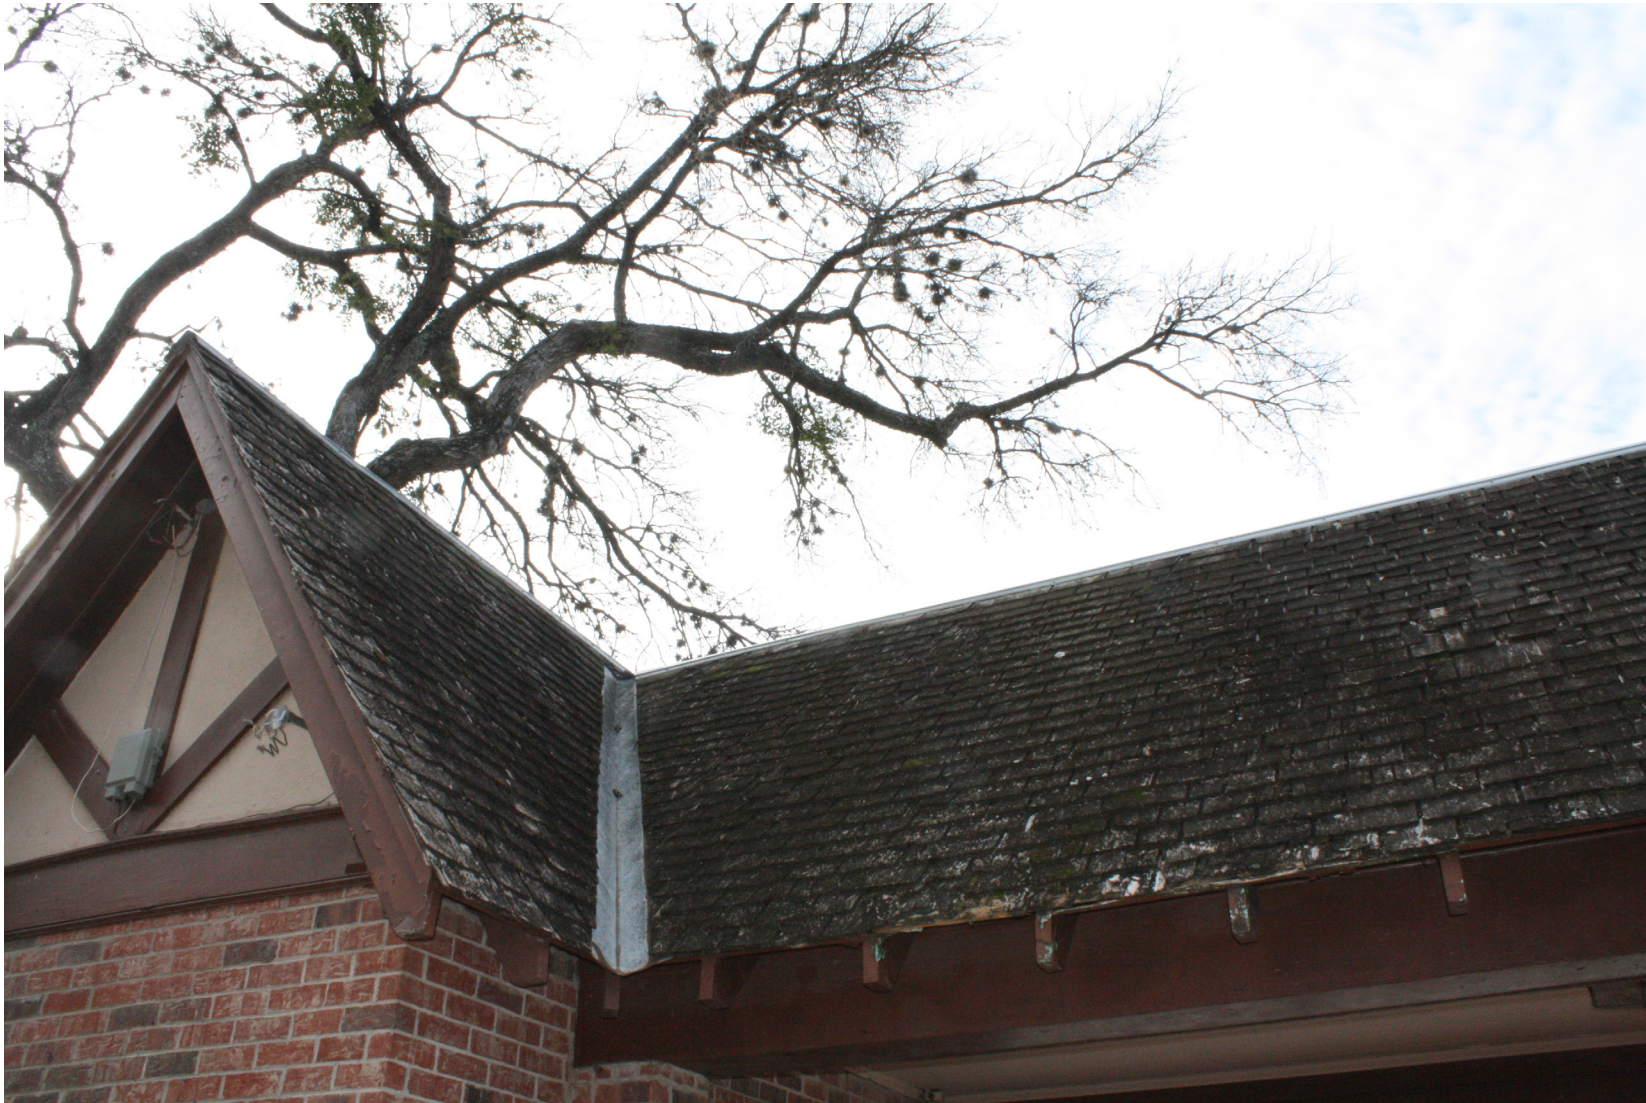
1. Roof replacement
 - a. The existing wooden shingle roof is badly deteriorated and failing (Fig. 5 & 6). The proposal calls for the replacement of the roof. The project budget specifies wooden shingles as the roofing material.
 - b. Considerations: Historic photos show that the ridgeline of the roof had wooden ridge cap shingles (Fig. 1), but this feature was eventually replaced by metal flashing. Wooden ridge cap shingles are recommended

Figure 5: Roof details on West Austin Shelter House.

- c. In the replacement of wooden shingle roofs on historic buildings, PARD will reference *NPS Preservation Brief 19: The Repair and Replacement of Historic Wooden Shingle Roofs* (Appendix B).

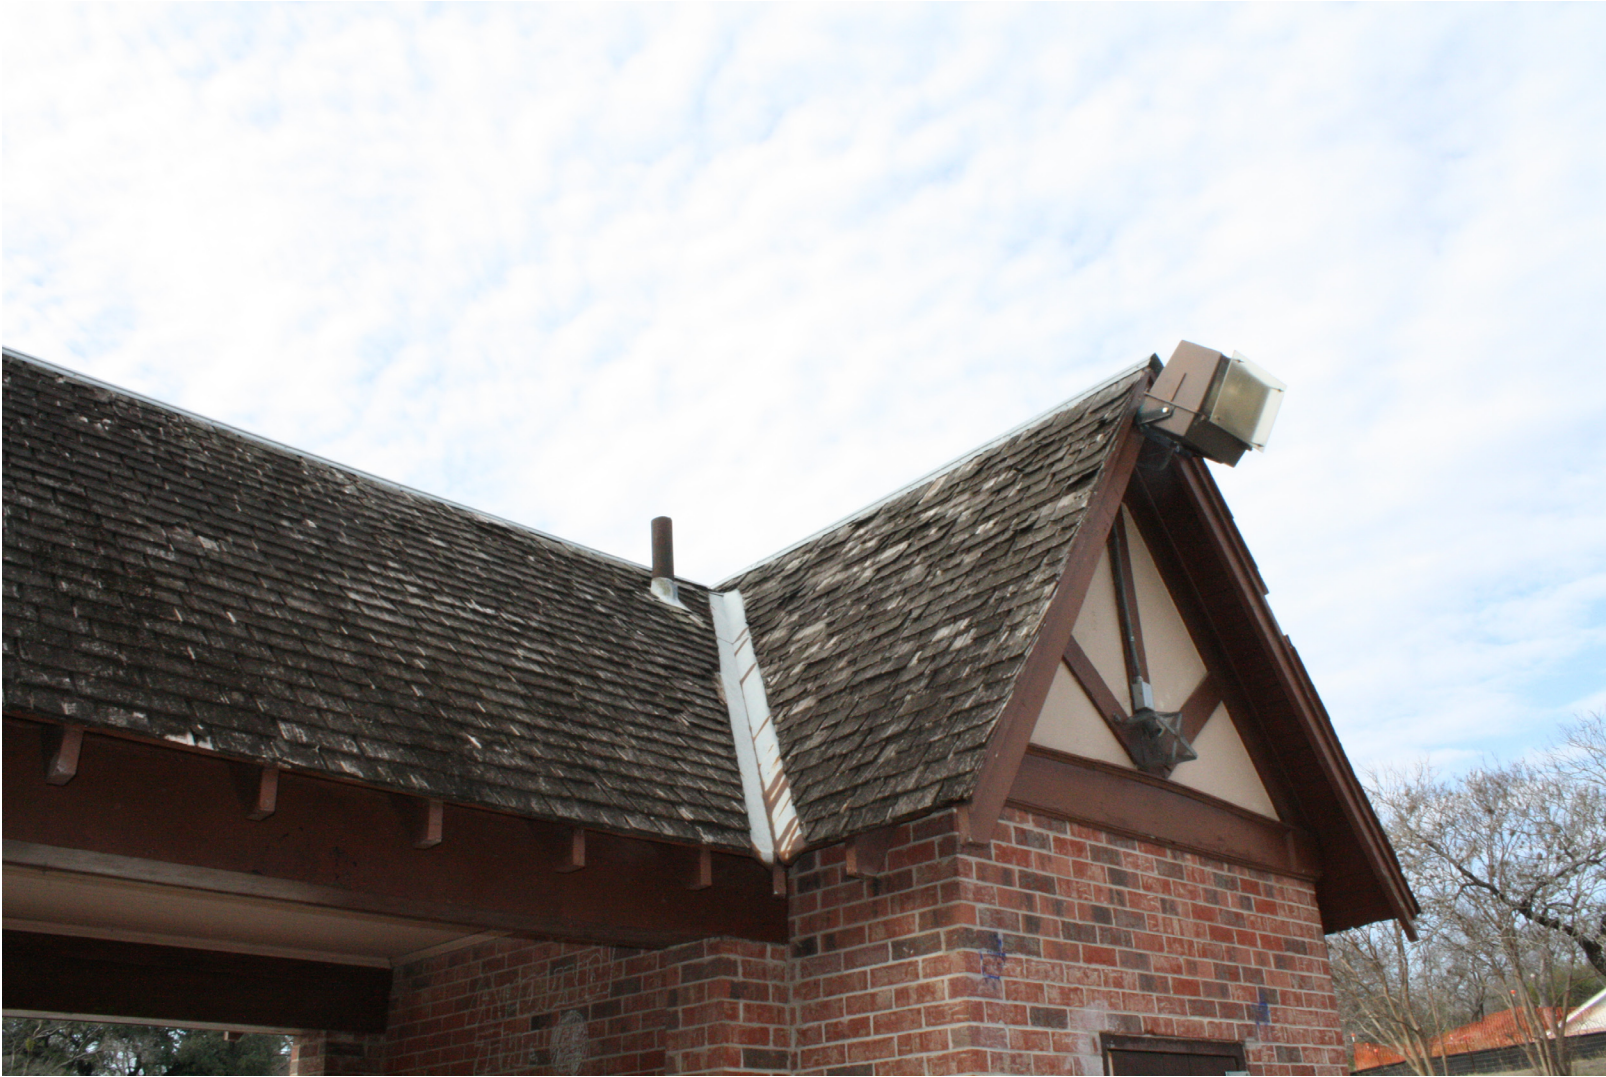
2. Replacement of lighting fixtures
 - a. The proposal calls for the replacement of seven exterior and three interior lighting fixtures (Fig. 6).
 - b. Considerations: As a part of the National Register application process, specific information about the type of exterior light fixtures will be requested. PARD recommends low-profile, under-eave LCD lighting as opposed to large fixtures.

Figure 6: Roof and lighting details on West Austin Shelter House.

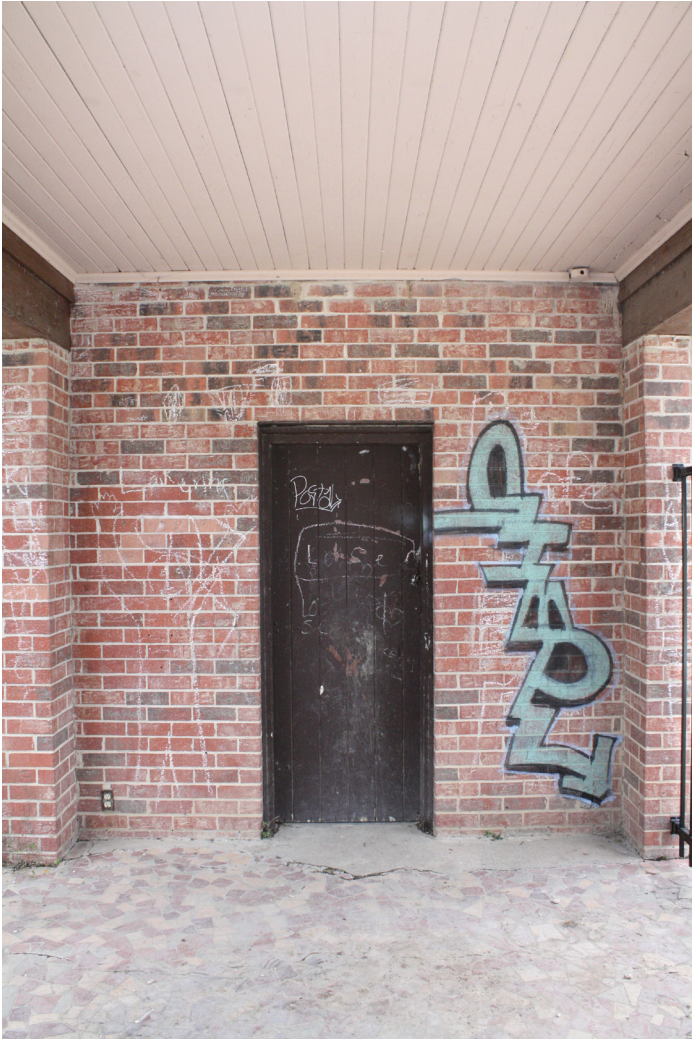
- b. Considerations: Graffiti removal is a challenging issue (Fig. 7). Removal of graffiti must be done carefully and no products can be used that are deleterious to the integrity of the brick and mortar. An excellent reference, *NPS Preservation Brief 38: Removing Graffiti from Historic Masonry*, is attached. (Appendix C).

Figure 7: Graffiti on West Austin Shelter House.
