HISTORIC LANDMARK COMMISSION FEBRUARY 27, 2012 APPLICATION FOR A CERTIFICATE OF APPROPRIATENESS C14H-2007-0011 Kocurek Building 511 W. 41st Street

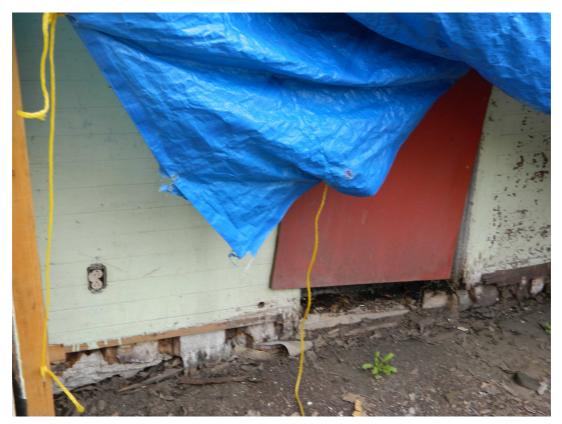
Please see the accompanying photographs of the existing, exposed back wall. There is evidence of board-and-batten siding under the now-exposed interior wall finish, although the battens have been removed and the boards are very deteriorated. It is also very probable that the entire house originally had board-and-batten siding, but the battens have all been removed and the house is now completely sheathed in asbestos shingles.

Rear wall of the auxiliary siding – the old board and batten is visible at the sill.

With the new plan that will restore more accurately the historic appearance of the house, staff recommends approval of the Certificate of Appropriateness for the demolition of the rear addition (now gone), the application of board-and-batten siding to the rear wall, and the replacement of the front porch posts with new wood posts of the same dimension.

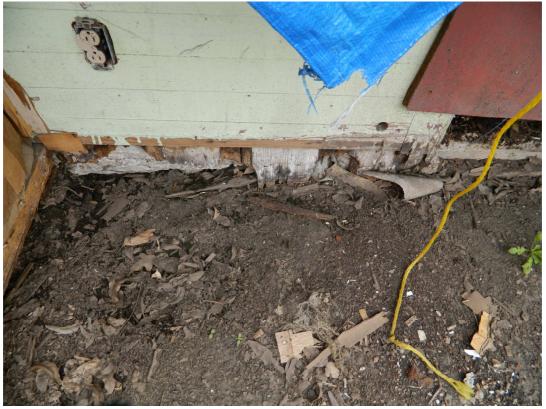
Detail view of the boards (missing battens) at the sill; south side of the building. The interior wall of the now-demolished rear addition covers the original boards.

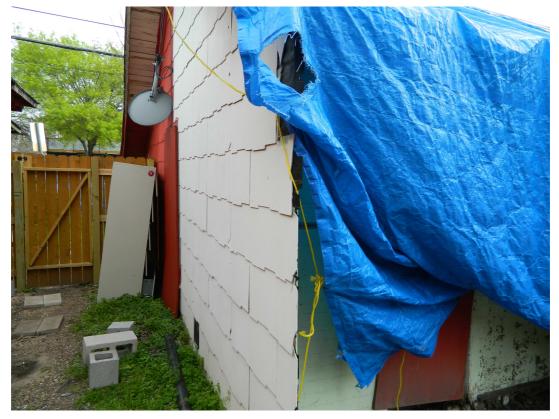
The west side of the building has asbestos siding; a horizontally-laid wood wall is underneath.
