Re: City of Austin Urban Forestry Board Recommendations For The Locating  
Of Art In Public Places (AIPP) And Related Structures Near Trees

RE: Brush square Oak, by o Henry and suzanna Dickinson museum

The purpose of this report is to evaluate the health and vigor of the live oak and overall impact of the site changes 2 years prior over the critical root zone. These include the installation of 2 historic buildings infringing on the critical root zone and an art patio work infringing in half the critical root zone.

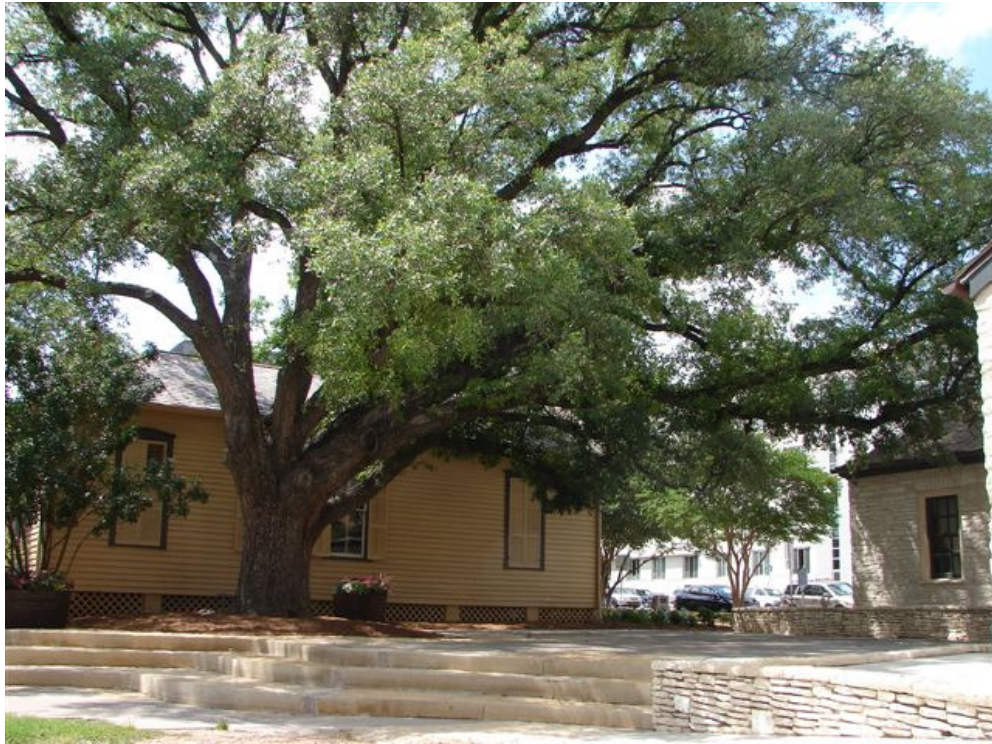
Site visit performed on Monday May 7<sup>th</sup>. *Quercus fusiformis*. DBH of 44". Half of critical root zone has a radius of 22 ft. Foliage is smaller and paler than nearby trees. Top half of the canopy is showing thinning estimated at 70% of its original density. No significant insect or disease impacts were observed.

Brush Square Heritage Live Oak Showing Thinning Canopy And Pale Leaves

The extensive site changes since 2009 are impacting the overall health of the tree. We expect more gradual decline in the coming years if corrective measures are not implemented. These measures should strive to provide a healthier root system. These can include a combination of several elements:

- Root wells through the changed grade and stone patio area
- Soil improvement with compost and mulch
- Compaction remediation and prevention with airspade and incorporation of 1' layer of sand and 1" layer of compost through the available critical root zone.

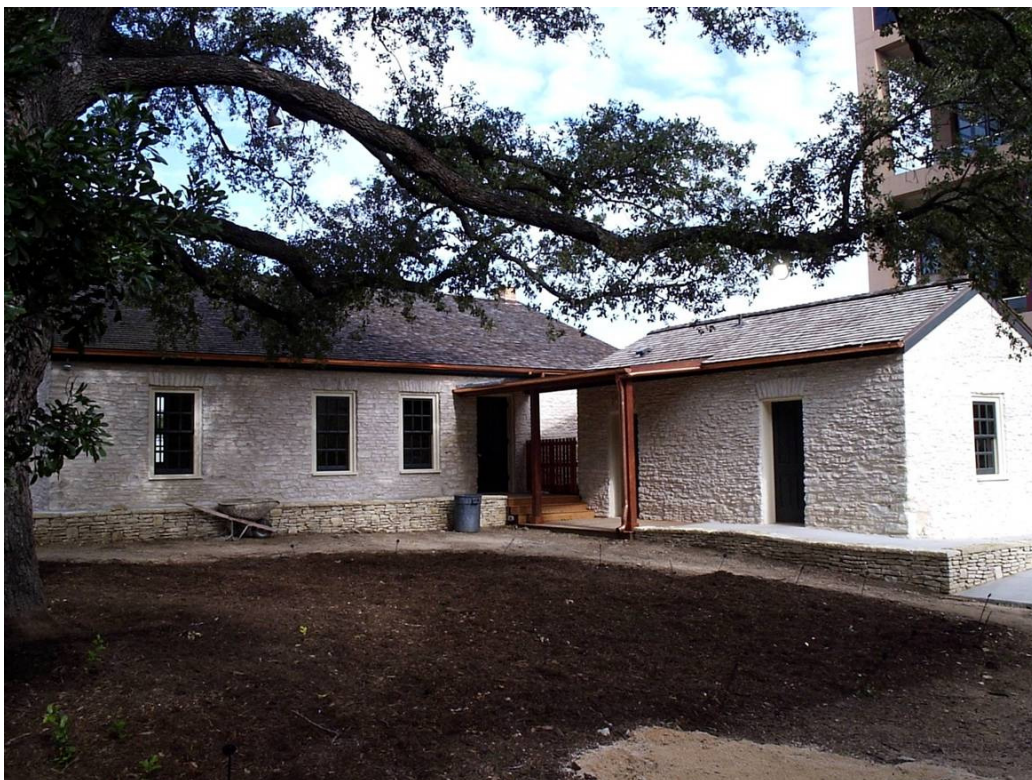
Original Grade Before Courtyard Installation

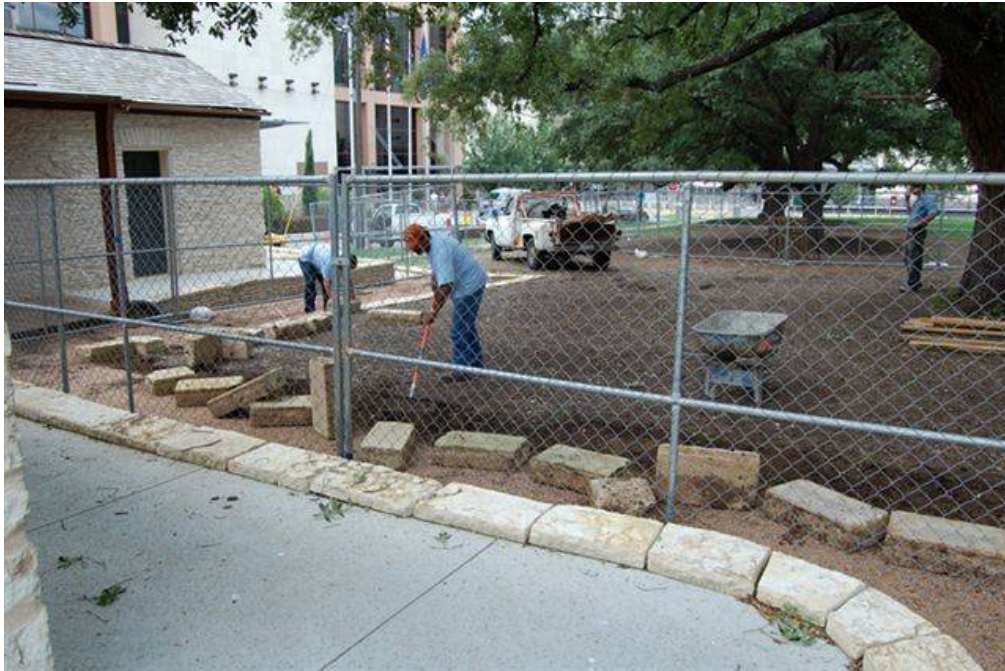
8 photographs provided by the museum curator showing the construction process. Grade changes are larger than 8 inches through a significant area of the CRZ. The patio coverage is made up of thick limestone slabs tightly juxtaposed with marble slabs. Joints are approximately 1/8 ". No information has been provided regarding root zone impact and mitigation actions during the project other than these photos.

Grade Was Raised Significantly in 2010 Over CRZ of Brush Square Tree

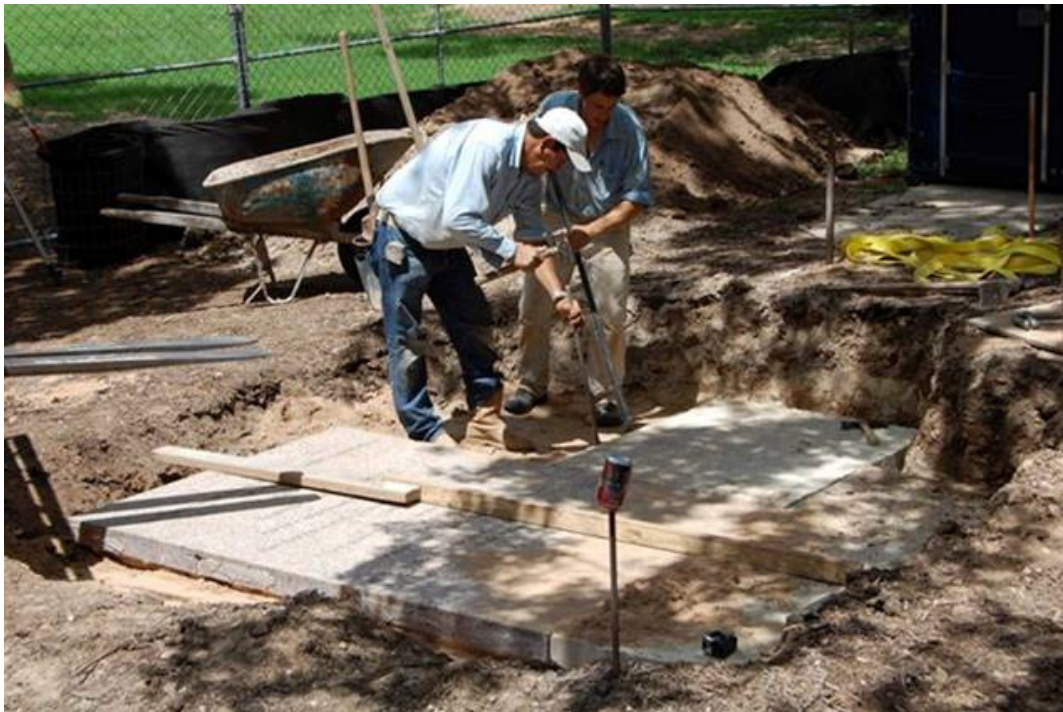
Large Deep Hole Dug Within  $\frac{1}{2}$  CRZ Of Brush Square Tree  
(7 ft. From The Trunk. Tree Is To The Right)

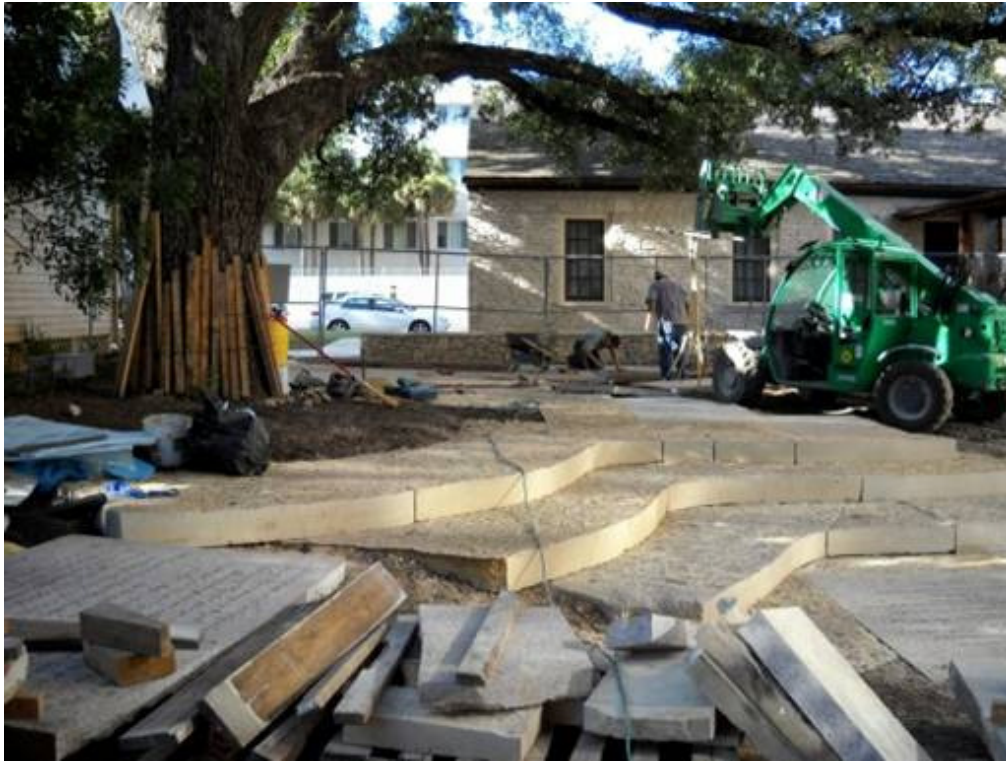
The occasional use of this public park has the effect of compacting the remaining pervious cover by pedestrian traffic and hampers water infiltration. No soil bulk density testing has been performed at this time.

## Machine Within CRZ Of Tree Compacting Soil

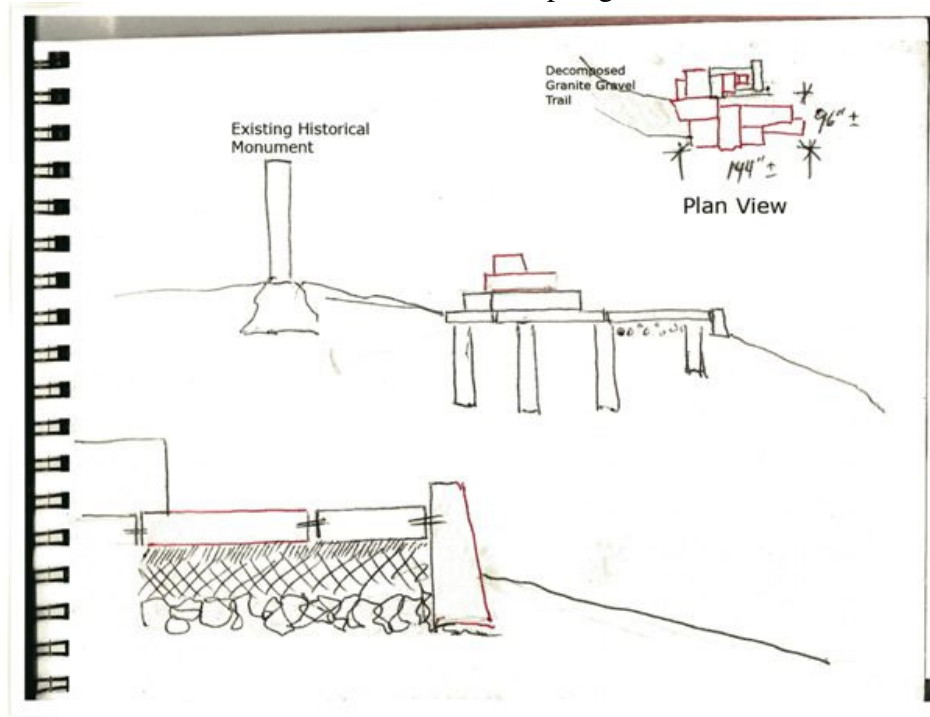
The second case brought to our attention is the heritage pecan on the south lawn of Barton Springs Pool. Artwork was to be installed within the CRZ of this tree in spite of PARD recommending numerous times over several months that it not be done. The installation of an overlook to serve as a base for the artwork required digging within the CRZ of this tree over a large area, but no certified arborists, landscape architects, or engineers were involved in the design. The artist submitted several sketches of the installation (attached). Acting PARD Forestry Manager Angela Hanson explained during a public review meeting that heritage trees already stressed by drought should not endure the additional stress of having artwork installed within their CRZ. It was not until more than 40 concerned citizens protested against this artwork at a public meeting, that it was moved from underneath the tree canopy and located outside the pool fence.

## Artist's Sketches For Overlook Construction Within CRZ Of Heritage Pecan Tree In South Lawn Of Barton Springs Pool

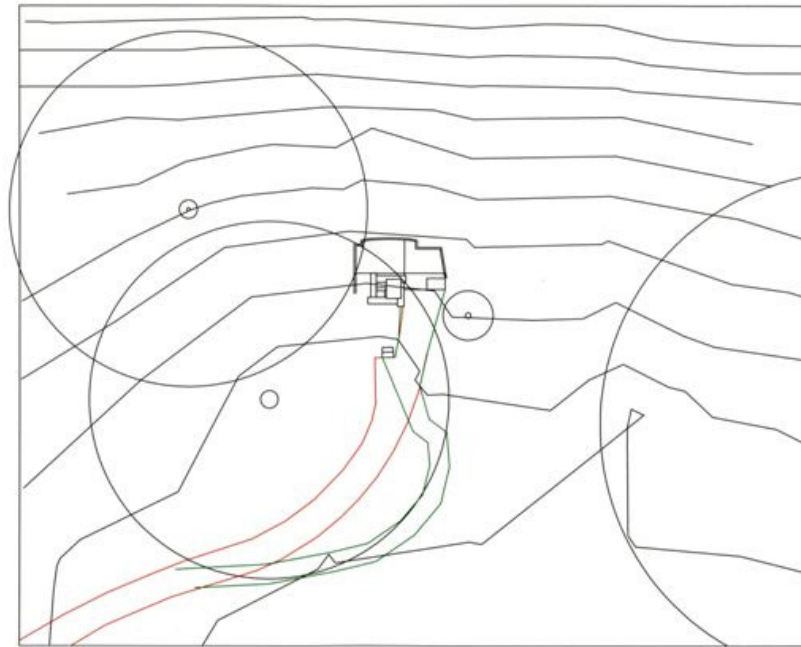
Artist's Plans To Install Overlook, Artwork and Path Within CRZ Of BSP Tree

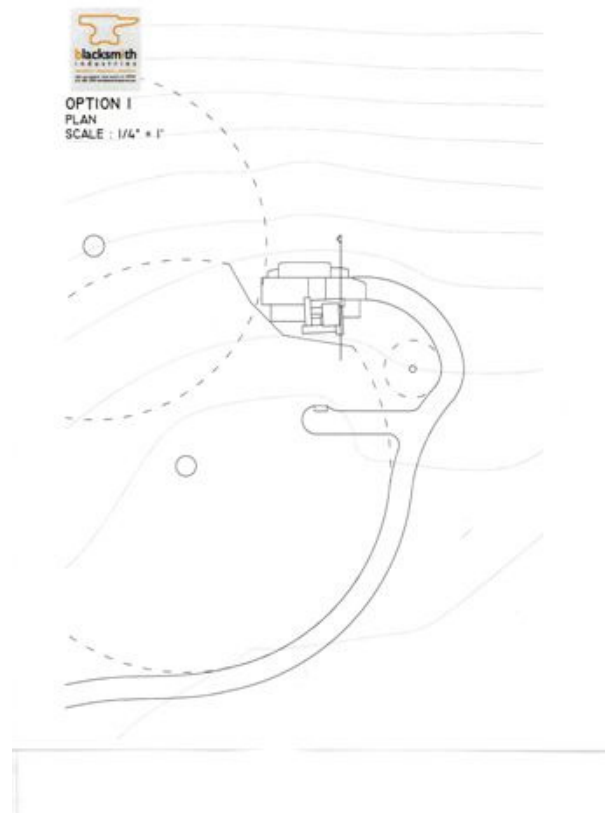
Another Version To Install Overlook, Artwork And Path Within CRZ Of BSP Tree
