**HISTORIC LANDMARK COMMISSION
JULY 30, 2012
NATIONAL REGISTER HISTORIC DISTRICT
NRD-2012-0090
Rainey Street
75.5 Rainey Street**

EXISTING FACADE CONDITIONS

PROJECT PROPOSAL AND SPECIFICATIONS

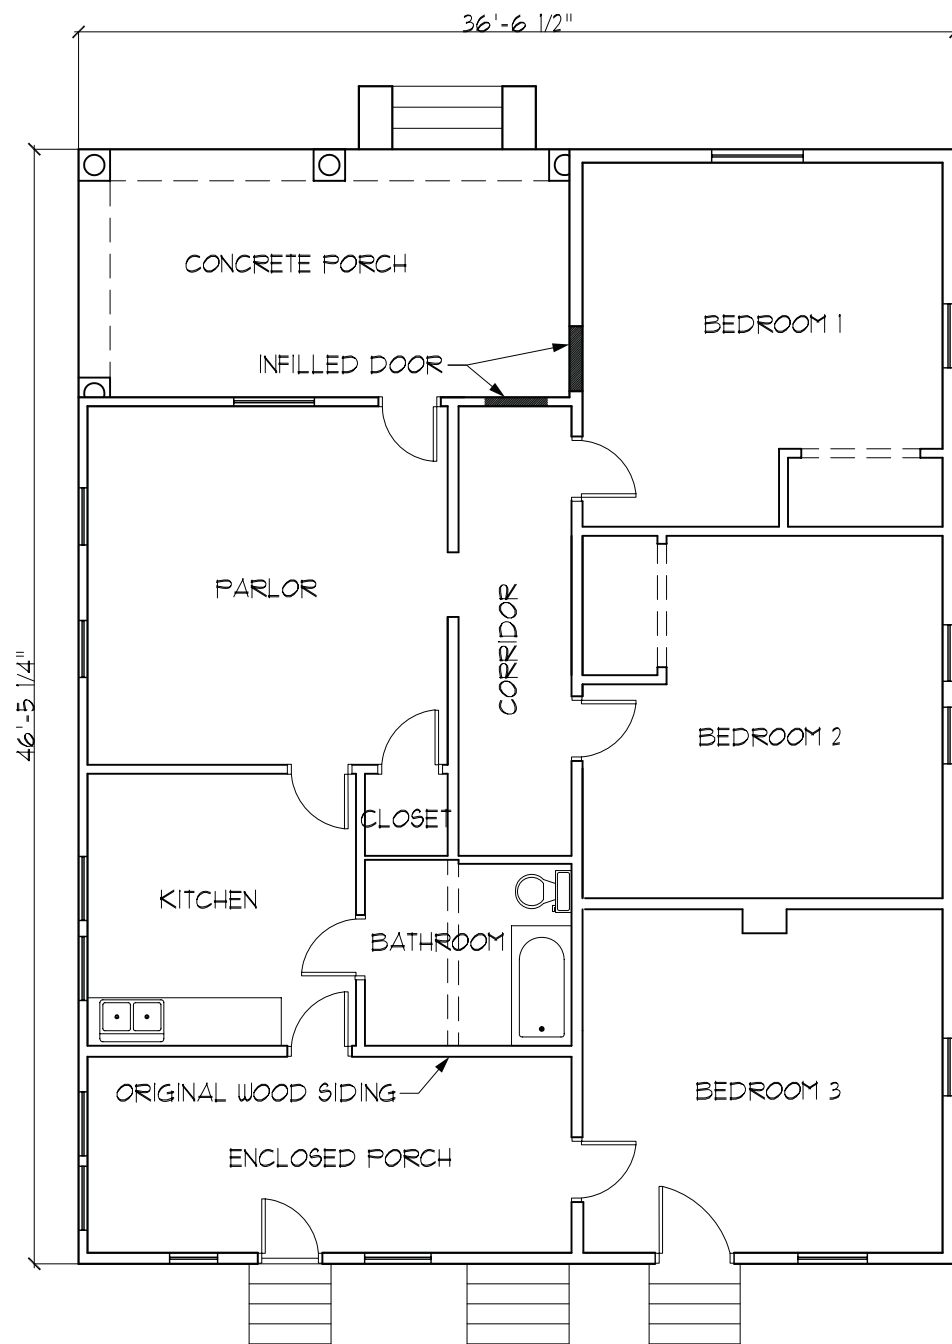
1. Differential settlement in this pier and beam framed structure has rendered most remaining original doors and windows inoperable
2. Water infiltration has caused widespread wood rot, and mold throughout the interior.
3. Interior walls are 2x4 frame with 1/2" gypsum that has been skim coated with plaster and painted.

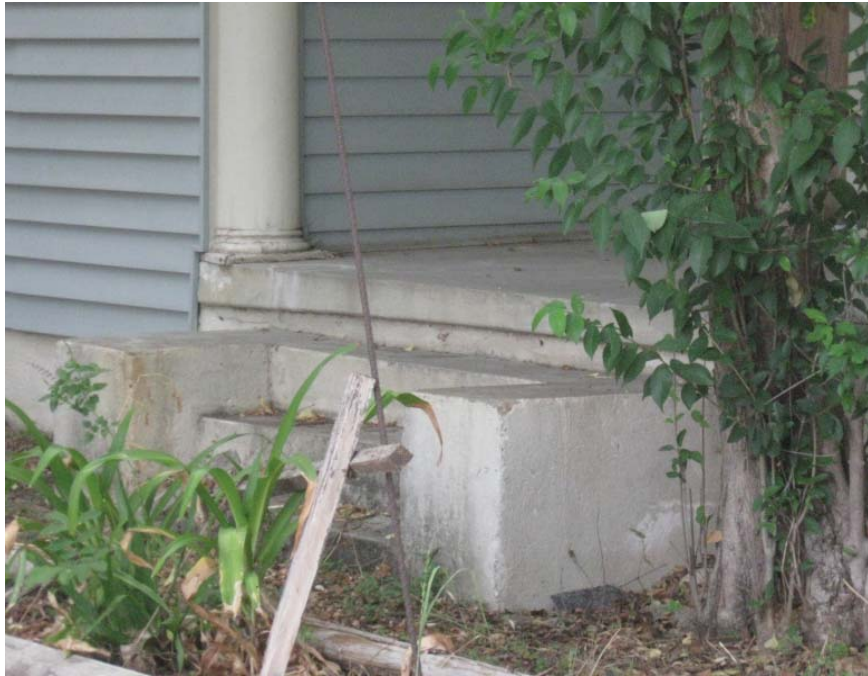
EXISTING STAIR NOT CODE COMPLIANT, TO BE REPLACED

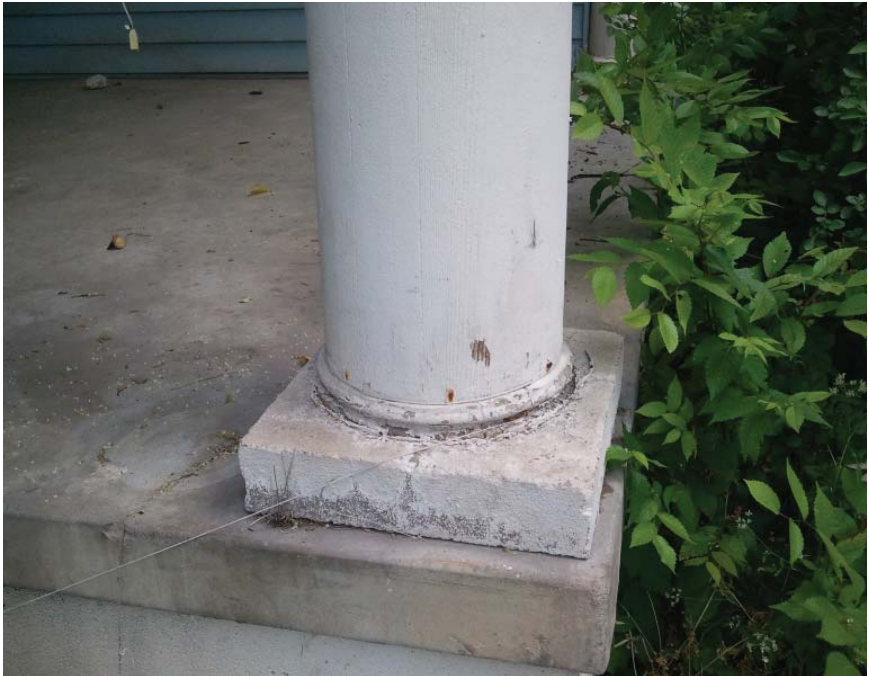
CONCRETE SLAB AND COLUMN BASE AT EXISTING PORCH

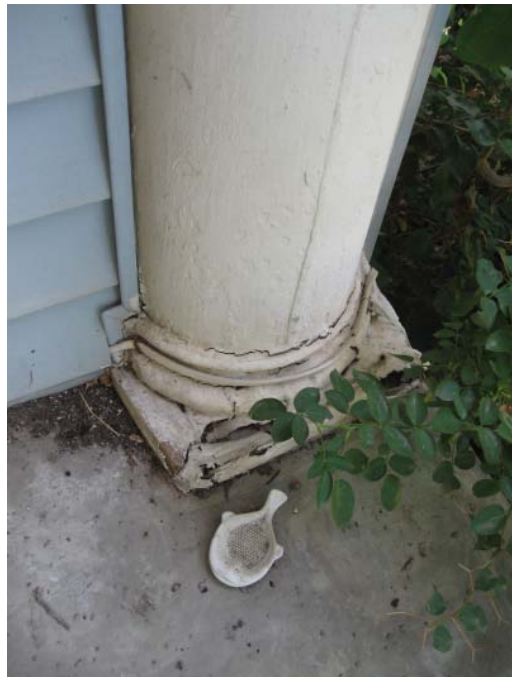
WOOD ROT AT BASE OF EXISTING PILASTERS

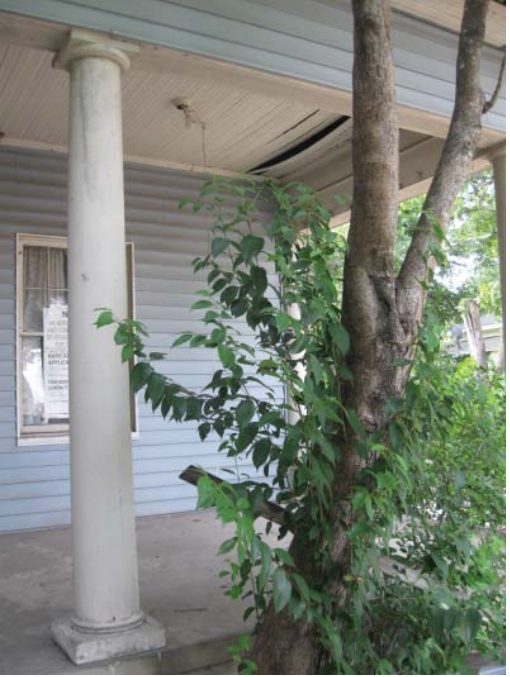
EXISTING ENCLOSED PORCH TO BE RENOVATED

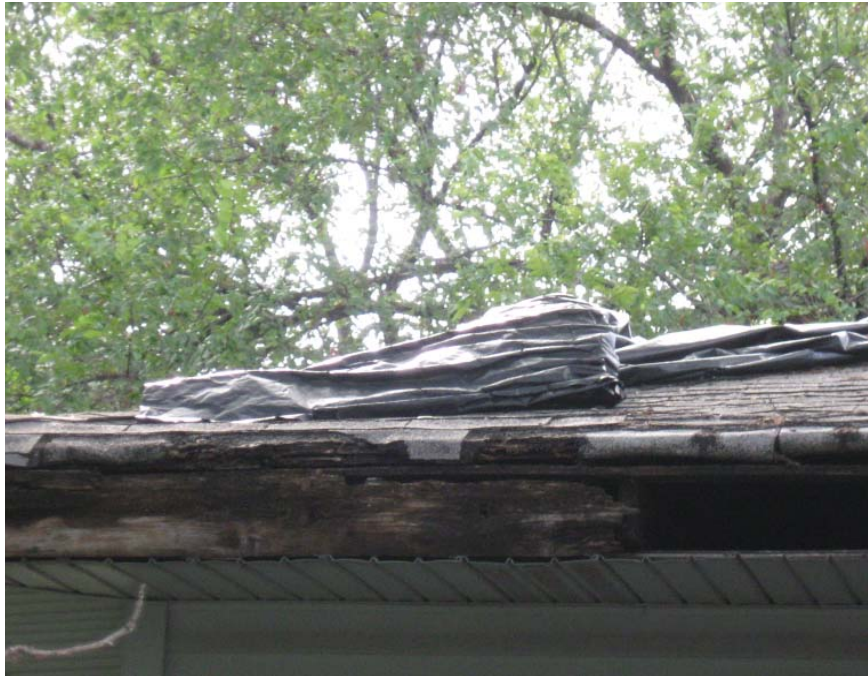
The location of doors and windows on the side and rear elevations will be revised to meet the functional requirements of the new occupant. The existing roof material and wood framing are in very poor condition due to substantial and long-term water damage. The applicant proposes to reconstruct the hipped roof with an identical slope and eave condition as currently exists, but will install metal roofing material.

TYPICAL CONDITION AT EXISTING ROOF AND FASCIA

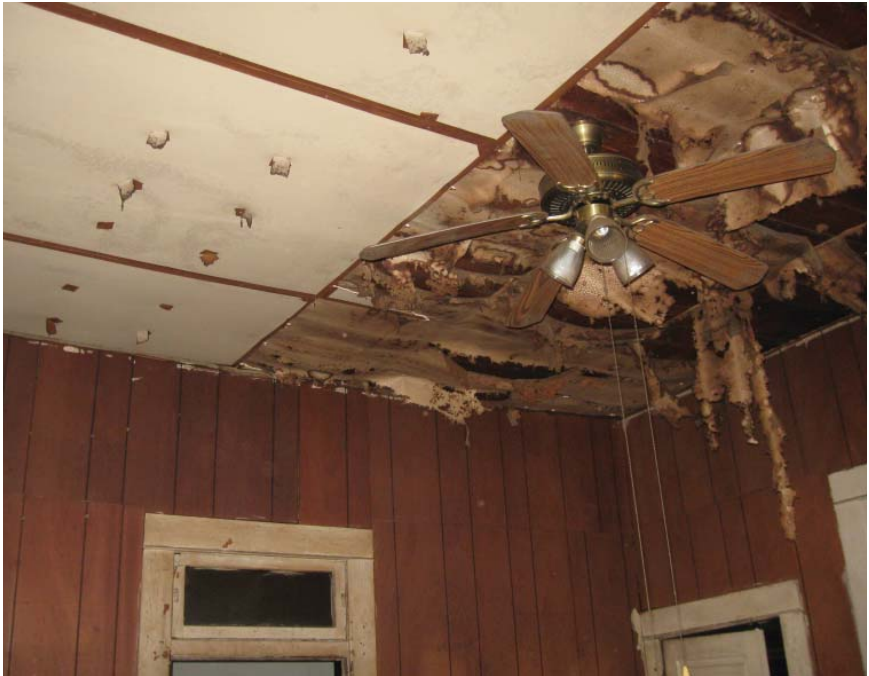
WATER DAMAGE AT INTERIOR CEILING

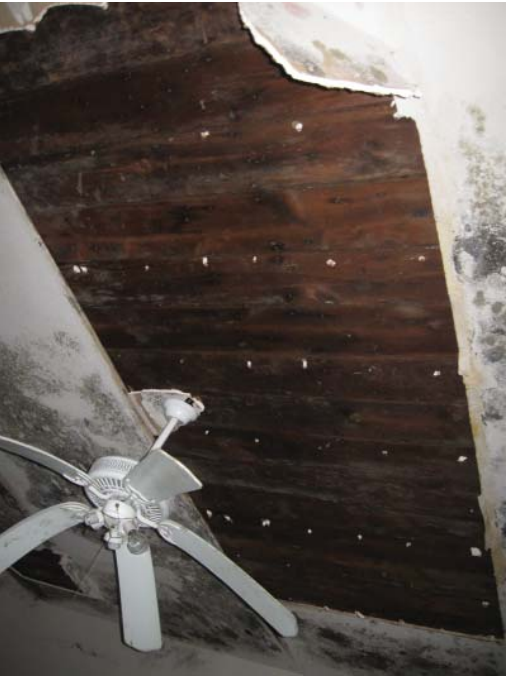
WATER DAMAGE AT INTERIOR CEILING

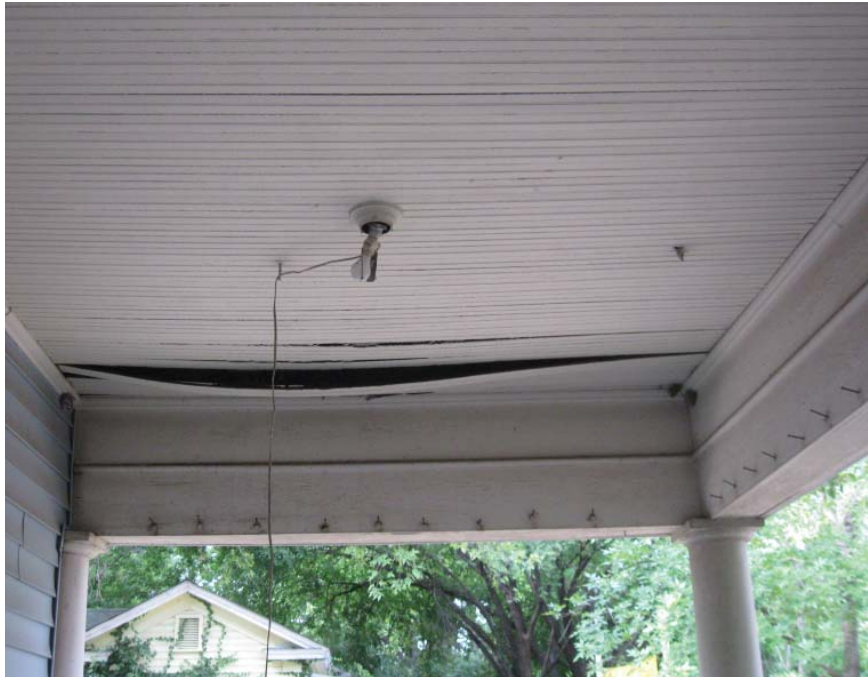
WATER DAMAGE AT CEILING OF EXISTING PORCH

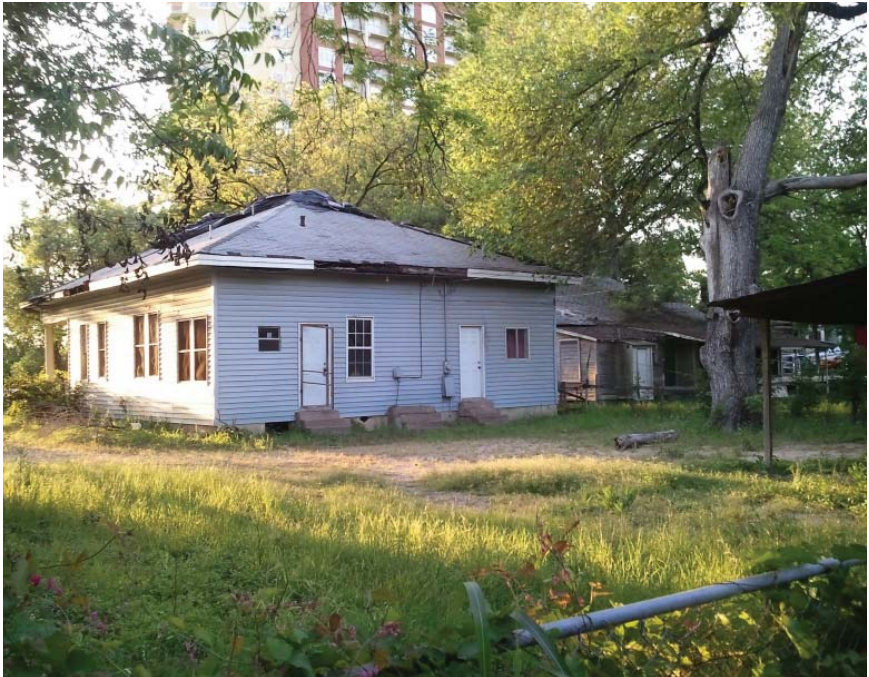
EXISTING ROOF TO BE REPAIRED

Roof is currently covered with tarp to prevent further damage

The existing roof material (composite shingles) and wood framing are in very poor condition due to substantial and long-term water damage. The renovation will reconstruct the hipped roof shape, with an identical slope and eave condition. However, the new occupants would like to utilize a metal roof (Tennessee ‘V’ groove) in lieu of shingles. The available historical information about this building does not indicate or document the original roof material. Further, it is relatively common for a house of this vintage and style to have an original metal roof, or to have one over the course of its history.

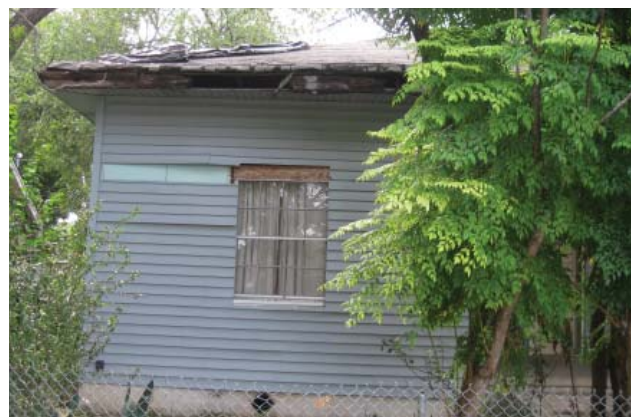
Replacement window, see elevation window #1

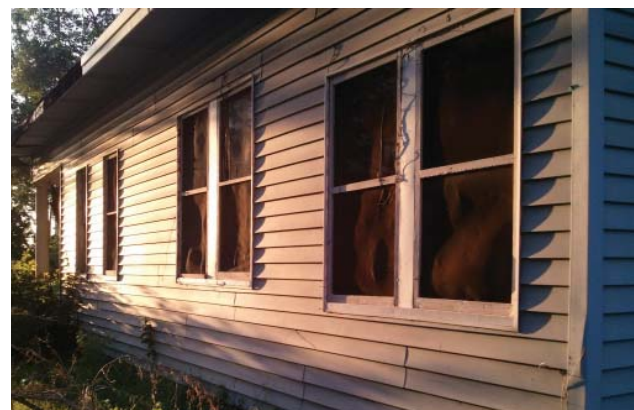
Replacement window, see elevation window #2,#3

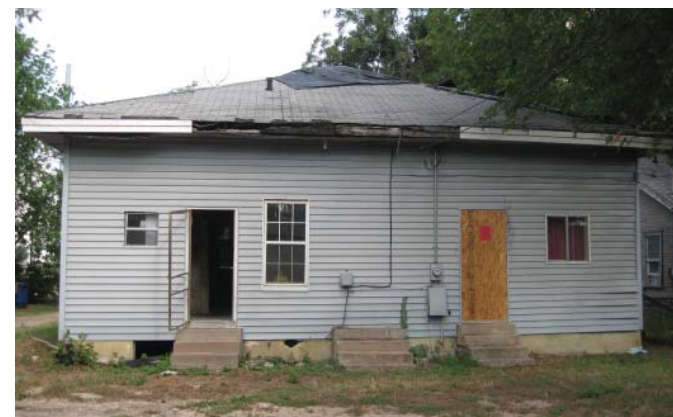
Replacement windows, see elevation window #4,#5,#6

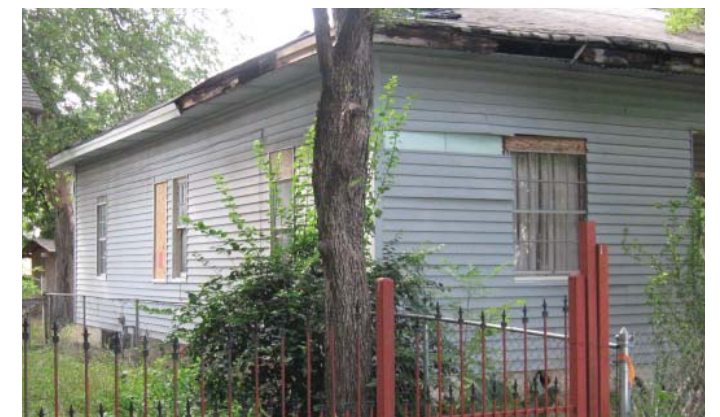
Replacement windows, see elevation window #7,#8,#9
