Application for Certificate of Appropriateness for a City Landmark or Local Historic District

Mayfield Park
Erosion Control &
Wall Stabilization
Plan Overview

Mayfield Park
Erosion Control &
Wall Stabilization
Plan Sketch

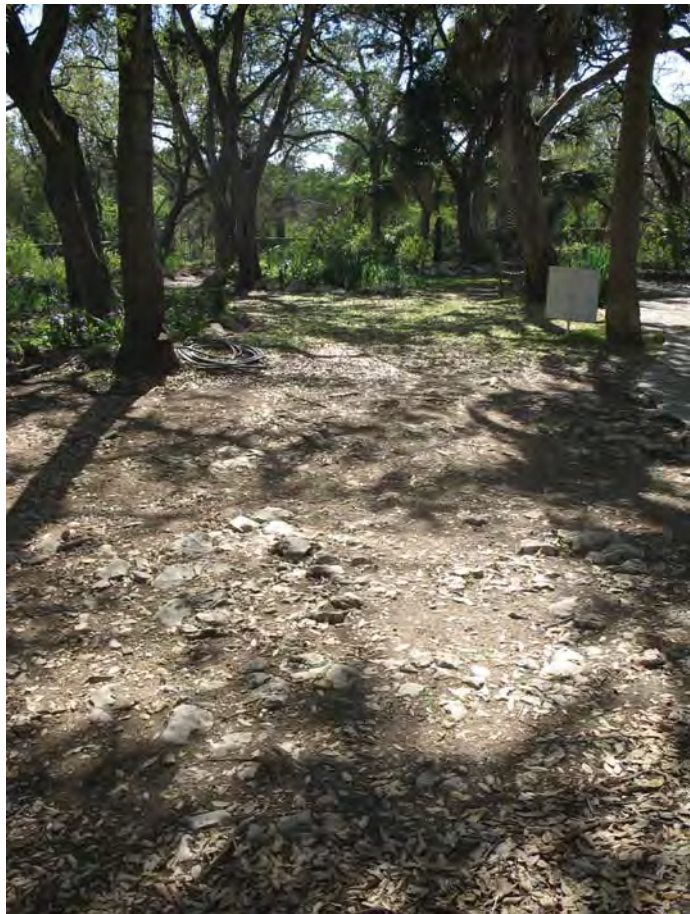
View facing West from Arch: erosion exposing stones and rock subgrade

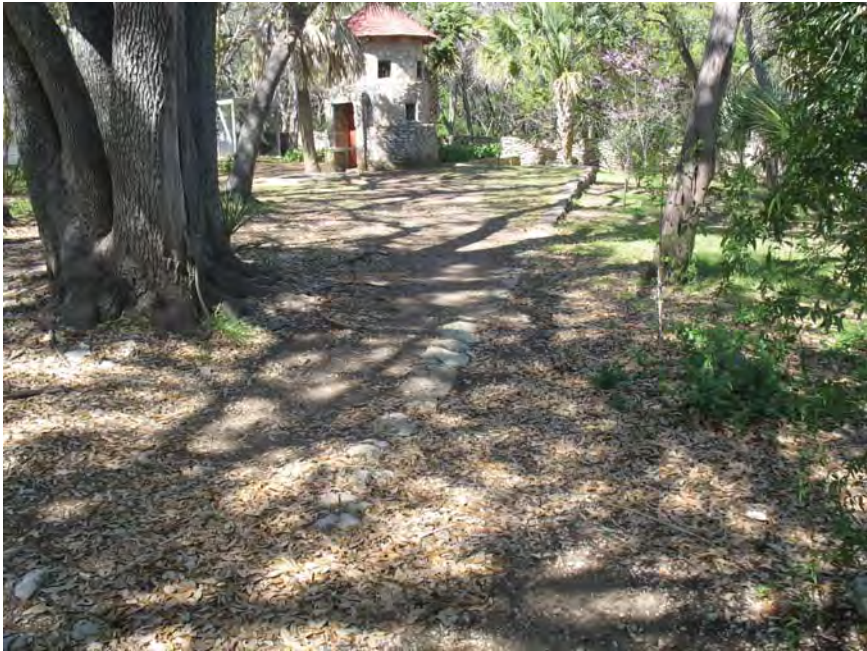
View facing North from Arch of stone wall remnants requiring reconstruction to prevent further site erosion

Existing wall to be repaired to match historic condition. (approximately 47' of wall at 9"-15" height). Verify extent of work and wall heights in field with Landscape Architect. Contractor to provide stone and mortar samples for Landscapes Architects review prior to installation.

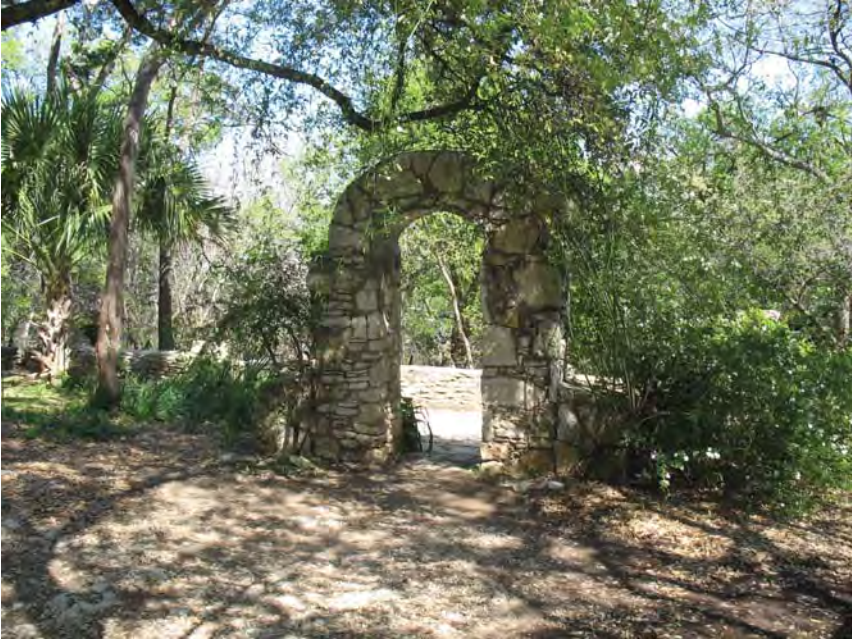
View facing East toward Arch-- erosion exposing stones and depositing soil into archway/overlook area

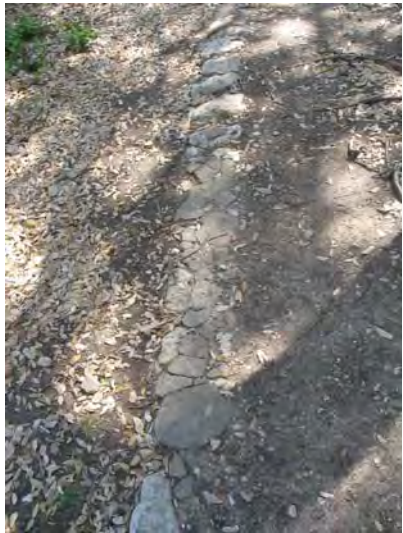
Close-up of wall remnants requiring reconstruction to prevent further site erosion

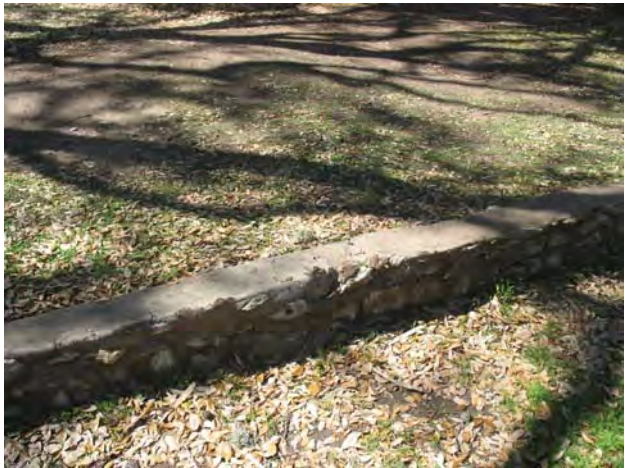
Close-up of existing wall in historic condition. Wall reconstruction to match

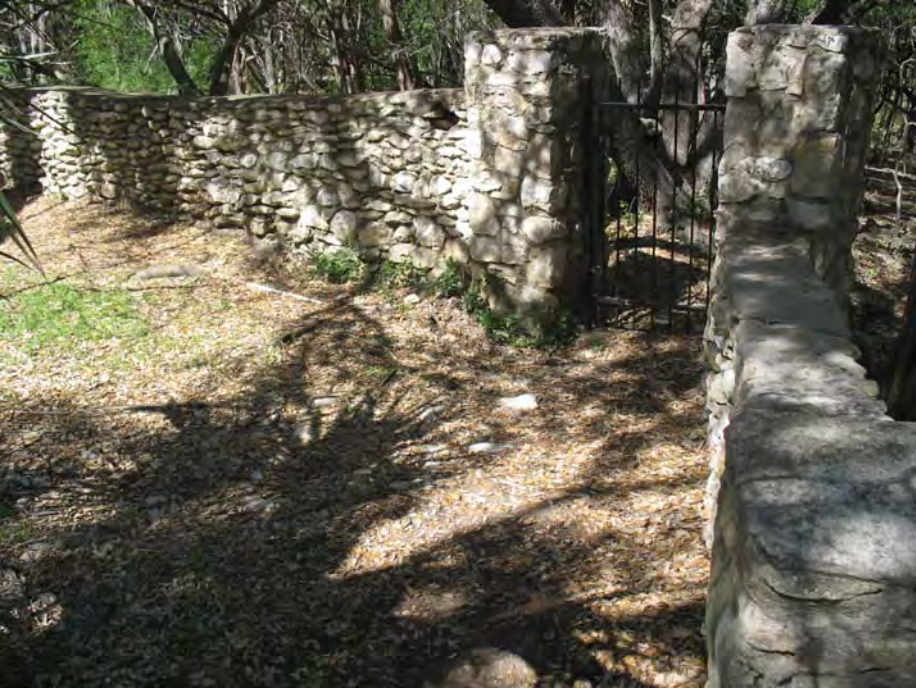
View facing North toward NE Gate -- erosion exposing irrigation pipes, roots, and depositing soil beyond gate

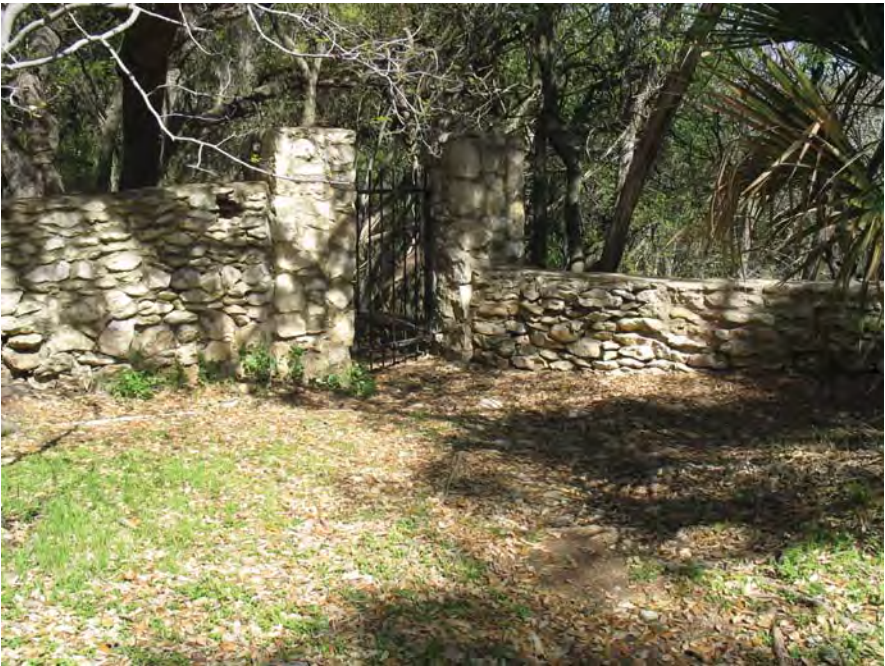
View facing East toward NE Gate -- erosion exposing irrigation pipes, roots, and depositing soil beyond gate
