Mayfield Park
Erosion Control &
Wall Stabilization
Plan Sketch

L1.01

3/21/13

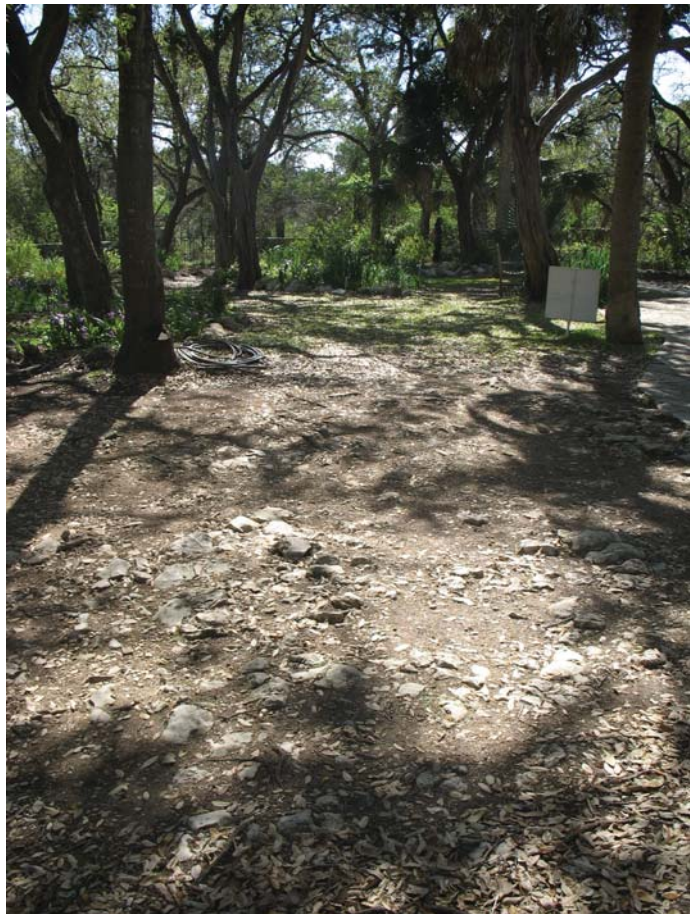
View facing West from Arch: erosion exposing stones and rock subgrade

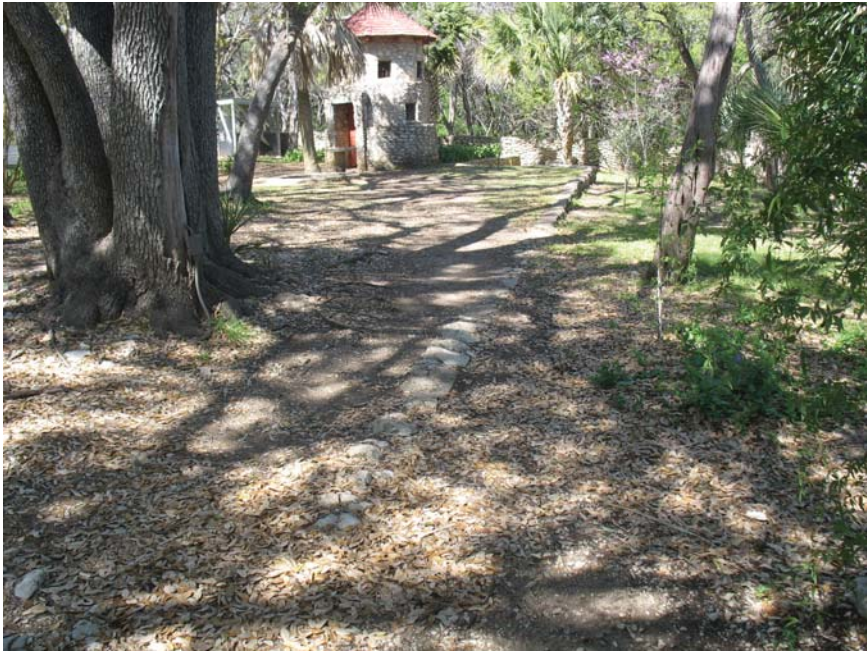
View facing North from Arch of stone wall remnants requiring reconstruction to prevent further site erosion

Existing wall to be repaired to match historic condition. (approximately 47' of wall at 9"-15" height). Verify extent of work and wall heights in field with Landscape Architect. Contractor to provide stone and mortar samples for Landscapes Architects review prior to installation.

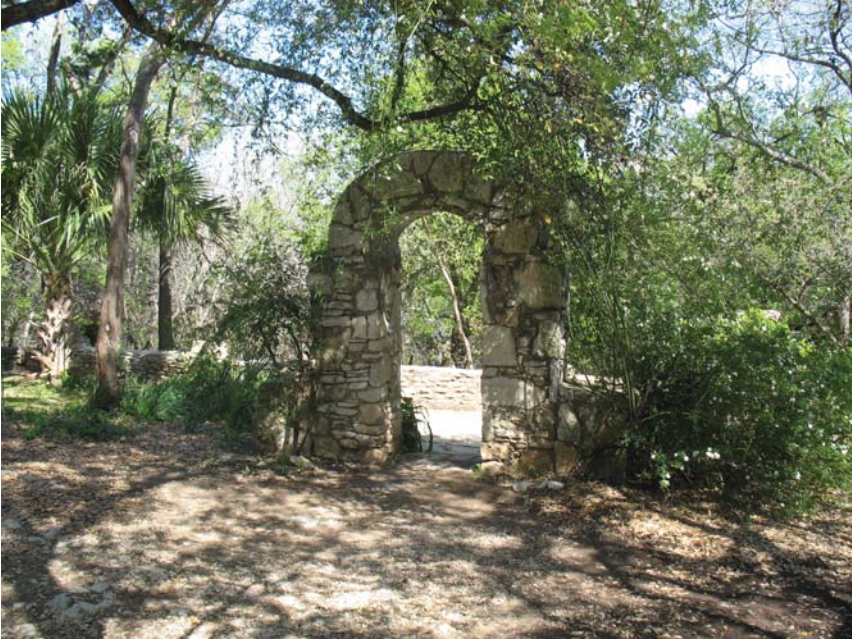
View facing East toward Arch-- erosion exposing stones and depositing soil into archway/overlook area

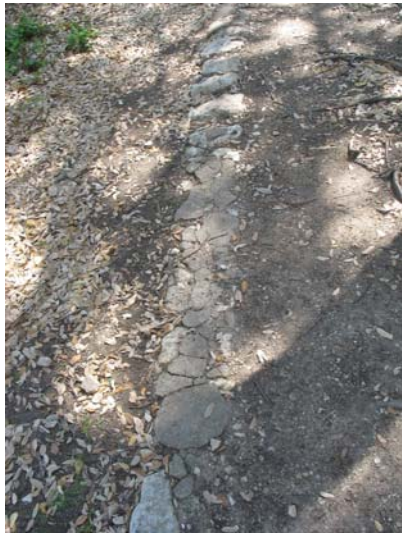
Close-up of wall remnants requiring reconstruction to prevent further site erosion

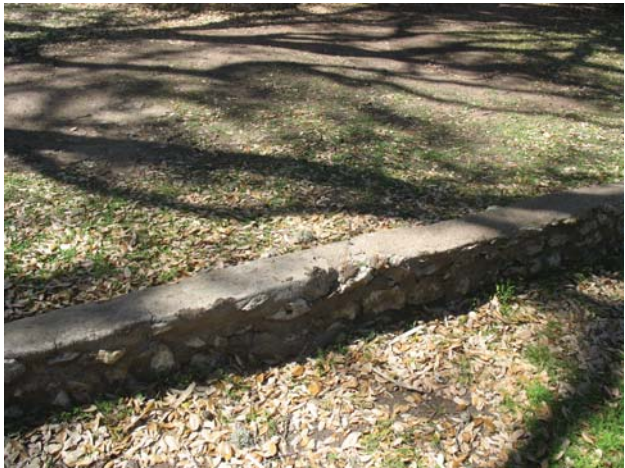
Close-up of existing wall in historic condition. Wall reconstruction to match

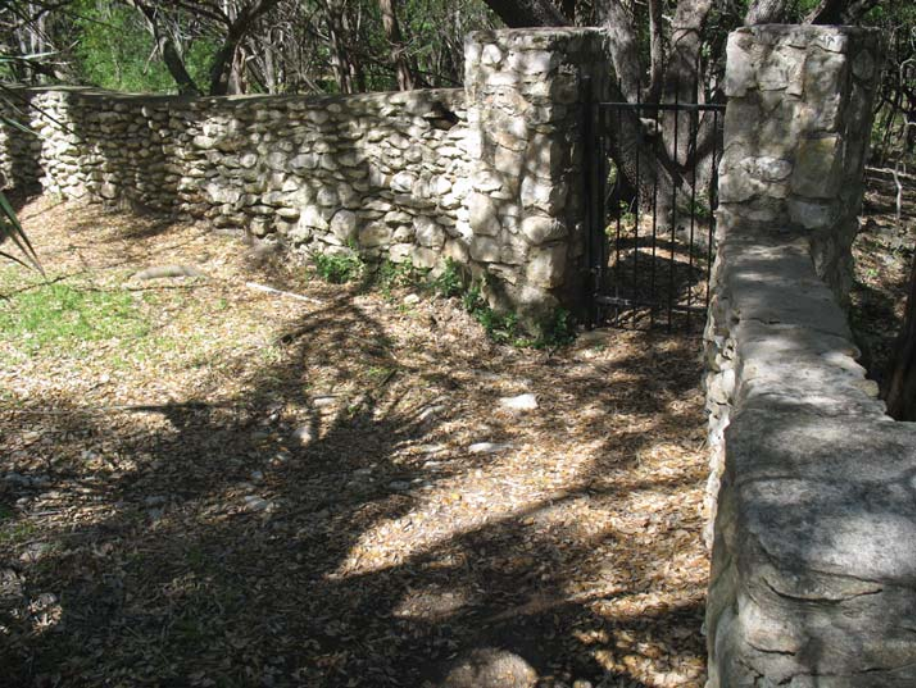
View facing North toward NE Gate -- erosion exposing irrigation pipes, roots, and depositing soil beyond gate

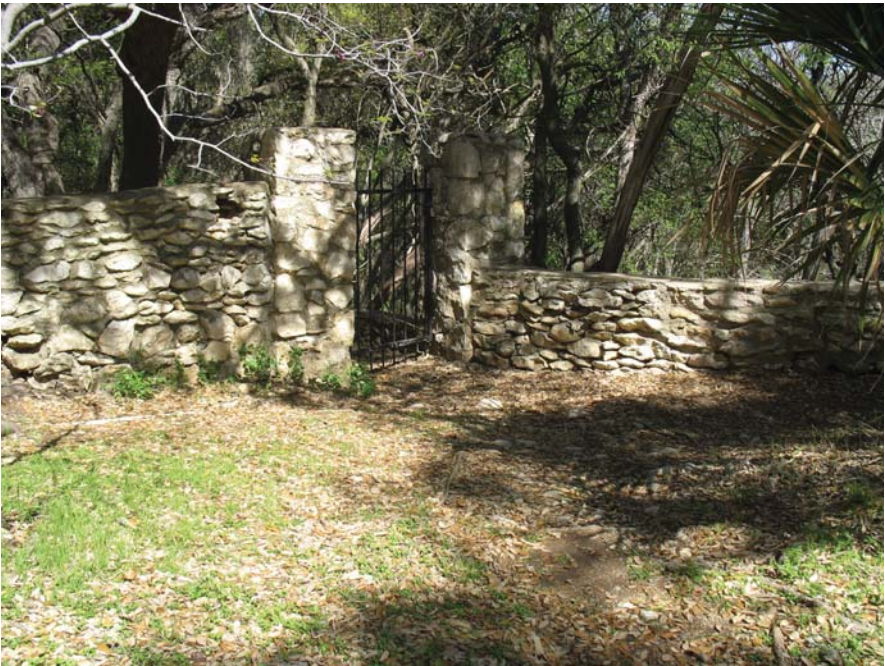
View facing East toward NE Gate -- erosion exposing irrigation pipes, roots, and depositing soil beyond gate
