From: R Krivoniak ~~City of Austin~~
Sent: Friday, July 11, 2014 3:48 PM
To: Heldenfels, Leane
Cc: tony sandefur
Subject: Case# C16-2014-0010 or 501 E. Oltorf
Attachments: Retaining wall str letter.pdf; Ret Wall Kaplan Letter to Neighbor 11 14 2011.pdf

Project: The District at SoCo
501 East Oltorf Street
Austin, Texas

Subject: Structural Engineering Inspection Letter-

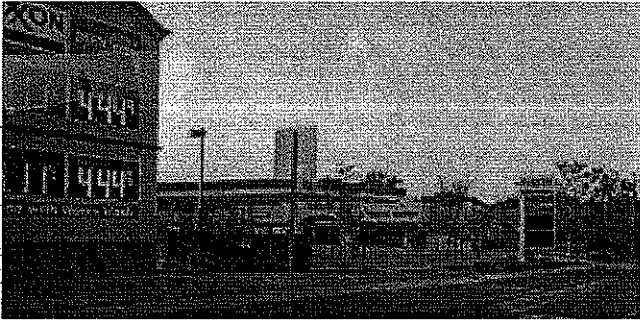
As the owners of duplexes at 500 and 502 Long Bow Lane, immediately behind the District at SOCO apartment complex at 501 E. Oltorf, we are opposed to the granting of a variance for a larger sign currently being sought by the project's management/owners. We encourage the Sign Review Board to enforce the City of Austin's sign ordinance. The existing sign is quite unattractive and is a perfect example of the reason the City of Austin has a need for a sign ordinance - to provide some aesthetic protection from such commercialization. Sadly, the sign ordinance is often quite weak, evidenced by the multiple glaring examples around town that should not be allowed.

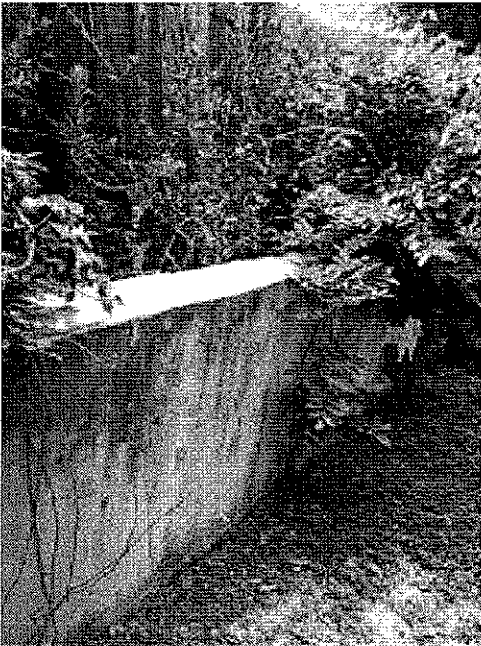
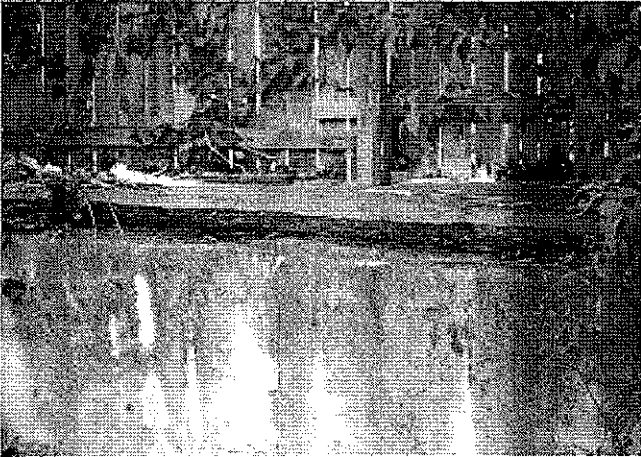
1. We requested assistance from Development Review and Code Enforcement during the construction of the District at SOCO regarding their severely leaning retaining wall that abuts several Long Bow Lane lots along the rear property lines. Even after meeting with the engineers representing SOCO, nothing was done. Exacerbating the retaining wall's unsightly appearance, the fence built a few feet back from their property line atop of wall created a "no man's land" of trash (which can realistically only come from their property) and weeds that we cannot easily reach. And, it's not our property to maintain!

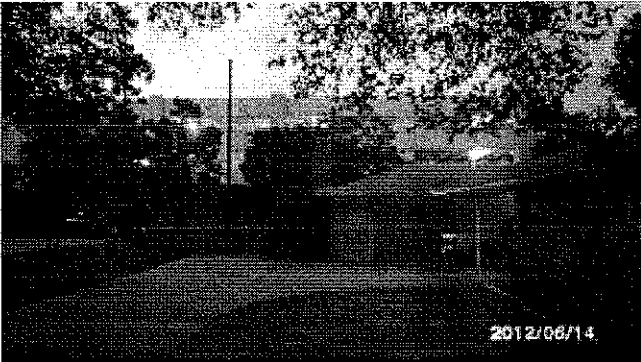
2. Interior lighting from the SOCO parking garage shines directly onto the bedroom windows of our and other duplexes along Long Bow Lane. We complained about this before the project was even finished, but apparently City ordinance only requires the shielding of the garage's "exterior" roof-level lights.

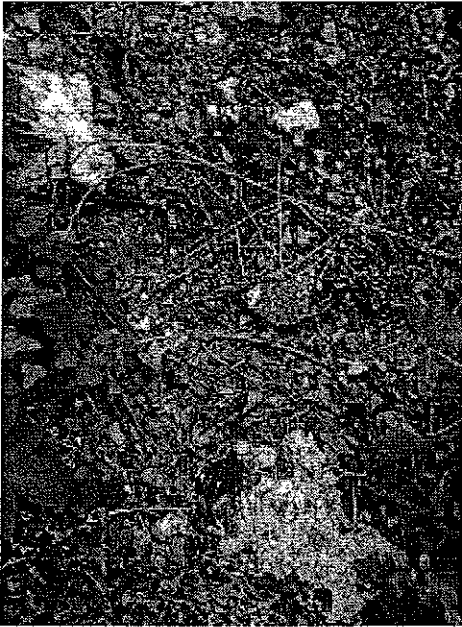
3. All stormwater runoff from this project was to be retained and released slowly on the Oltorf side to flow into the creek a bit further east. However, runoff from the SOCO rear setback field still flows under the fence at the northwestern end of 500 Long Bow, causing erosion onto our property.

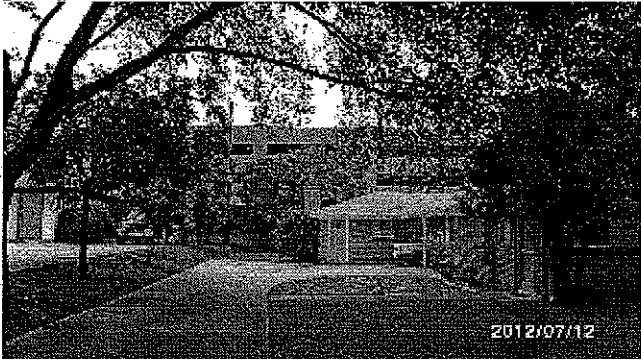
4. Over our objections, the rear face of the parking garage was painted a garish green. We requested that ANY of the colors used elsewhere on the project would be far preferable. It remains quite an eyesore from our perspective.
