**HISTORIC LANDMARK COMMISSION
JULY 27, 2015
DEMOLITION AND RELOCATION PERMITS
HDP-2015-0467
1613 CANTERBURY STREET**

PROPOSAL

Demolish a ca. 1908 house.

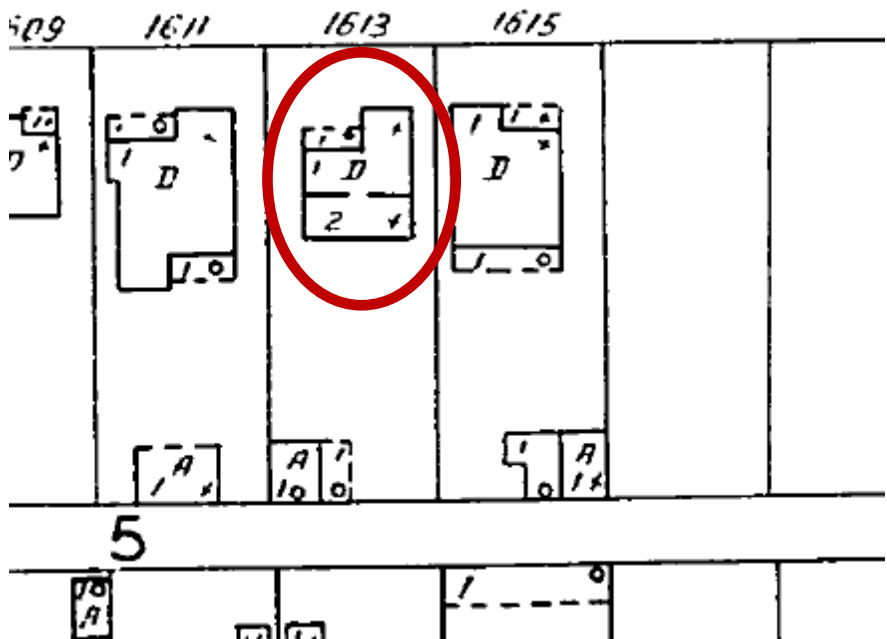
The 1935 Sanborn map shows the 2-story addition to the house.

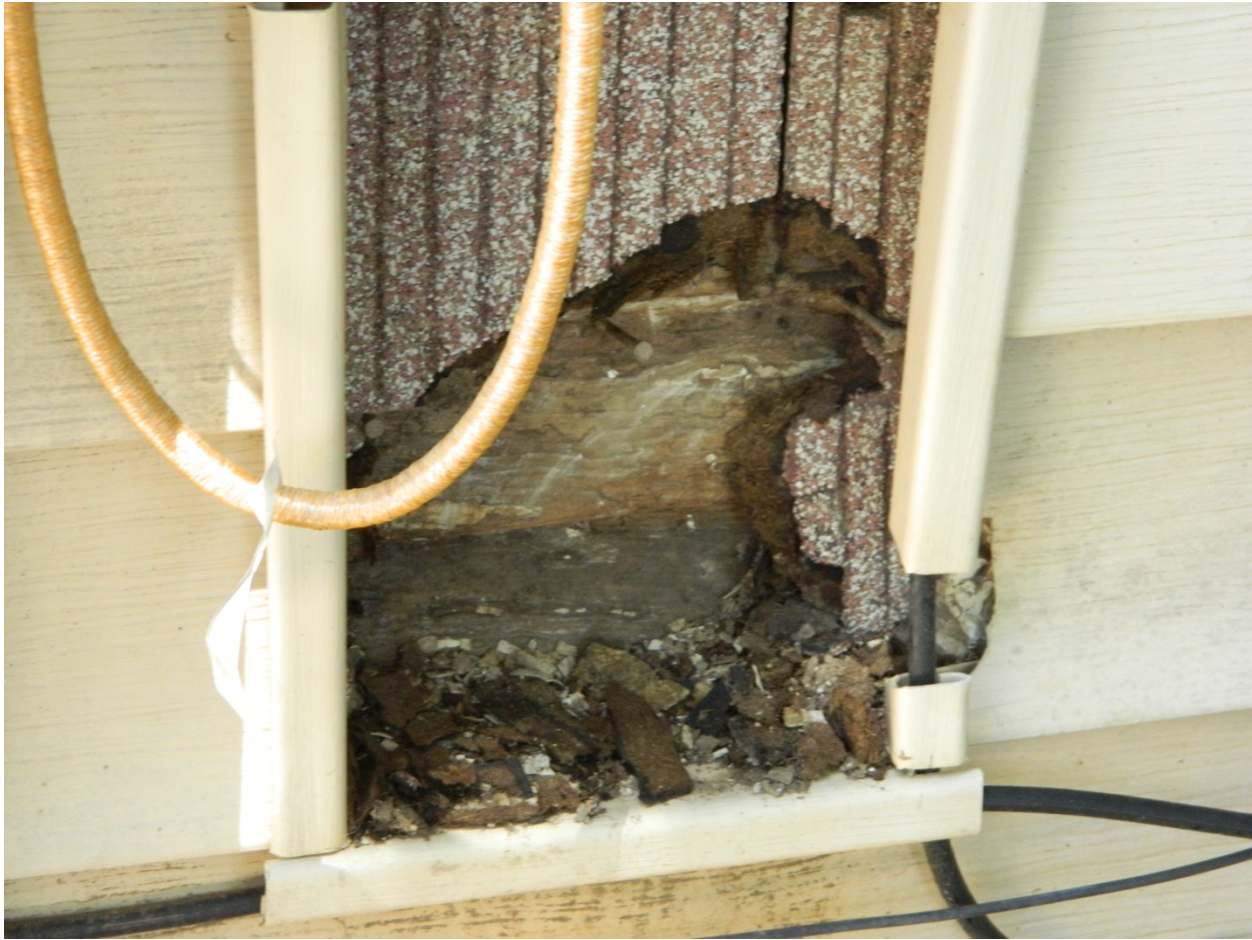
The house is not listed in any City survey. It has vinyl siding on top of asphalt siding, on top of wood, which appears to be very deteriorated. Many of the original windows have been replaced with metal windows.

Staff photograph taken July 17, 2015 showing the vinyl siding, with asbestos siding underneath, and the condition of the original wood siding of the house.

The exterior walls of the residence are covered with vinyl siding over insulation board glued to the original wood siding. At one location there are asphalt shingles attached to the face of the wall below the insulation. The condition of the siding could not be determined although it is suspected there are decay problems with the siding due to the absence of a vapor barrier.

The renovation of the exterior will be extensive. All vinyl siding, foam board, asphalt shingles and original wood will need to be removed. The usable original wood siding will need to be sanded and repaired prior to paint. All vinyl windows will need to be replaced with wood windows matching the original time period. All soffits will need to be replaced as will the existing roof. The roof will also require repair due to existing water damage from leaks. Estimated cost is:

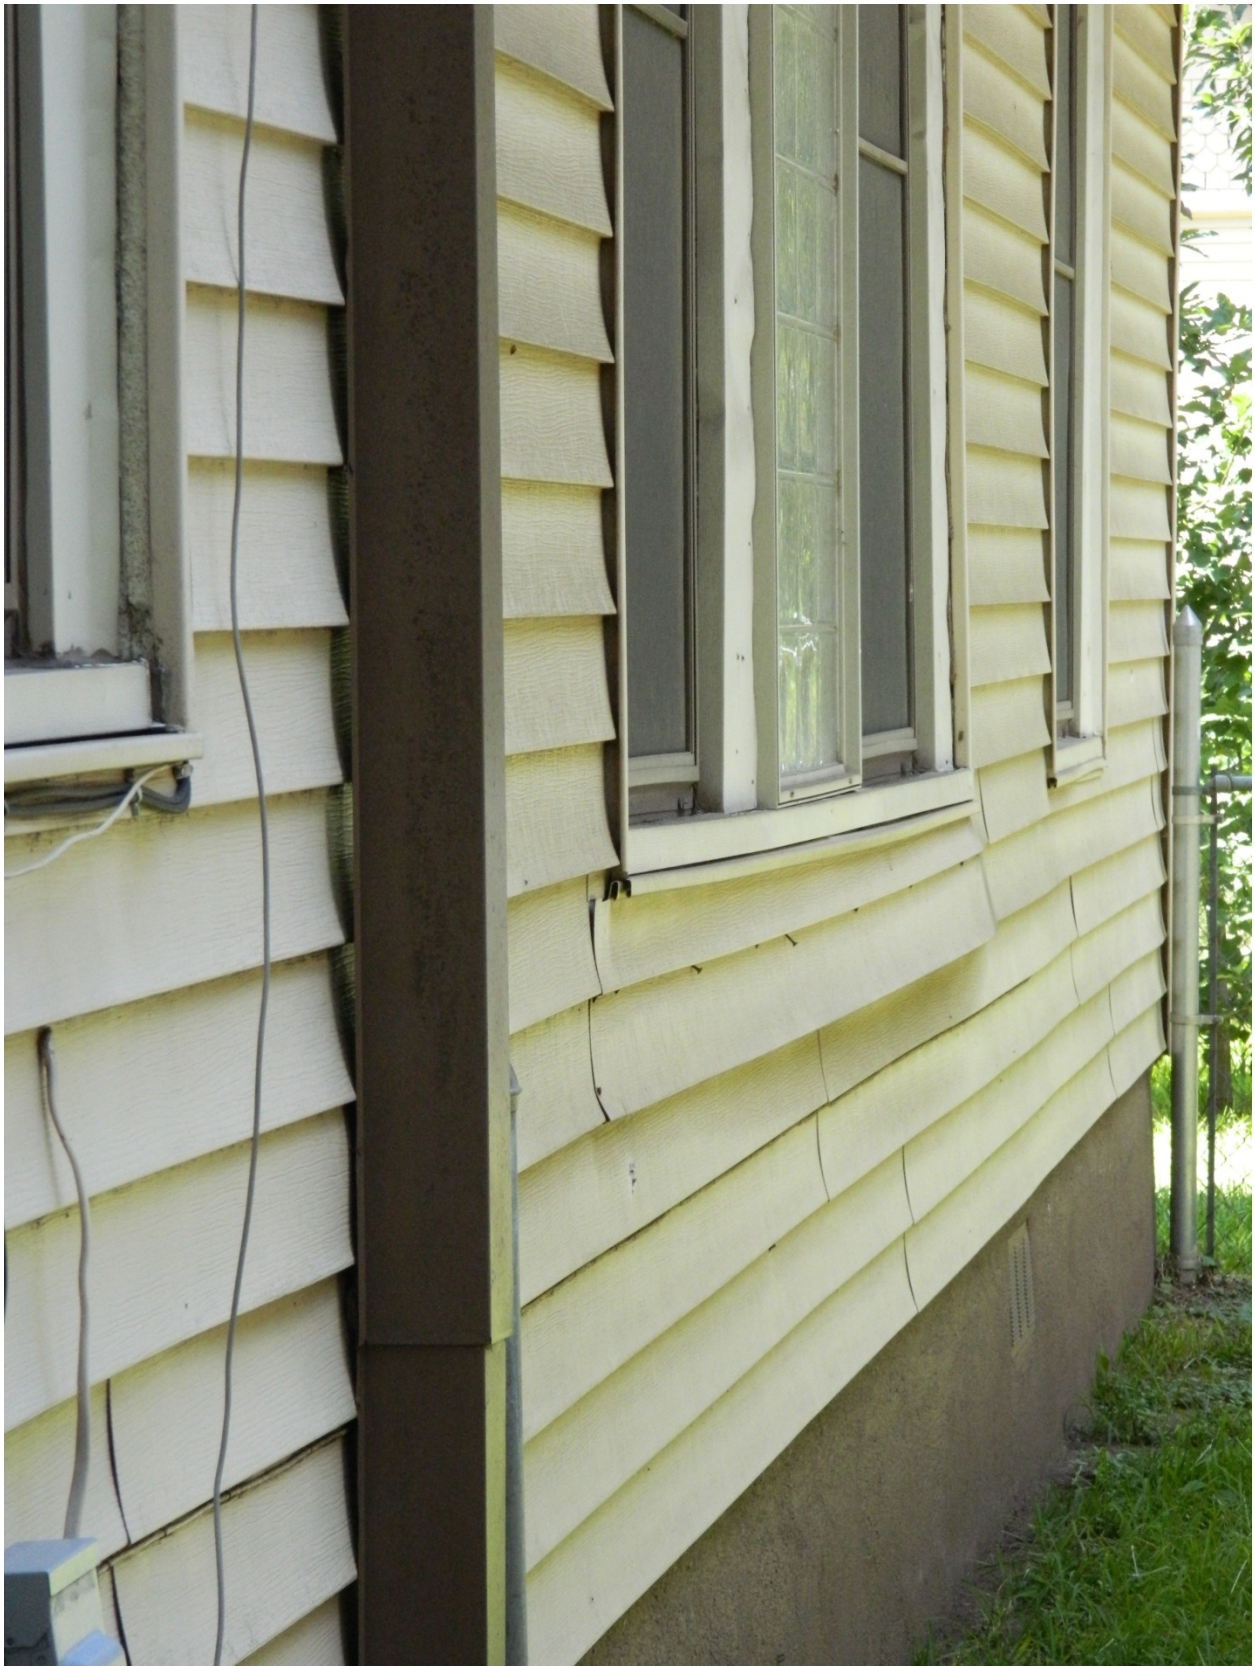
Staff photograph taken July 17, 2015 showing the condition of the vinyl siding on the house.
