Table of Contents for Carpenter Hall Site Plan
Heritage Tree Variance Package

ITEM FOR ENVIRONMENTAL COMMISSION AGENDA

SITE PLAN #: SP-2016-0073

Tree Risk Assessment Report

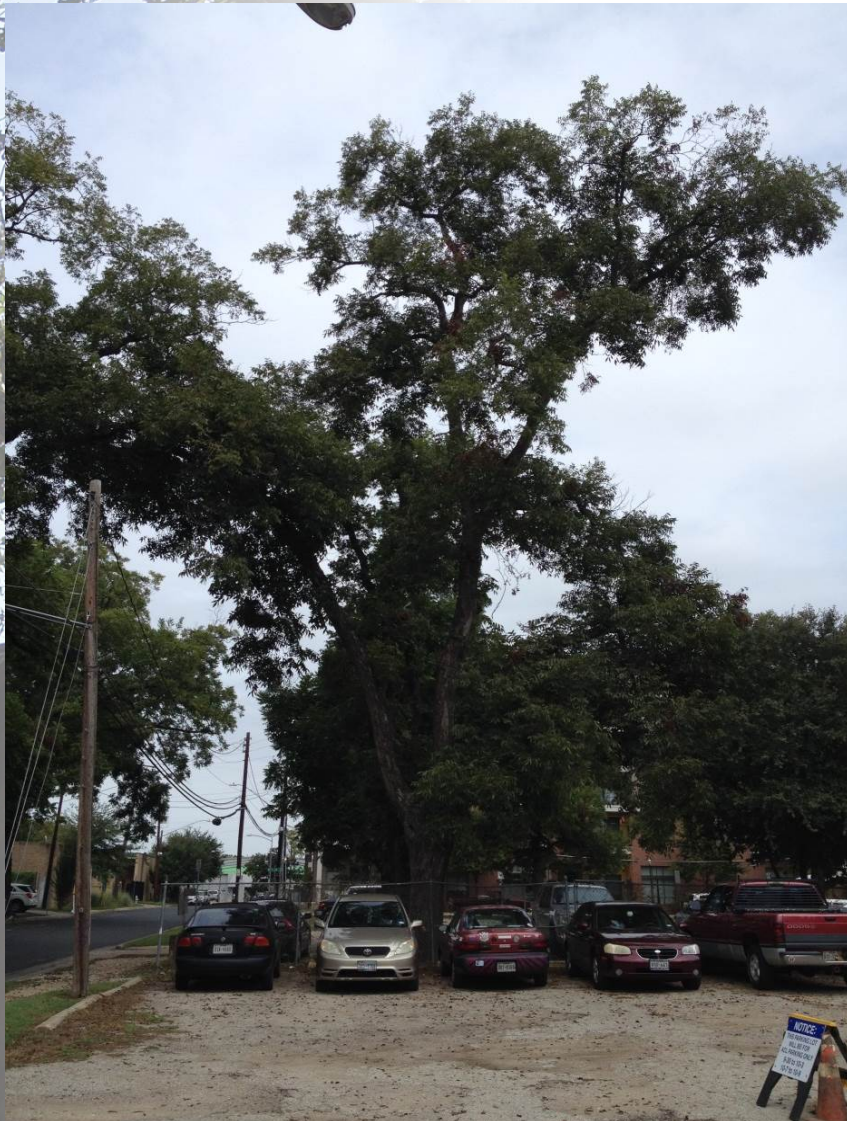
Both canopies display minor to major asymmetry as a result of prior limb failures (Exhibit 1). Storm damage is evident in the canopy as most leaders have abrupt termination of the tapering to branches (Exhibit 2). Tree #908 displayed a heightened

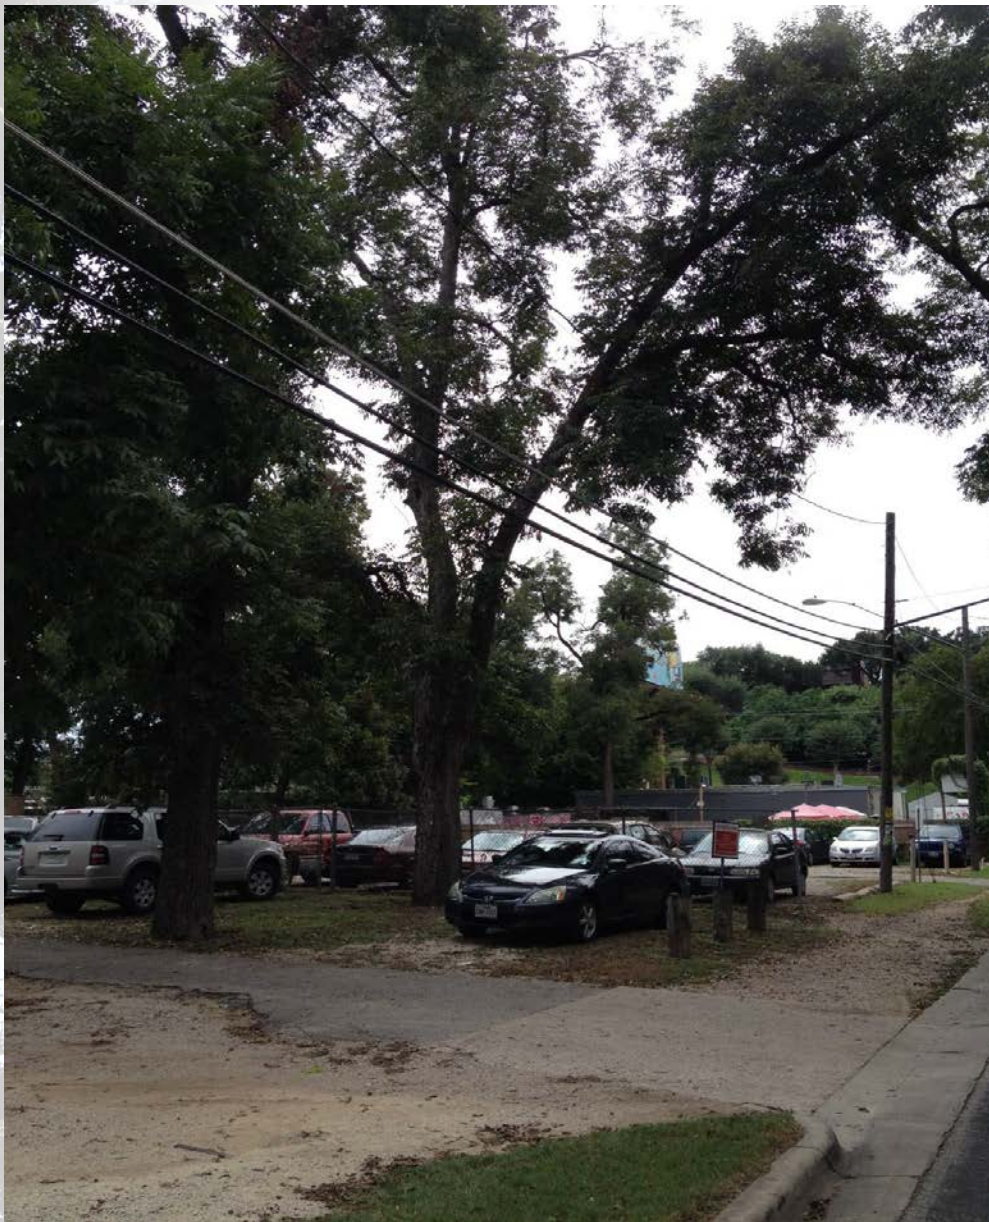
Exhibit 3

loading on the stems as a result of the length and excessive end weight on the branches (Exhibit 3).

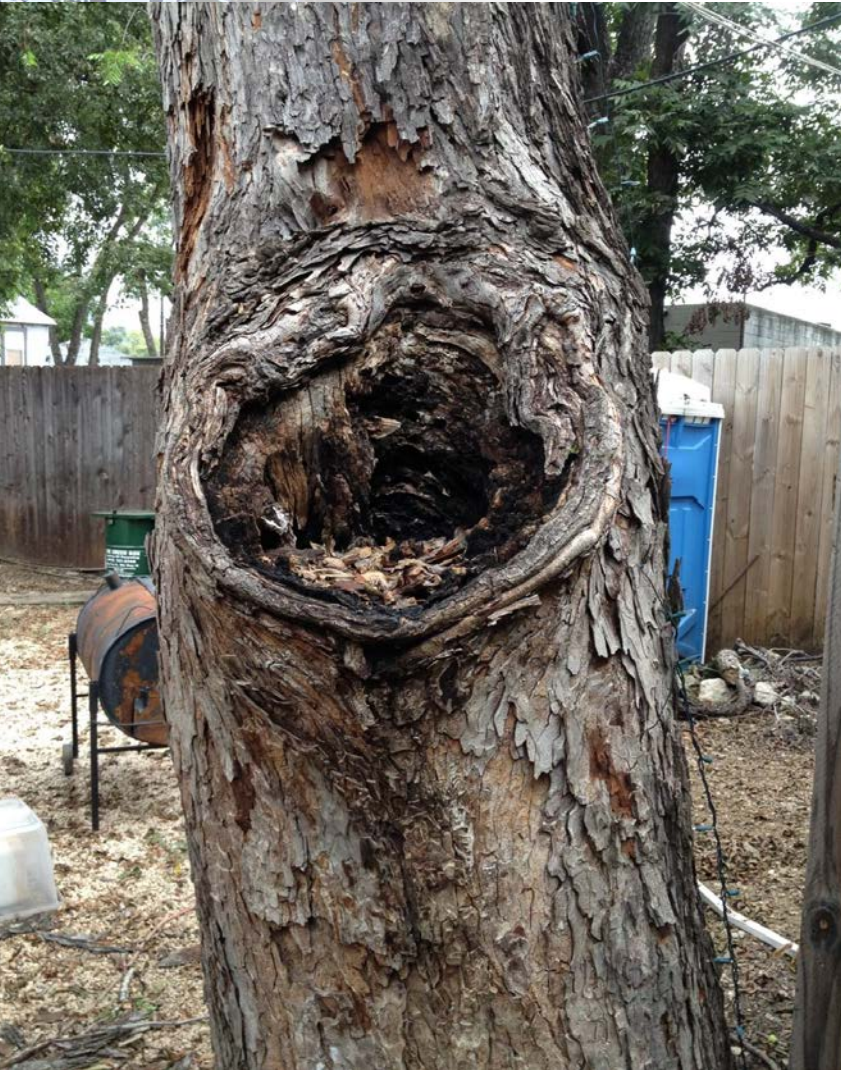
There is a 2'x2' wound and cavity on tree #919 and a small cavity is present just above the lateral union of tree #908 (Exhibit 4).

Tree #919 is likely hazardous due to: (1) the location and size of the cavity, and (2) the cavity occurs in the plane of the lean away from upright further compromising the mechanical integrity of the trunk to remain upright. Tree #908 is in fair condition. More details on the overall condition can be found in the City Arborist Tree Evaluations (Exhibit 7).

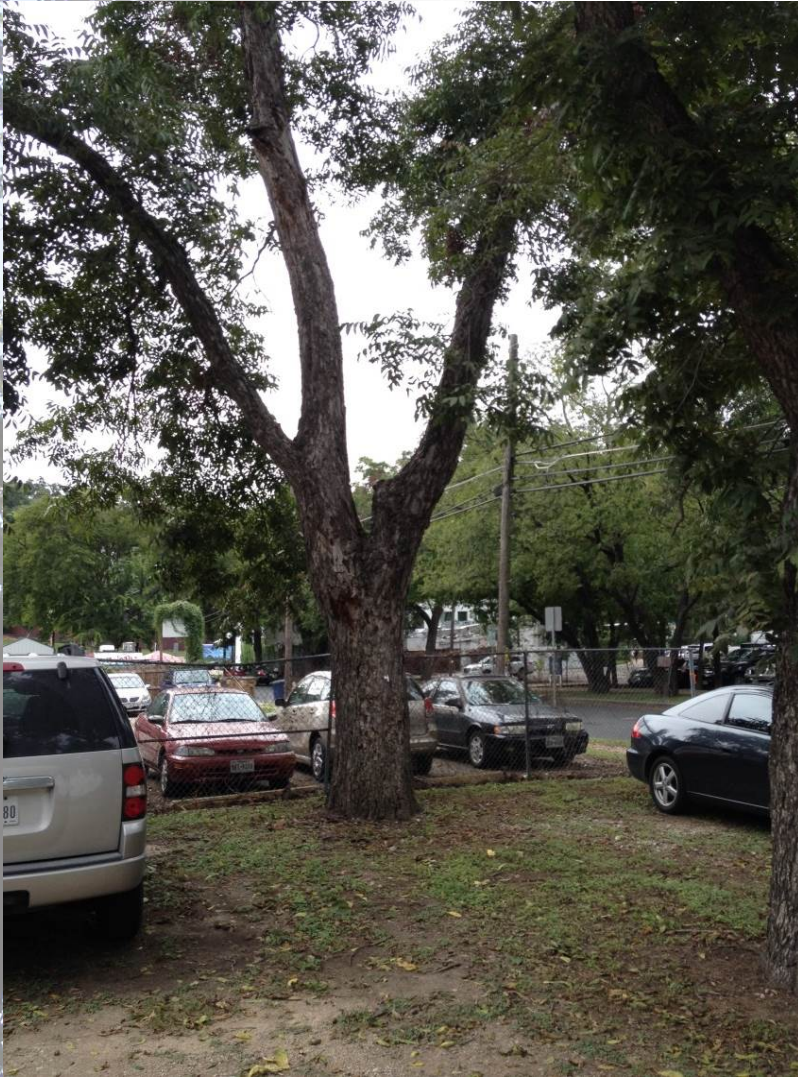
Tree # 908

Both root systems are entirely covered with disturbed and compacted cover (Exhibit 5). Tree #919 has been buried to an unknown depth as the root flare is not visible (Exhibit 6).

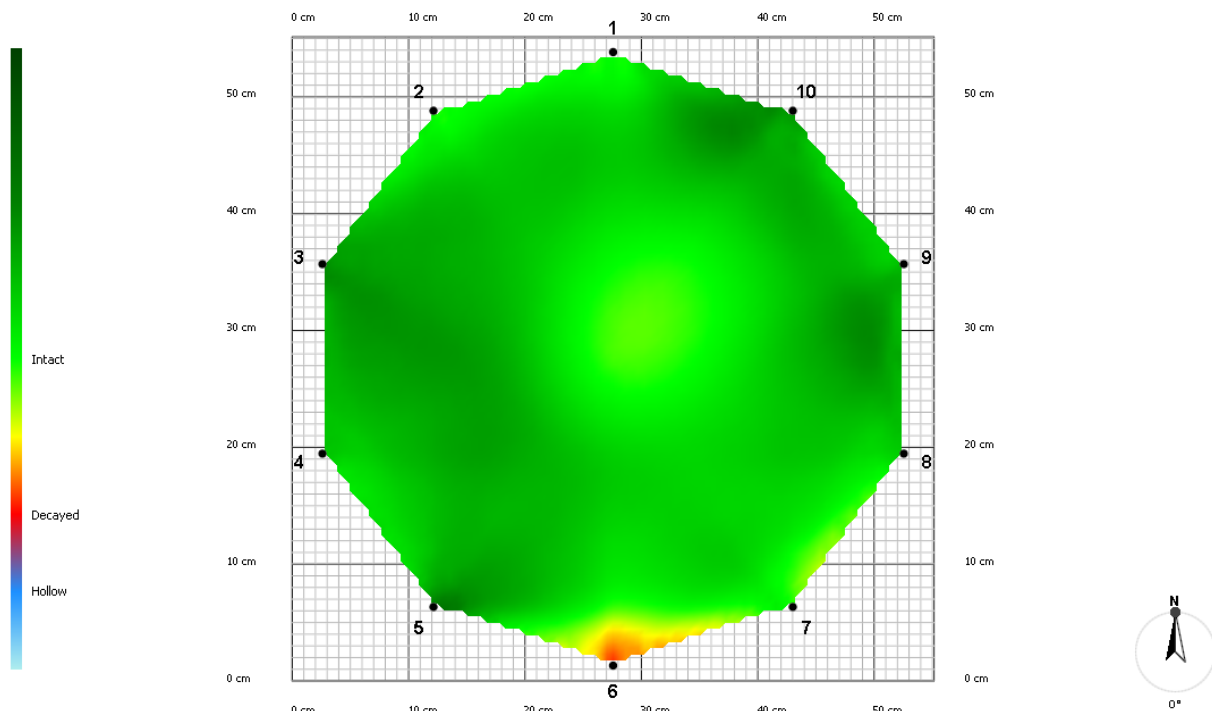
Regarding the east stem, the tomograph at 1% decay is negligible and indicates that the observed cavity is fairly shallow and should seal.

Tree #908: East stem tomograph below cavity showing 1% decay

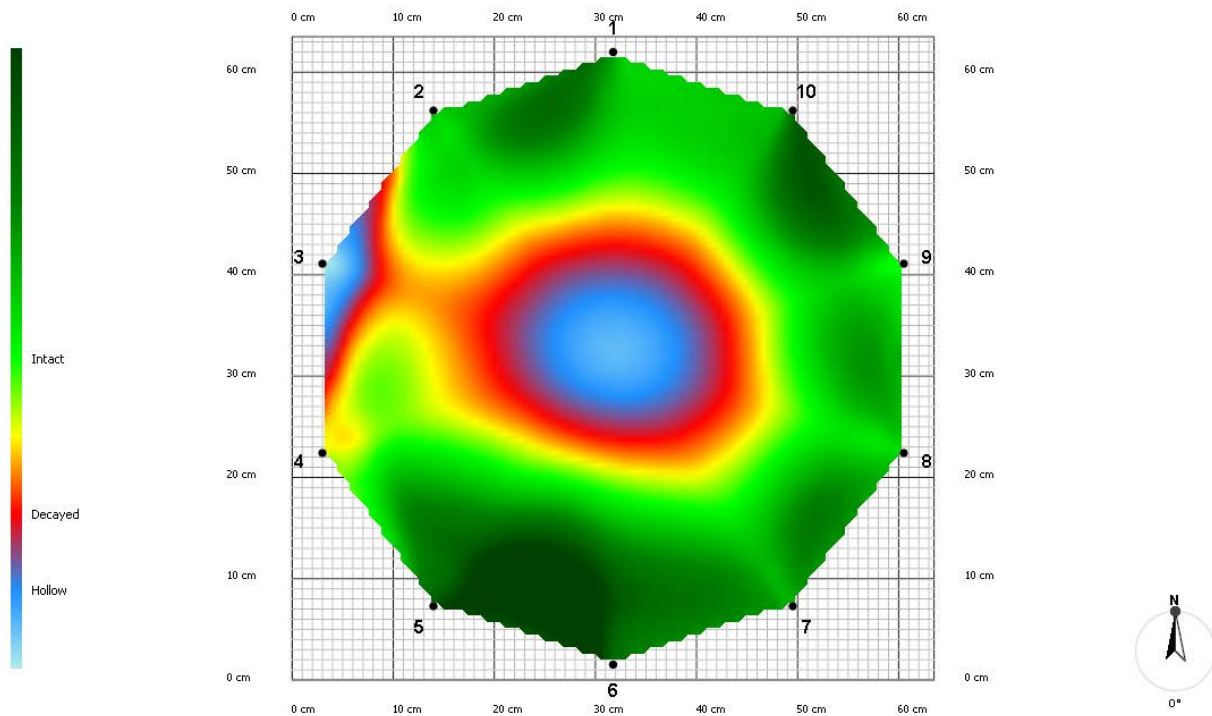
Regarding the west stem in particular, while solid wood appears mostly to surround the decay column, the decay does connect to the exposed cavity, which is large. This condition makes it likely that the decay will increase faster than wound closure. The location of this decay just above the crotch of the main stem also creates concern. The load on the west stem is *significant*, and the likelihood of failure for this tree part is *probable*.

Tree #908: West stem tomograph near crotch at 9.5 feet above grade showing 31% decay

- Remove the west stem.
- Prune the remaining tree to reduce weight at branch ends and to clean the canopy of dead branches one inch in diameter and greater.
- Install support cabling in the upper third of the canopy to provide mechanical support to weak branch unions to reduce risk of failure.
- Aerate the soil within the entire CRZ with a specialized tool, such as an Airspade, to reduce compaction.

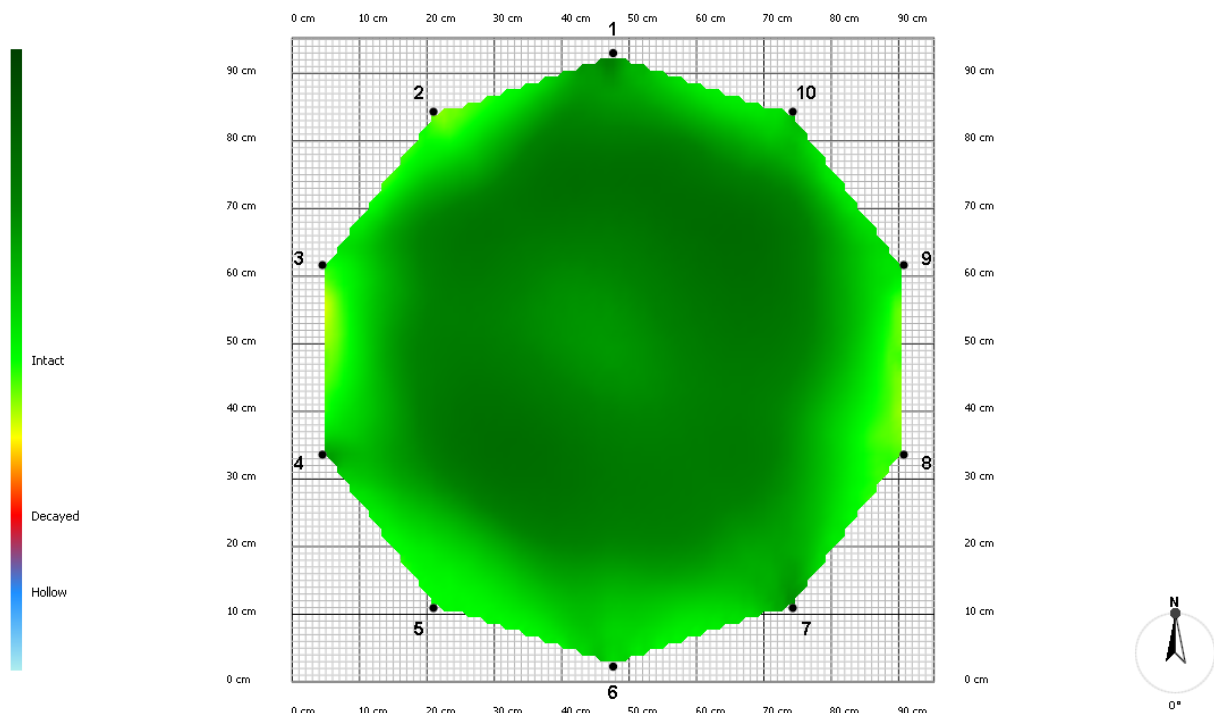
Tree #908: Layer 1 tomograph at 8.5 inches above grade showing 0% decay

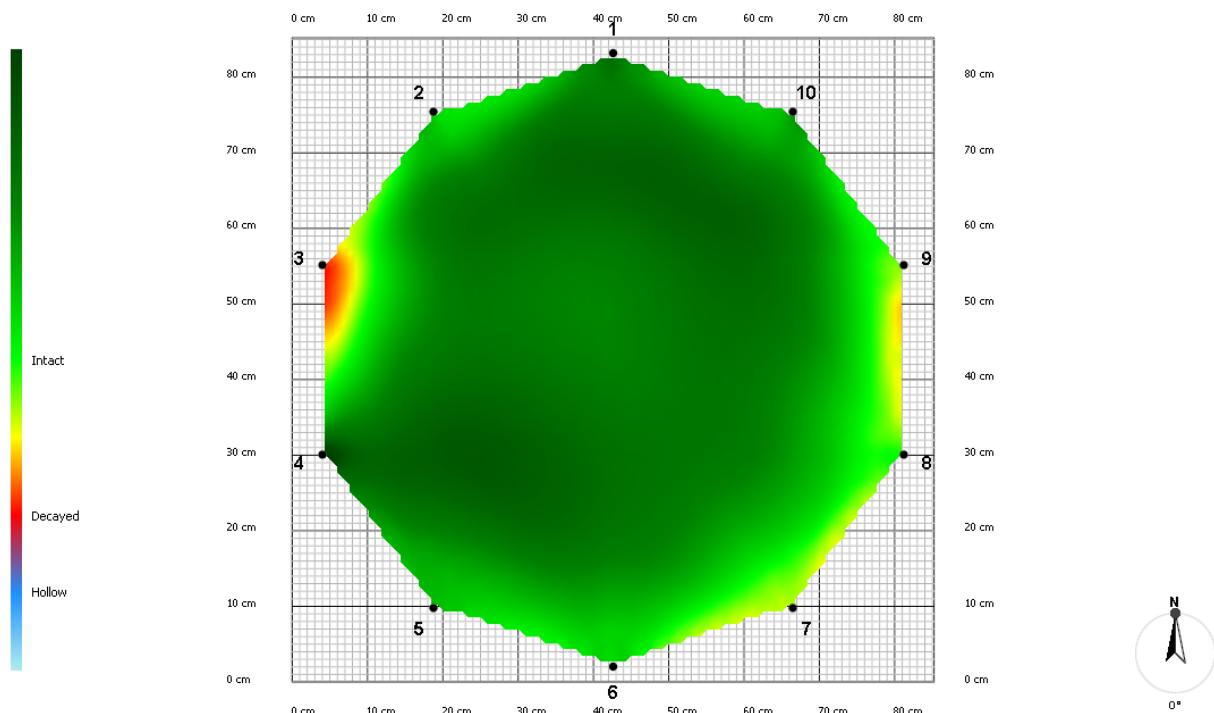
Tree #908: Layer 2 tomograph at 37.5 inches above grade showing 1% decay

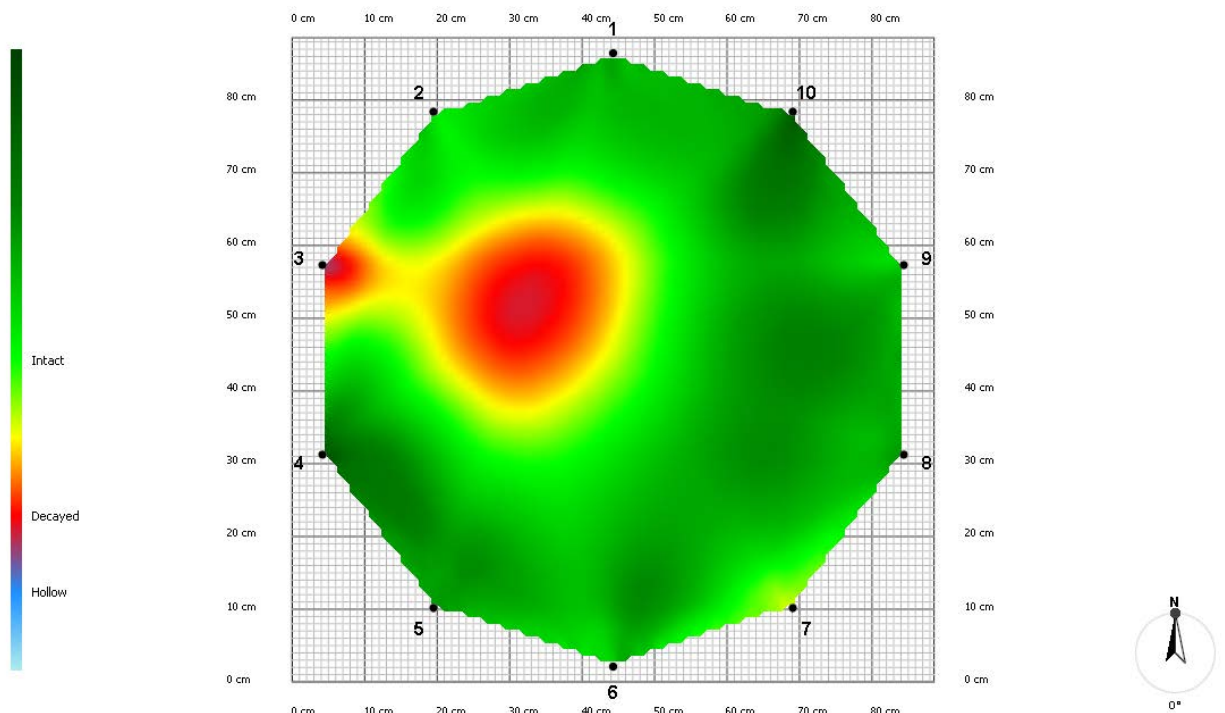
Tree #908: Layer 3 tomograph at 7.5 feet above grade showing 13% decay

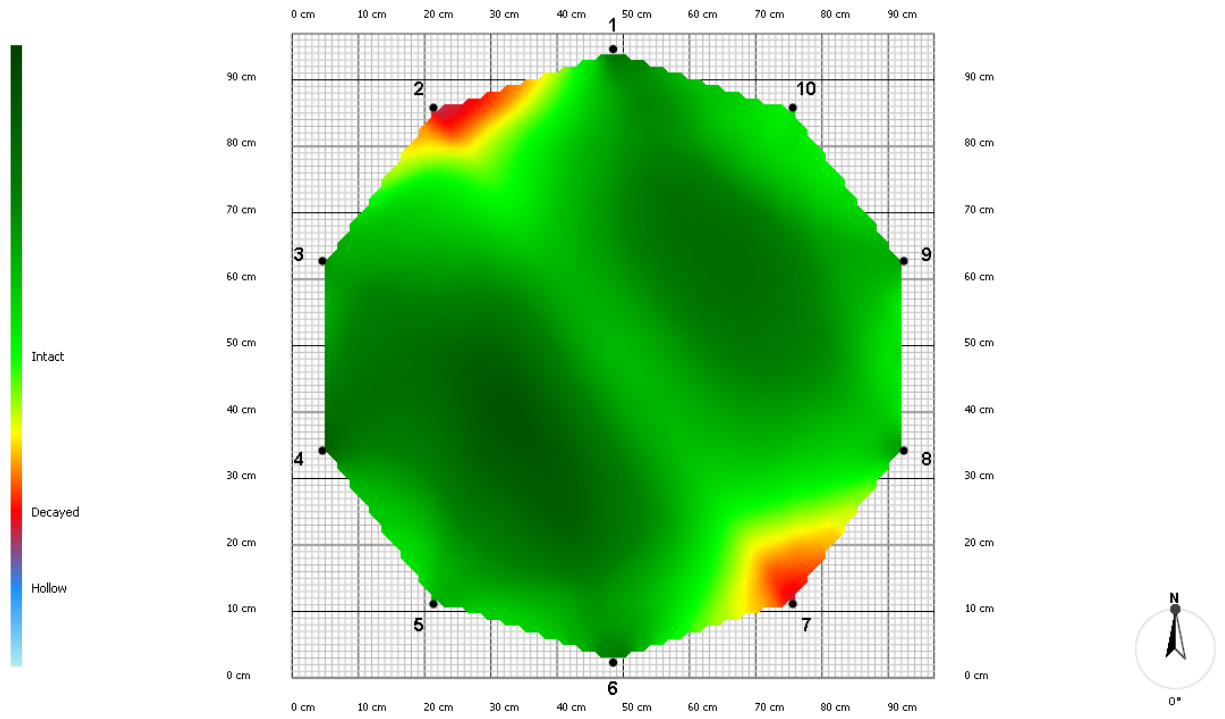
Tree #919: Layer 1 tomograph at 12 inches above grade showing 4% decay

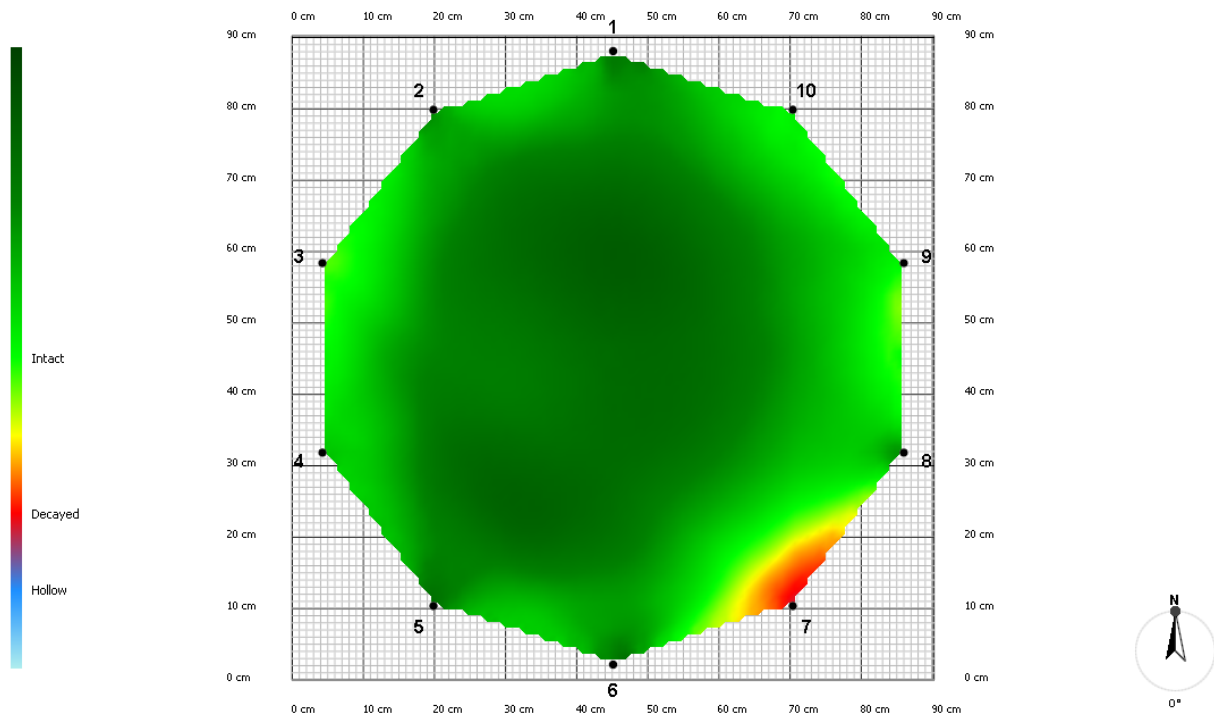
Tree #919: Layer 2 tomograph at 31.5 inches above grade showing 2% decay

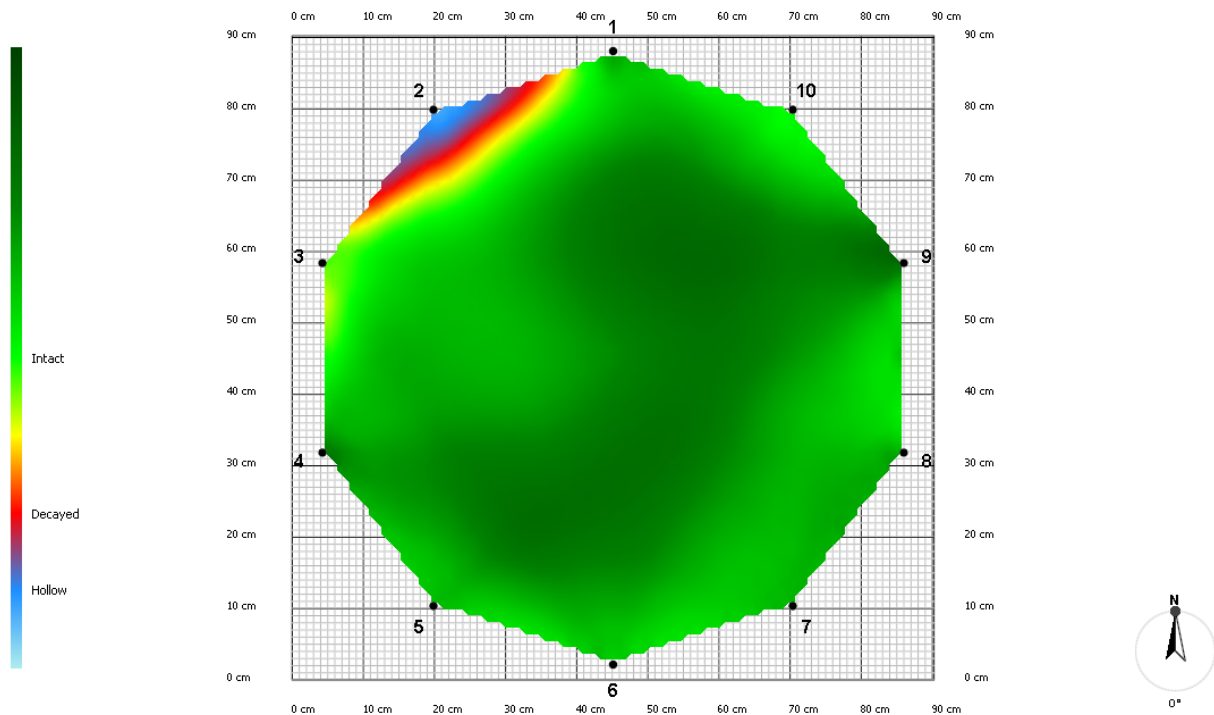
One of the main concerns for this tree is the large cavity at five feet above grade. The Layer 3 and 4 tomographs were taken above and below the cavity to determine if the tree had compartmentalized (walled off) this wound or if a decay column was forming inside the stem instead. The absence of internal decay shown in the Layer 3 and 4 locations suggests that adequate solid wood is present in the stem and that the likelihood of stem failure is *possible*, but not *probable* or *imminent*.

Tree #919: Layer 3 tomograph at 46 inches above grade showing 4% decay

- Prune the remaining tree to reduce weight at branch ends and to clean the canopy of dead branches one inch in diameter and greater.
- Install support cabling in the upper third of the canopy to provide mechanical support to weak branch unions to reduce risk of failure.
- Aerate the soil within the entire CRZ with a specialized tool, such as an Airspade, to reduce compaction.

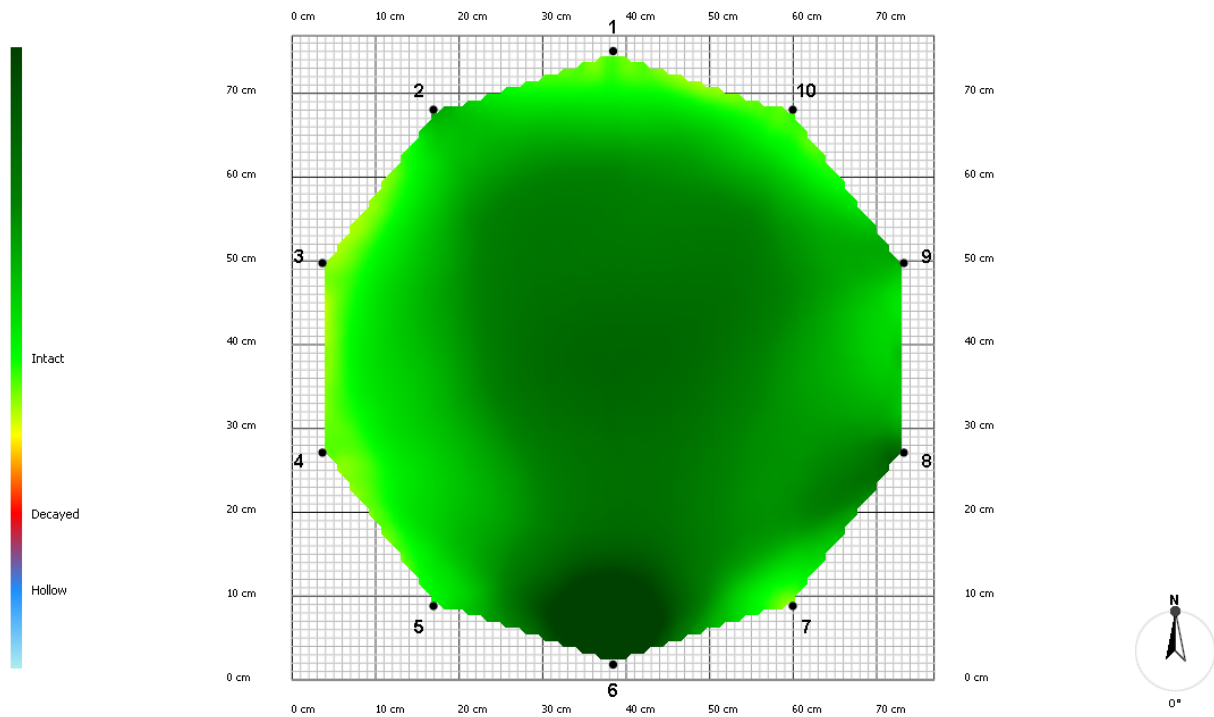
Tree #919: Layer 4 tomograph at 7 feet above grade showing 0% decay
