Table of Contents for Carpenter Hall Site Plan
Heritage Tree Variance Package

SITE PLAN: The Carpenter (SP-2016-0073C)

REQUEST: The applicant is requesting to remove two heritage trees, each with a single-stem greater than 30 inches as allowed under LDC 25-8-643

Tree Risk Assessment Report

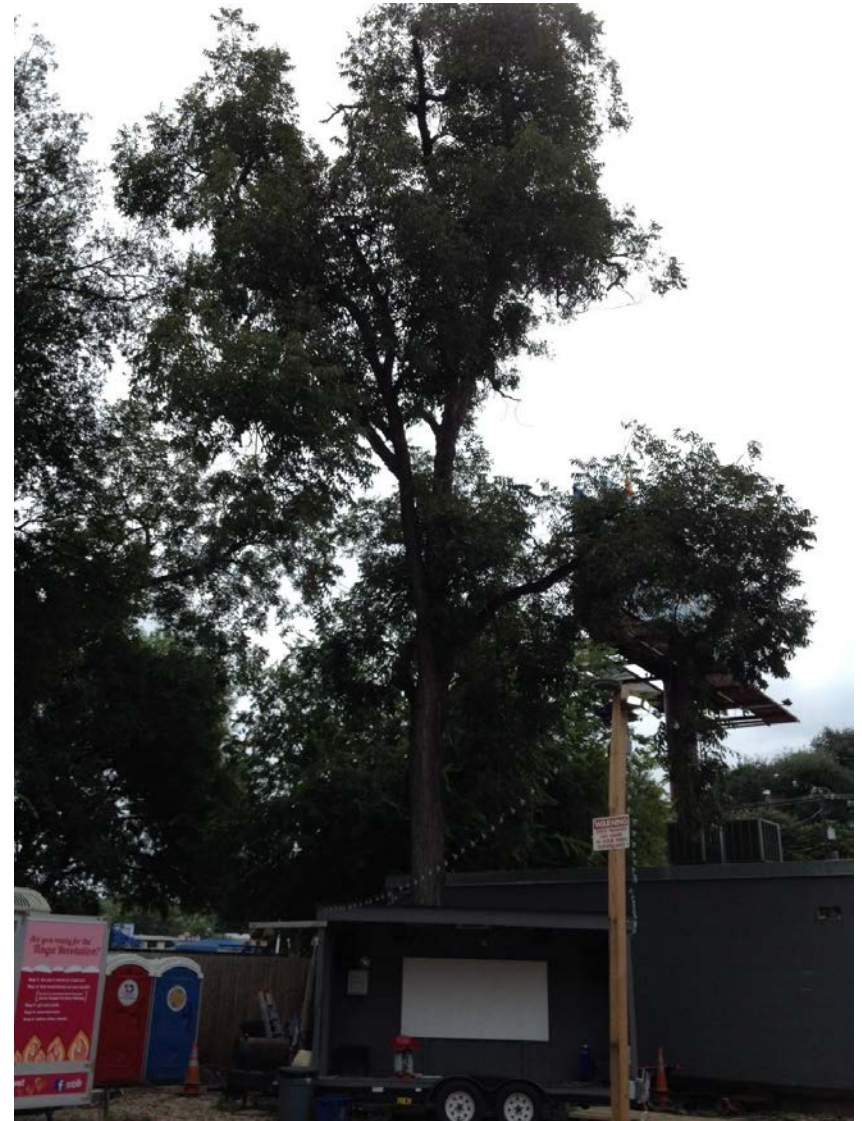
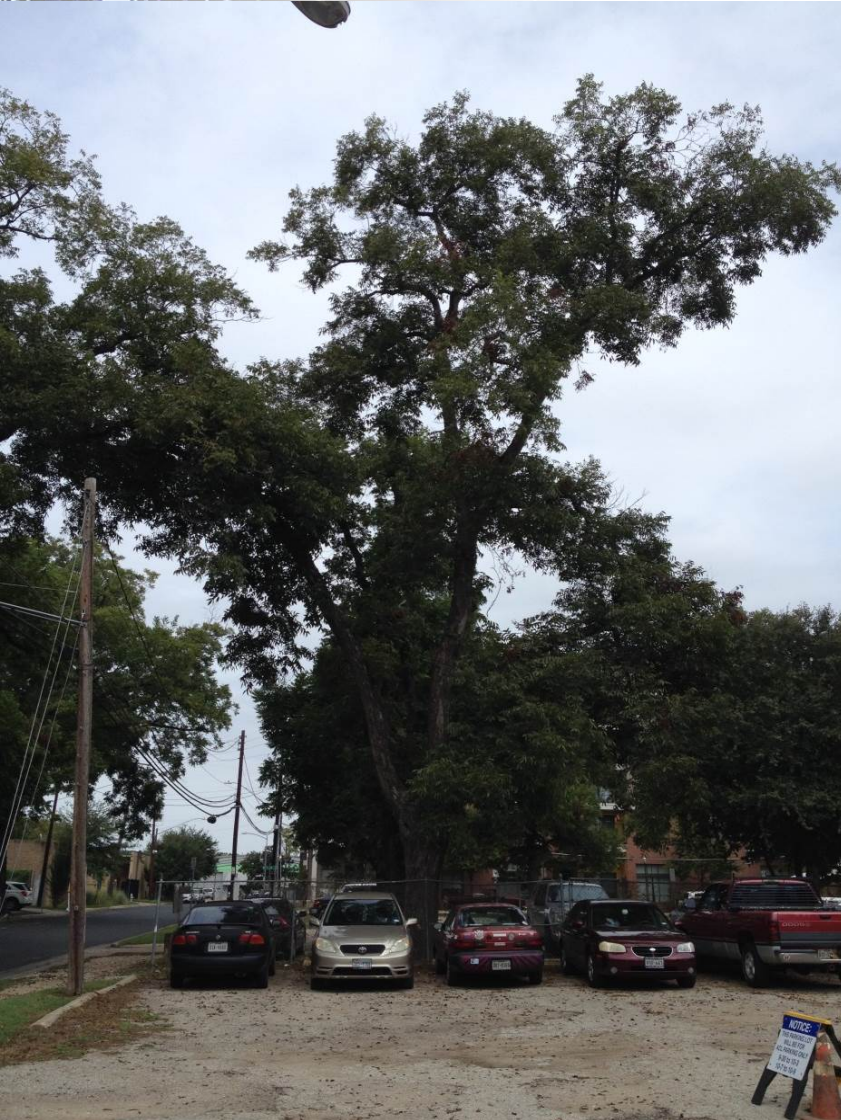
Exhibit 1

Both canopies display minor to major asymmetry as a result of prior limb failures (Exhibit 1). Storm damage is evident in the canopy as most leaders have abrupt termination of the tapering to branches (Exhibit 2). Tree #908 displayed a heightened

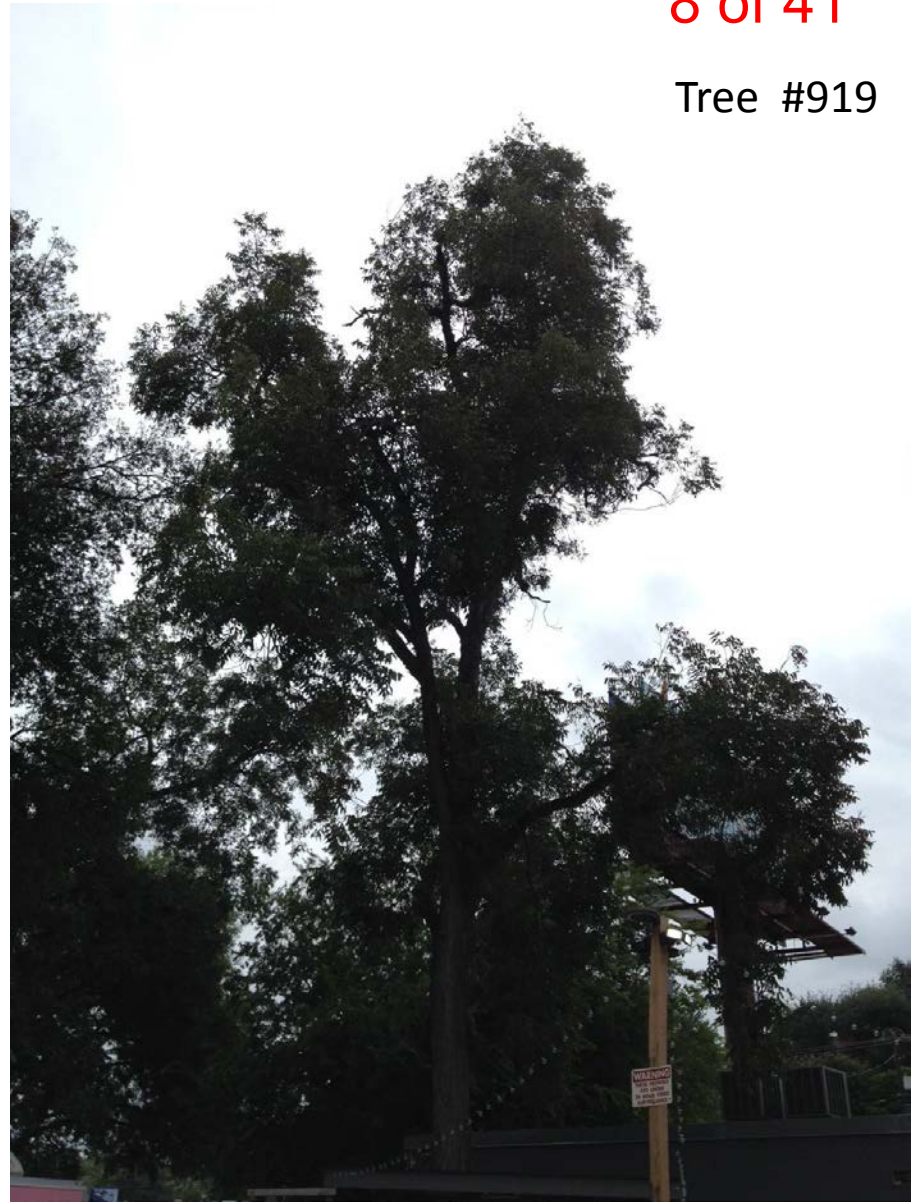
Exhibit 2

loading on the stems as a result of the length and excessive end weight on the branches (Exhibit 3).

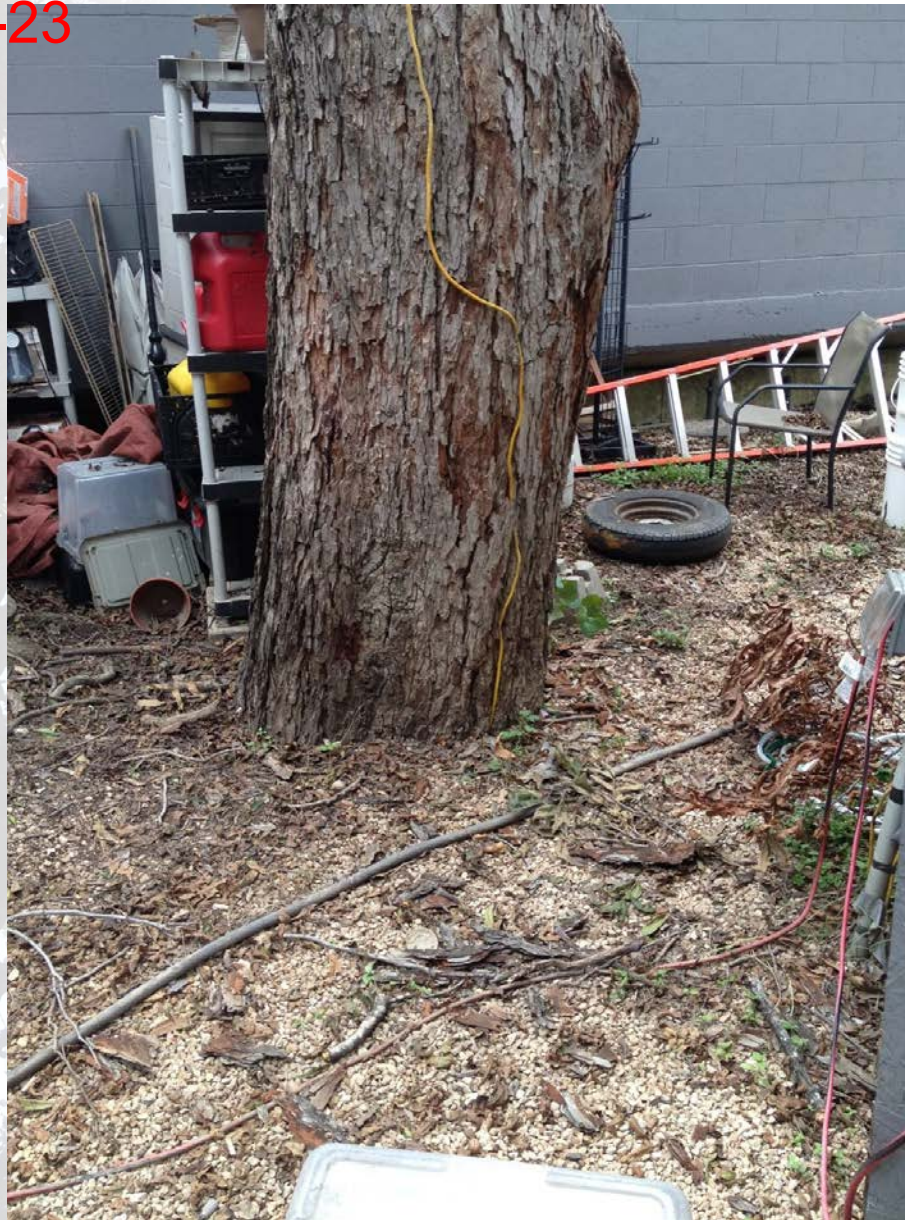
Exhibit 6

Both root systems are entirely covered with disturbed and compacted cover (Exhibit 5). Tree #919 has been buried to an unknown depth as the root flare is not visible (Exhibit 6).

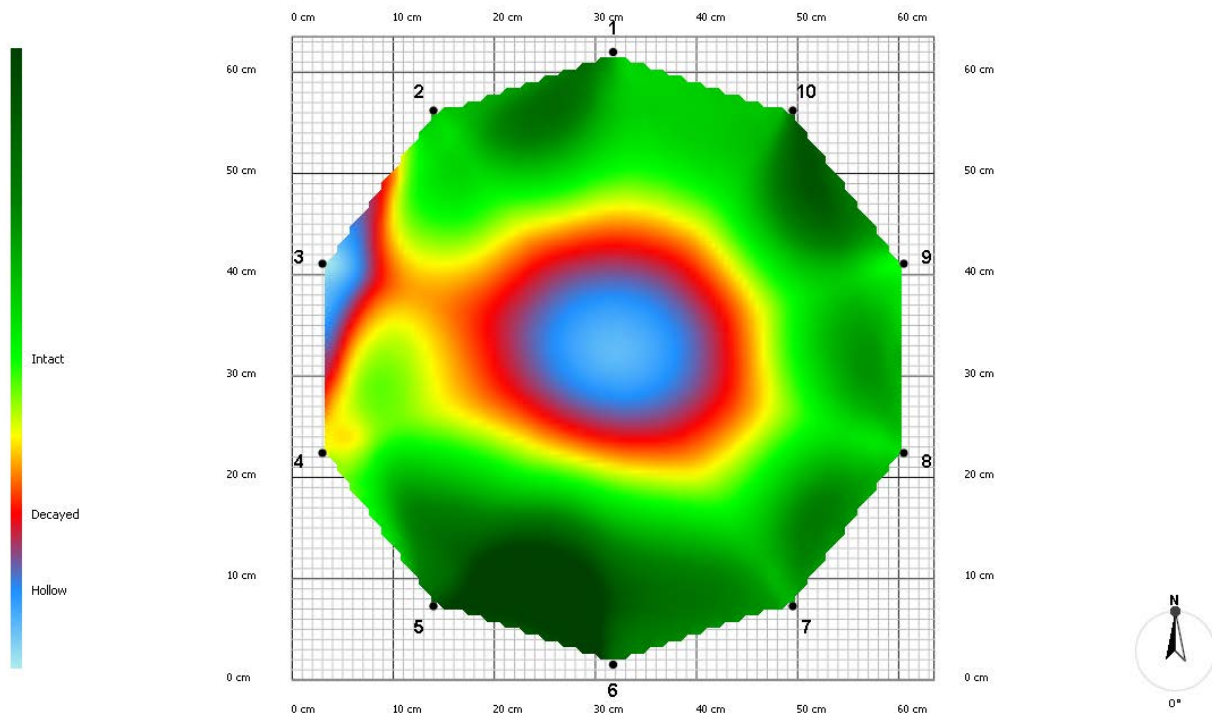
Regarding the west stem in particular, while solid wood appears mostly to surround the decay column, the decay does connect to the exposed cavity, which is large. This condition makes it likely that the decay will increase faster than wound closure. The location of this decay just above the crotch of the main stem also creates concern. The load on the west stem is *significant*, and the likelihood of failure for this tree part is *probable*.

Tree #908: West stem tomograph near crotch at 9.5 feet above grade showing 31% decay

- Remove the west stem.
- Prune the remaining tree to reduce weight at branch ends and to clean the canopy of dead branches one inch in diameter and greater.
- Install support cabling in the upper third of the canopy to provide mechanical support to weak branch unions to reduce risk of failure.
- Aerate the soil within the entire CRZ with a specialized tool, such as an Airspade, to reduce compaction.

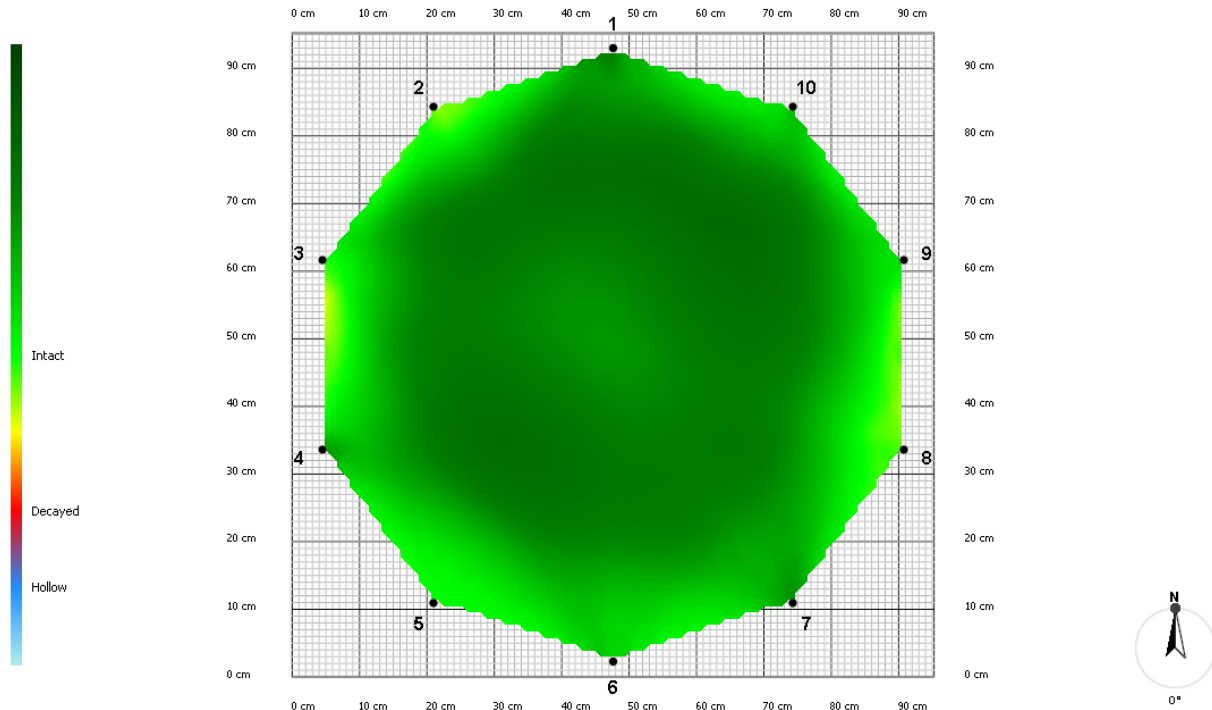
Tree #908: Layer 1 tomograph at 8.5 inches above grade showing 0% decay

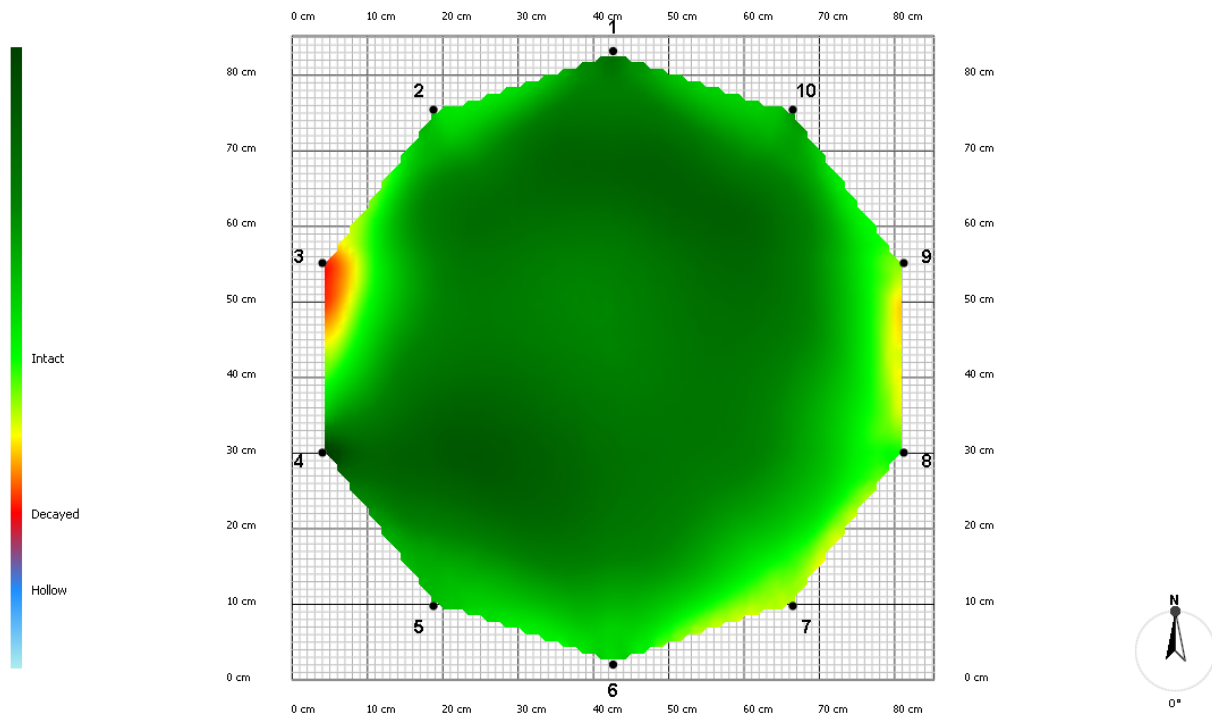
Tree #908: Layer 2 tomograph at 37.5 inches above grade showing 1% decay

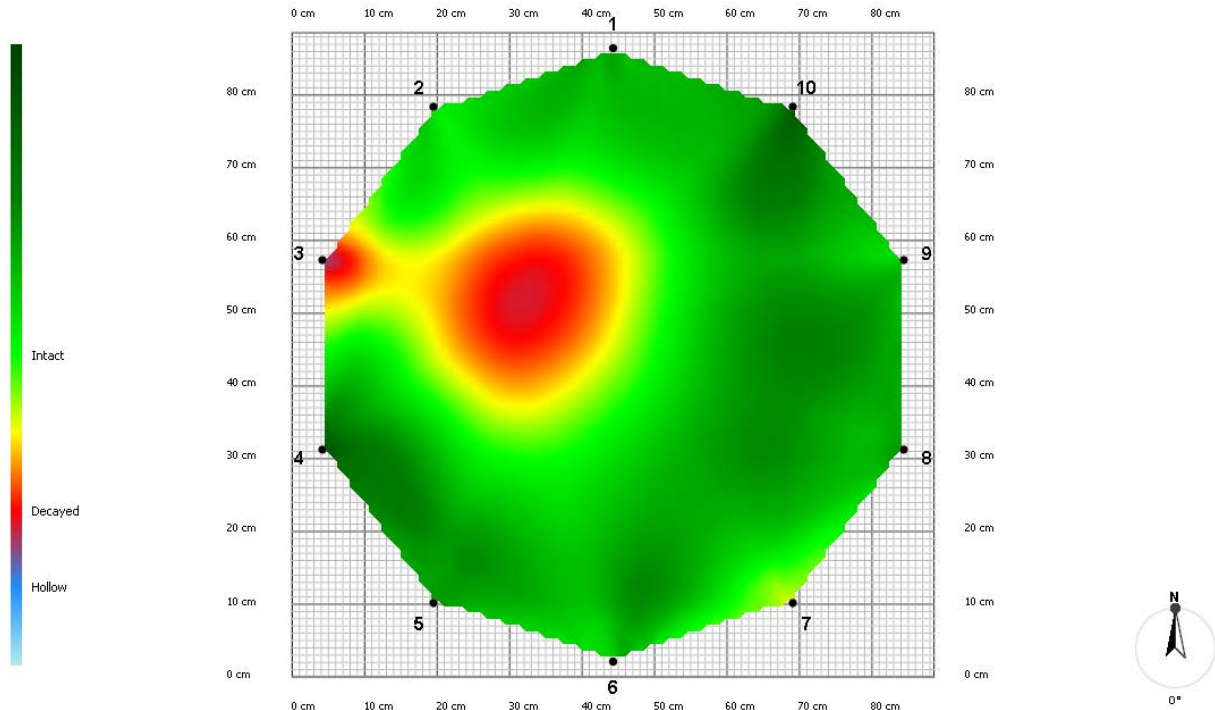
Tree #908: Layer 3 tomograph at 7.5 feet above grade showing 13% decay

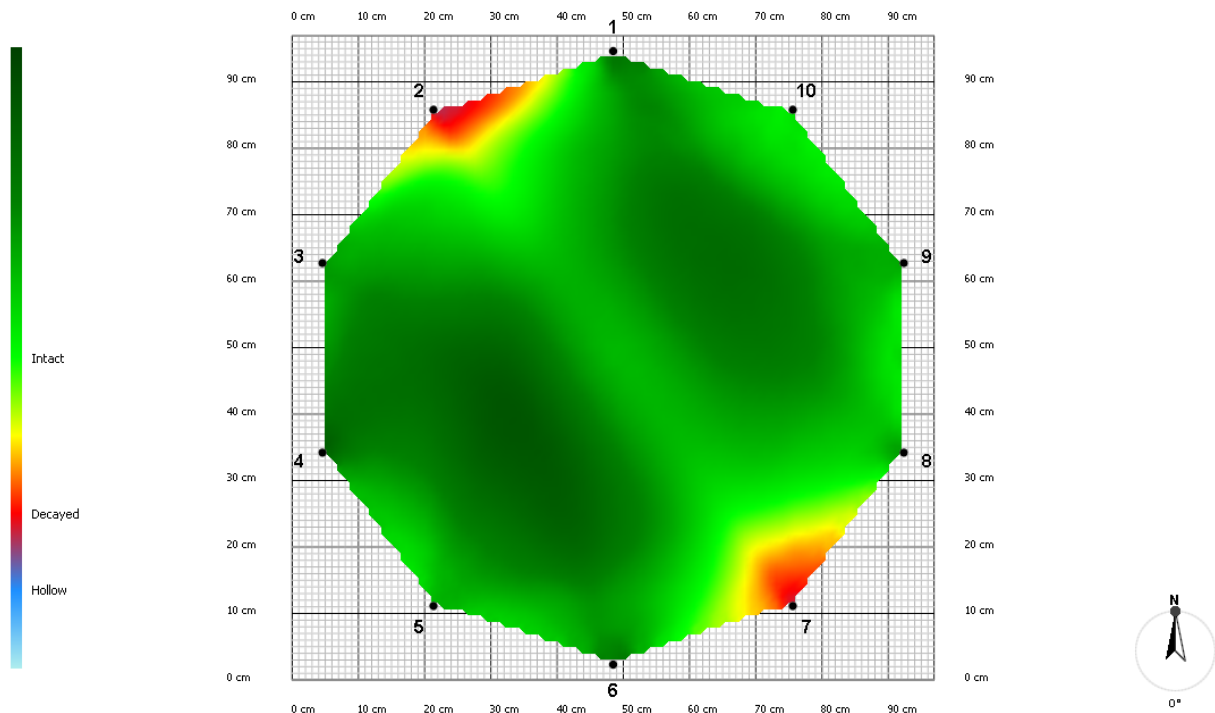
Tree #919: Layer 1 tomograph at 12 inches above grade showing 4% decay

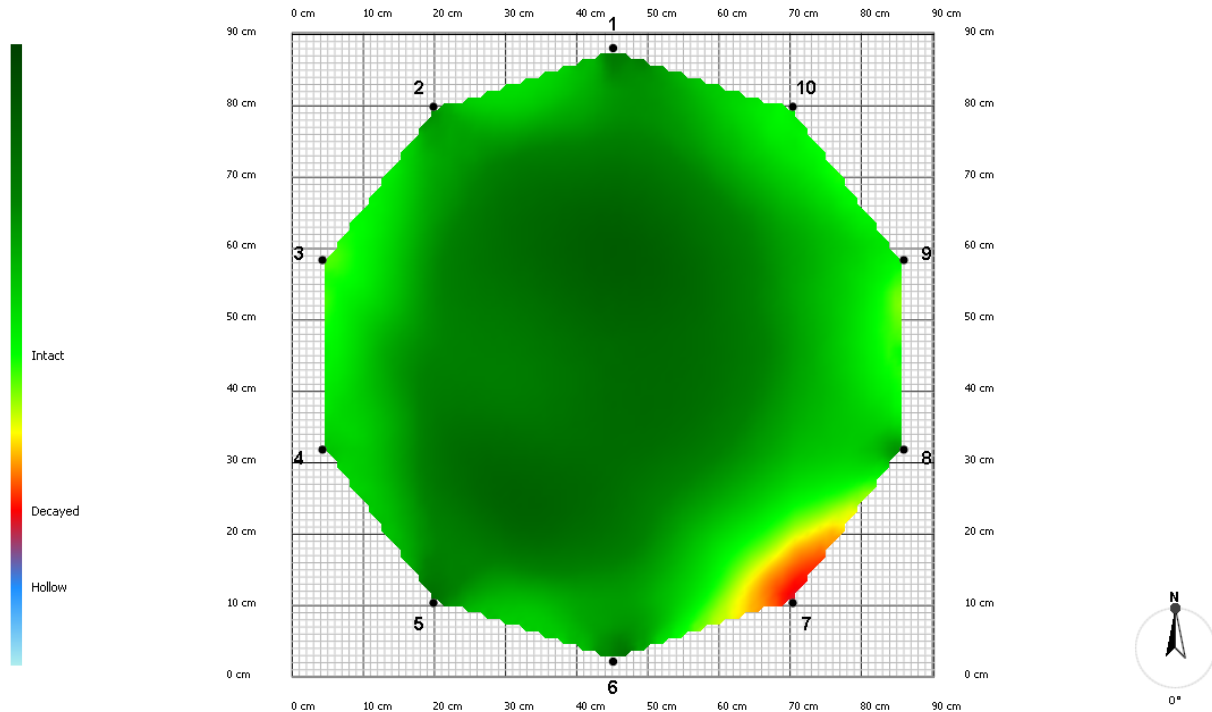
Tree #919: Layer 2 tomograph at 31.5 inches above grade showing 2% decay

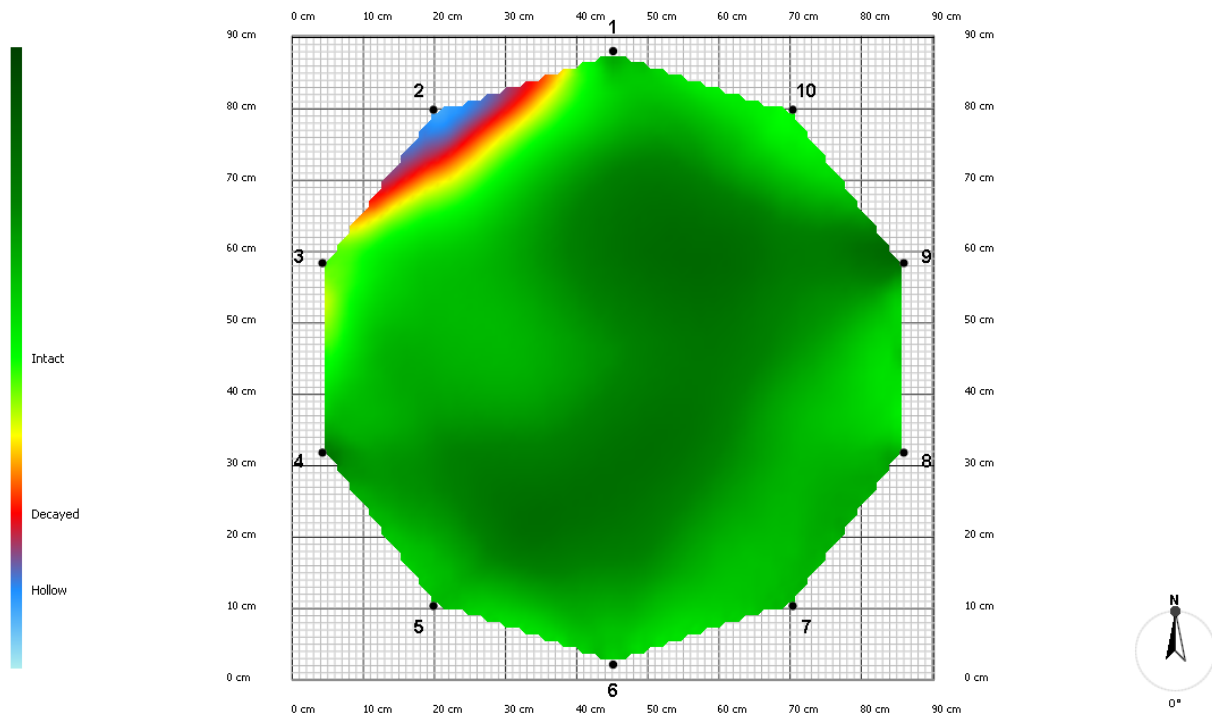
One of the main concerns for this tree is the large cavity at five feet above grade. The Layer 3 and 4 tomographs were taken above and below the cavity to determine if the tree had compartmentalized (walled off) this wound or if a decay column was forming inside the stem instead. The absence of internal decay shown in the Layer 3 and 4 locations suggests that adequate solid wood is present in the stem and that the likelihood of stem failure is *possible*, but not *probable* or *imminent*.

Tree #919: Layer 3 tomograph at 46 inches above grade showing 4% decay

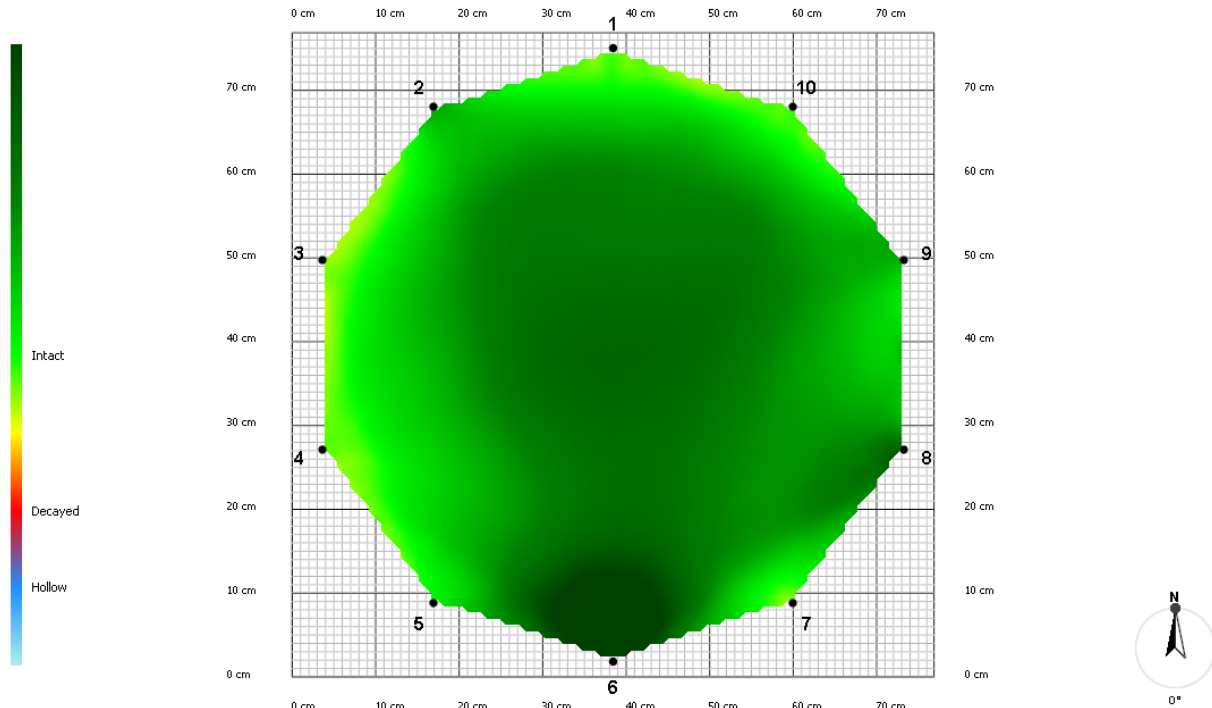
Tree #919: Layer 4 tomograph at 7 feet above grade showing 0% decay
