HISTORIC LANDMARK COMMISSION
FEBRUARY 27, 2017
APPLICATION FOR A CERTIFICATE OF APPROPRIATENESS
C14H-1974-0015
Elisabet Ney Museum
304 E. 44th Street

Clean, repoint, and selective reconstruction of historic stone wall; restoration of historic gate.

ELISABET NEY MUSEUM RESTORATION
Building, Interior & Site Improvements
Austin, Texas
for
City of Austin

Certificate of Appropriateness application

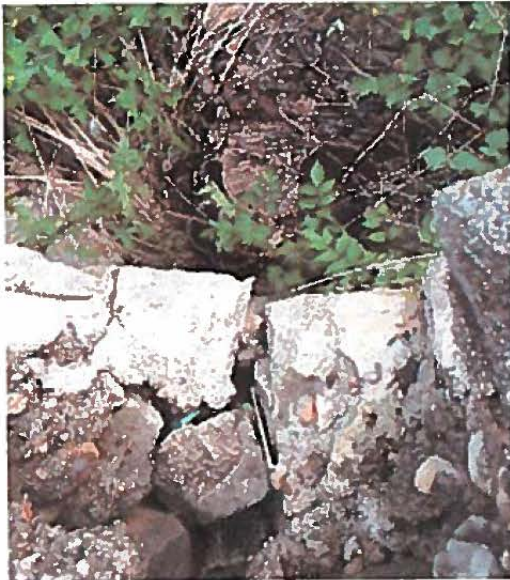
6. At east end of wall where a tree has caused the stone to crack and shift as it meets the stone column, the wall and column will be dismantled and reconstructed. A steel reinforced concrete foundation will be installed. The historic stone will be cleaned of mortar and rebuilt to match the original design of the wall and column.

Right Corner of stone wall: remove tree stump; Reconstruct this section of wall and column adding new footers

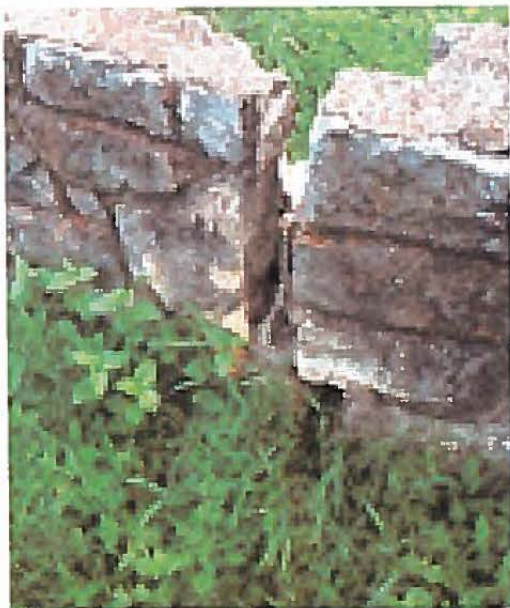
Repair split in wall (right side)

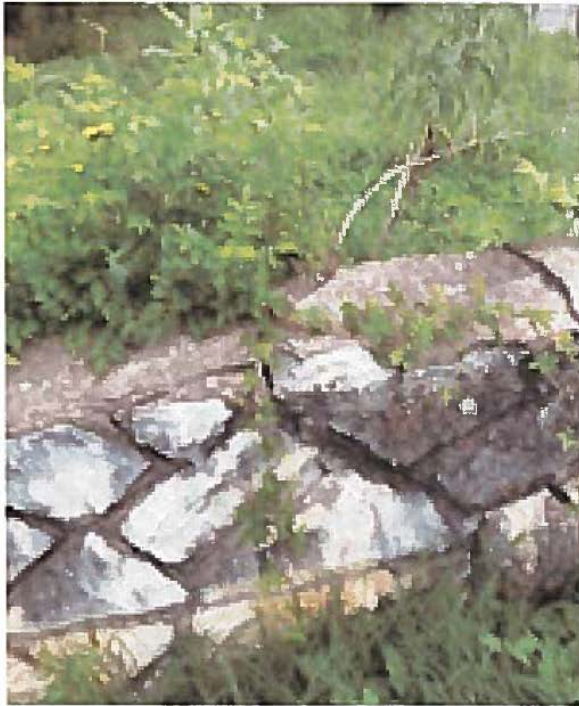
Cracks in wall cap.

1. Masonry Cleaning--Gentle cleaning of entire wall through light pressure wash and Prosoco Revive.
2. Masonry Repair, Repointing and application of new mortar cap. Existing cracks at the mortar joints will be removed and repointed with historically consistent mortar. The mortar cap has failed in many locations along the historic wall. Ash Masonry will install a new mortar cap approximately 300 feet long.

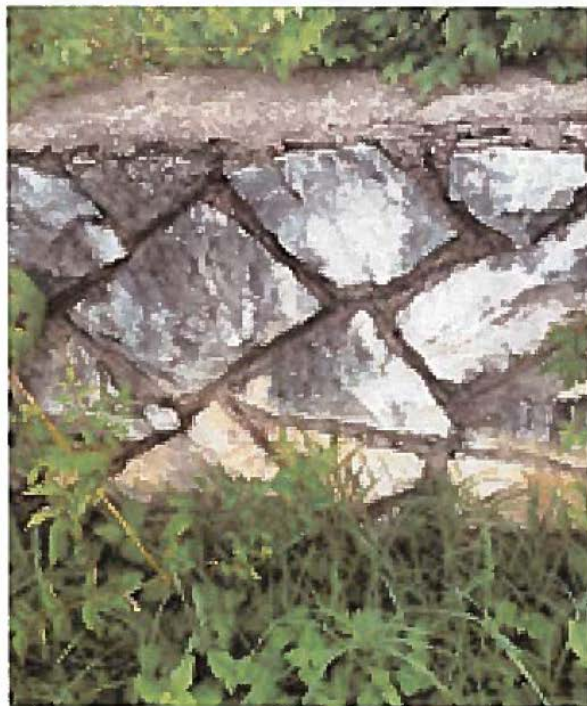
V-shaped profile to be maintained.

3. Mortar mix: Approval of mock-ups by Kim McKnight and Elizabeth Brummett for color & consistency
4. Reproduce V shaped joint profile
5. The curved stone walls at entry gate will be dismantled where they have become separated and rebuilt using the same historic stone. A steel reinforced concrete foundation will be installed where necessary.

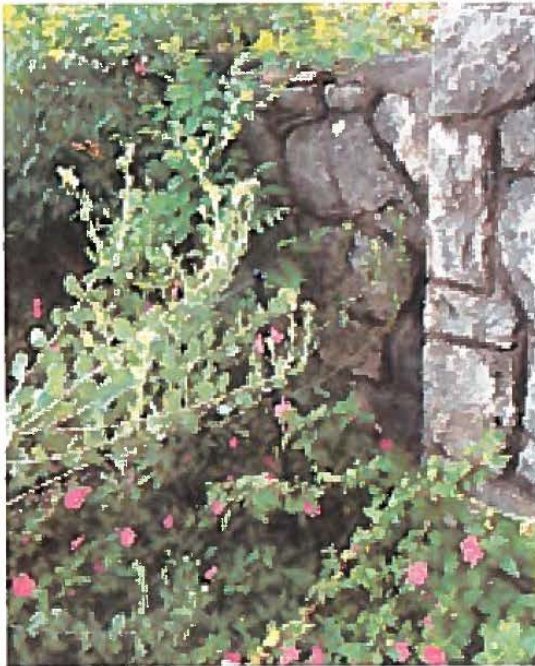
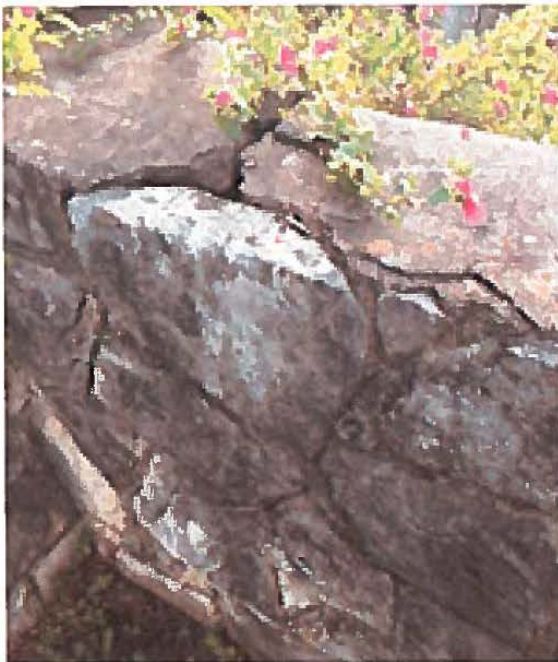
Left side of gate structure

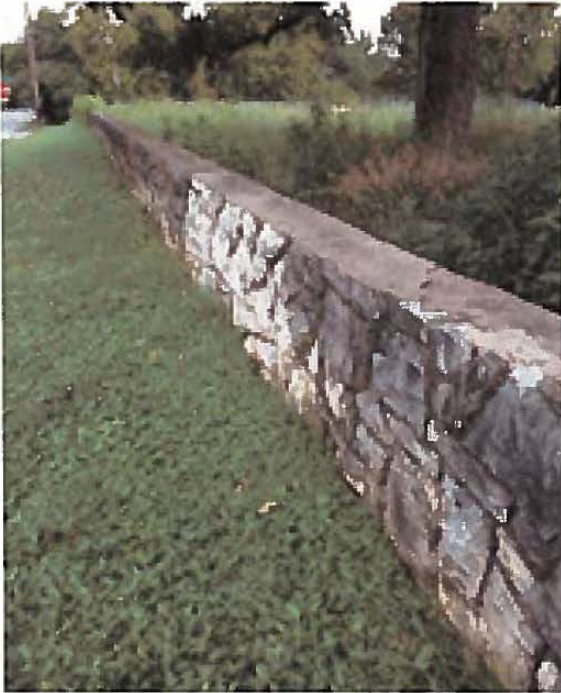
Wall west of gate (note graffiti on left side of wall)

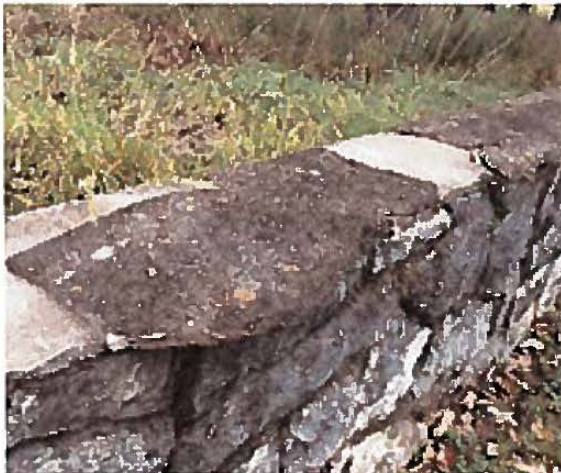
Deteriorated mortar cap
