Rainey Tower SPC-2021-0129C

January 19, 2022

Heritage Tree Variance Request

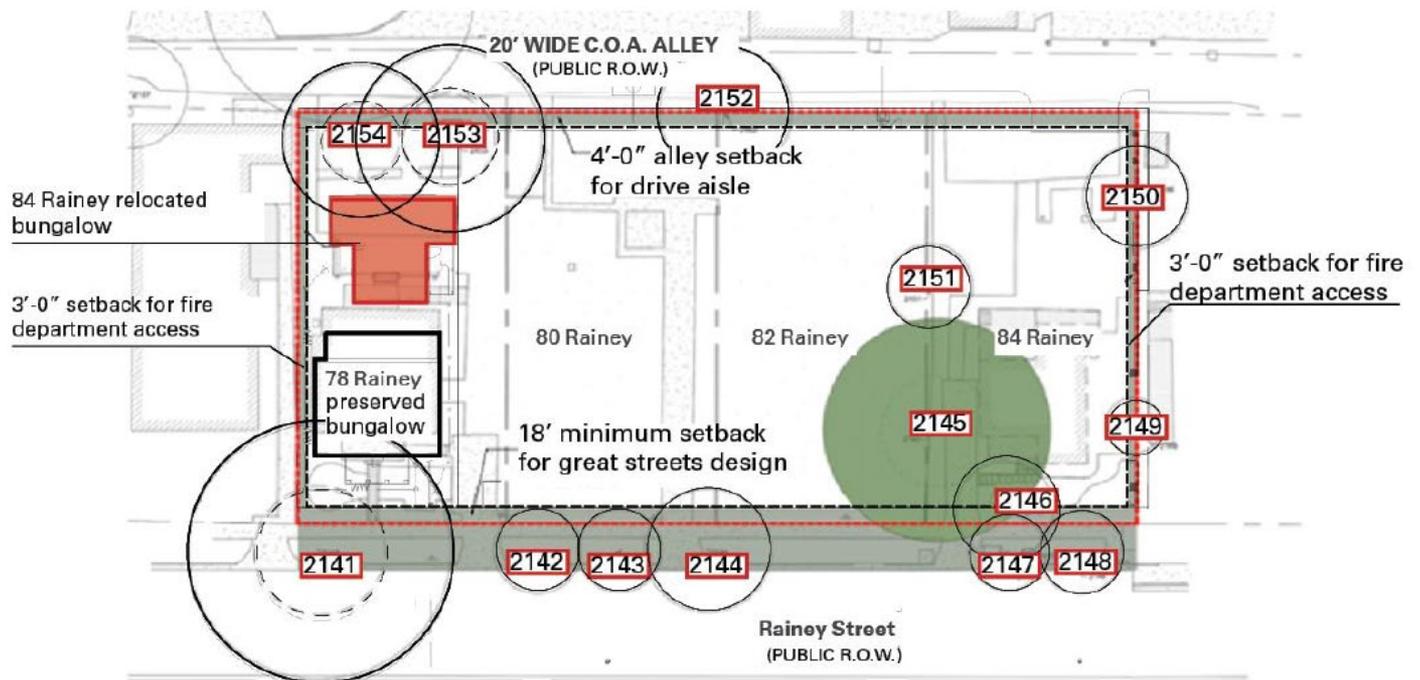
Site Constraints: Great Streets Master Plan

- Requires 18 ft. setback along Rainey St.
- Limits the developable footprint
- 4' alley setback for drive aisle
- 3' setbacks both north and south sides of property from fire department
- Tree #2145 is centrally located at the property (middle third)

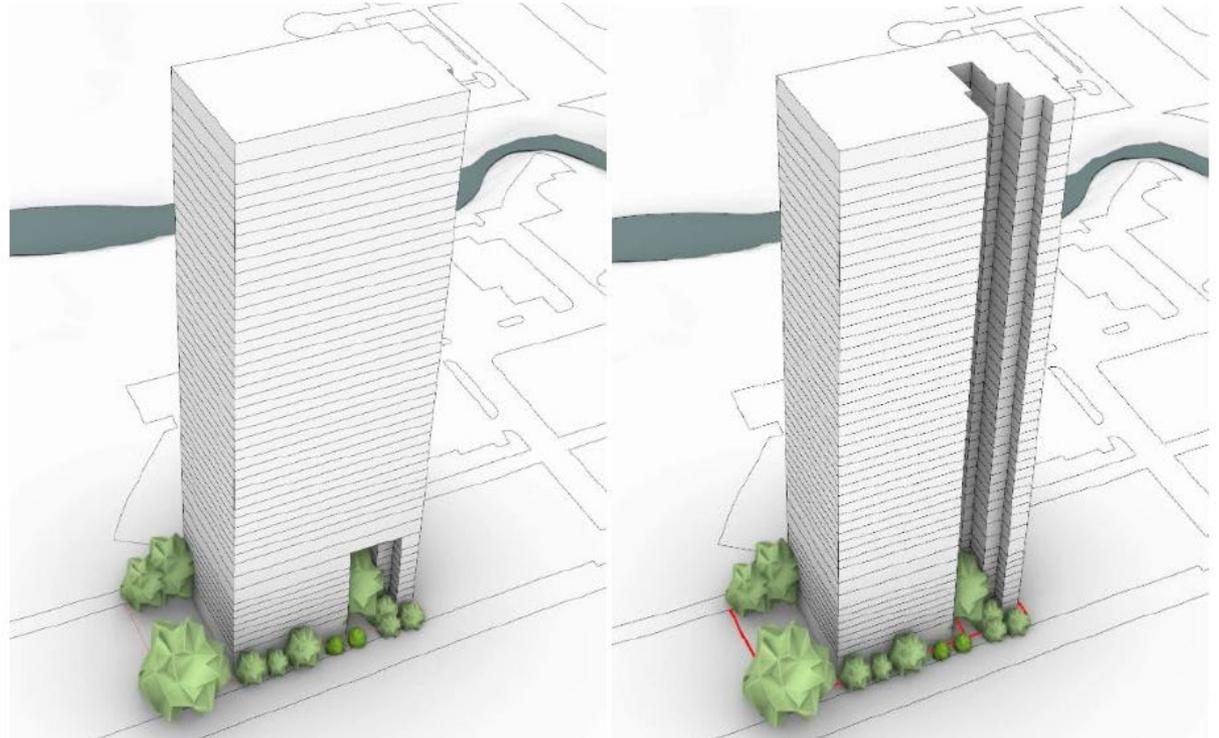
Site Constrains- buildable floorplates

Tree #2145 impacts 11% of site

- Prevents structured parking – 14% reduction of buildable area
- Prevents workable building floorplates

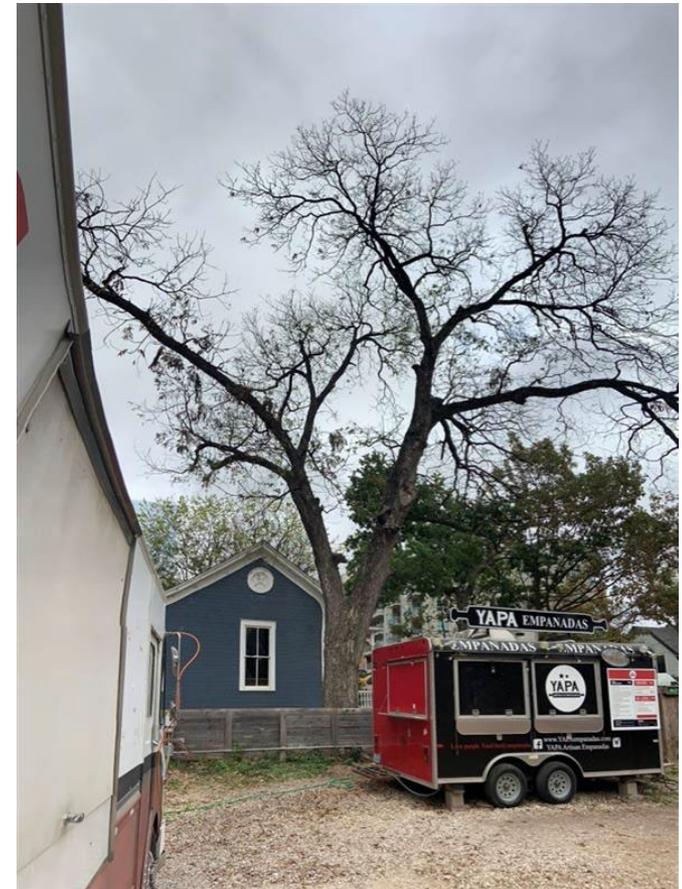
Tree structure

- Co-dominant leaders; previous 10" limb failure south side of trunk; previous 8" limb failure north side resulting in damage to roof and house of adjacent building; 27" longitudinal crack in main trunk (west side) 7 ft from grade. Tomography was done at the supporting union of the canopy, results indicate it may be structurally compromised.

Large previous failures and damage to present building

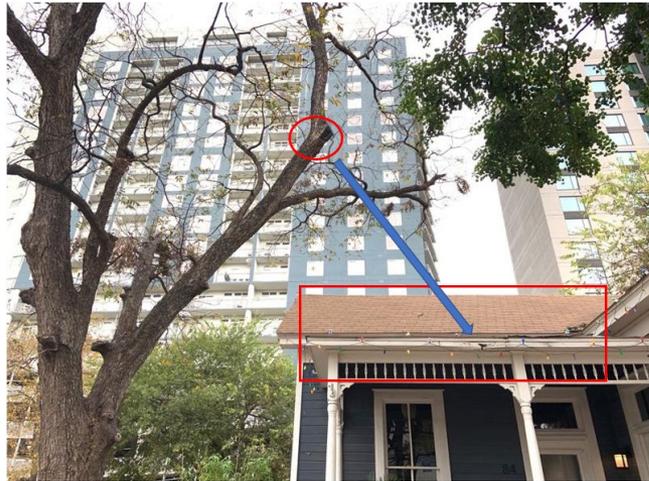
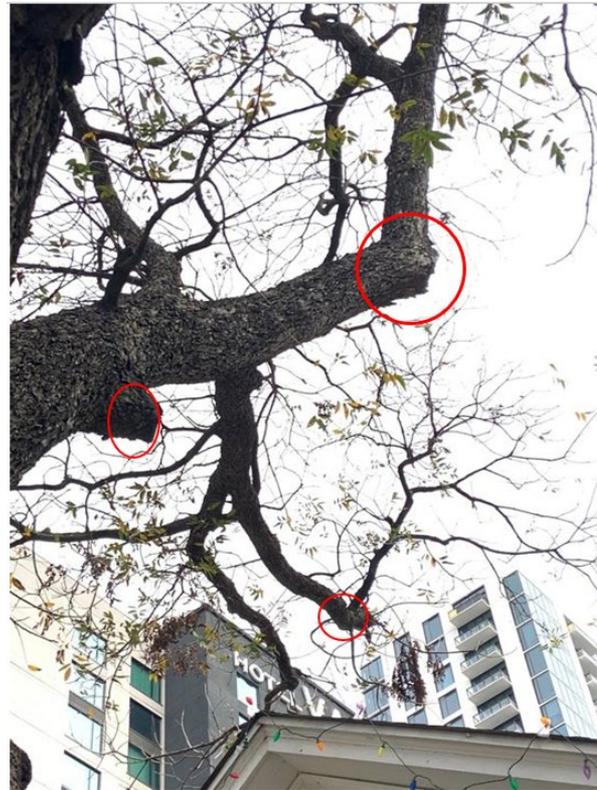
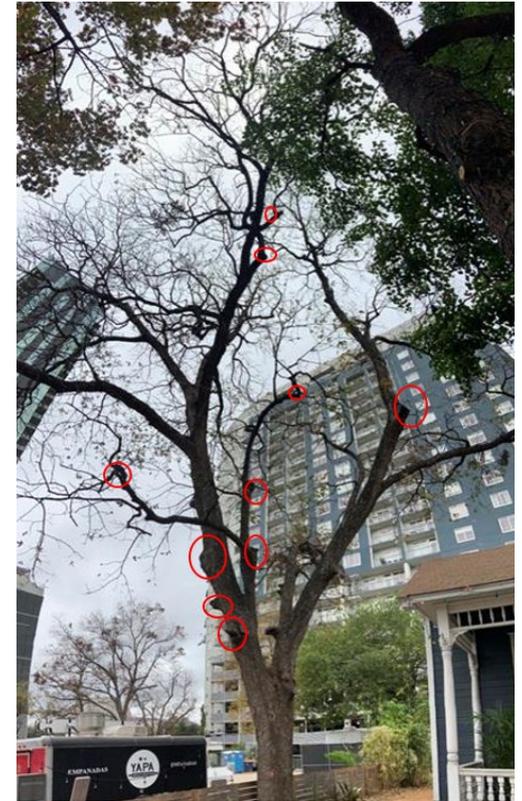
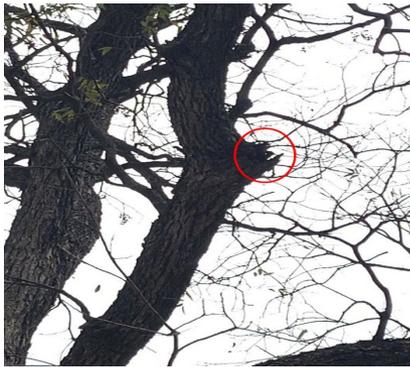
Tree structure (cont.)

Horizontal and longitudinal cracks developing seven feet above grade. May be an imminent hazard within 5-10 yrs.

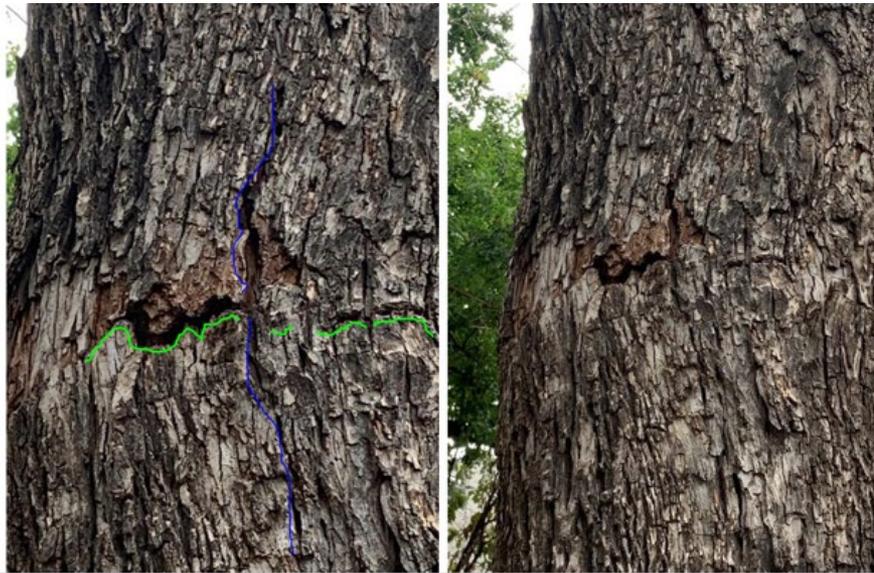
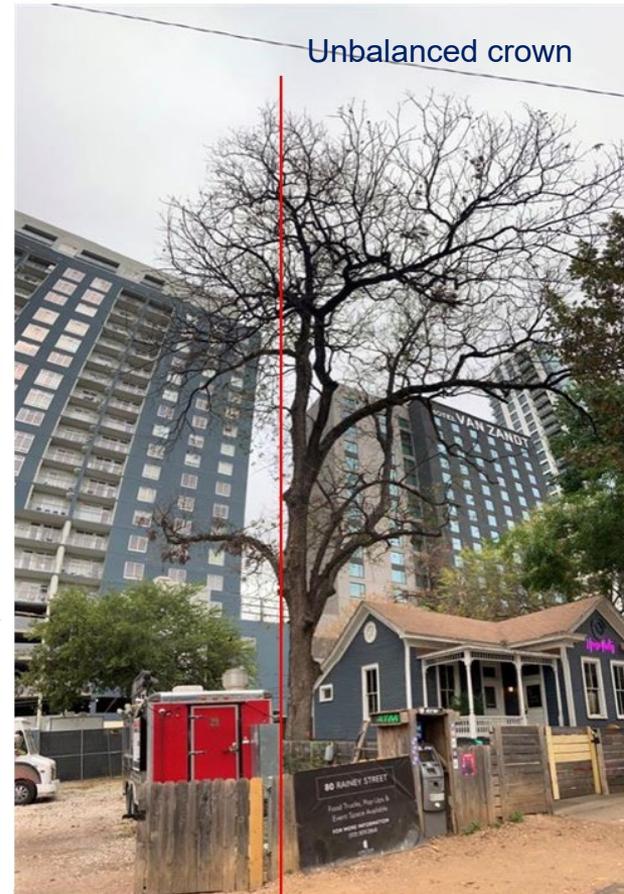
Tree structure (cont.)

Sonic tomography report

Scan at 625 cm

This scan shows less sound wood in the center and extending outwards through the shell wall between sensors 3-8, and between 8-1. This scan was taken below an old, exposed pruning wound, and above branch nubs. Failure of this portion of the tree would result in the loss of a significant part of the tree canopy (Image 2). Eight sensors were used in this scan. The scan at this level is structurally compromised.
