Shoal Cycle SP-2021-0350C

September 7, 2022

Heritage Tree Variance Request

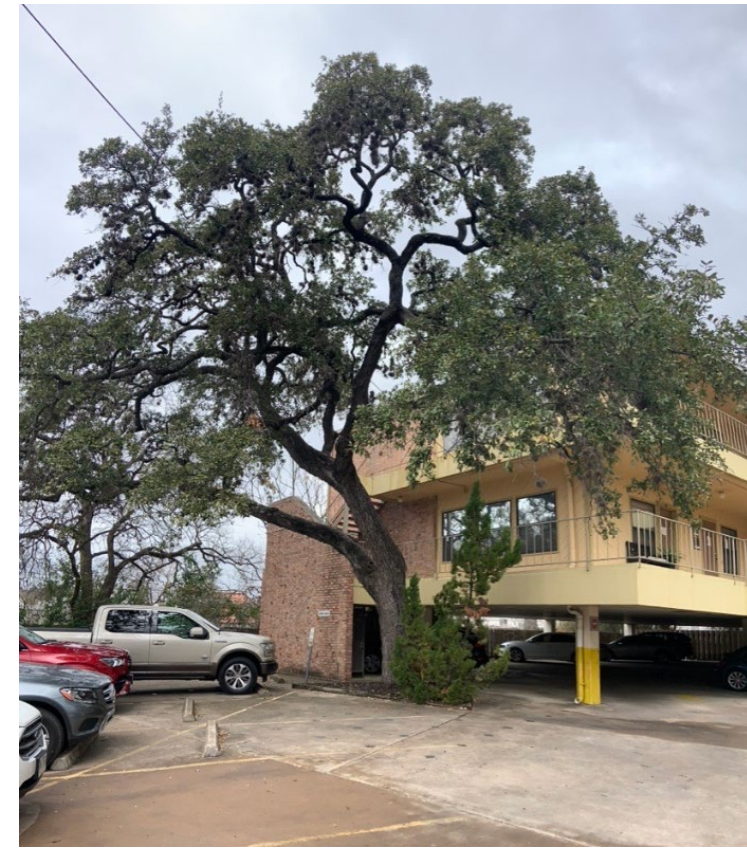
Condition Evaluation Tree #287

Tree #287 – 32-inch Live Oak

- Asymmetric crown; thin canopy; chlorotic (likely due to nutrient deficiency); copious amount of epiphytic ball moss usually prevalent on declining trees; leans southwest due to existing location of existing building; overhead utility lines run through the canopy.

- Trunk leans over the parking lot. Sonic tomography was conducted of the trunk which indicated moderate decay present at three different vertical planes with the tree – estimates 22-24% loss in structural integrity of the tree. Large decay pockets on upper side of two scaffolding limbs observed.

- 95% of the critical root zone is impacted by existing concrete pavement and building envelope; chlorosis in canopy likely due to impervious cover.

- Fair condition; poor structure; moderate risk determination

The City Arborist recommends removal of the tree due to the applicant demonstrating that the tree prevents reasonable use of the site.

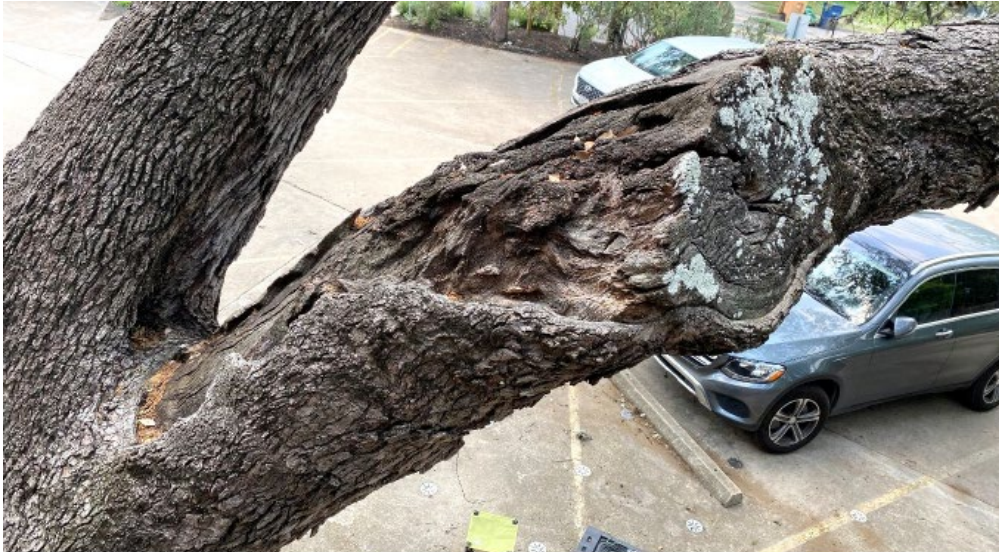
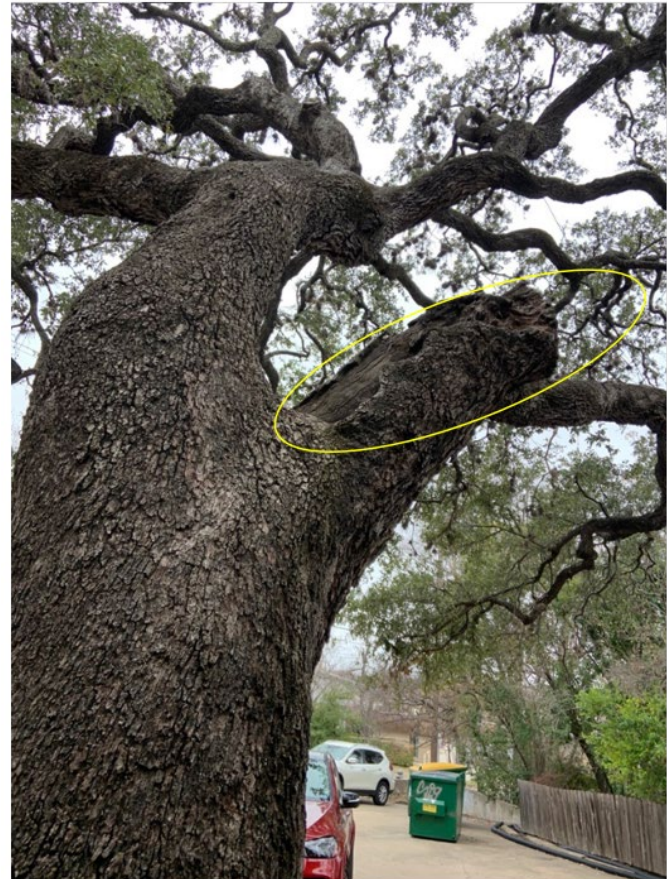
Tree structure

Large scaffold leader decay – west stem

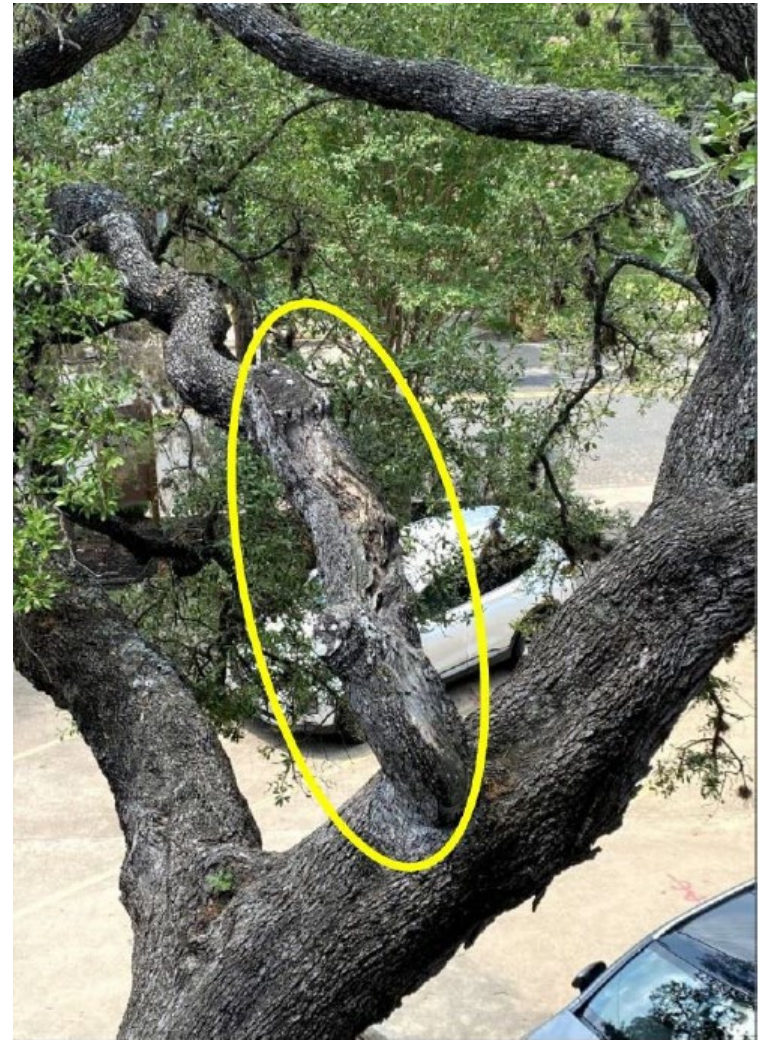
Tree structure (cont.)

Large scaffold leader decay – east stem

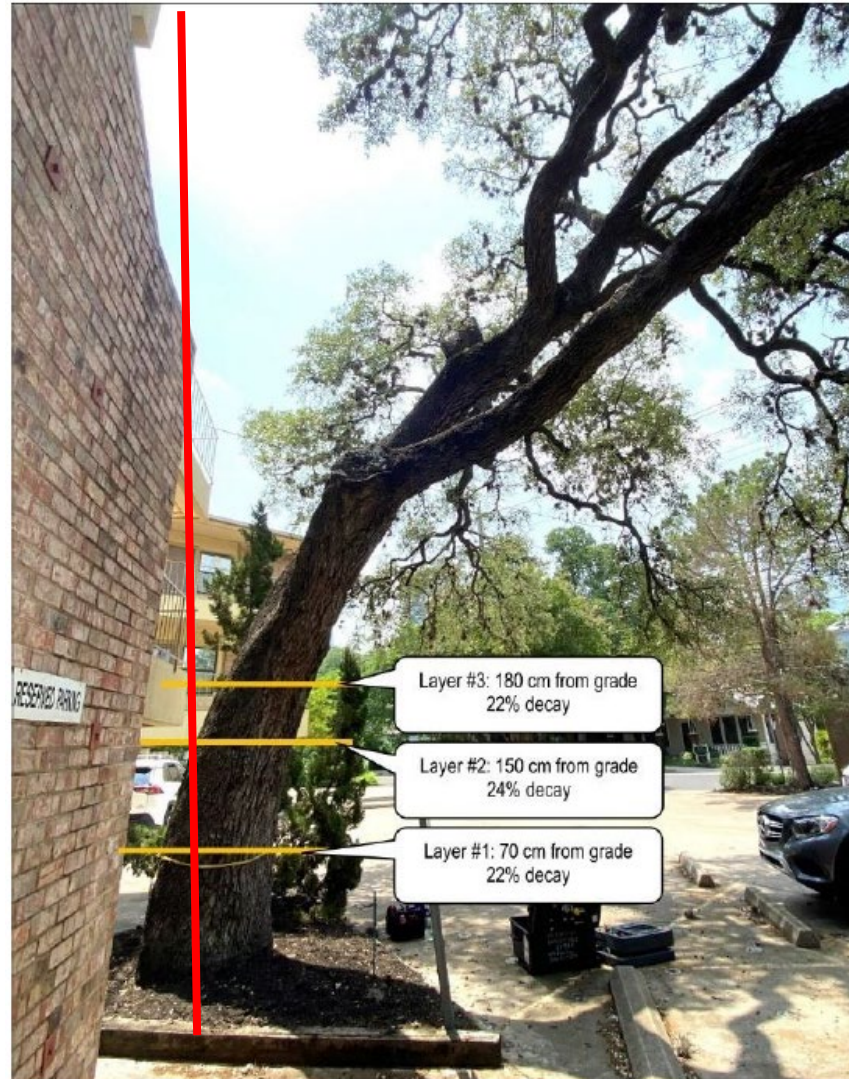
Tree structure (cont.)

- Unbalanced crown
- High load on top of asymmetrical structure

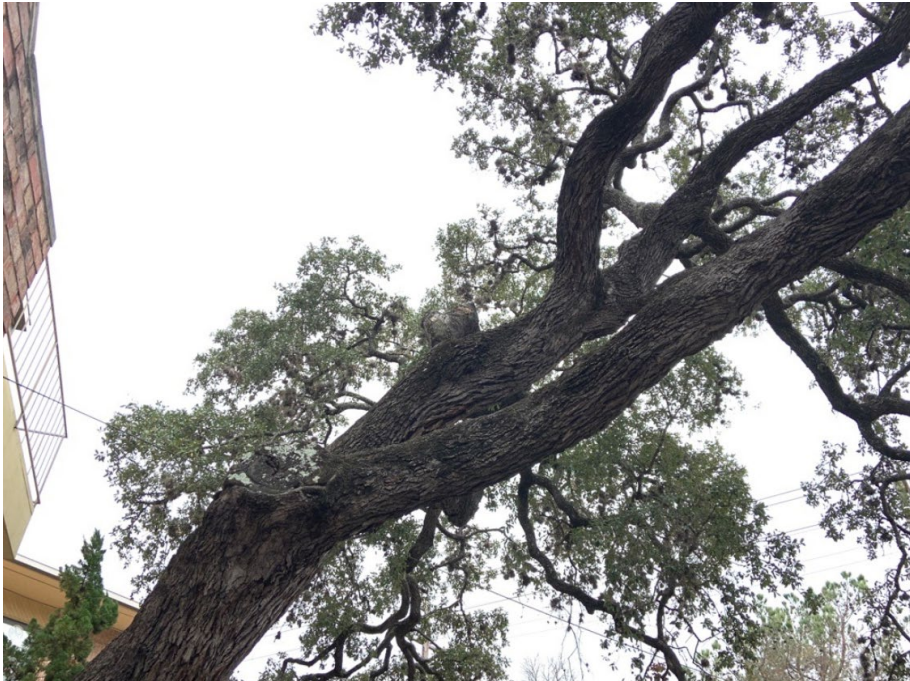
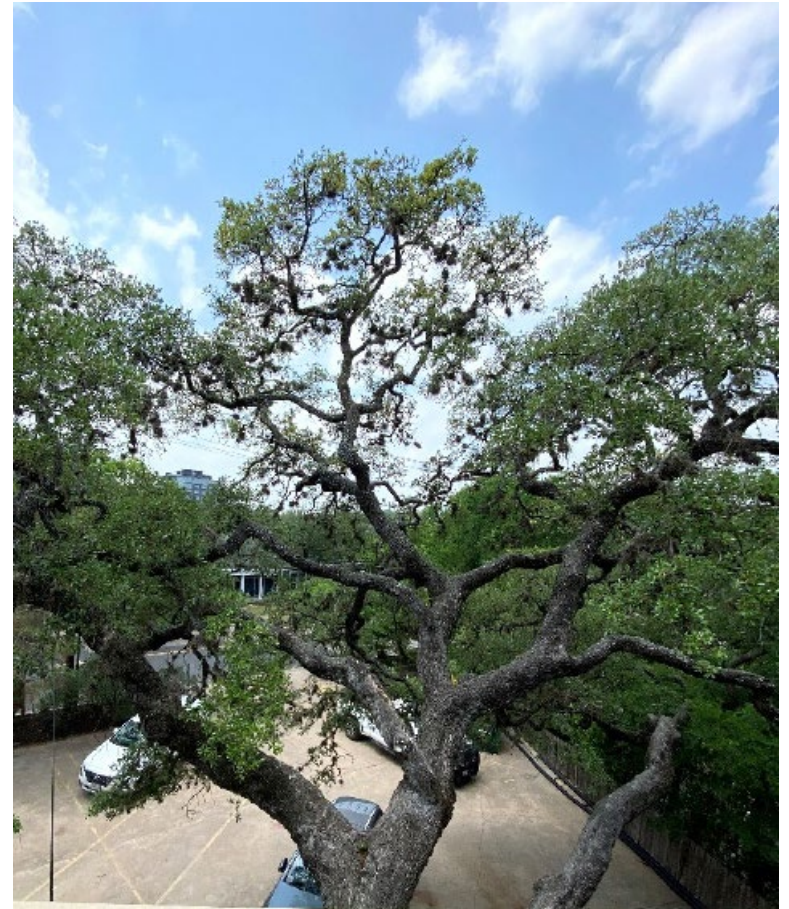
Tree Canopy/Crown

- Thin canopy
- Epiphytic ball moss
- Chlorosis
