ZONING CHANGE REVIEW SHEET

CASE NUMBER: C14H-99-0000

HISTORIC NAME: Austin Athletic Club

ADDRESS OF PROPOSED ZONING CHANGE: 1301 Shoal Creek Boulevard

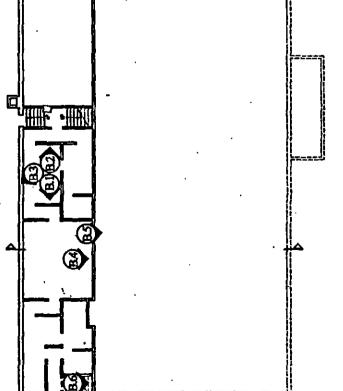
Photo B.5, Flooring Beneath Gymnasium Photo B.2, Baseme Ĩ

Photo B.6, Basement Stains

Basement. The portion of the basement walls below grade are made of cast-im-place concrete. The segments of the walls above grade are made of wood studi. The floor of the basement is cast from concrete (refer to Photos B.1-3, pages 20 & 21). The building is located in a 100-year flood plain. As a result, there is accumulation of water in the mechanical room from site runoff and possibly from ground scepage. Cracks have developed in the concrete besement walls, most likely due to ground movement during the drying and wetting cycles.

Because of potential flooding, we recommend filling the basement with a "flowable fill" (a mixture of send, fly ash, a small amount of cement, and water) rather than repairing and renovating it. The cost of renovation of the basement would be substantial in trying to make it watertight and to bring it up to the current code requirements. Additionally, it would not be advisable to reuse the existing mechanical room to store mechanical and electrical equipment.
