THE BATHHOUSE

Building Condition

MASTER PLAN The Bathhouse

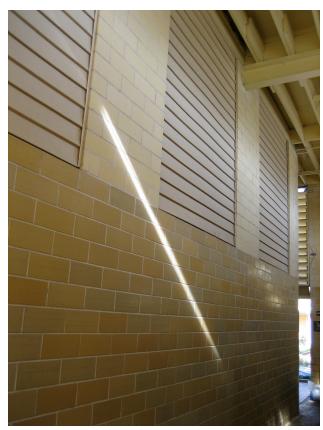
What were originally designed as generous openings into the basket rooms are covered with vinyl siding. A rehabilitated Bathhouse should replace the siding with glass to create a light-filled, double-height space.

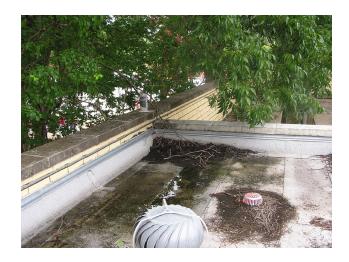
With a single area drain, and no overflow drain, a clog could lead to a catastrophic roof collapse.

Many of the subordinate roofs are flat, and are surrounded by parapet walls. Because they are designed with a primary roof drain and no overflow drain, they do not meet today's code (above). Some of the roof membranes are pulling away from their substrates and puckering (below).

Instead of replacing parts of the roof, this plan recommends that the entire roof be replaced at this time. The existing roof is old and it leaks and its insulation is questionable anyway, so an entire roof replacement makes sense from an economy-of-scale standpoint. This work should include new insulation, flashings and new code-compliant drains.
