EXISTING CONDITIONS AND CONSTRAINTS

PRELIMINARY PLAYGROUND DESIGN

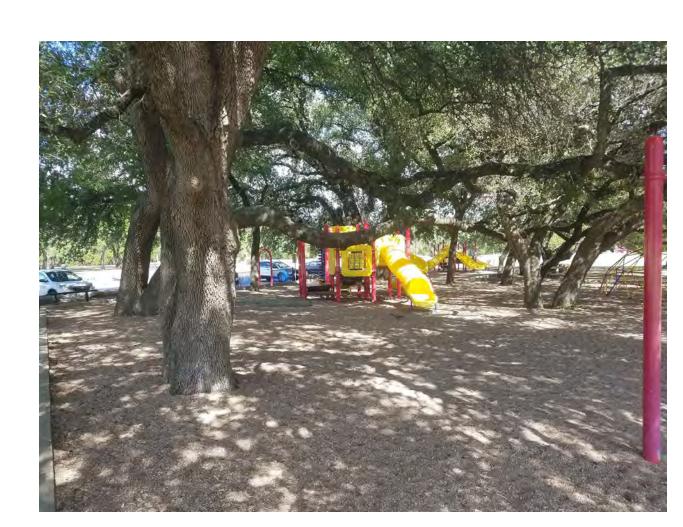
ALMOST THIRTY YEARS OF TREE GROWTH SINCE THE PLAY EQUIPMENT WAS INSTALLED

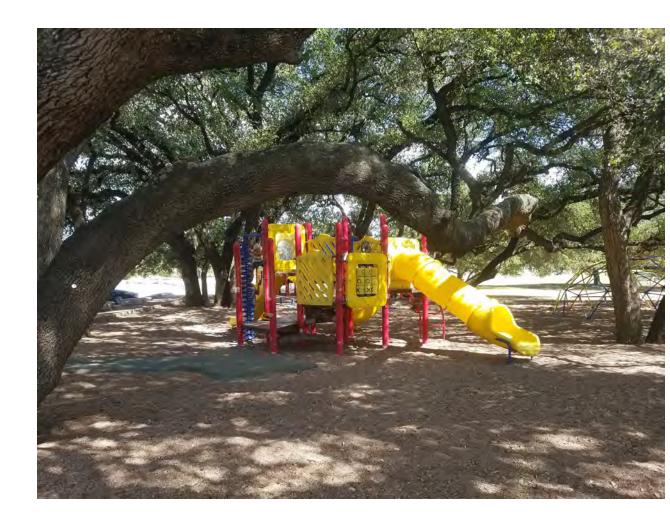
LOW BRANCHES LIMITING POSSIBLE LOCATION OF NEW PLAY EQUIPMENT

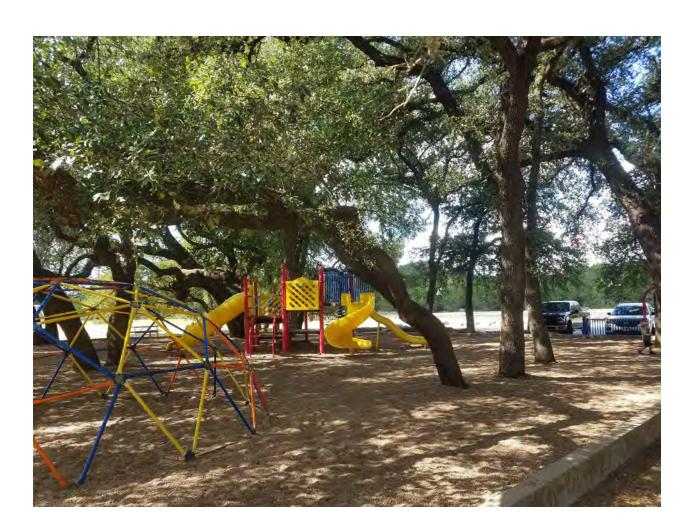
NO ACCESSIBLE PLAY OPTIONS AT EXISTING LOCATION. IF PEAGRAVEL WERE REPLACED WITH 12" DEEP SAFETY MULCH IT COULD CAUSE ROT AND MOISTURE DAMAGE AT THE BASE OF THE TREE TRUNKS

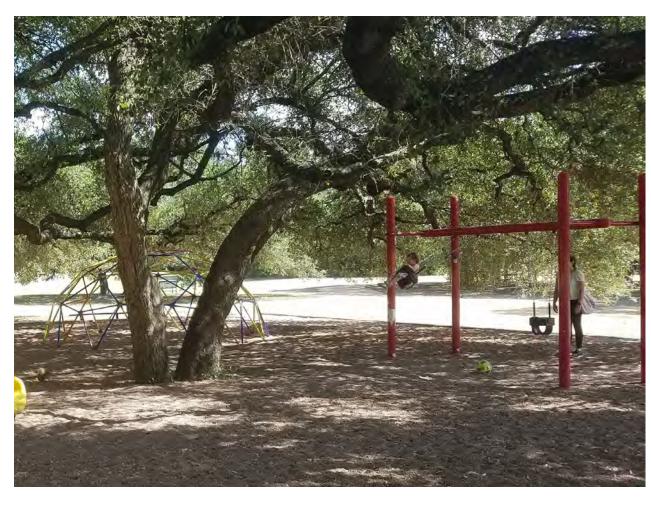
LOW BRANCHES THAT INTERACT WITH PLAY FEATURES CREATE SAFETY HAZARDS IN THE PLAY AREA

TYPE OF SWINGS ARE LIMITED BY TREE BRANCHES AND MEASURES OF CLEAR ZONES REQUIRED BY CONSUMER PRODUCT SAFETY COMMISSION
