**Phase I Environmental Site Assessment
Sunscape Apartments, 2425 West Cardinal Loop**

June 2004

Sunland Group
1907 N. Lamar Blvd
Austin, Texas 78705
Tel: 512.494.0208
Fax: 512.494.0406

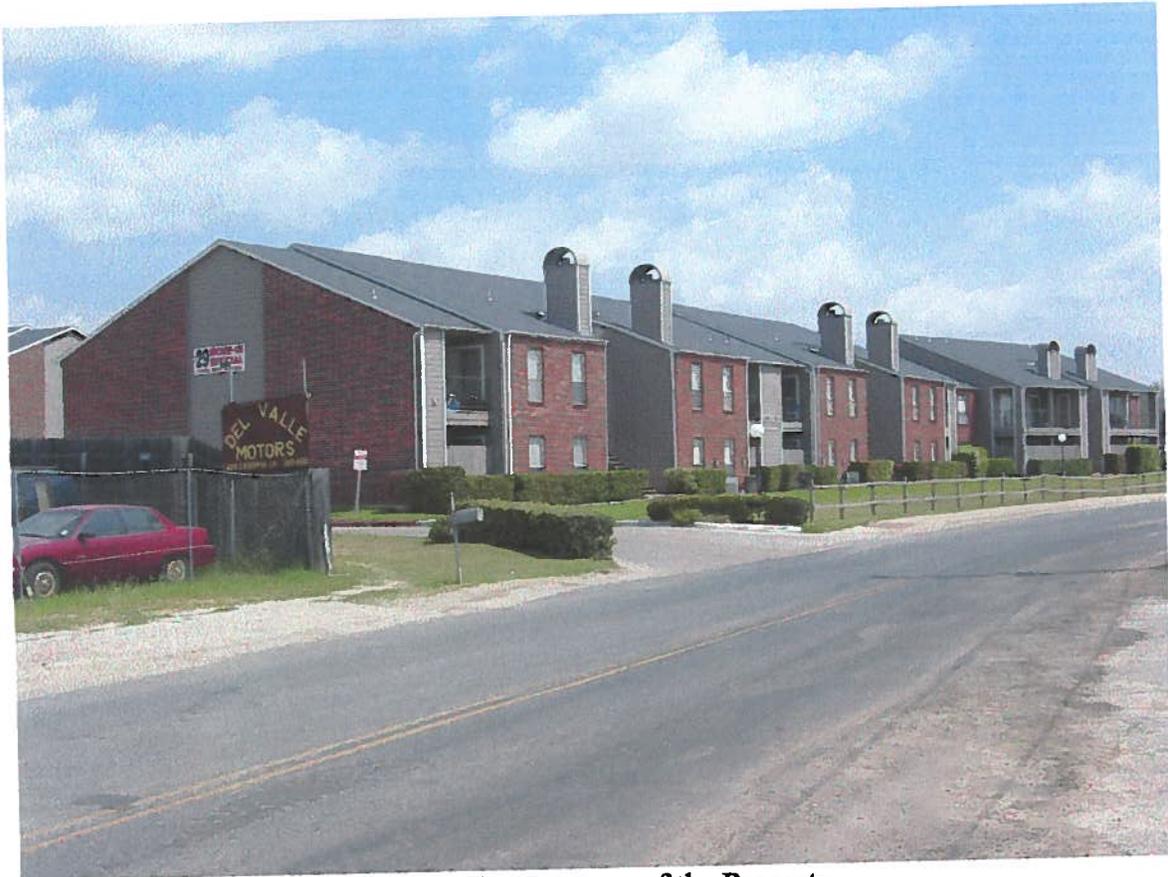
Photograph 1 shows a general view of the southeast corner of the Property. The south Property boundary (shown in Photograph 2), as with the west and north property boundaries, are denoted by a wooden privacy fence. What appeared to be a plugged monitoring well, shown in Photograph 3, was located near the southeast corner of the Property. This "well", located within a parking spot, had a 14-inch by 14-inch elevated pad which had been cut into the concrete parking area and a layer of concrete over the top of the elevated pad. A large crack in the concrete where the base material had given way was located approximately 120 feet from the southeast corner of the Property. This failure in the concrete is shown in Photograph 4. Two pole mounted transformers were located along the south property line. The first of these to the west of Cardinal Loop was the only one on the

Photograph 1: General view of the southeast corner of the Property.

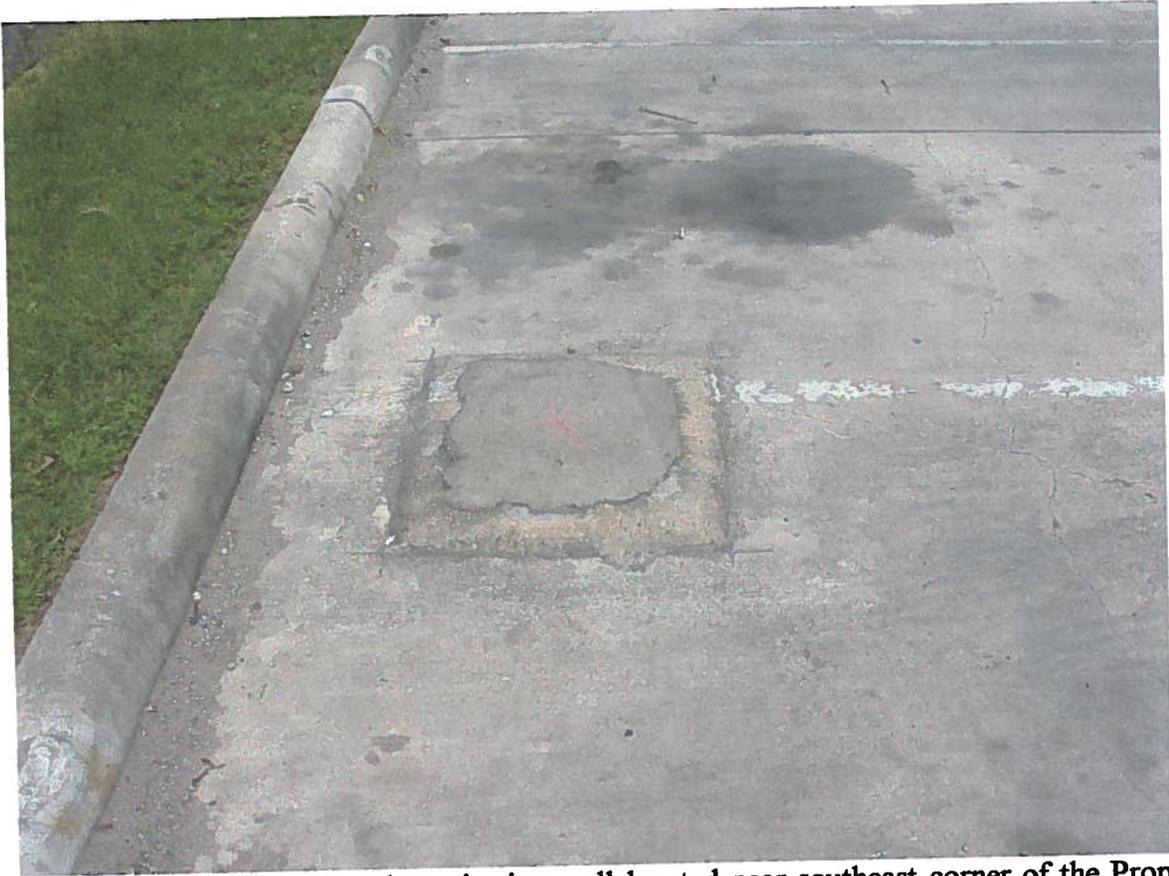
Photograph 3: Probable plugged monitoring well located near southeast corner of the Property along the south property line. No record of a well in this area of the Property was found.

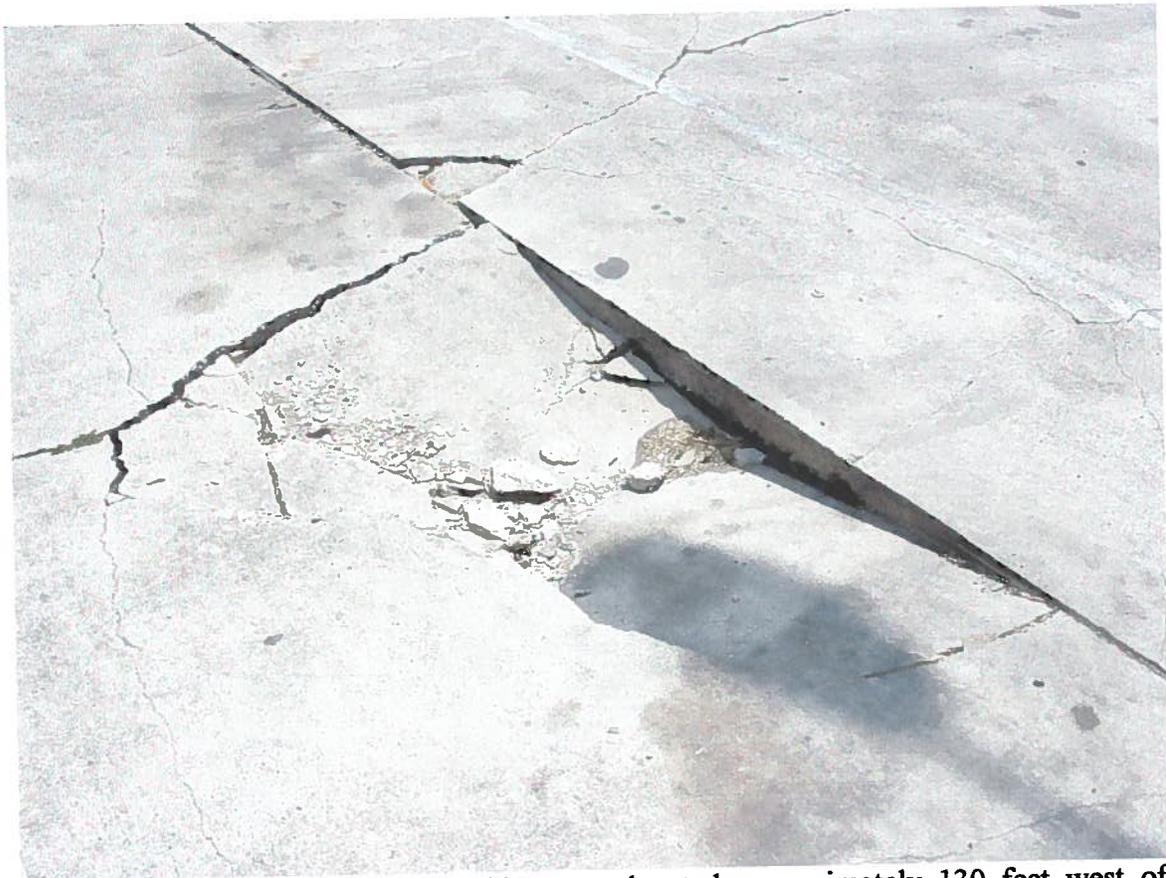
Photograph 4: Failure in concrete parking area located approximately 130 feet west of the southeast corner of the Property.

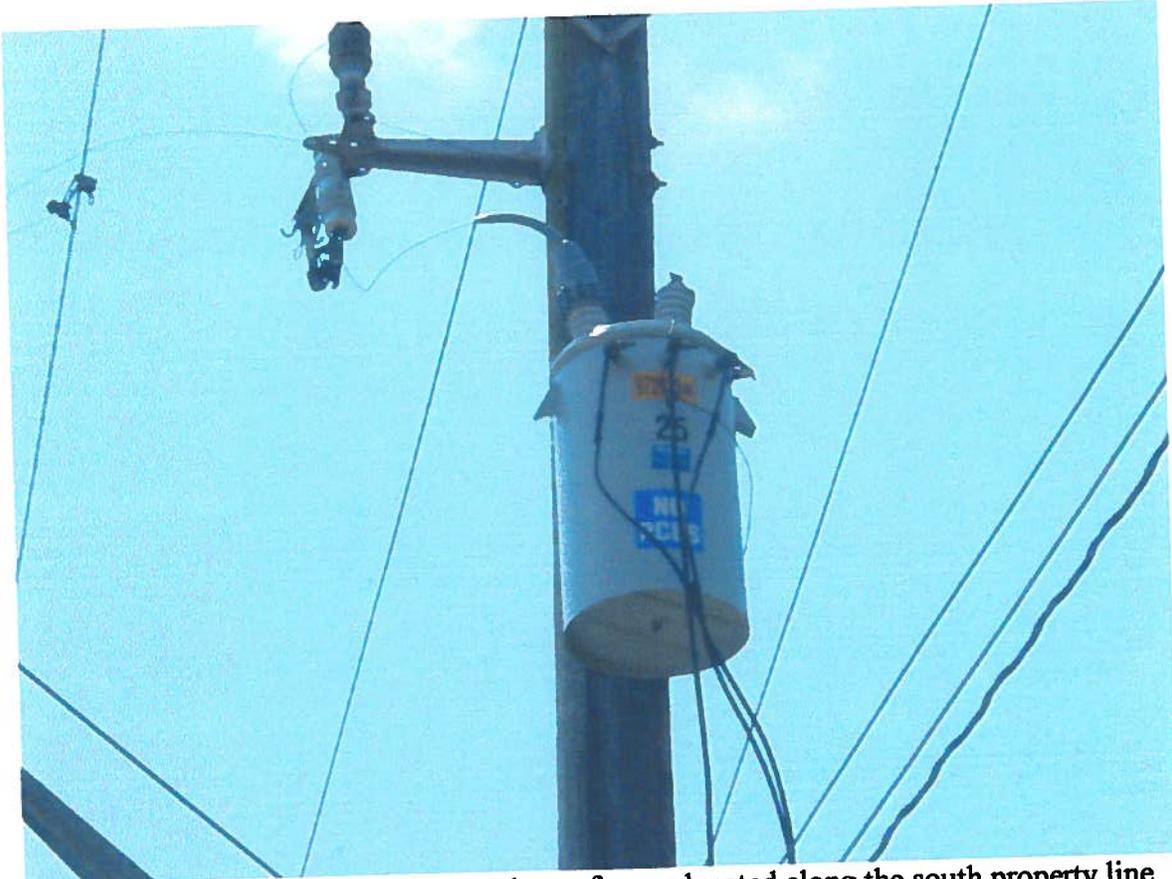
Property designated as not containing PCBs. This pole mounted transformer is shown in Photograph 5. The second pole mounted transformer located on the south property line (shown in Photograph 6) was nearly surrounded by a woody vine. This transformer appeared to have been in use for a number of years. The monitoring well located at the southwest corner of the Property, and previously mentioned in the original Phase I ESA, is shown in Photograph 7. Two small areas of stained soils, shown in Photographs 8 and 9, were also located at the southwest corner of the Property. These areas were less than four square feet combined and appeared to be a result of dumping used automotive oil. The discharge from these dumping occurrences on-site crossed the south property line and appeared to flow onto the adjacent property. Modifications to the southwest corner of the parking area have been made to accommodate for storm water drainage. A three-foot section of curb has been removed and a minor drainage channel with minimal relief was installed. As a result of this, storm water now drains to the west from this point where the original Phase I ESA noted all storm water drained to the east then north. This modification to the northwest corner of the parking area is shown in Photograph 10.

Photograph 5: Eastern most pole-mounted transformer located along the south property line.

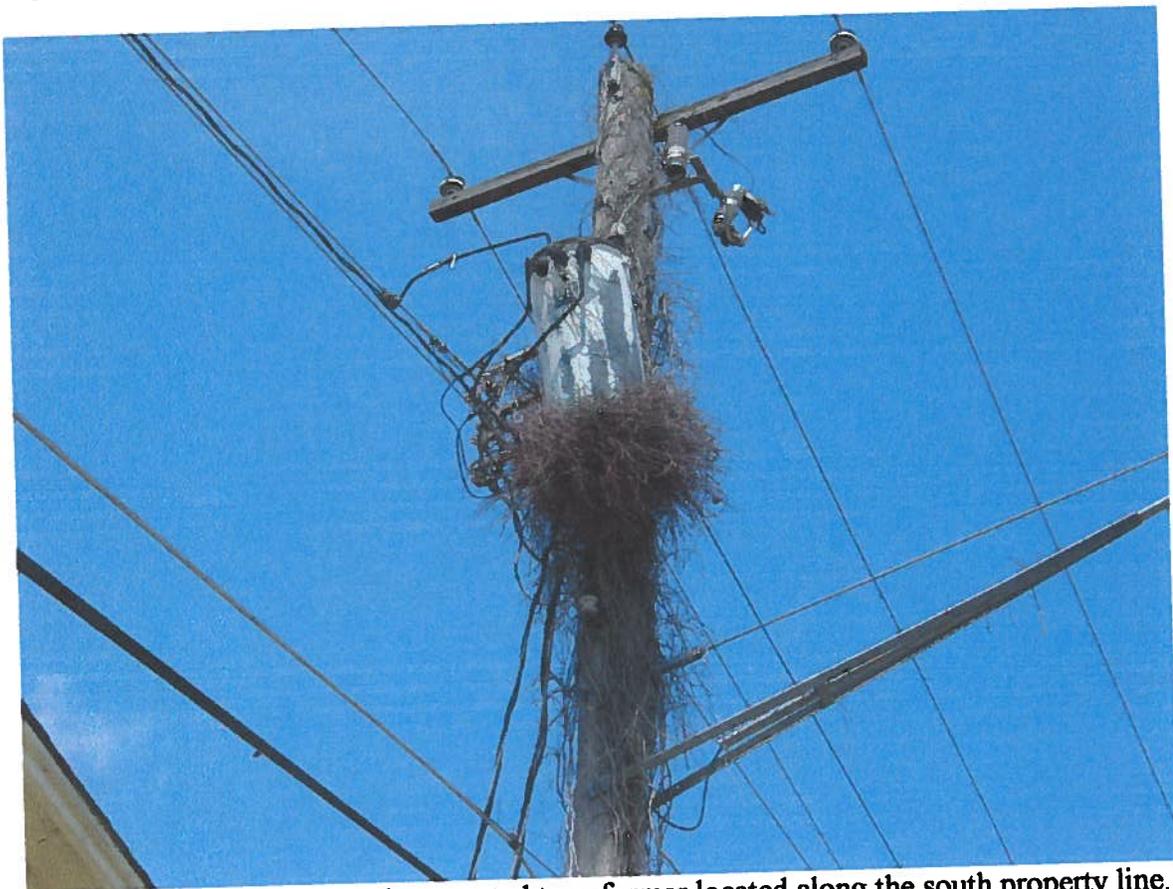
Photograph 6: Western most pole-mounted transformer located along the south property line.

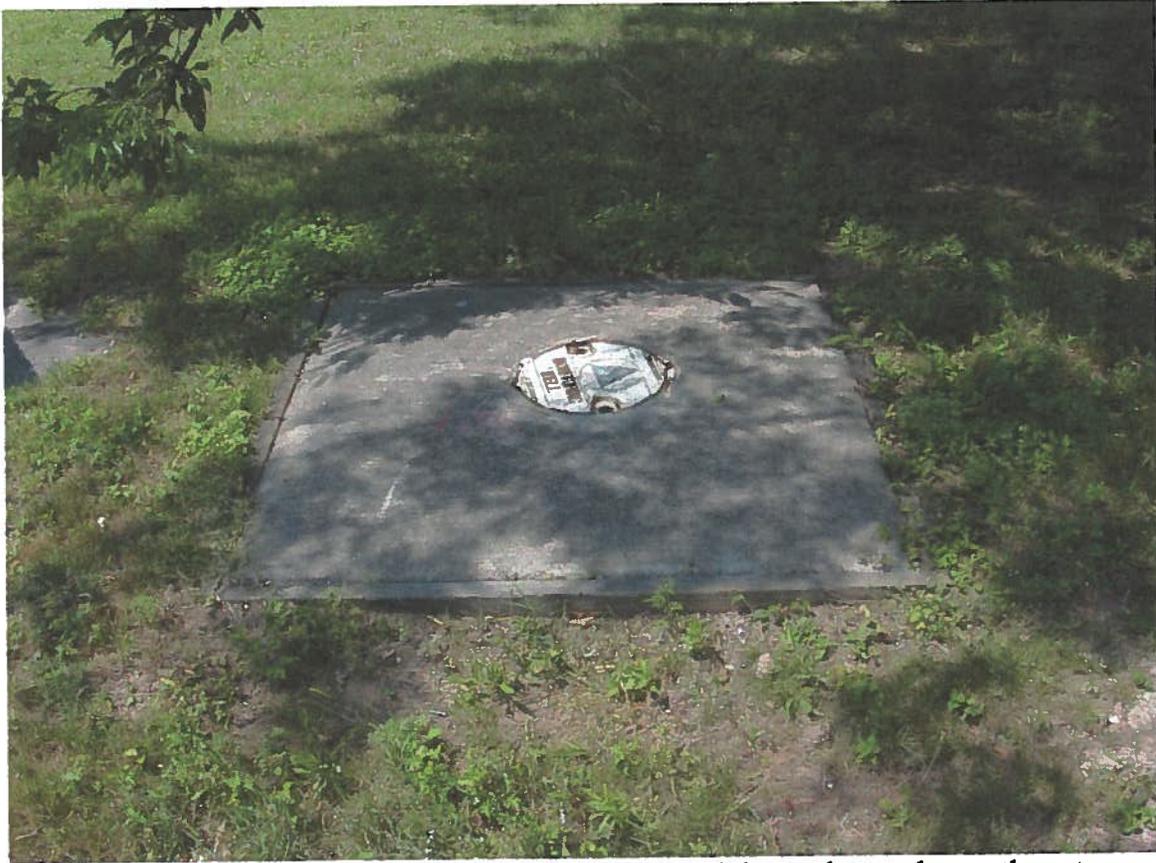
- There were two groundwater monitoring wells located on the Property. These wells are associated with remediation efforts for a TCE plume that originated on the north side of the former Bergstrom Air Force Base located on the south side of HWY 71. Remediation and monitoring efforts have been continuous for several years and a steady decline of TCE concentrations has been seen. Sampling events which have taken place in 2002 showed the area of contamination (plume) has receded to the south away from the Property. Concentration levels of TCE found under the Property were well below the MCL and PQL levels published by the Texas Commission on Environmental Quality. Given the level of decline in concentration and the effective withdraw of this constituent from the Property, there is little reason for concern to the condition of the Property.

Photograph 7: Groundwater monitoring well (# SM69MW) located near the southwest corner of the Property.

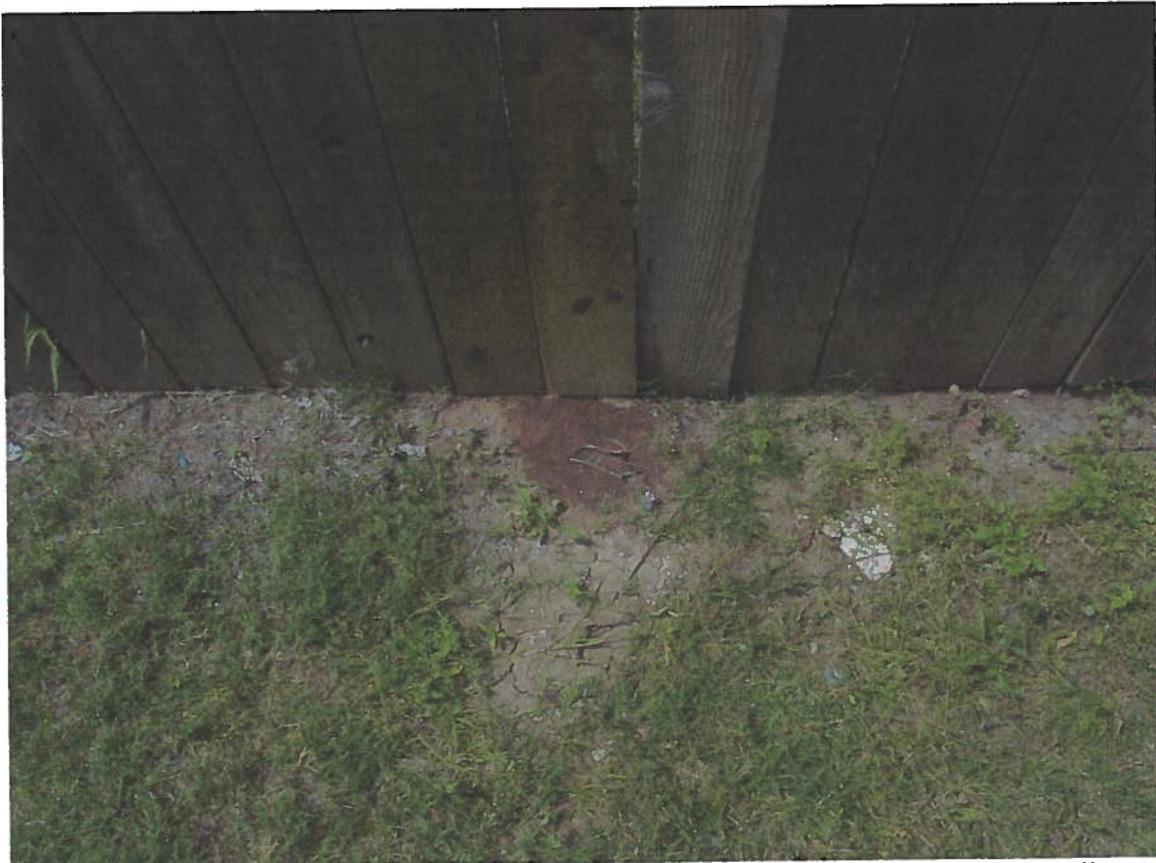
Photograph 8: One square foot area of stained soils located along the south property line at the southwest corner.

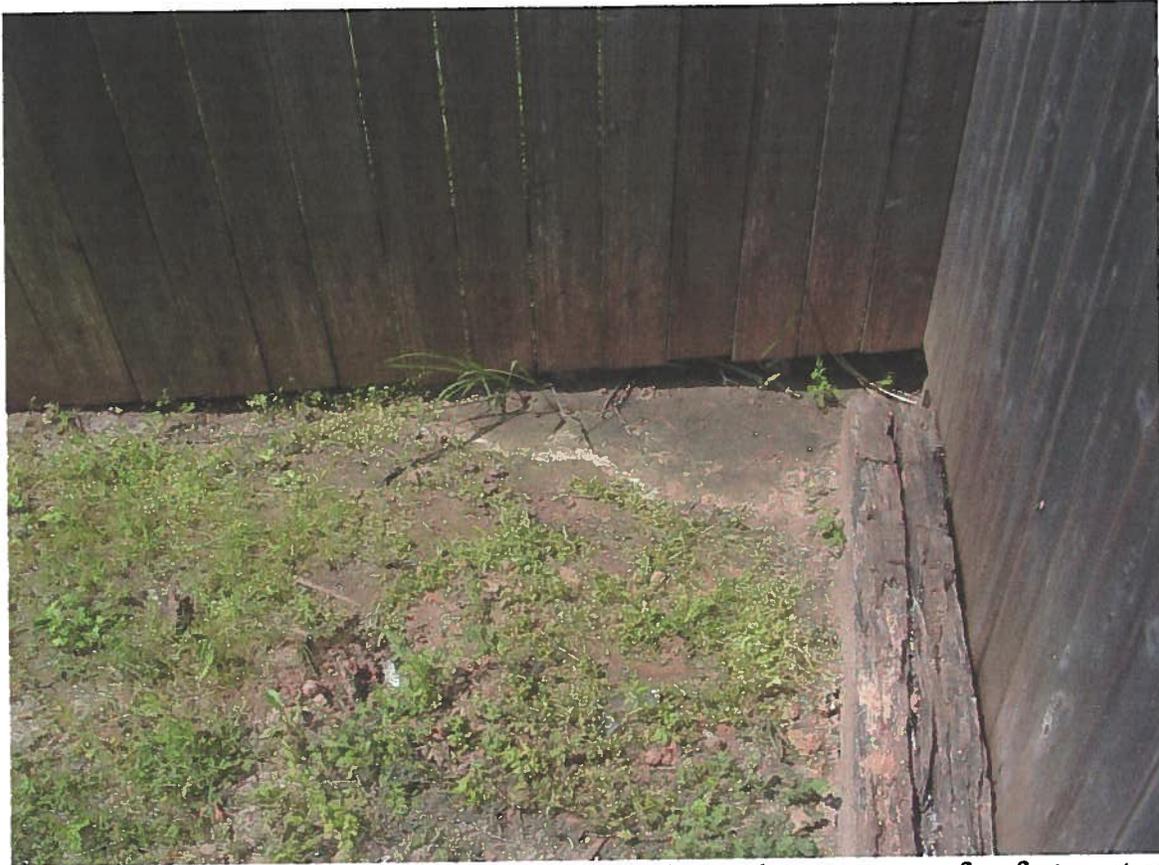
Photograph 9: Second area of stained soils located at the southwest corner a few feet west of the one shown in the previous photograph.

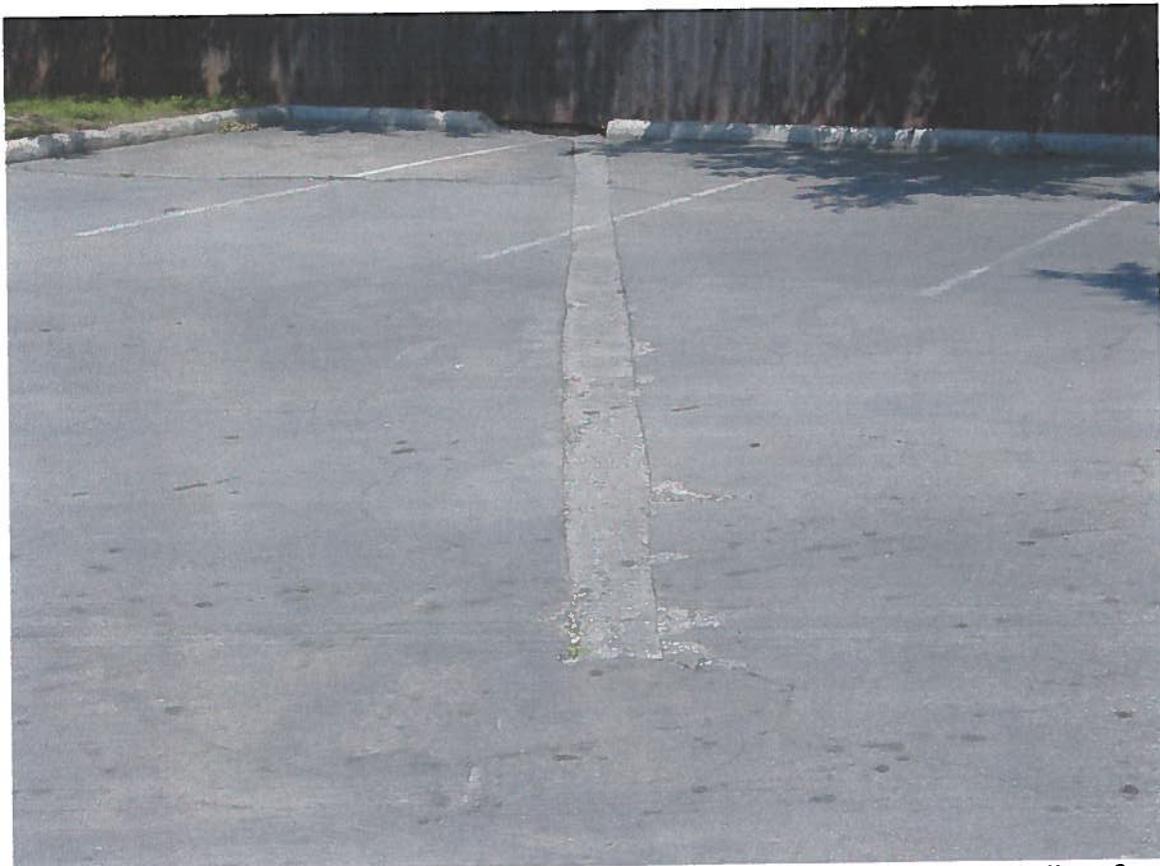
Photograph 10: Modification to concrete parking area near the southwest corner to allow for drainage to the southwest.

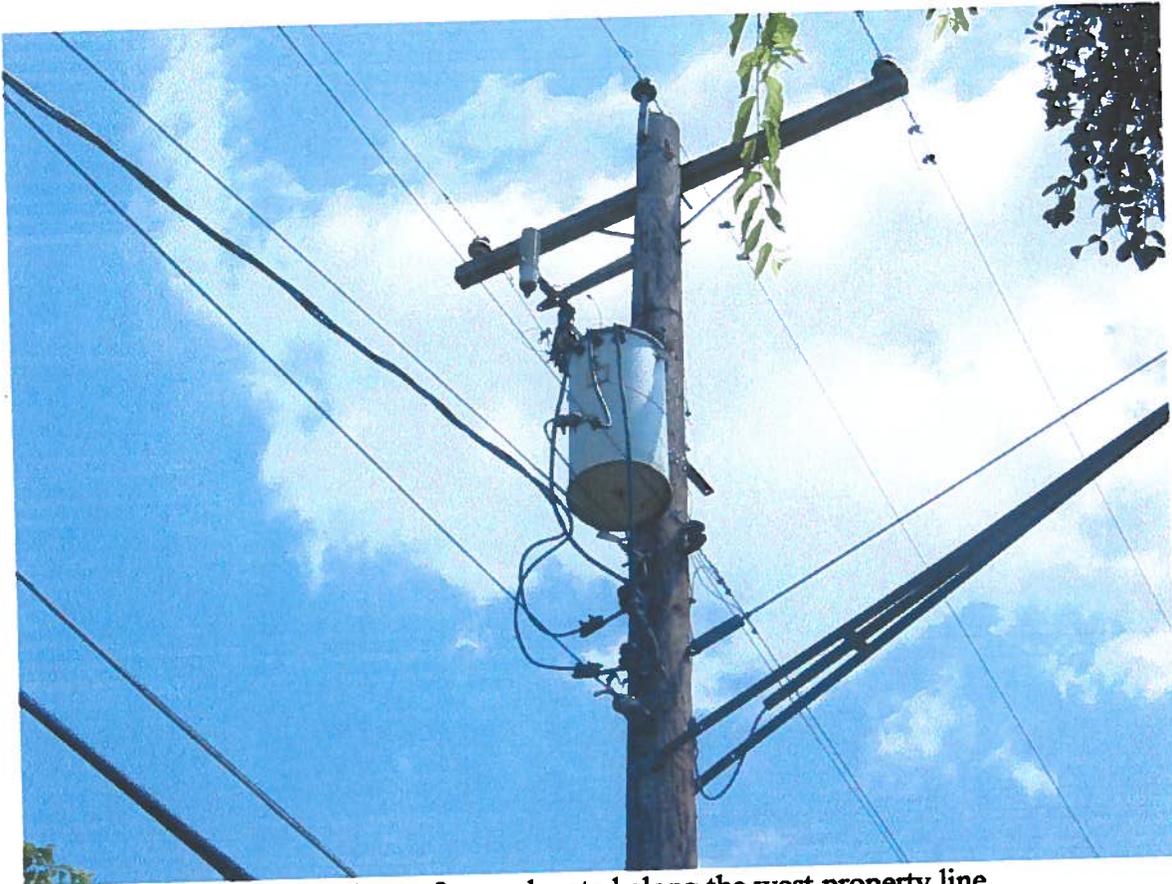
Only one pole mounted transformer was located on the west property line. This transformer, shown in Photograph 11, was not labeled as to whether or not it contained PCBs; however, it appeared to be in good condition and did not show any signs of a release. There were four other small areas of stained soils along the west property/fence line. Three of these areas appeared to be the result of used oil discharge (probably from automotive oil changes done by residents of the apartment complex) and the remaining area consisted of what appeared to be tar. These areas are shown in photographs 12 through 15.

Photograph 11: Pole-mounted transformer located along the west property line.

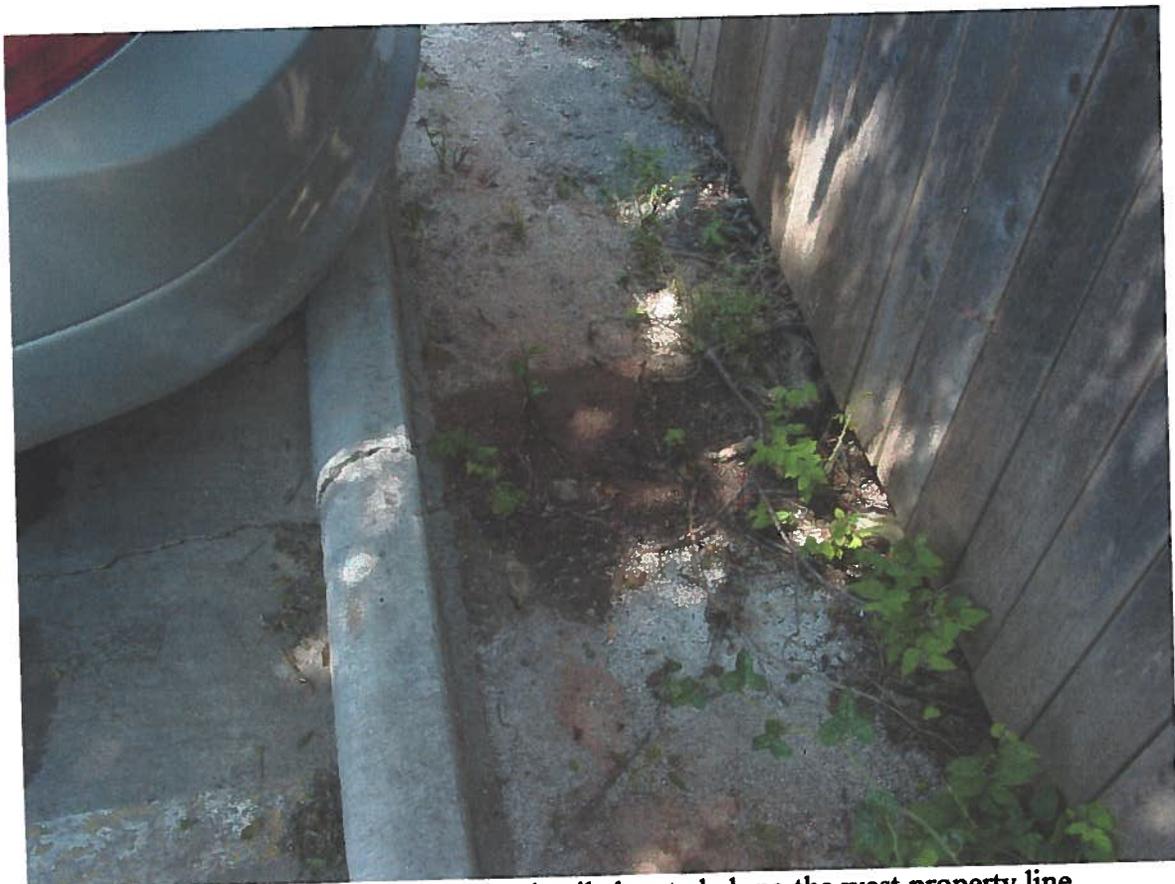
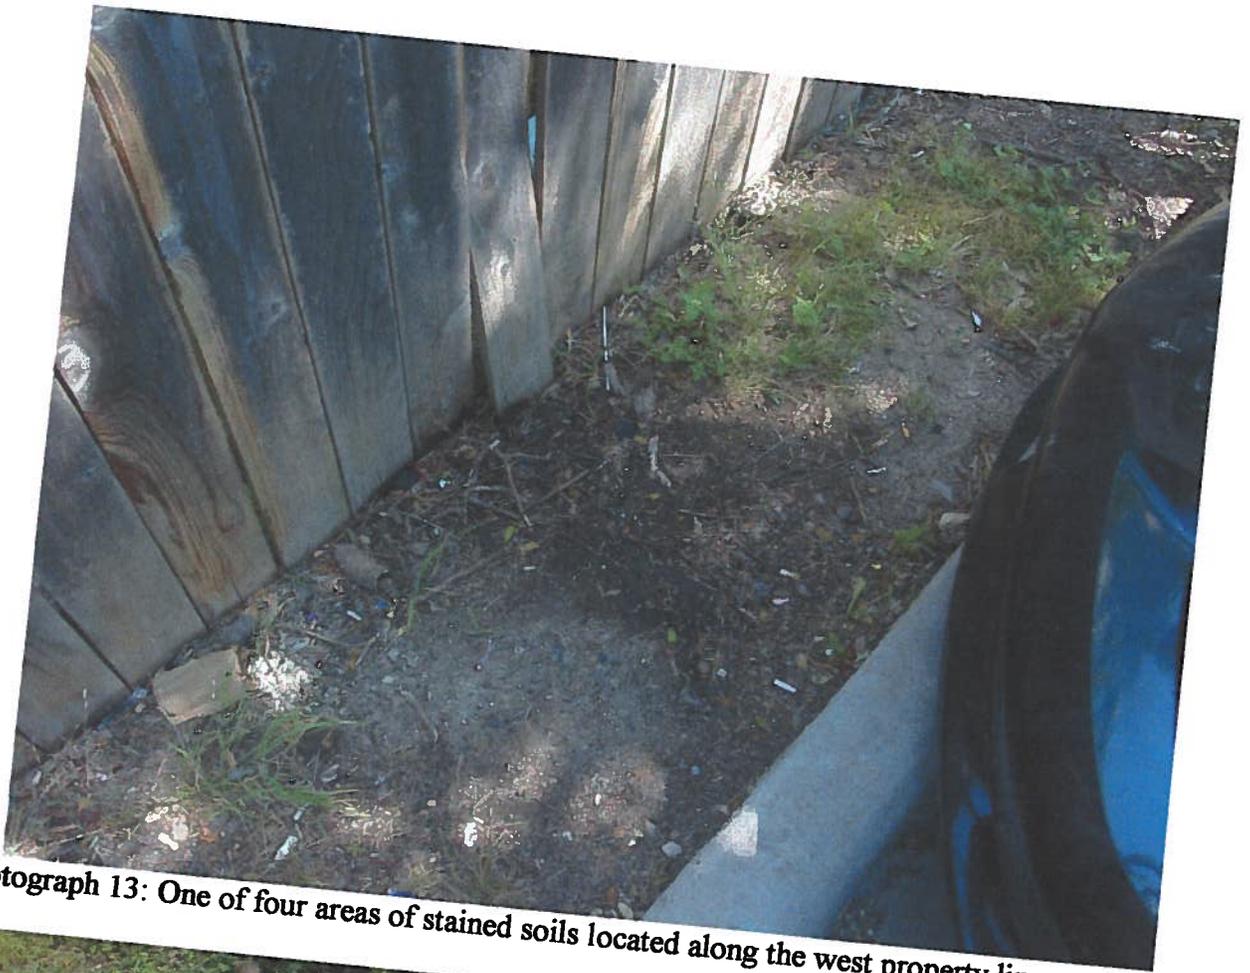
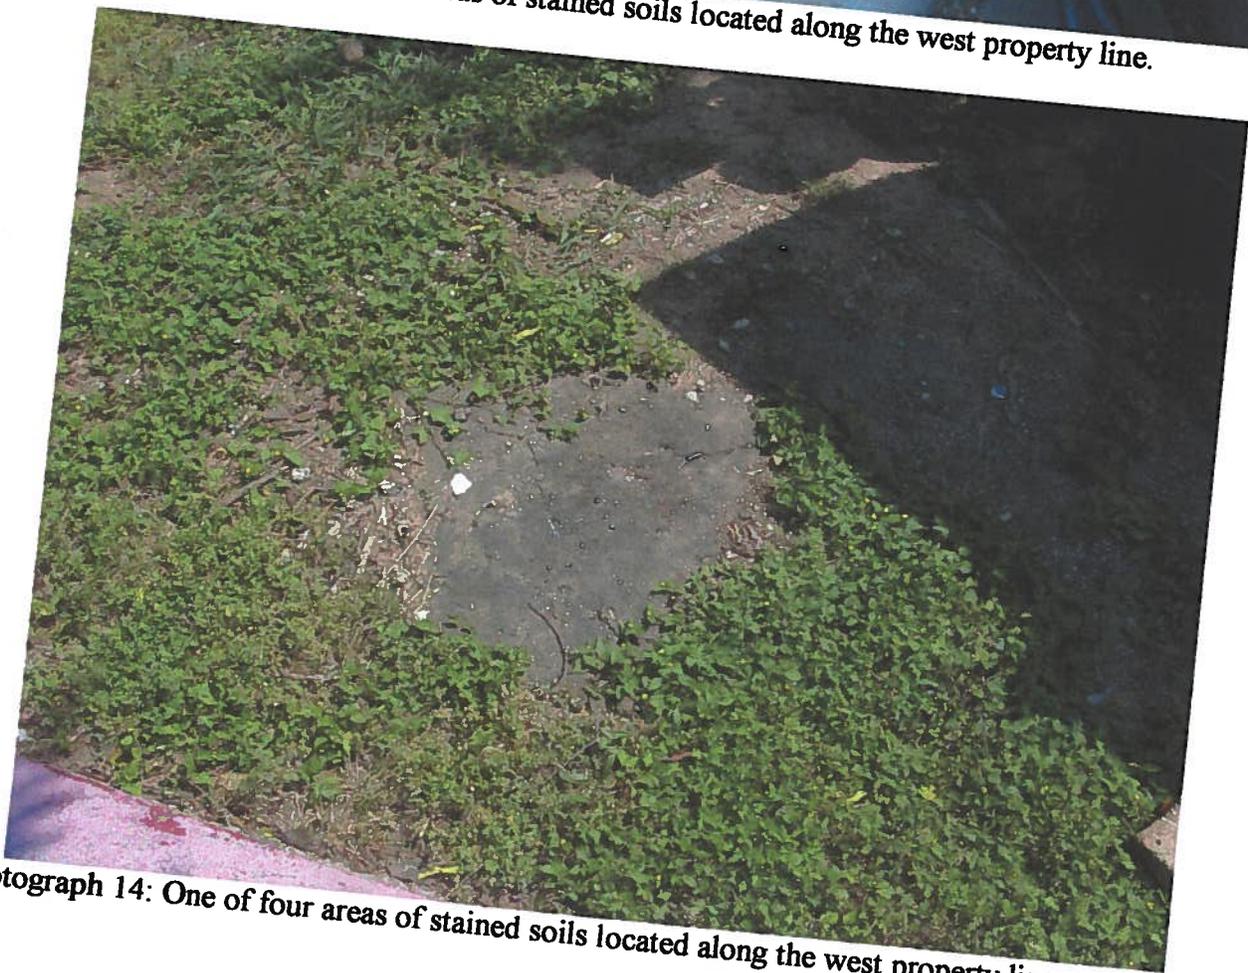
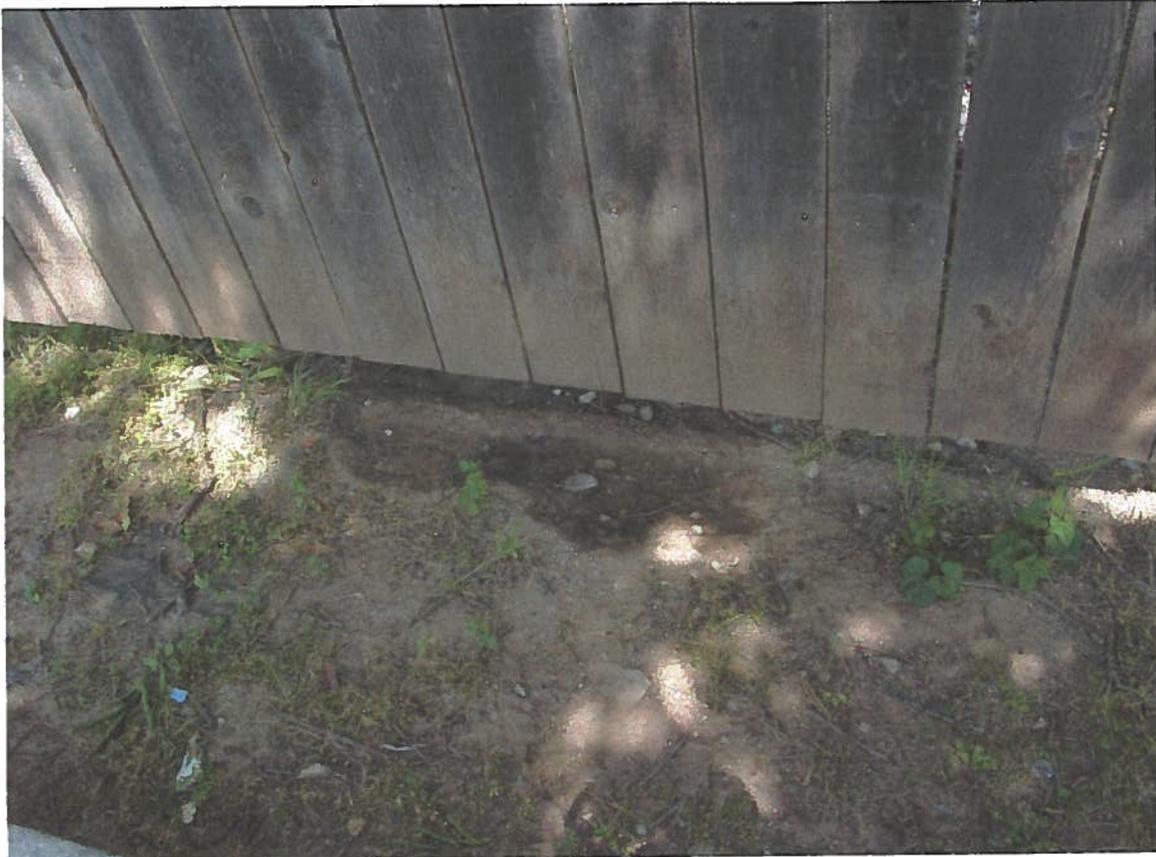
- There were small areas of stained soils located along the west property line that appeared to be the result of minor dumping of used automotive oil. Other than these small areas, there was no evidence of hazardous substance spills or releases on the Property.

Photograph 12: One of four areas of stained soils located along the west property line.

Photograph 13: One of four areas of stained soils located along the west property line.

Photograph 14: One of four areas of stained soils located along the west property line.

Photograph 15: One of four areas of stained soils located along the west property line.

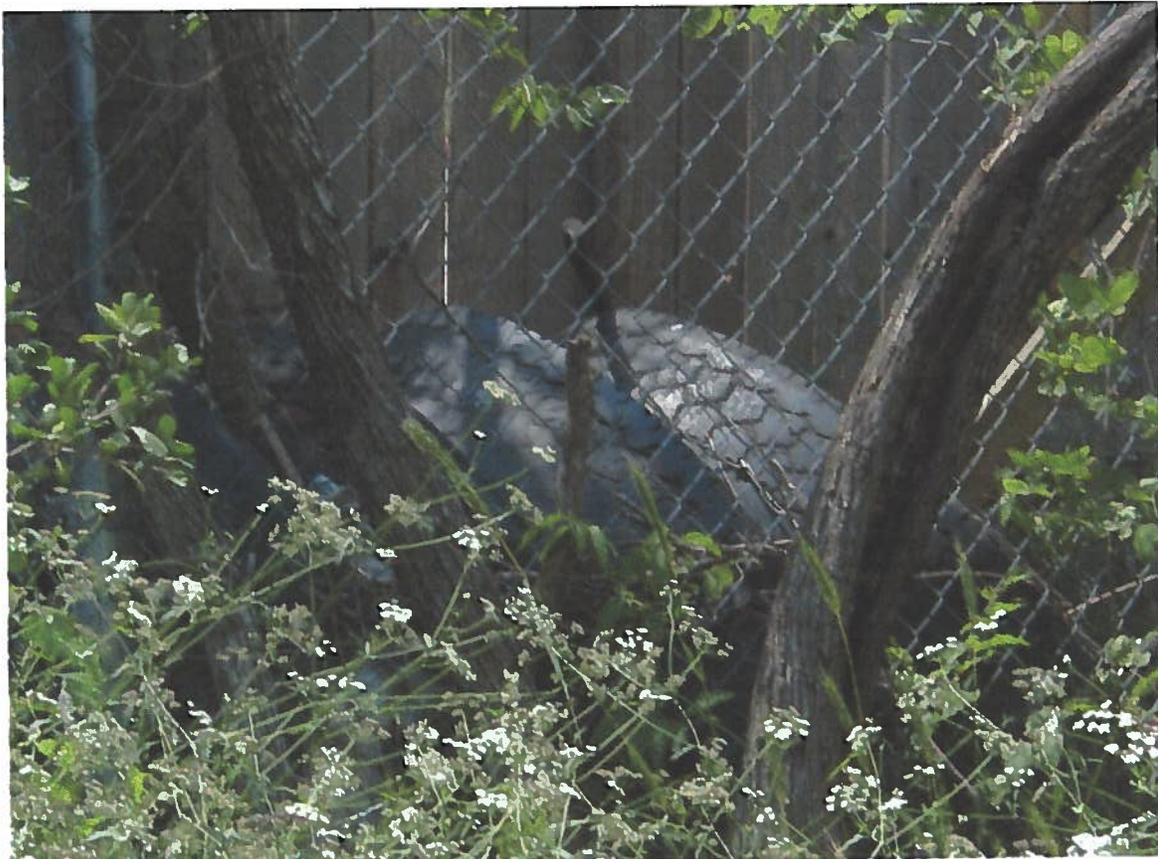
Photograph 16: Used tires located at the northwest corner of the Property, on the west side of the wooden fence.

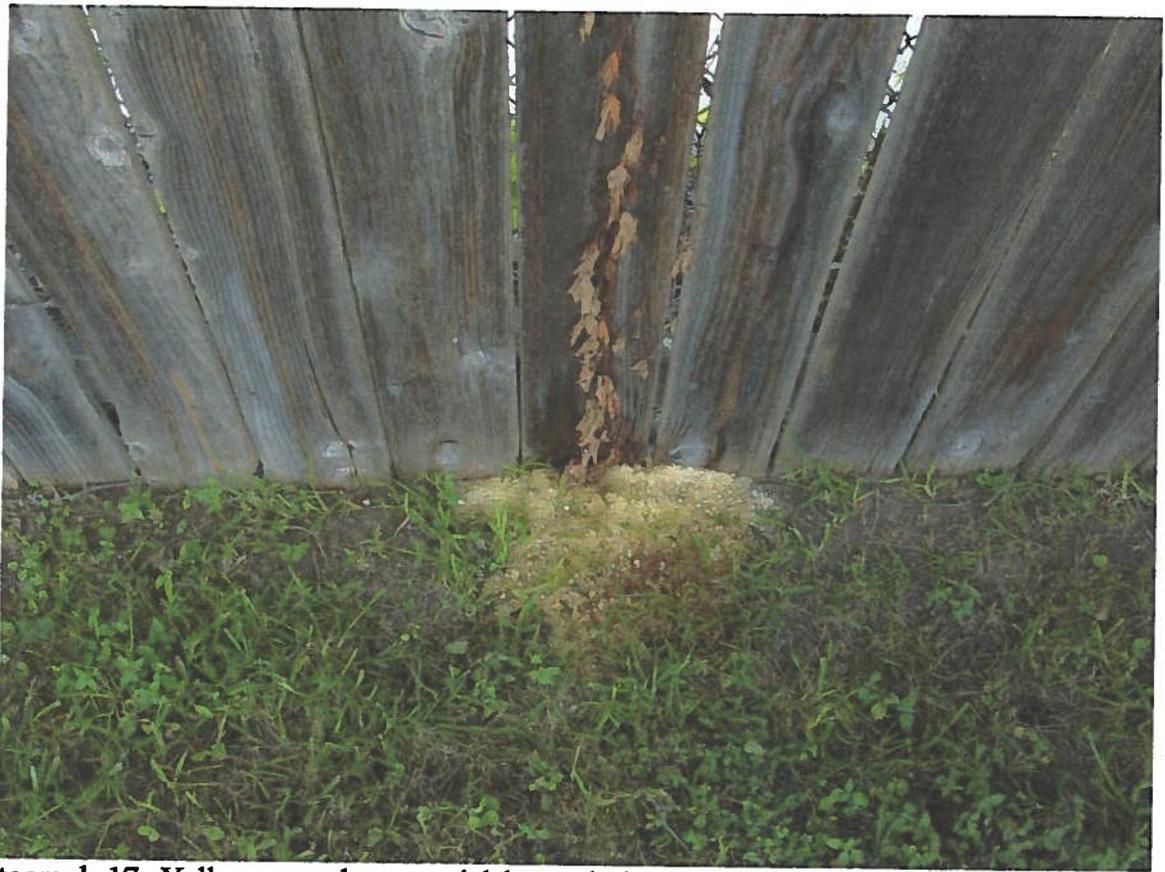
Photograph 17: Yellow granular material located along the north property line. Note that this material is at the base of a stressed/dead plant.

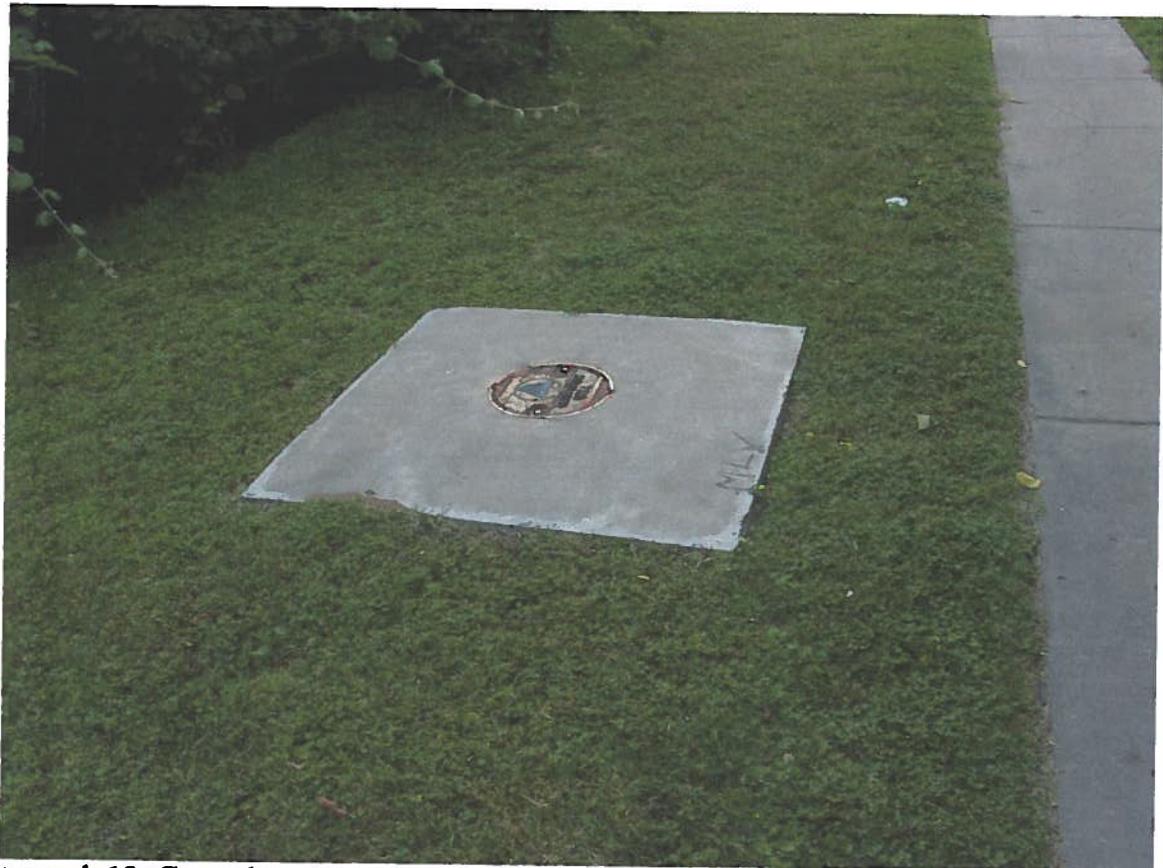
Photograph 18: Groundwater monitoring well (# SM73MW) located near the northeast corner of the Property.

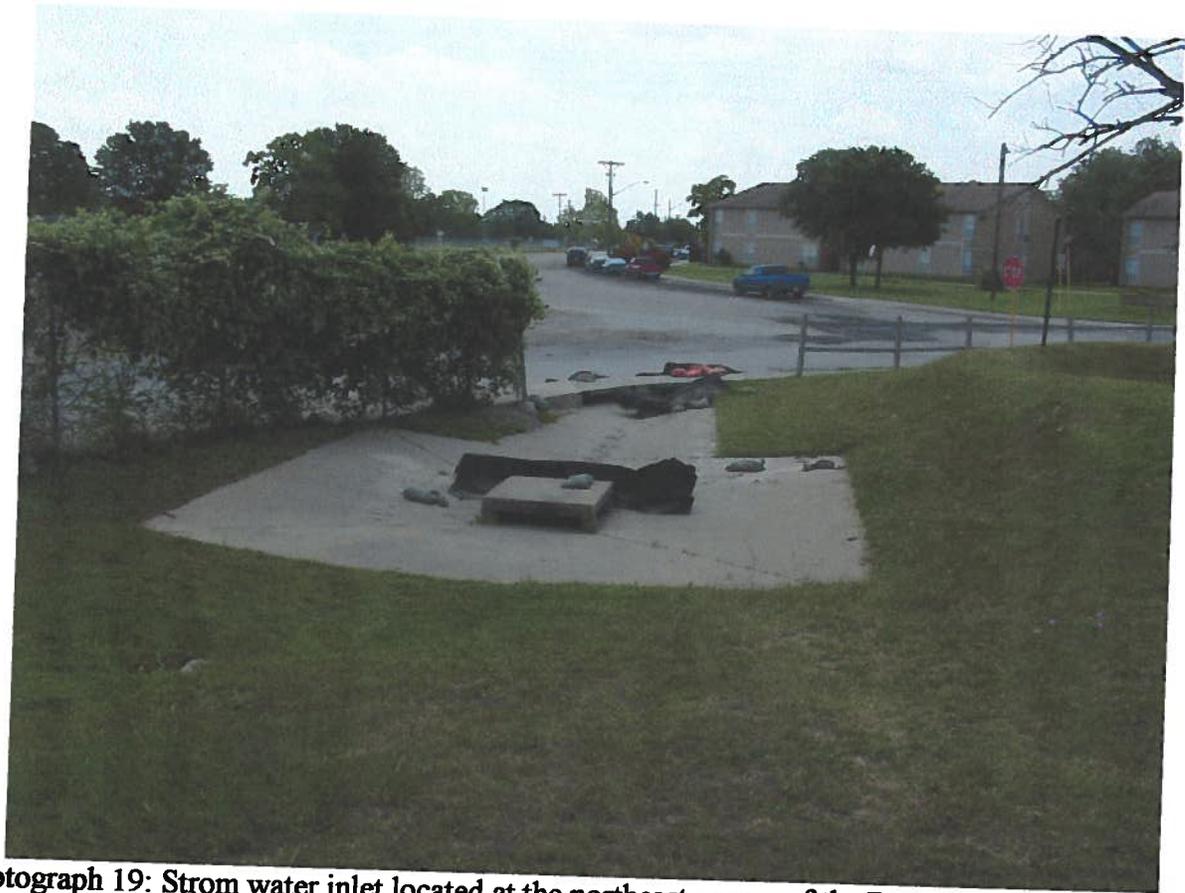
Photograph 19: Storm water inlet located at the northeast corner of the Property.

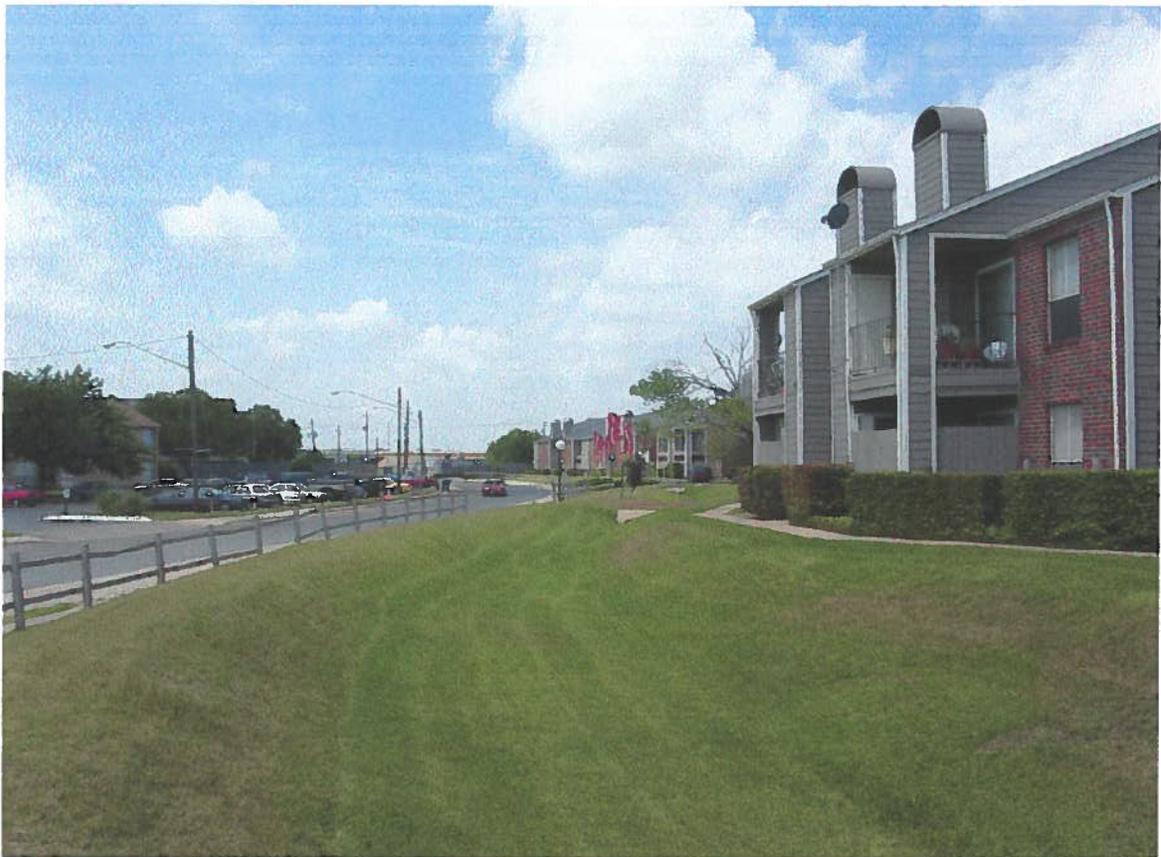
Photograph 21: Drainage swell located along the east property line that discharges to storm water inlet located at the northeast corner of the Property.
