**Phase I Environmental Site Assessment
Sunscape Apartments, 2425 West Cardinal Loop**

June 2004

Sunland Group
1907 N. Lamar Blvd
Austin, Texas 78705
Tel: 512.494.0208
Fax: 512.494.0406

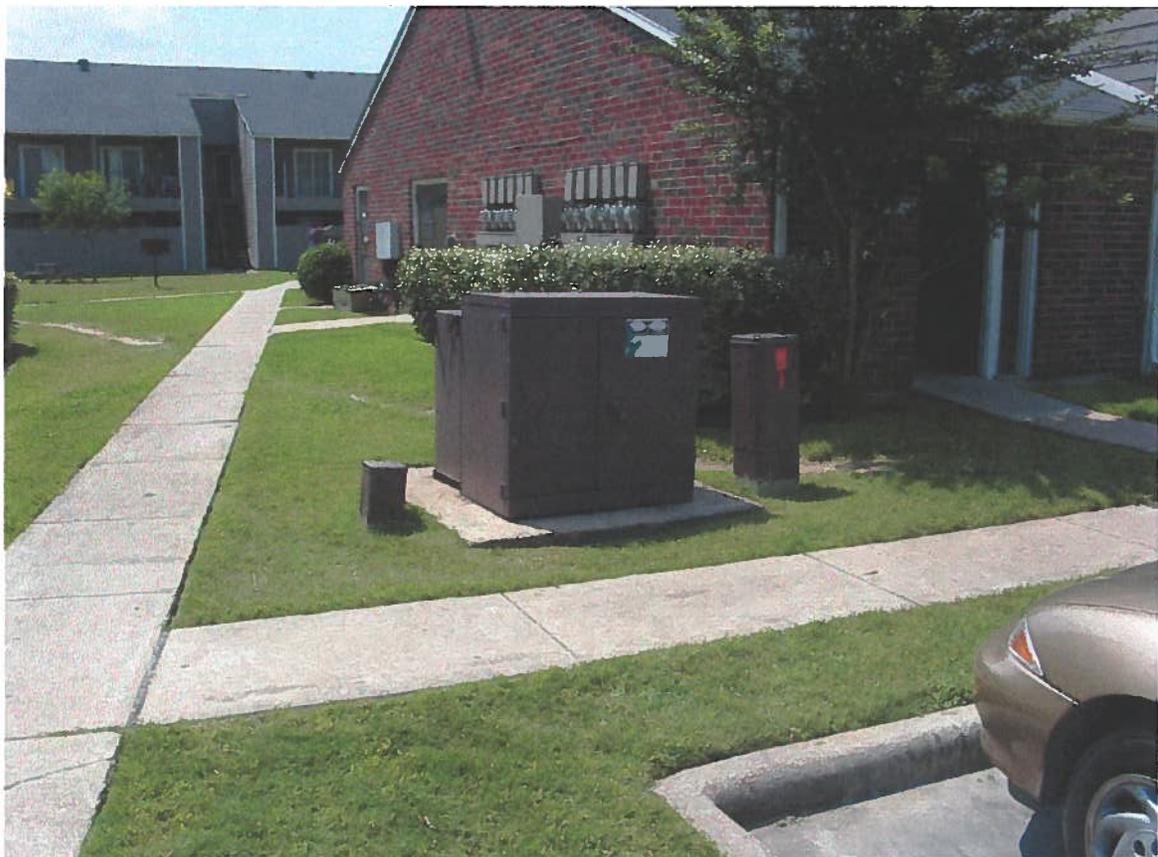
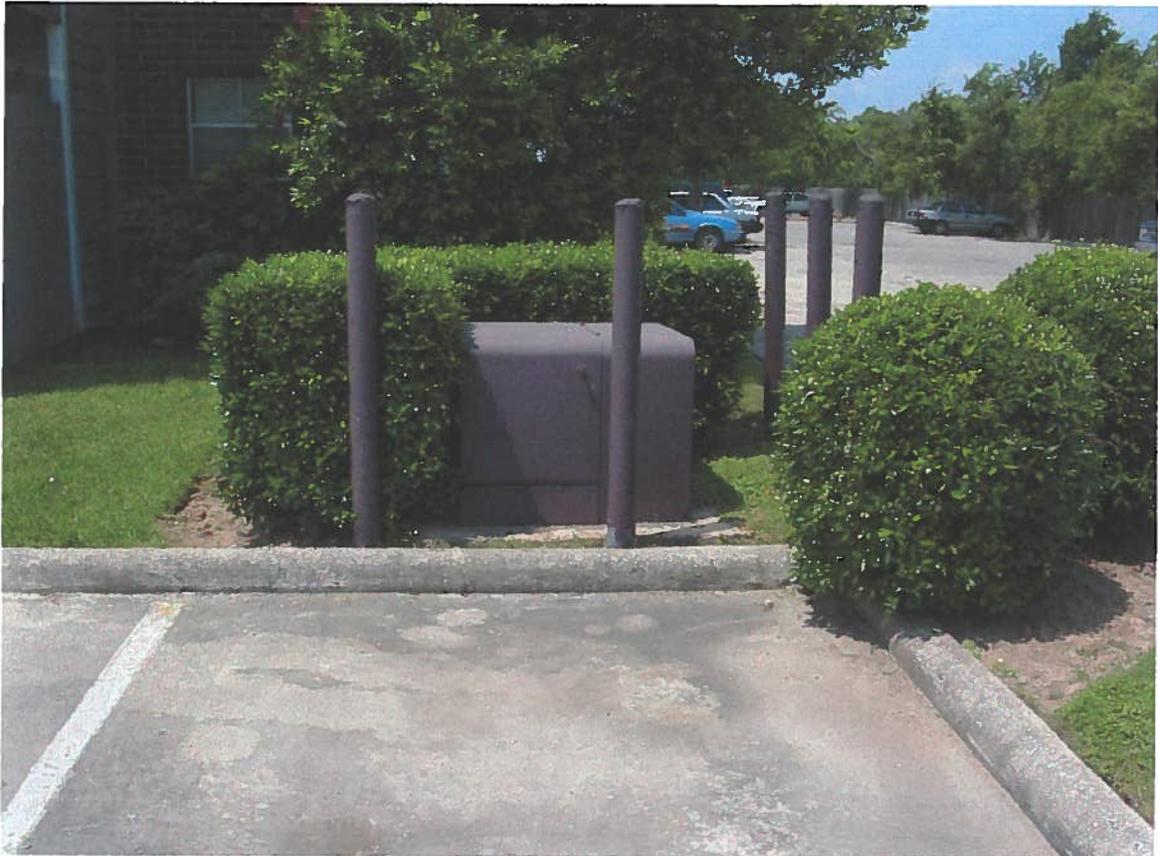
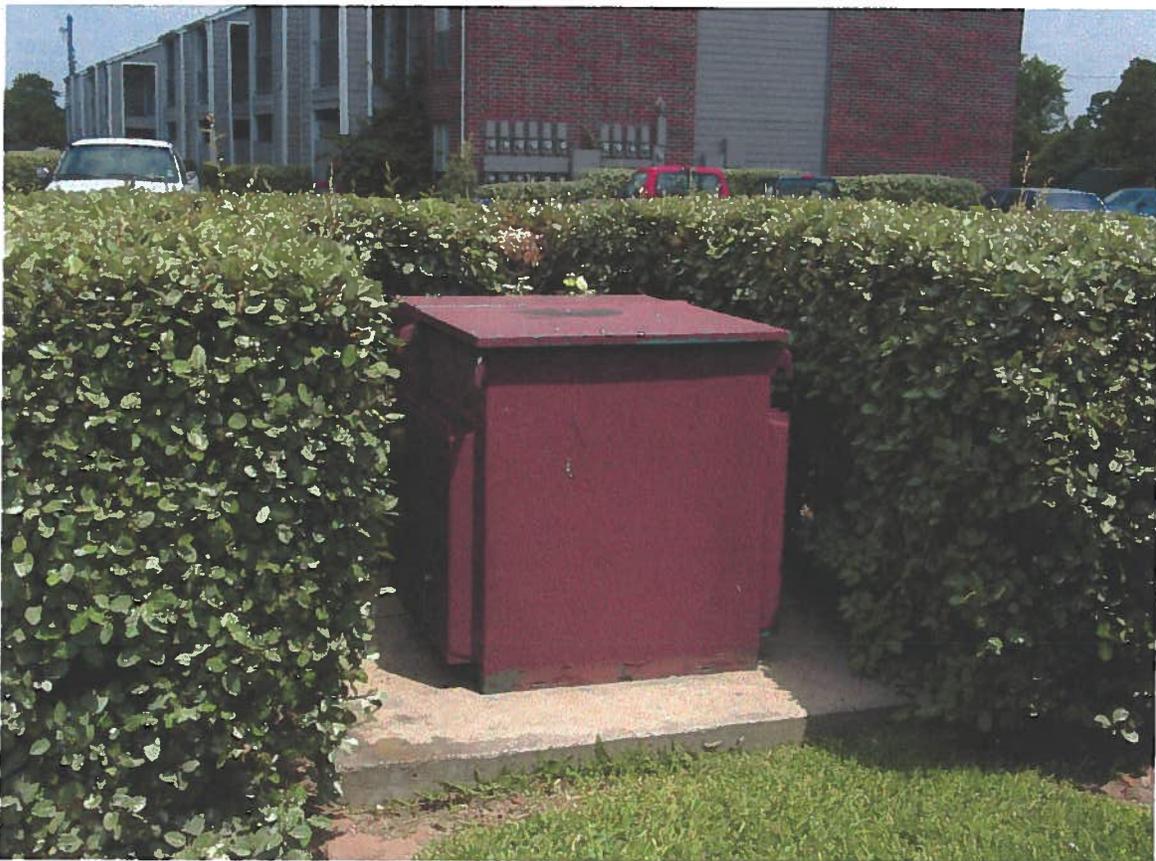
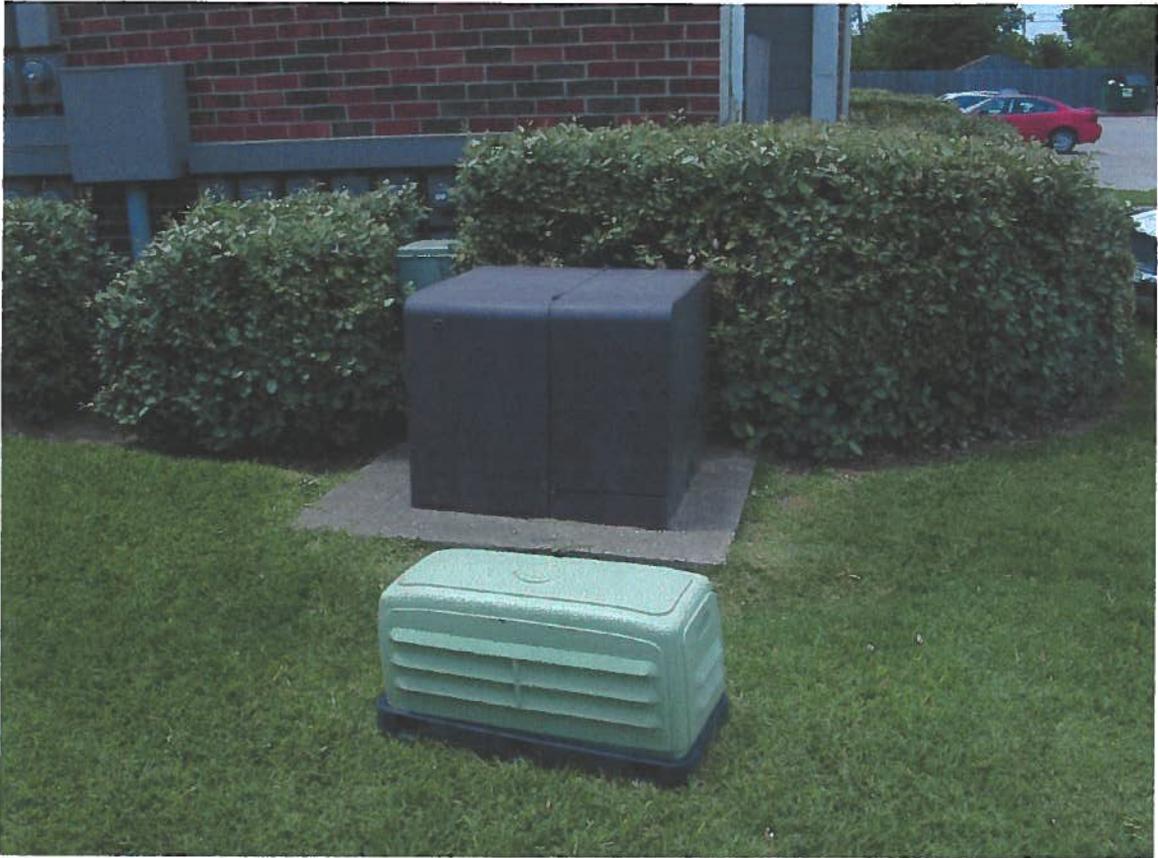
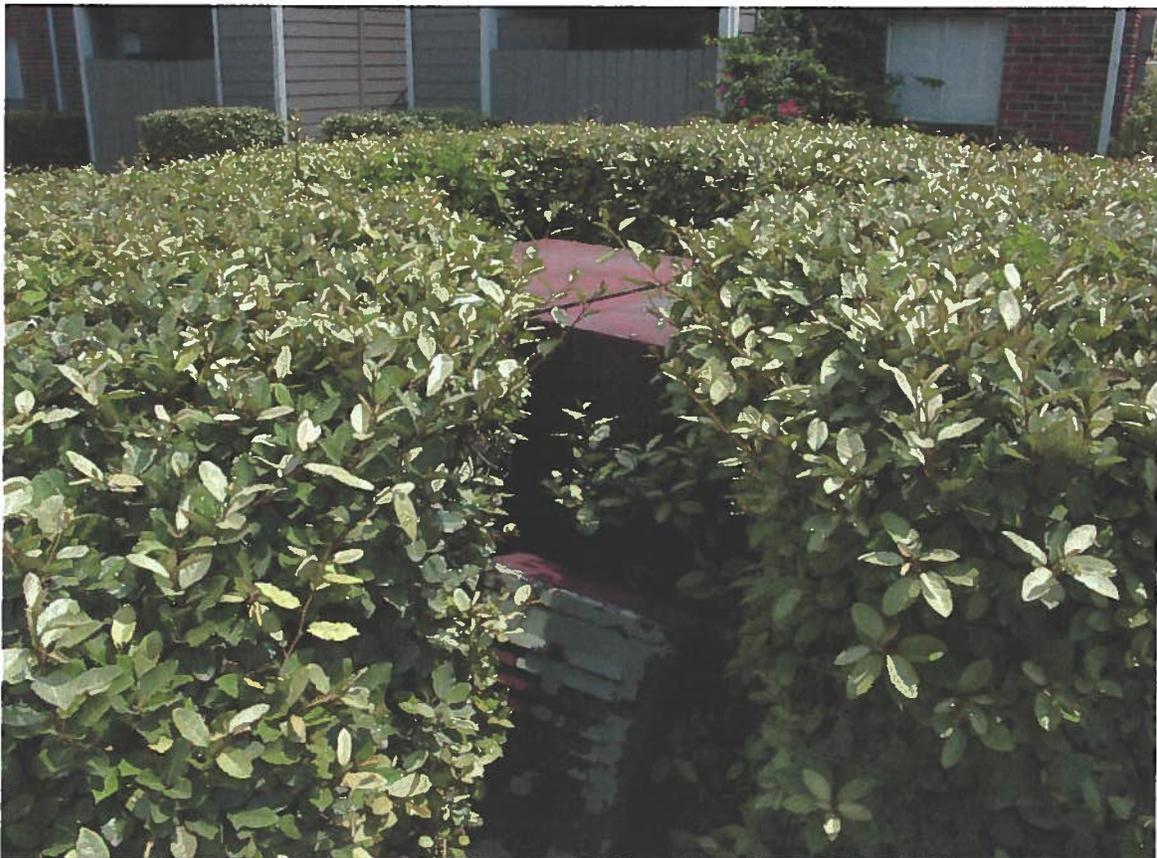
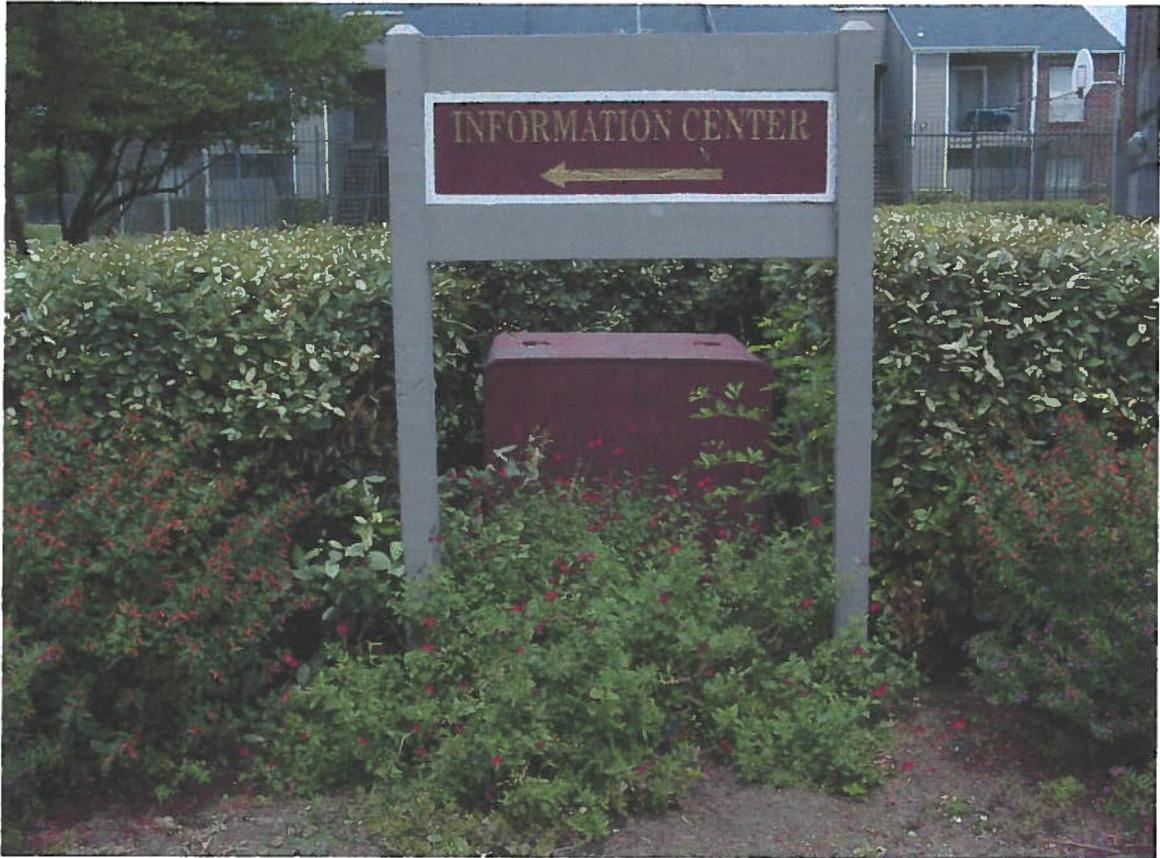
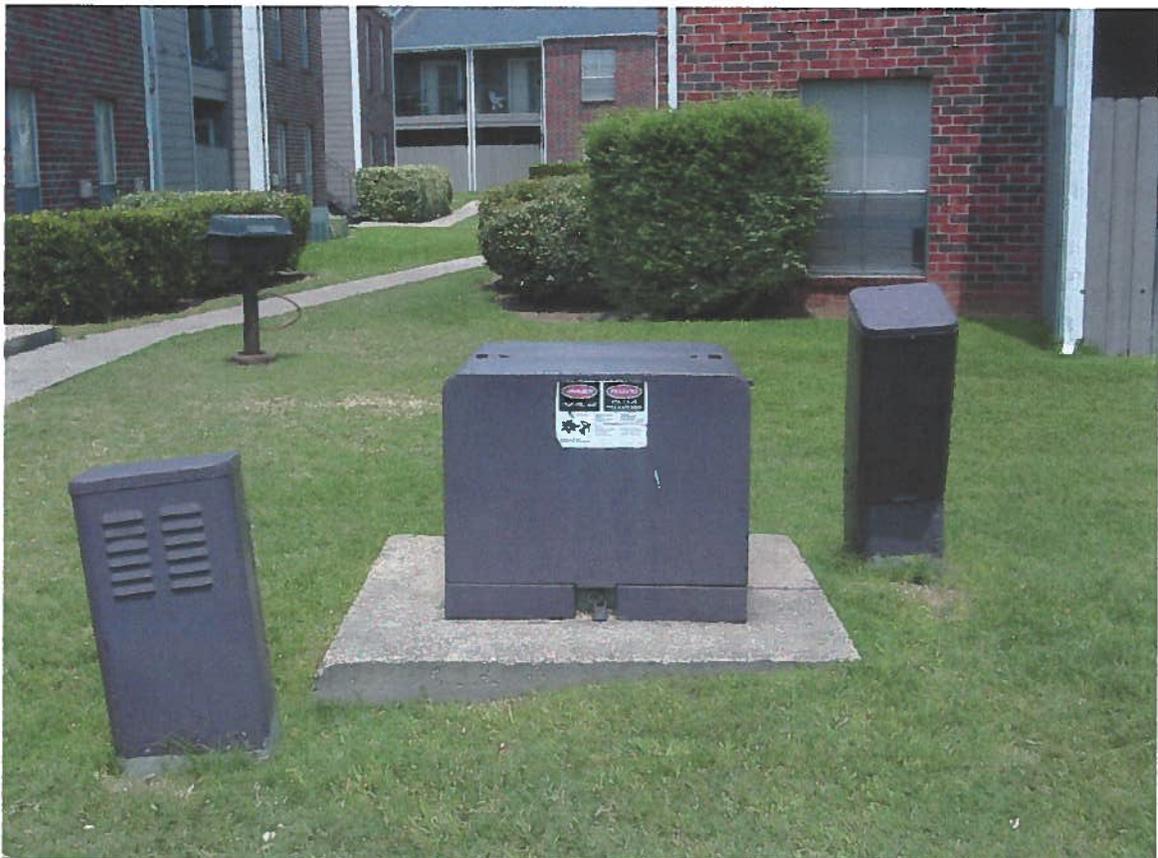
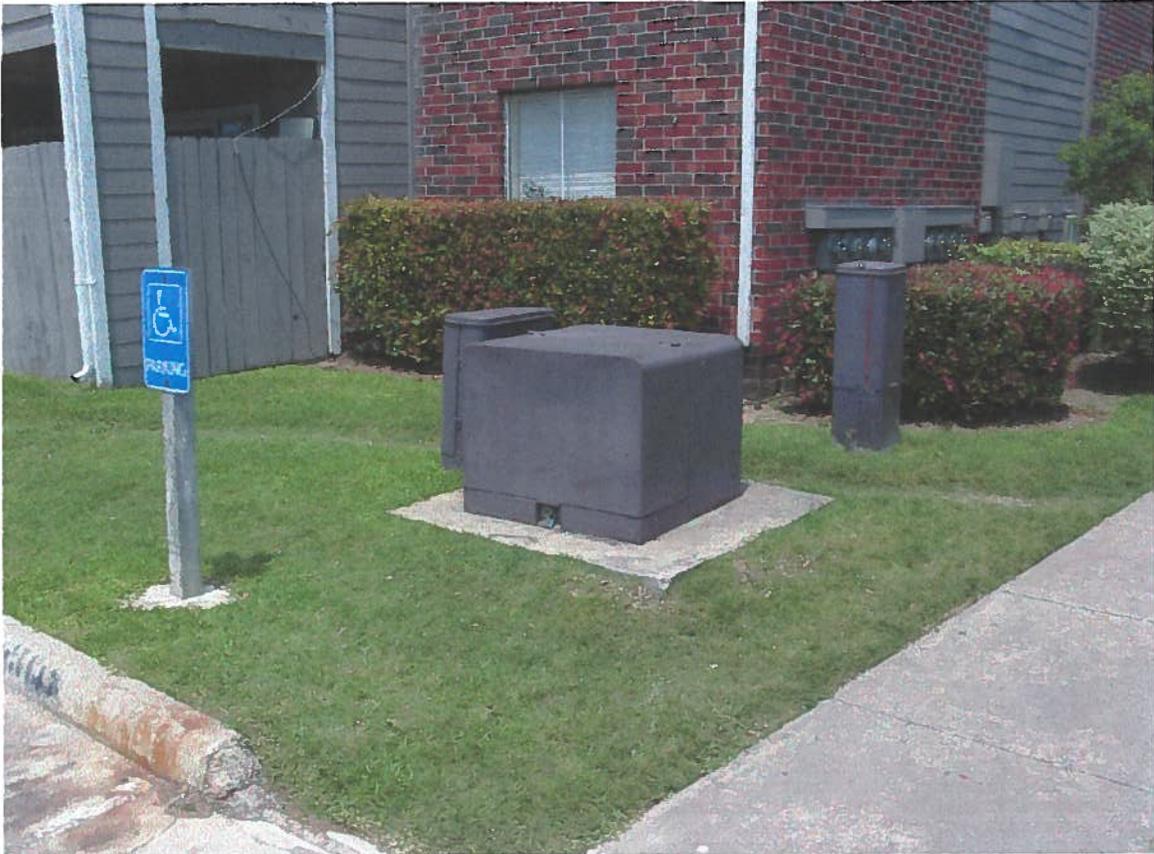
Pad mounted transformers, shown in Photographs 23 through 30, were located throughout the interior of the Property. All of these transformers appeared to be in good condition and showed no indications of a release either by the presence of stained soils or stained concrete.

Only one of the pole mounted transformers was marked as non PCB containing. The remaining pole mounted transformer and none of the pad mounted transformers were marked as “non PCB” or “PCB”. However, all of the transformer appeared to be in good condition and showed no evidence of past or current releases from these units.

Photograph 22: Pad-mounted transformer located on the west side of the Property between Buildings F and G.

Photograph 23: Pad-mounted transformer located near the northwest corner of Building J.

Photograph 24: Pad-mounted transformer located near the southwest corner of Building N.

Photograph 25: Pad-mounted transformer located on near the northwest corner of Building D.

Photograph 26: Pad-mounted transformer located between Buildings L and K.

Photograph 27: Pad-mounted transformer located just north of the office.

Photograph 28: Pad-mounted transformer located near the northeast corner of Building E.

Photograph 29: Pad-mounted transformer located near the northeast corner of Building B.

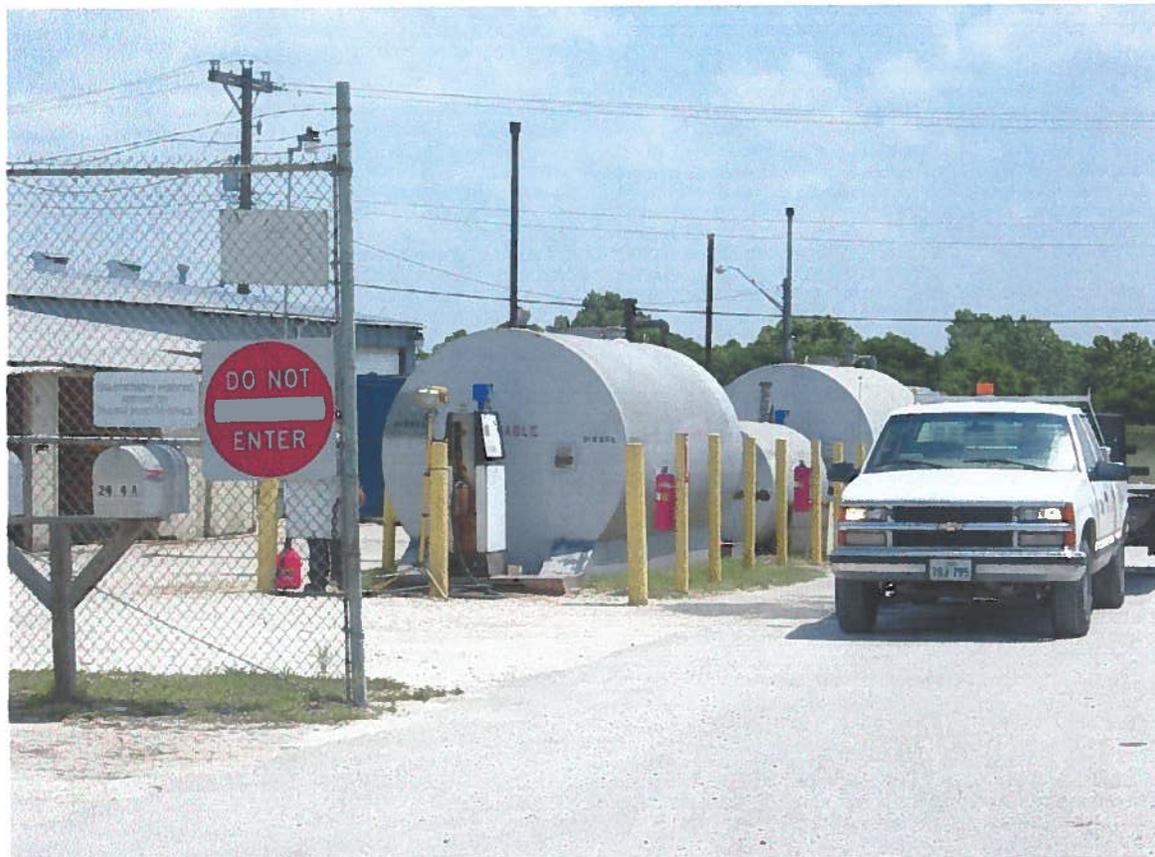
Photograph 40: View of above ground storage tanks located within the Del Valle Independent School District bus depot.
