JOLLYVILLE TRANSMISSION MAIN: Environmental Commissioning Monthly Report

**Presented to the Austin Environmental Board
September 19, 2012**

Jollyville Transmission Main Project

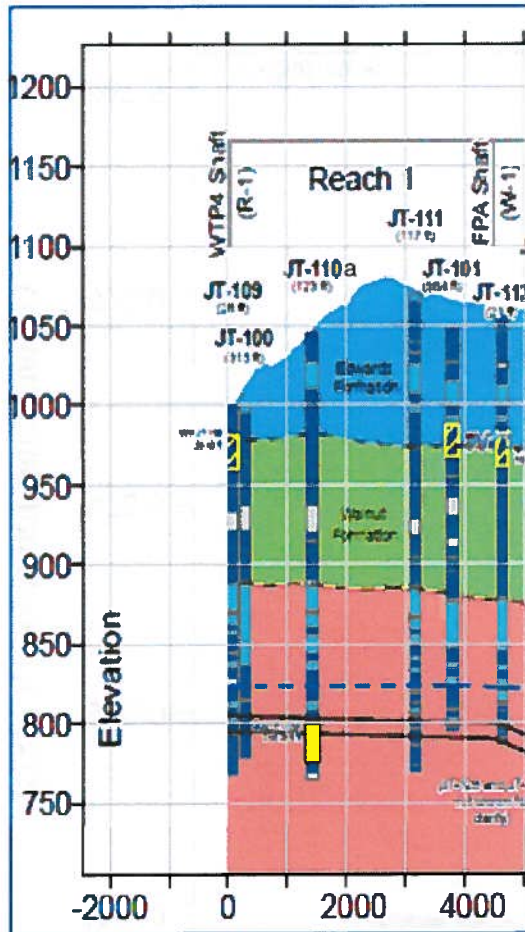
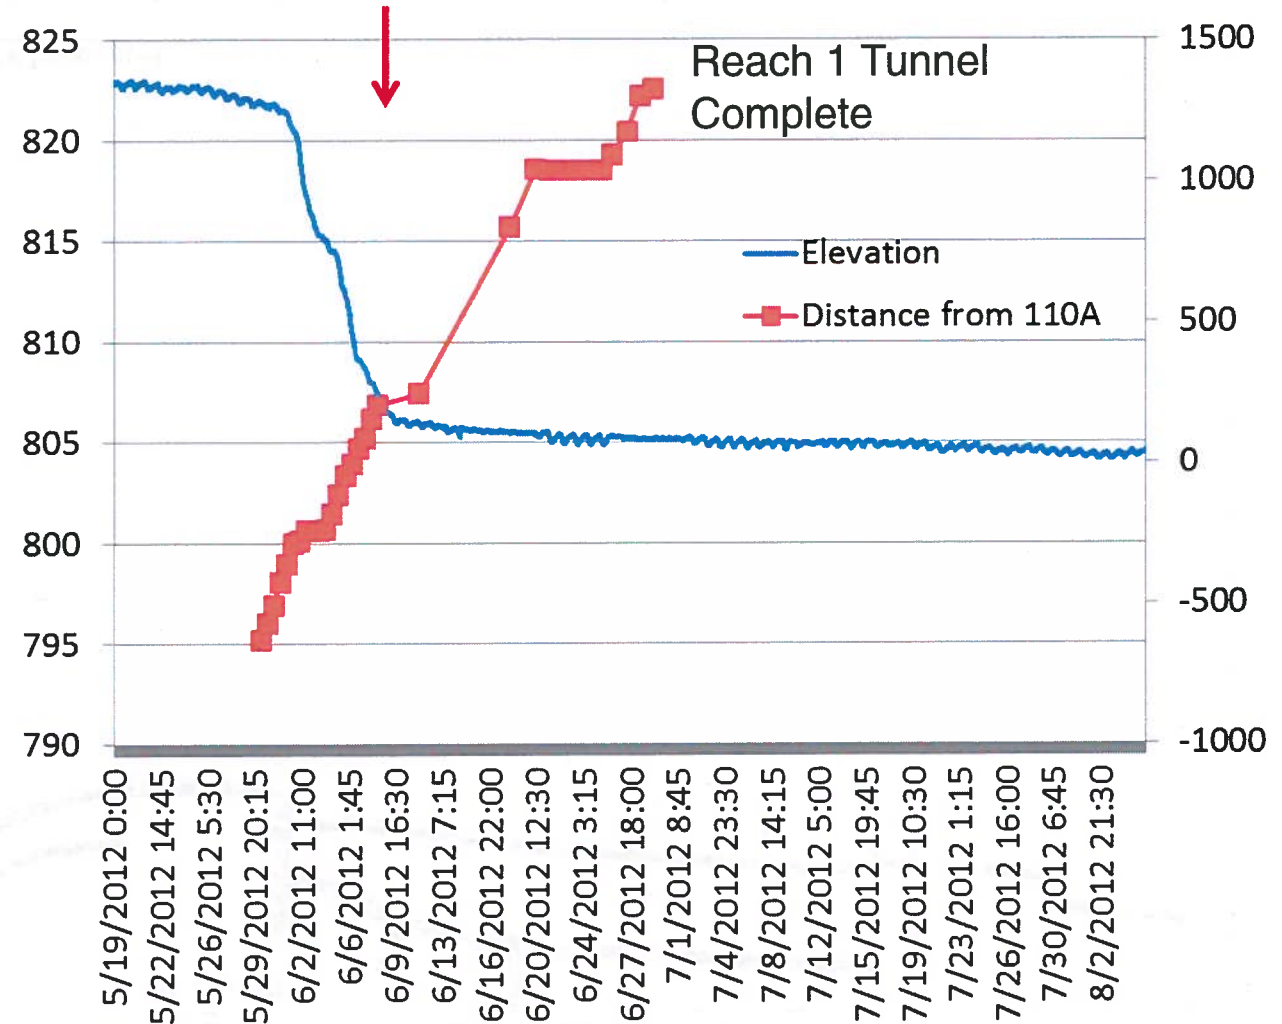
110A Well

Tunnel passes well

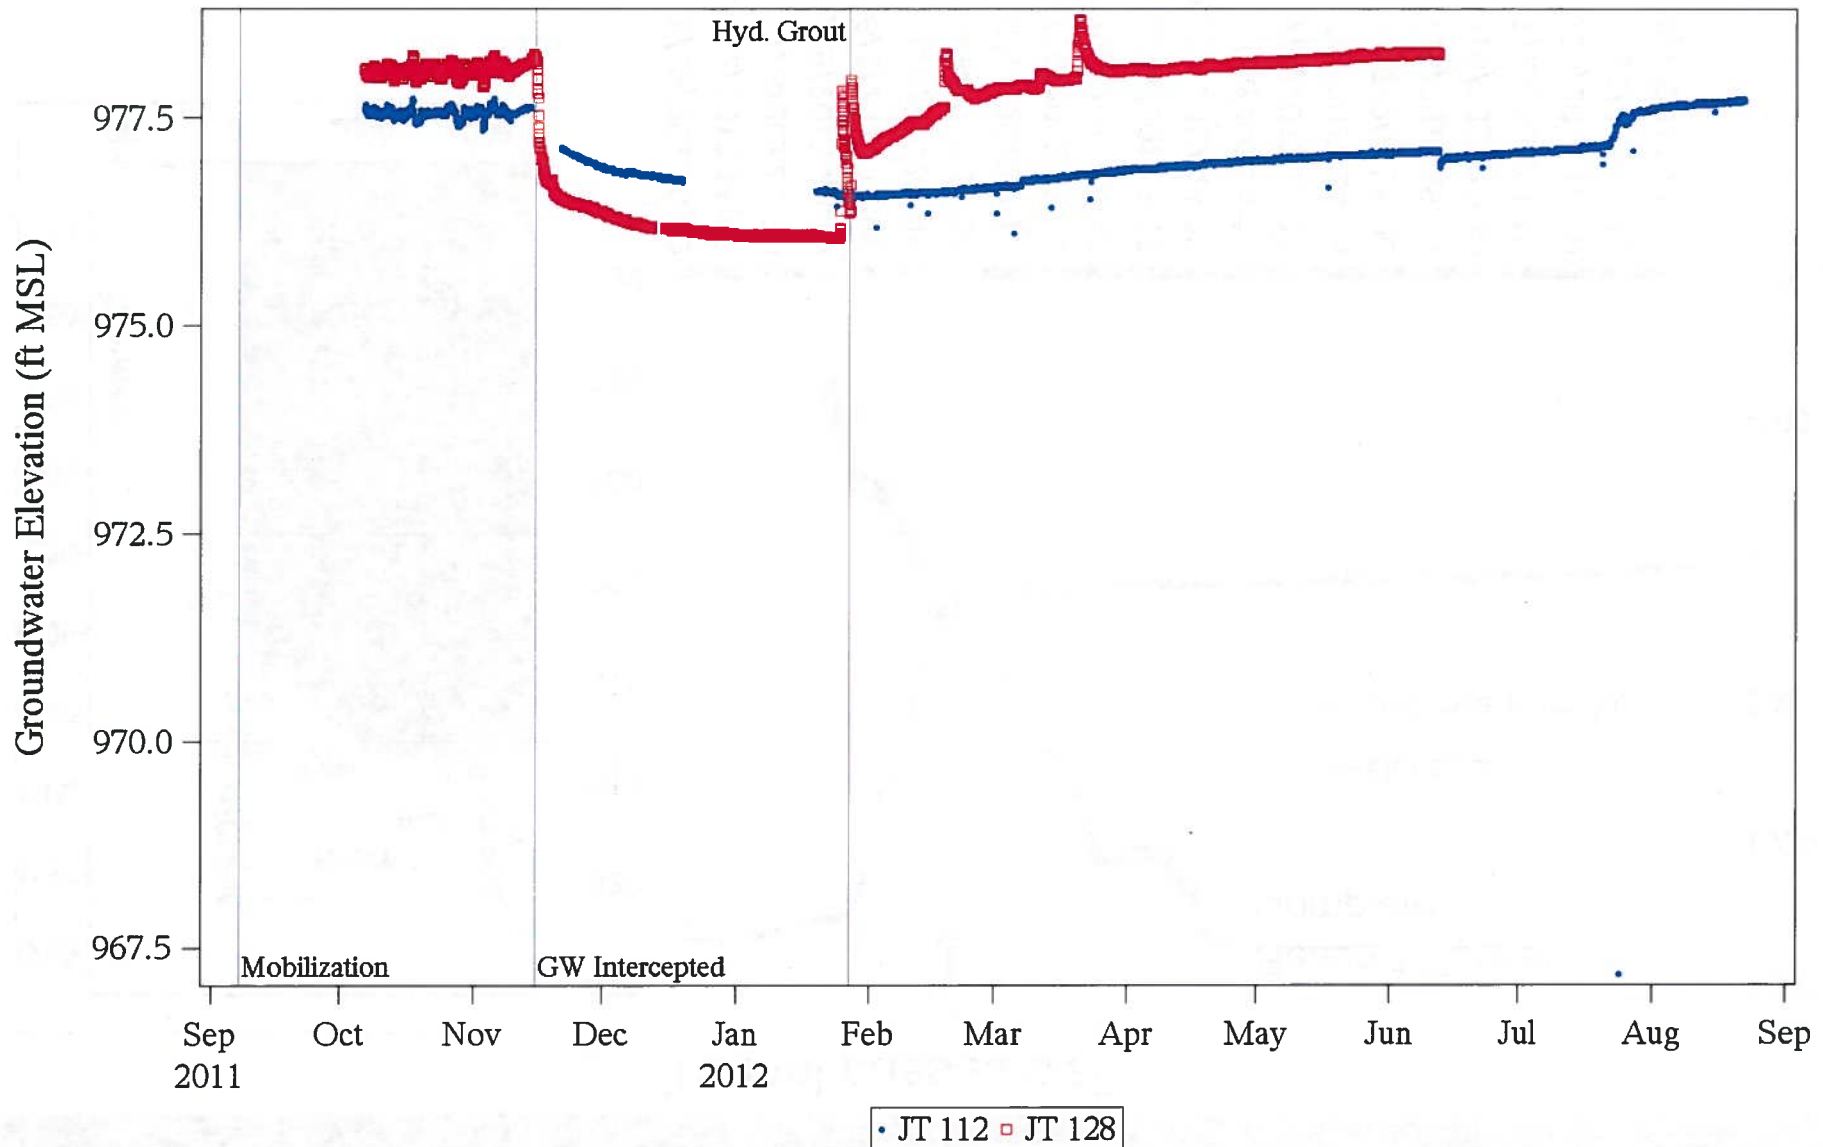
Wells JT112 and JT128 Trolls

- Groundwater levels near Four Points shaft continue to rise. Both wells now at or above preconstruction levels. Dye trace injection probably responsible for July bump in 112 levels.

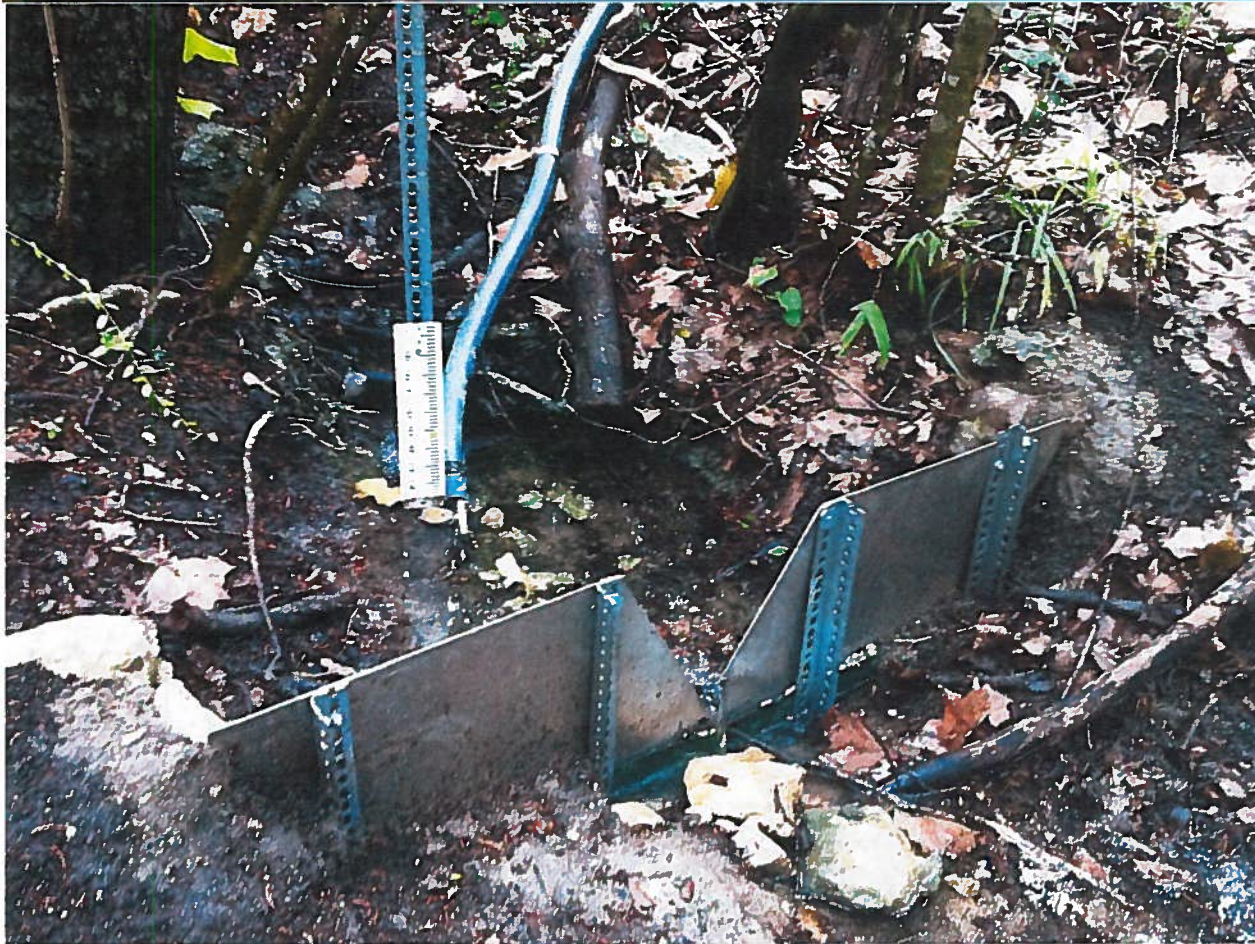
Environmental Monitoring Update – Surface flow

- All springs and stream reaches flowing through dry conditions
- Water quality parameters within expected ranges
- Nondetects for indicators of mining, vehicular operation, and drilling (TPH, Cu, Cr, Zn)
- Nondetects for di-n-butyl grout compounds in JT-112, Gaas spring

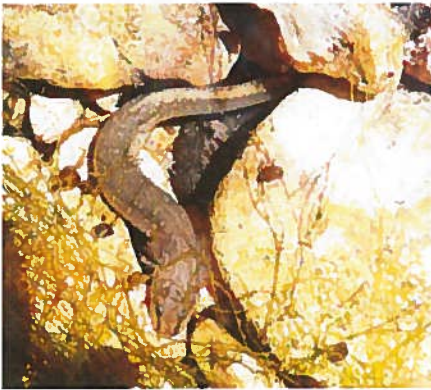
Jollyville Plateau Salamander Monitoring

Site	Date of Last Count	Count #	Historical Average (& last four counts)
Lanier	Sept 7, 2012	100	65 (100,56,48,59)
Franklin/Pit	May 18, 2012	100	78 (73,87,39,100)
Tanglewood	May 16, 2012	3	8 (0,0,0,3)
Lower Ribelin	Jan 6, 2012	42	42 (53,176,43,42)
Upper Ribelin	May 23, 2011	75	64 (123,74,67, 75)
Trib 4 @ Spicewood	August 1, 2012	0	10 (20, 9, 2,0)

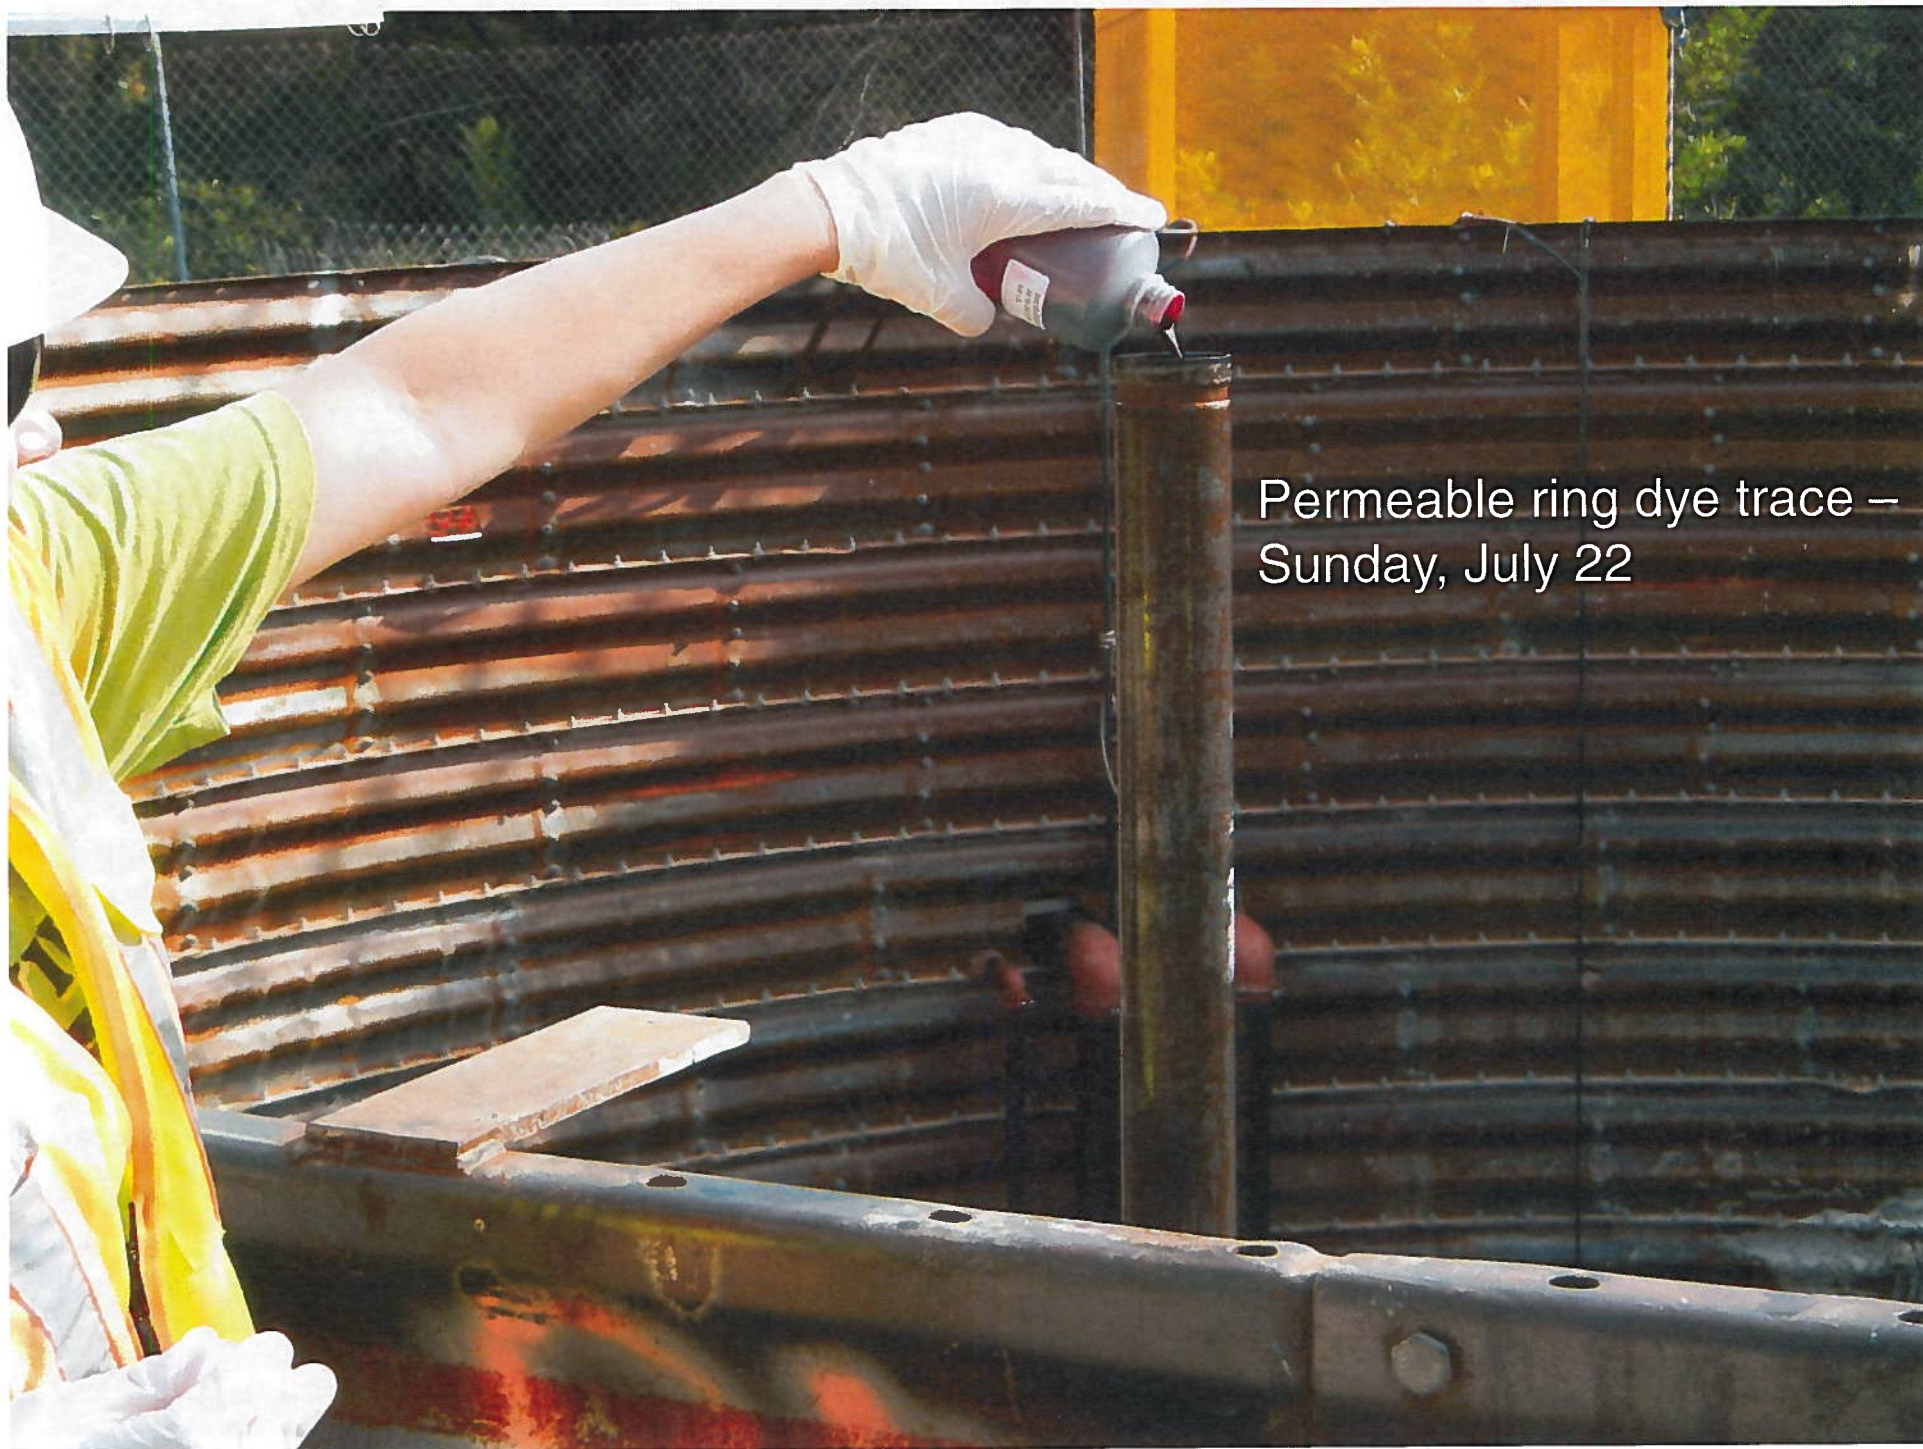
Four Points Trace March 2011

Results Interpretation: March 2012
