### JOLLYVILLE TRANSMISSION MAIN: Environmental Commissioning Monthly Report

Presented to the Austin Environmental Board January 16, 2013

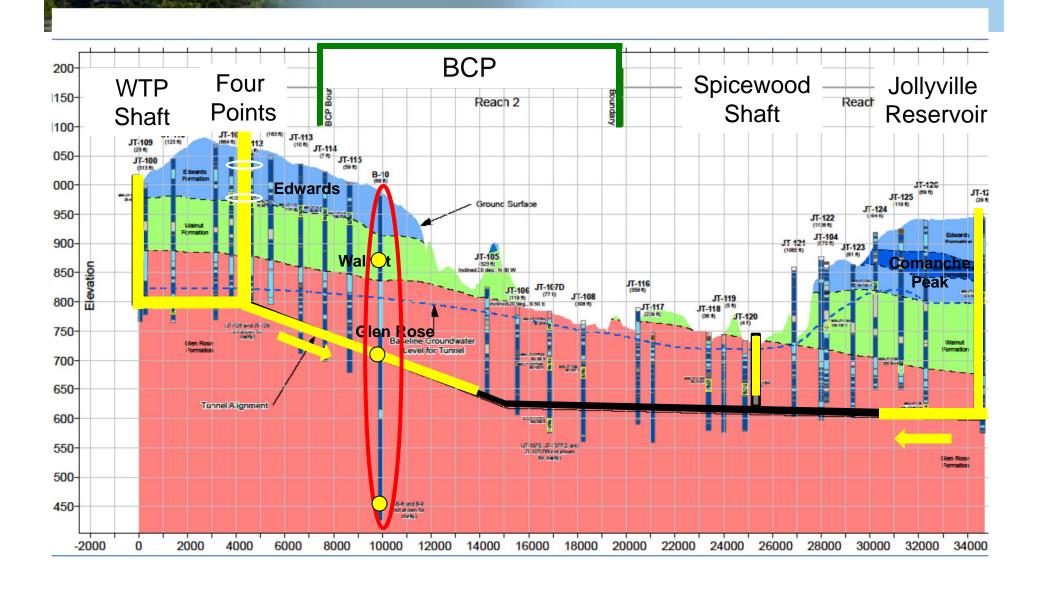
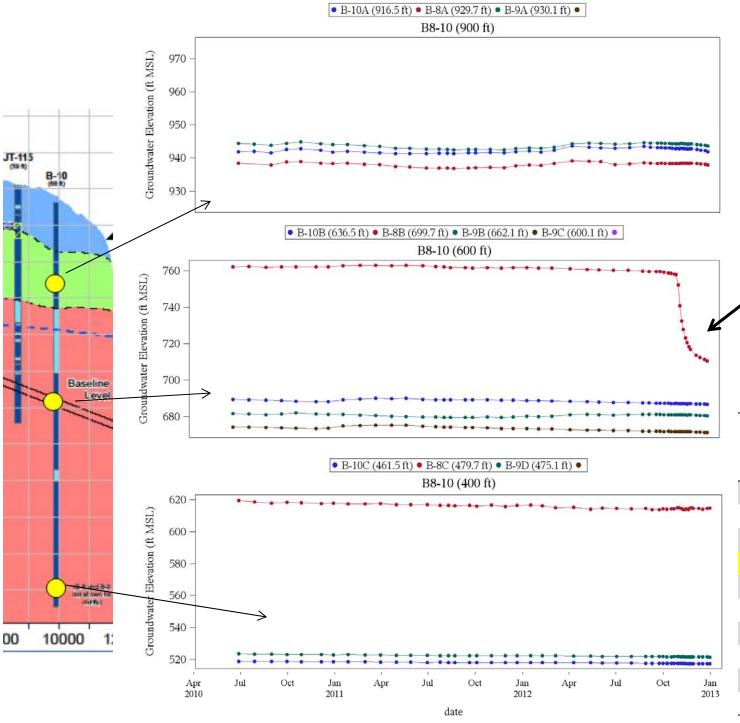
Tunnel affects groundwater levels at tunnel horizon, but not above or below.

B8-b – screened @ tunnel horizon ~50 ft drop as tunnel passes.

Fugro	Piezometer
Boring Id	Elevation (ft
_	msl)
B-9A	930.05
B-8A	929.7
B-10A	916.54
B-8B	699.7
B-9B	662.05
B-10B	636.54
B-9C	600.05
B-8C	479.7
B-9D	475.05
B-10C	461.54

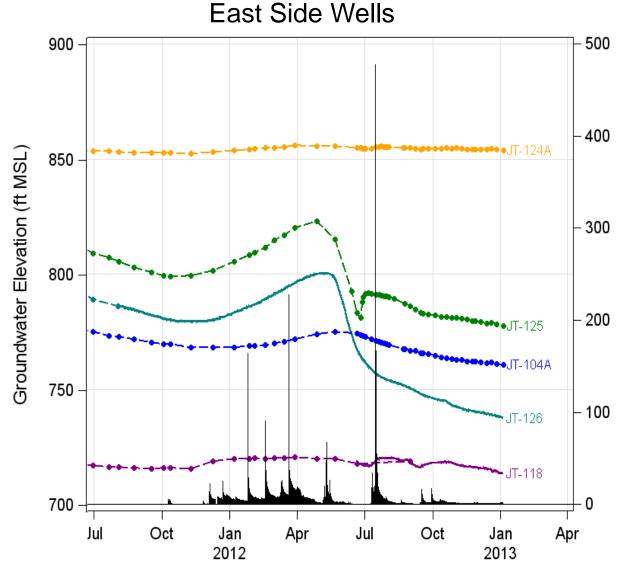
- All GR wells declining, in addition to 104 in Walnut.
- JT-124 Walnut well level relatively flat.

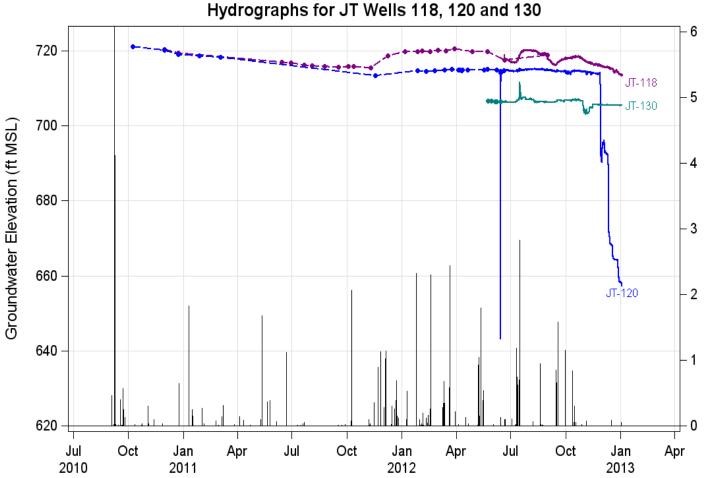
#### Spicewood Shaft Wells

- Additional grouting procedure in November 2011 helped reduce seepage into shaft and water levels in JT-130 to rebound
- JT-120 is located adjacent to the shaft and screened well below JT-130 screen (liner plates down to 70 ft below ground, JT120A screened from about 73-93 ft below ground so shaft is now (roughly 100 ft) well below bottom of 120A)
- Unclear whether 118 responding to drought or shaft

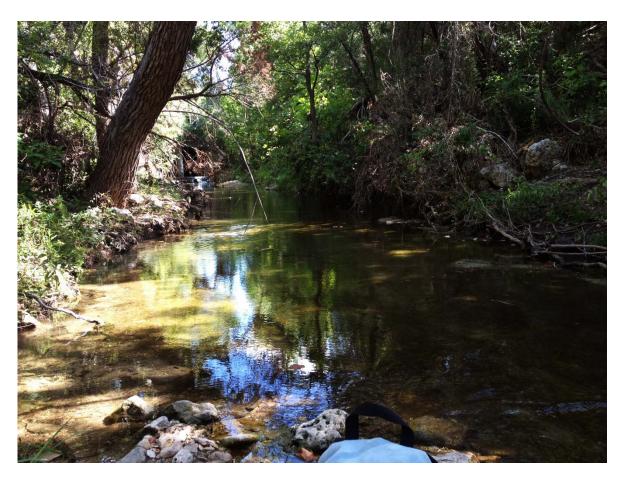
Trib 4 by Spicewood Shaft 7/25/12

- All springs and stream reaches flowing but low due to drought
- Water quality parameters within expected ranges
- Nondetects for indicators of mining, vehicular operation, and drilling (TPH, Cu, Cr, Zn)
- Nondetects for di-n-butyl grout compounds in JT-112, Gaas spring
