HISTORIC LANDMARK COMMISSION APRIL 22, 2013 NATIONAL REGISTER HISTORIC DISTRICT NRD-2013-0019 Old West Austin 2515 McCallum Drive

Construct a rear addition and remodel the façade of a c. 1939 contributing house.

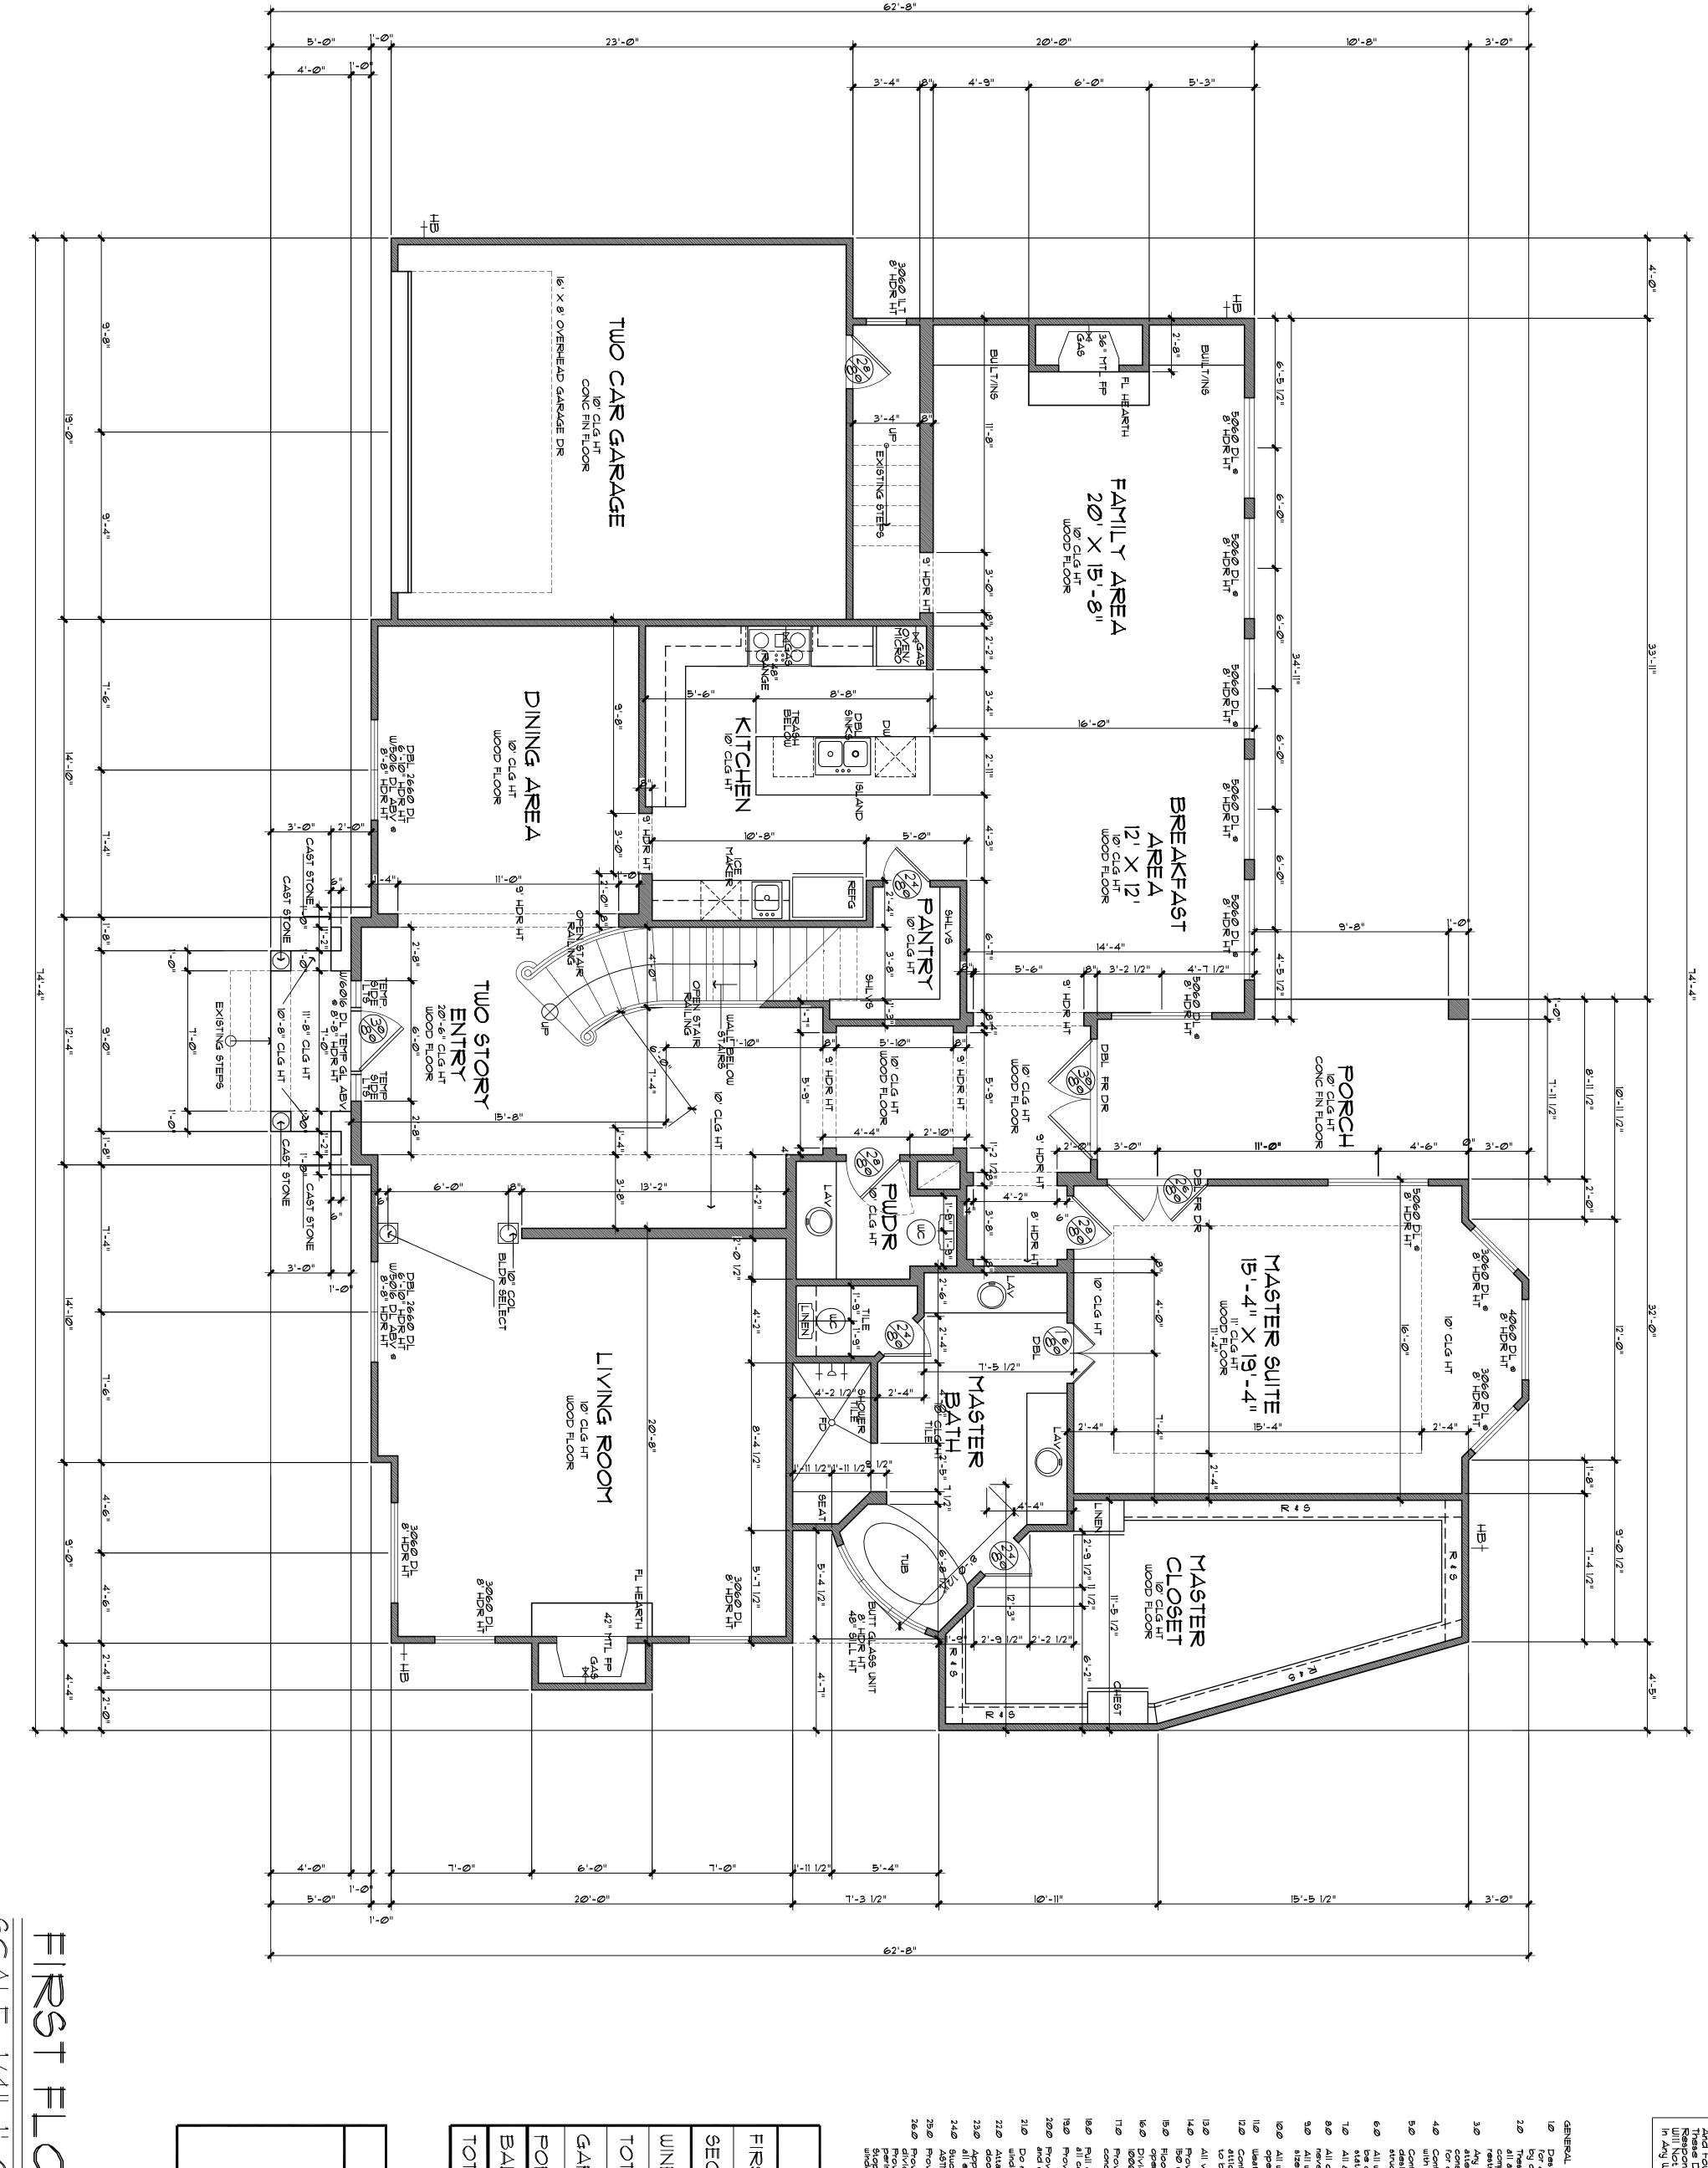
TOTAL COVERED	BALCONY	TORCI	GARAGE	TOTAL LIVING	MINE CELLAR	SECOND FLOOR	FIRST FLOOR	NEW AREA'S
5835	152	143	432	8 20 20	287	1988	2833
