JOLLYVILLE TRANSMISSION MAIN: Environmental Commissioning Monthly Report

Presented to the Austin Environmental Board July 17, 2013 David Johns, Watershed Protection Department

Environmental Commissioning Activities - JVTM

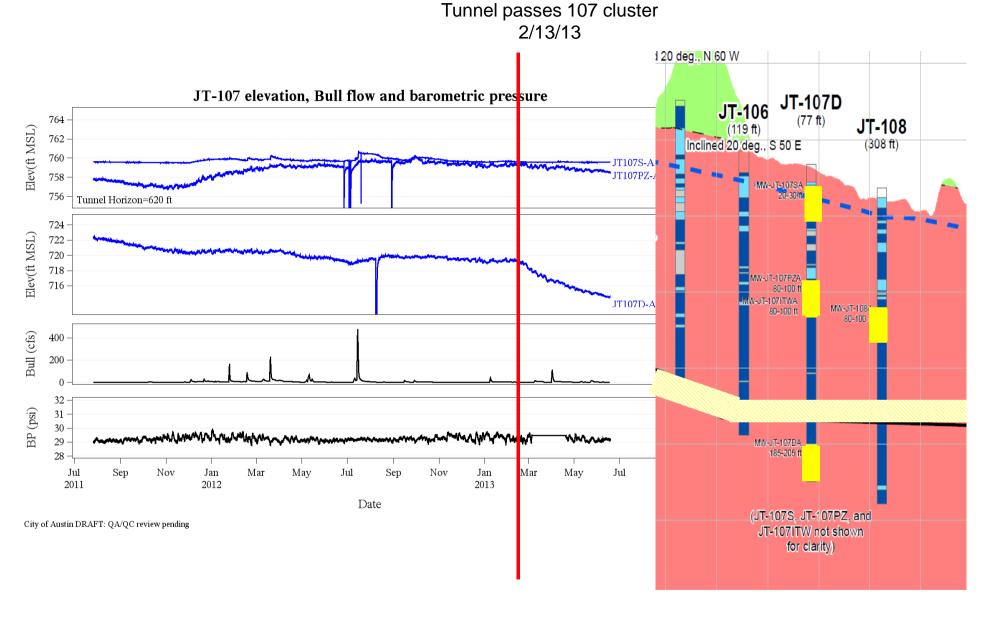
Tunnel Exiting BCP

-Decline (~8 feet) in deepest well as tunnel passes; small decline in PZ-A -no decline in 107S-A.

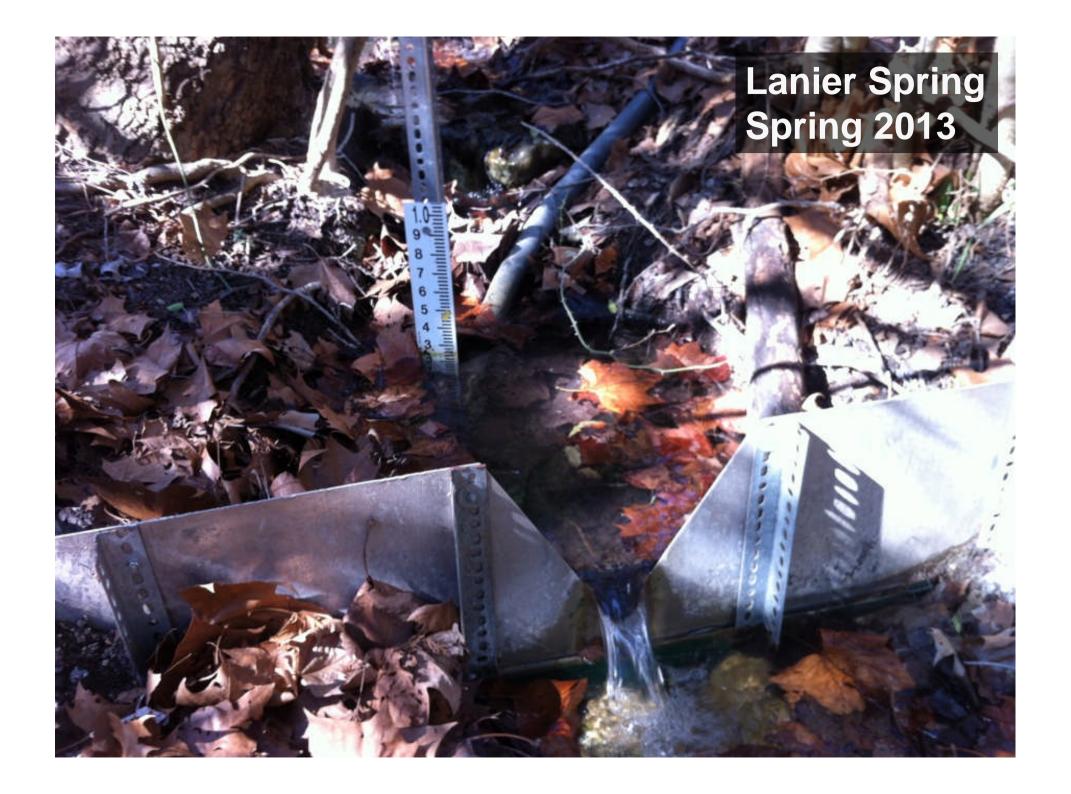
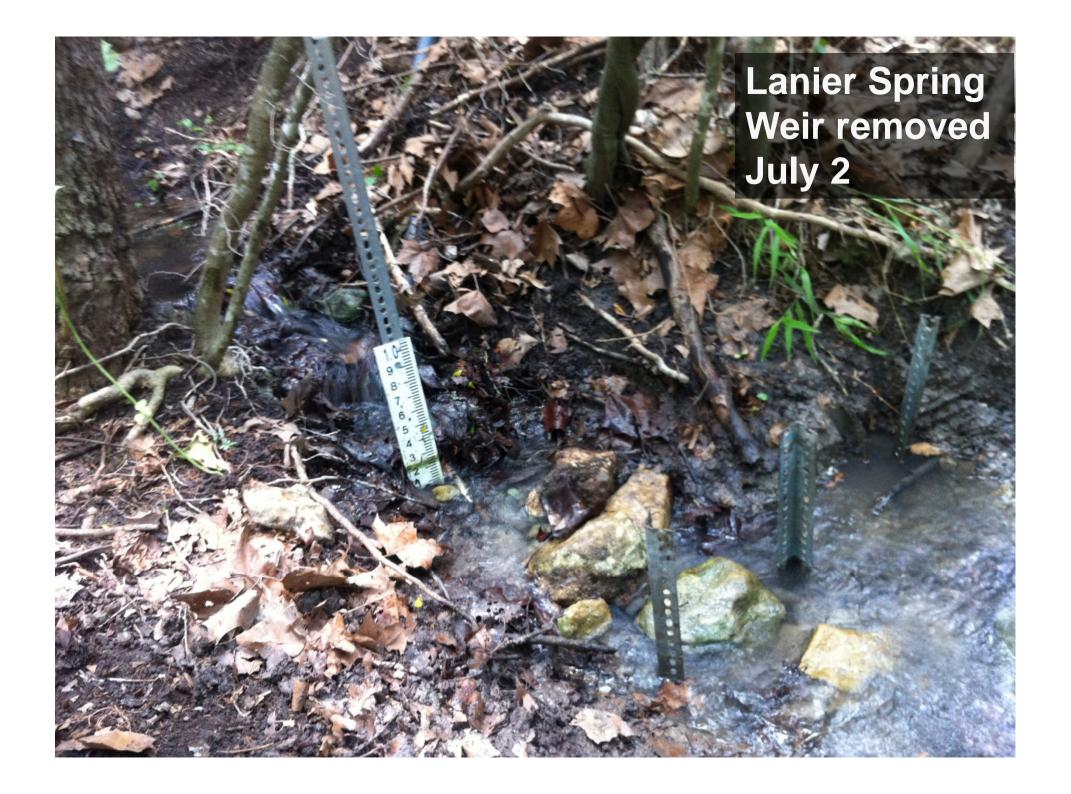
Bull Creek @ Trib 7 (Pit Spring proxy)

- Main stem of Bull Creek is dry above Pit Spring, flow too slow to measure downstream of Pit (but some water present)
- Pit still has some very minimal flow at farthest downstream point
- Lanier Spring at ~ 0.03 cfs
- Trib 4 near Spicewood flow too slow to measure
- Values typical for midsummer

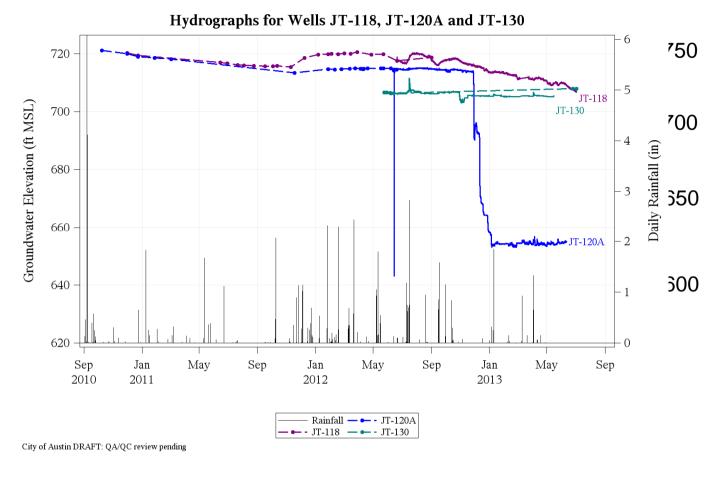
Spicewood Shaft Wells

- JT-120 (adjacent to shaft) water level at bottom of screen
- JT-118 declines influenced by shaft
- JT-130 has been re-engineered to withstand truck traffic: stickup removed, new pad with rebar poured. Transducer removed, now measuring with e-line.

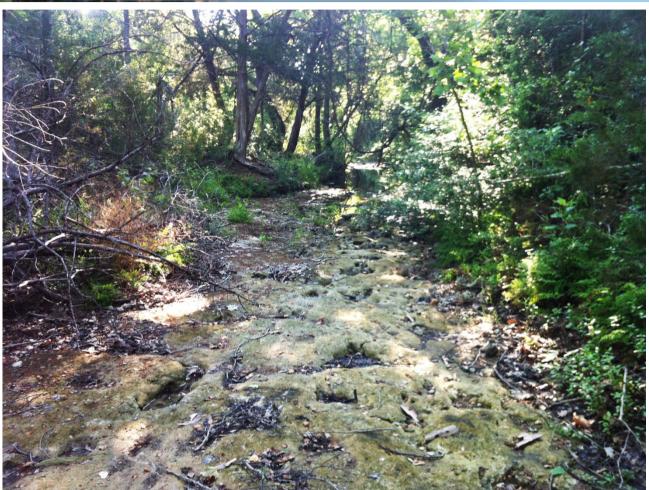
Pit Spring 7/2/13

- Main stem Bull creek below Pit Spring is flowing; upstream, creek and springs are dry or very minimal flow due to drought. Water quality parameters within expected ranges
- Nondetects for indicators of mining, vehicular operation, and drilling (TPH, Cu, Cr, Zn)
- Nondetects for di-n-butyl grout compounds in JT-112, Gaas spring
