## **Inflatable Flotation Device Prohibition Amendment**

### **Supplemental Report**

*Austin City Council*

*October 17<sup>th</sup>, 2013*

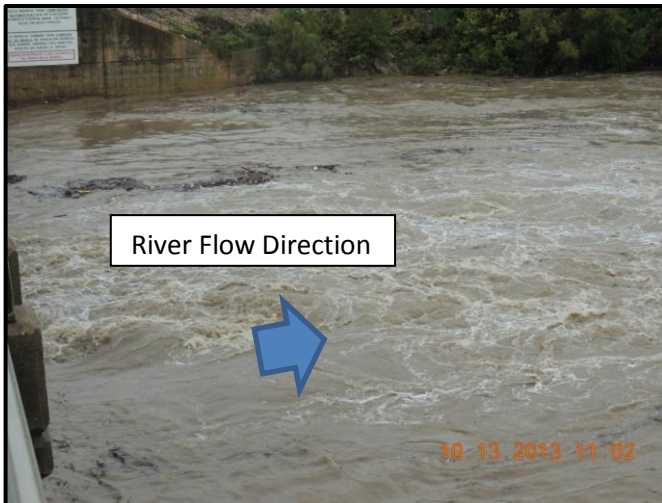
This photo on the left was taken directly below Longhorn Dam and illustrates the swift waters and currents generated by the releases from Longhorn Dam. Photo on the right depicts the rise of the Colorado River.

The following are a series of photographs taken between 11 a.m. and 11:30 a.m. on Sunday, October 13. At this time the river had already crested and was beginning to recede. The rate of flow at 11:30 a.m. was 22,500 cfs.

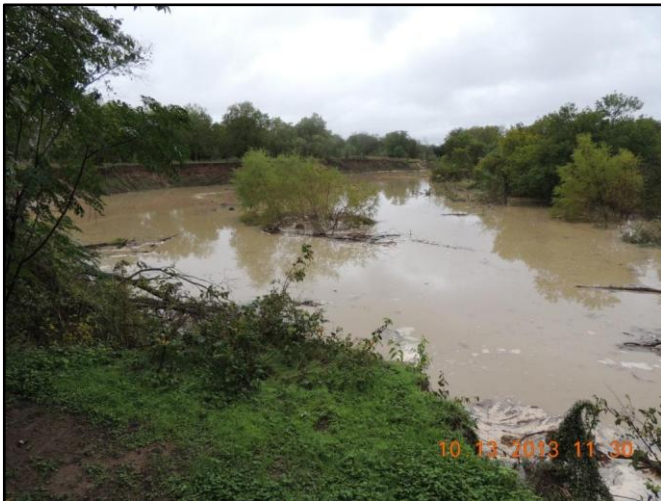
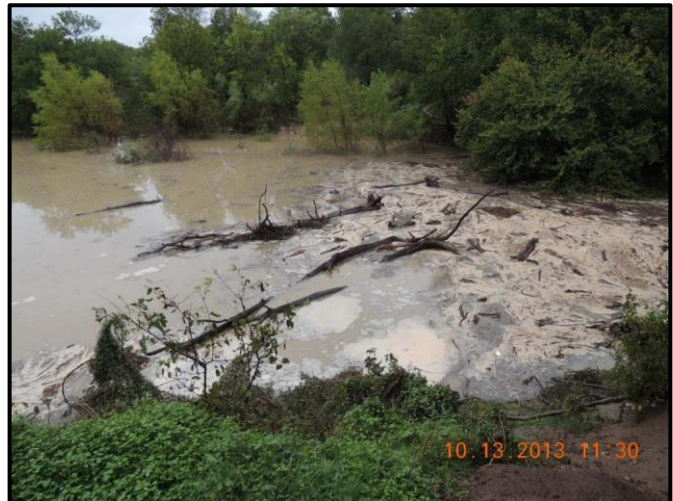
These photos show the debris and change in river geometry as flood waters move down the river.

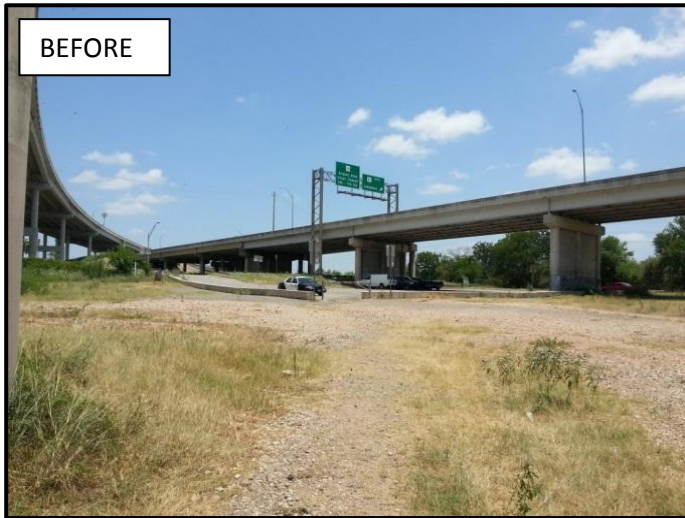
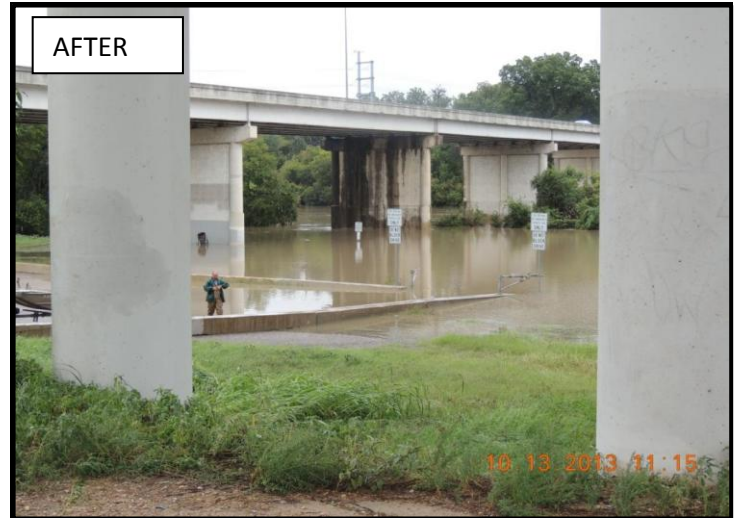
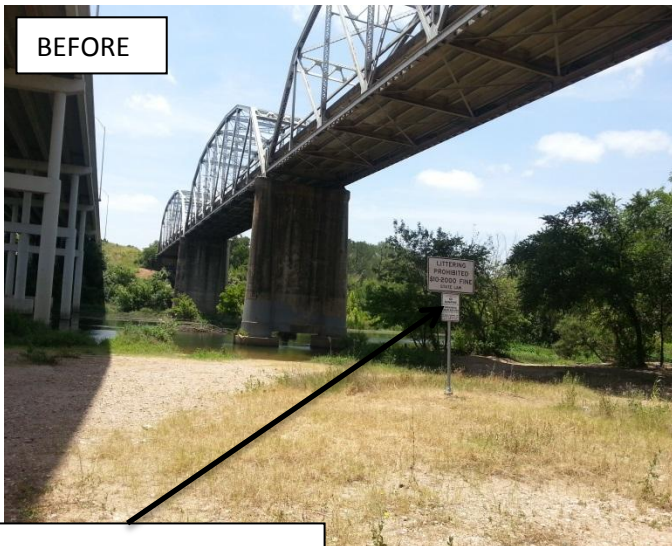
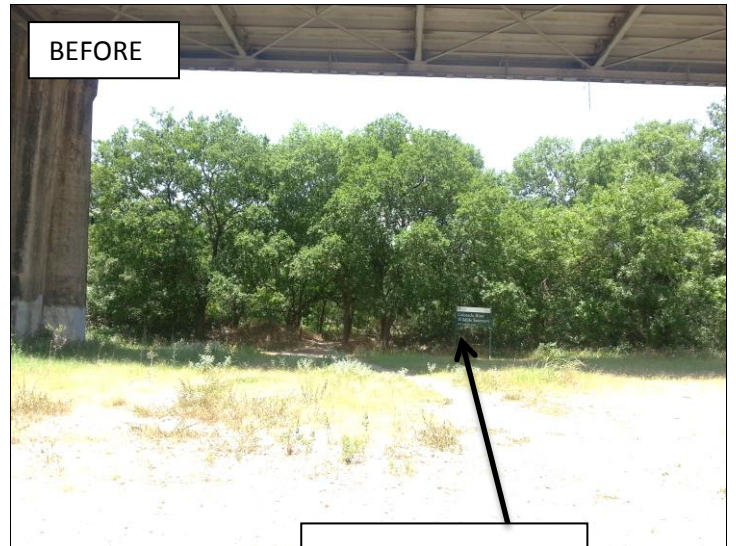
The pictures above and below are of the area below the Hwy 183/Montopolis Bridge. Photos taken June 26, 2013 (BEFORE) reflect river height with an average low-flow of approximately 200 cfs. Pictures from October 13, 2013 (AFTER) rain event show the change in width of the channel as river rises.
