**NAME & NUMBER
OF PROJECT:** APAC TEXAS - BUCK
SP-2013-0301D

REQUEST: Variance request is as follows:
To allow construction in the (CWQZ) Critical Water
Quality Zone.
LDC Section 25-8-392

SUBJECT: APAC Texas - Buck - SP-2013-0301D

**CITY OF AUSTIN ENVIRONMENTAL ASSESSMENT
FOR THE
APAC TEXAS-BUCK TRACT
(FORMERLY SHUMAKER-BUCK II TRACT)**

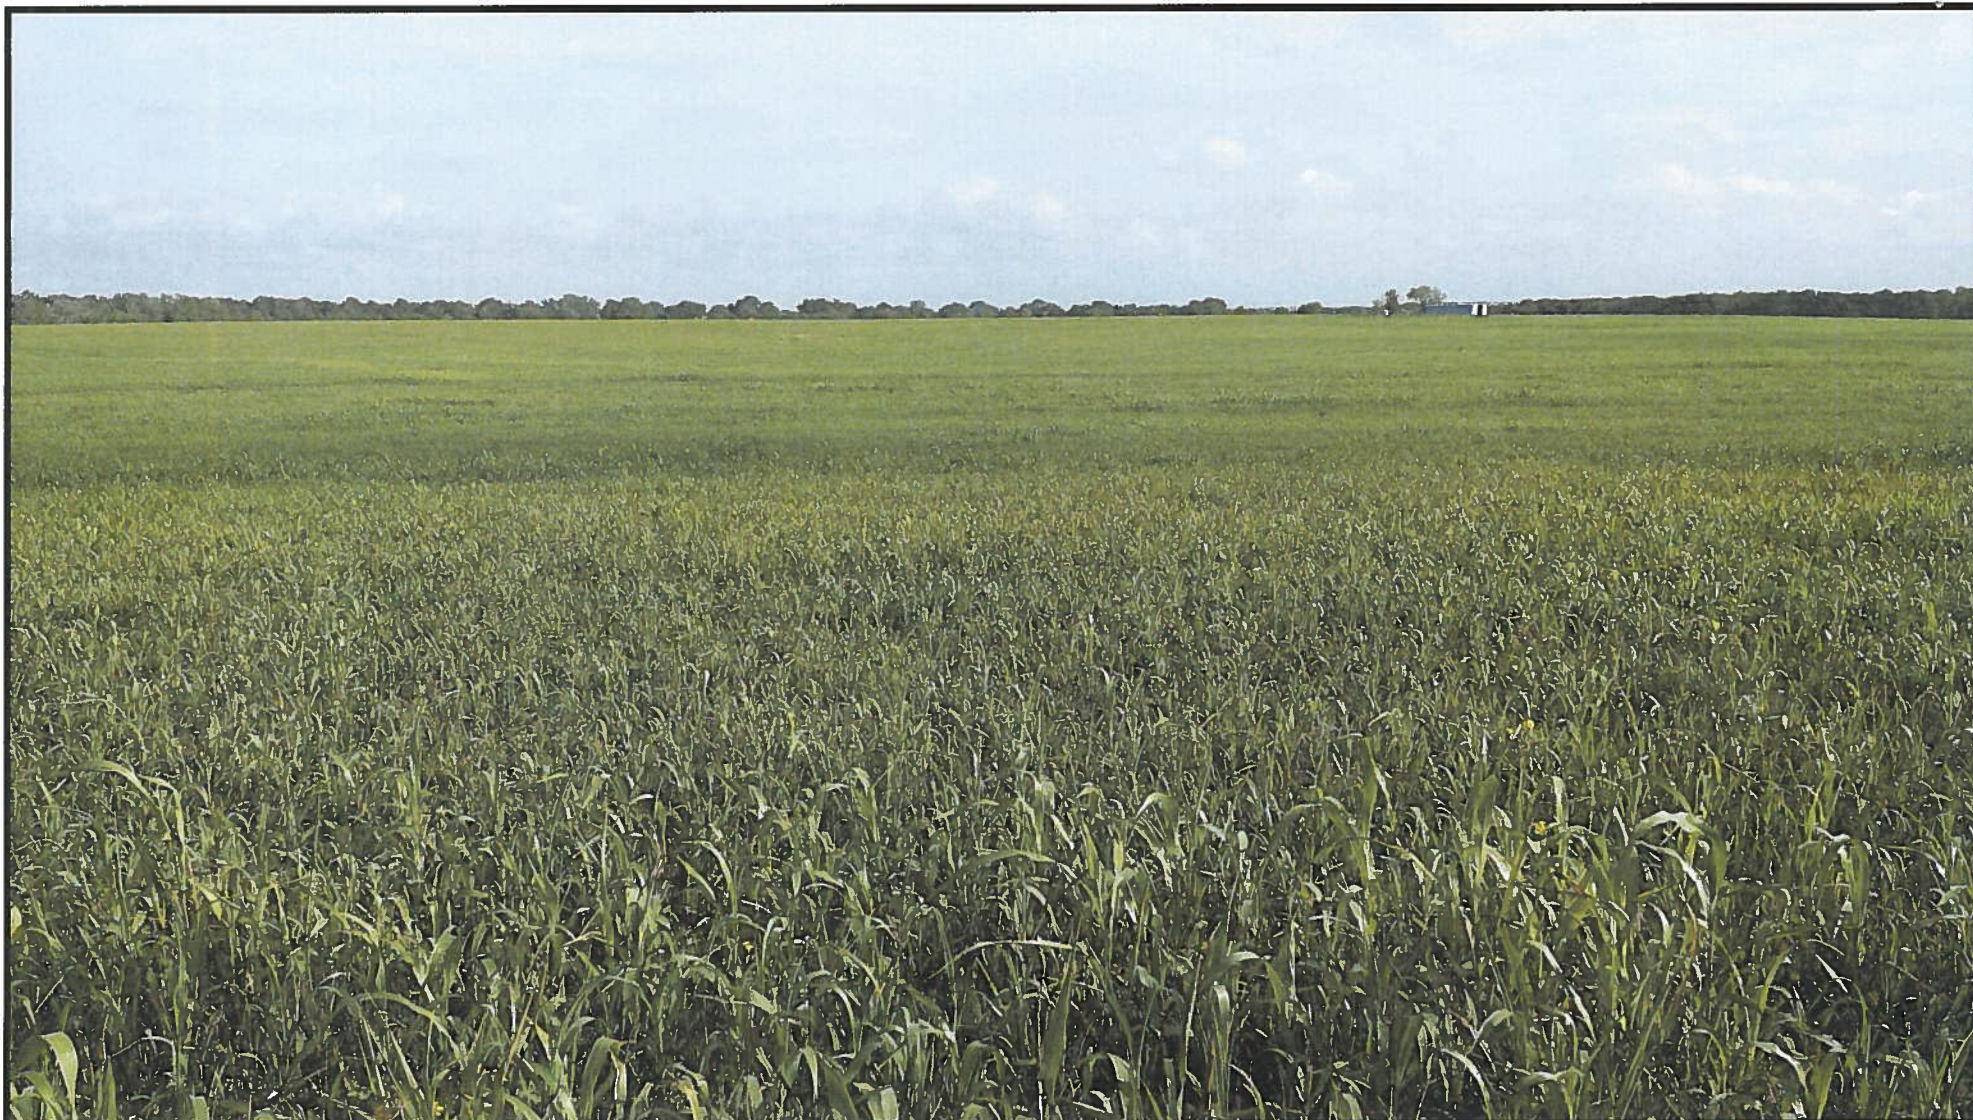
APAC TEXAS - BUCK
SITE PHOTO 1
VIEW TO NORTH ACROSS CWQZ

The drainage is a Minor Waterway by definition only due to the contributing drainage area. There is no definition of a bed and bank that normally characterizes a stream channel. The topography consists of a gradual slope to a generally flat area and a repeat of the gradual slope on the opposite

side. Because of this gentle topography, the area has been amenable to cultivation. Soils in the CWQZ consist of the Altoga, Bergstrom, Heiden, and Houston Black Series. These all are described in the NRCS Soil Survey of Travis County (Survey) as being of silty loam to clay in composition. None of these soils are described in the Survey as "frequently flooded" as compared to soils in other drainages in the area. This provides further evidence for the lack of storm flow frequent enough for channel formation in the drainage.

The proposed crossing will not alter the existing topography. The crossing will consist of a concrete travel surface 50 feet wide. It will be constructed level with the topography so that when any storm flow occurs, it will be spread over the same width as if the crossing did not exist. There will be no impact upon the floodplain. The crossing, being at existing land grade, is of low impact as compared to one elevated to accommodate a culvert. The disadvantage of the latter is the elevated crossing increases the floodplain, and the culvert creates a concentrated discharge with increased velocities. The approaches to the Critical Water Quality Zone will consist of a raised profile or hump to divert runoff away from the road rather than down the road and into the CWQZ. The disturbed area within the CWQZ outside the limits of the concrete will be restored per the City's 609S revegetation criteria consisting of native grasses. Temporary erosion controls will be in place during construction.

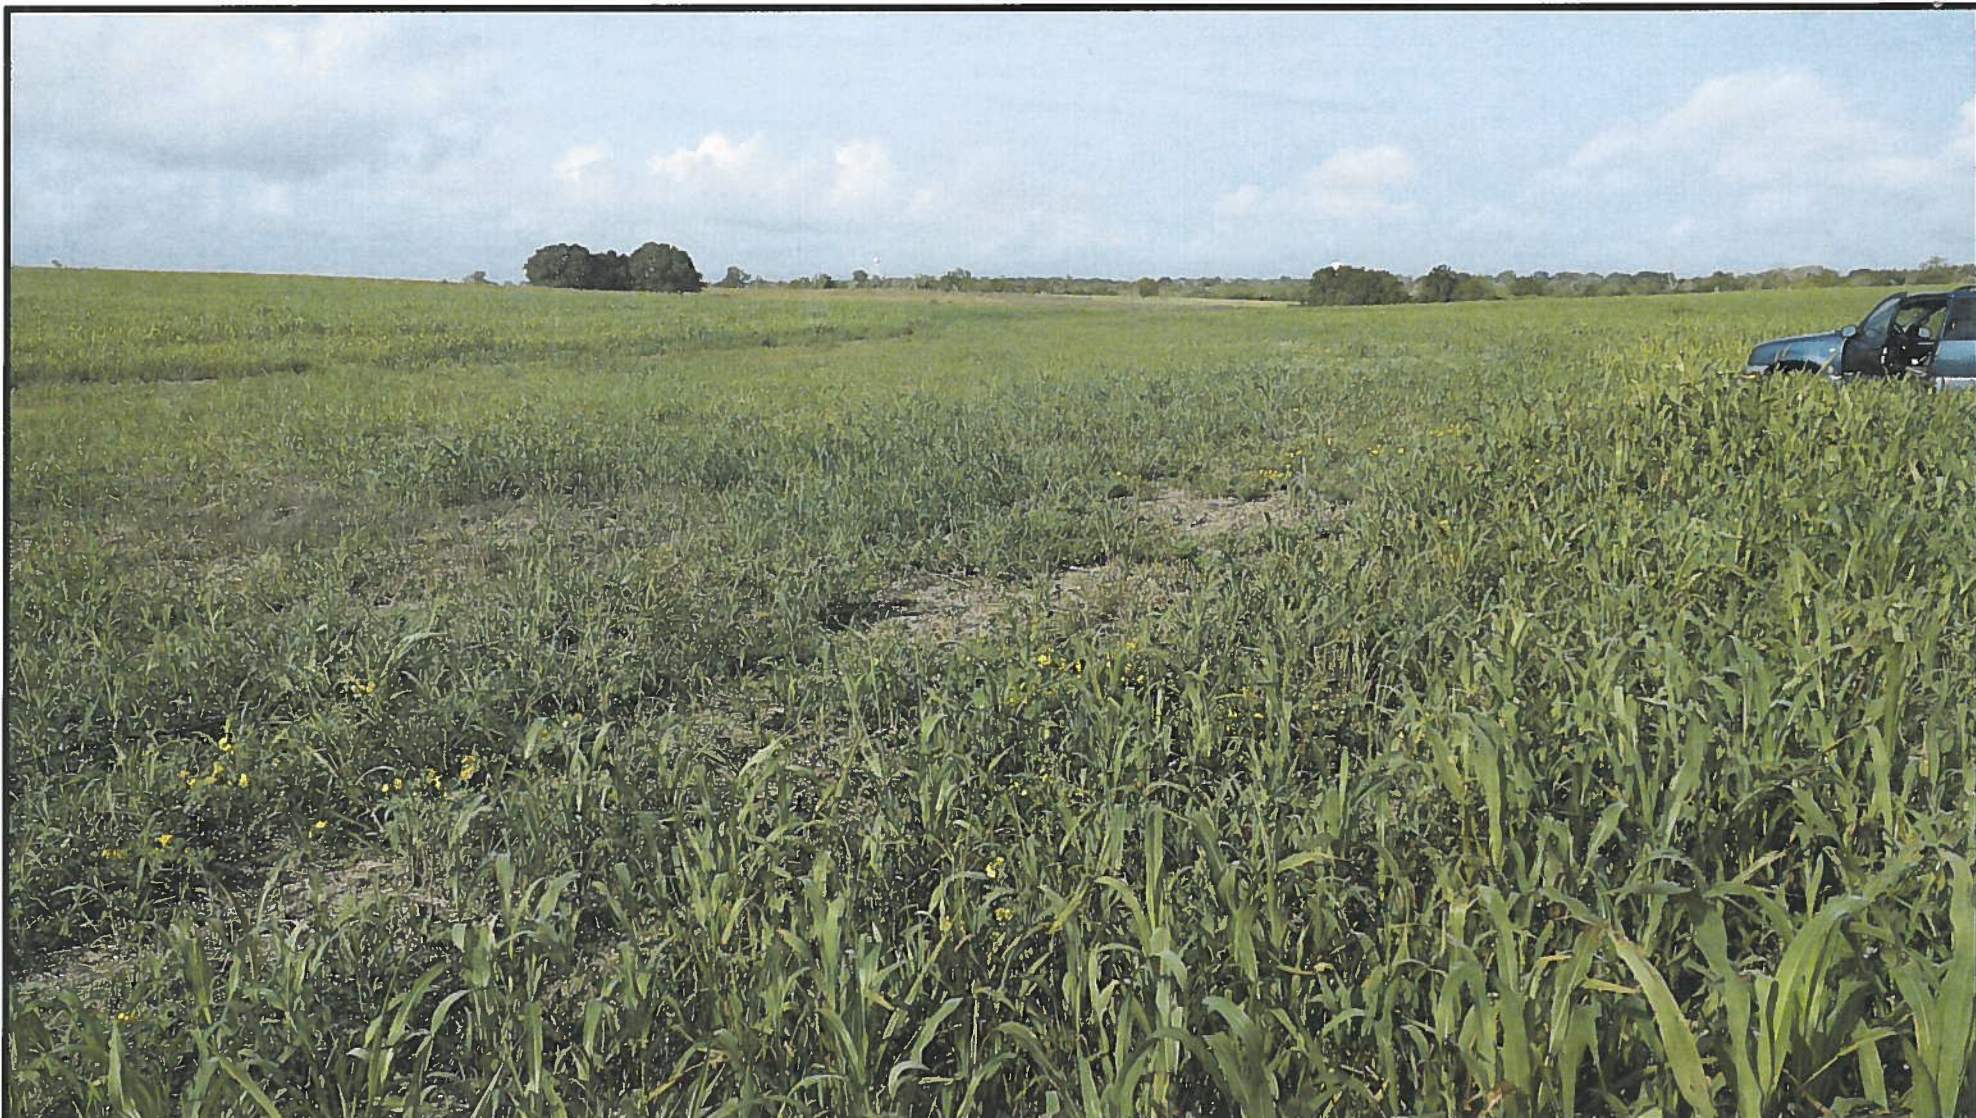
APAC TEXAS - BUCK
SITE PHOTO 2
VIEW UPSTREAM IN "CHANNEL"

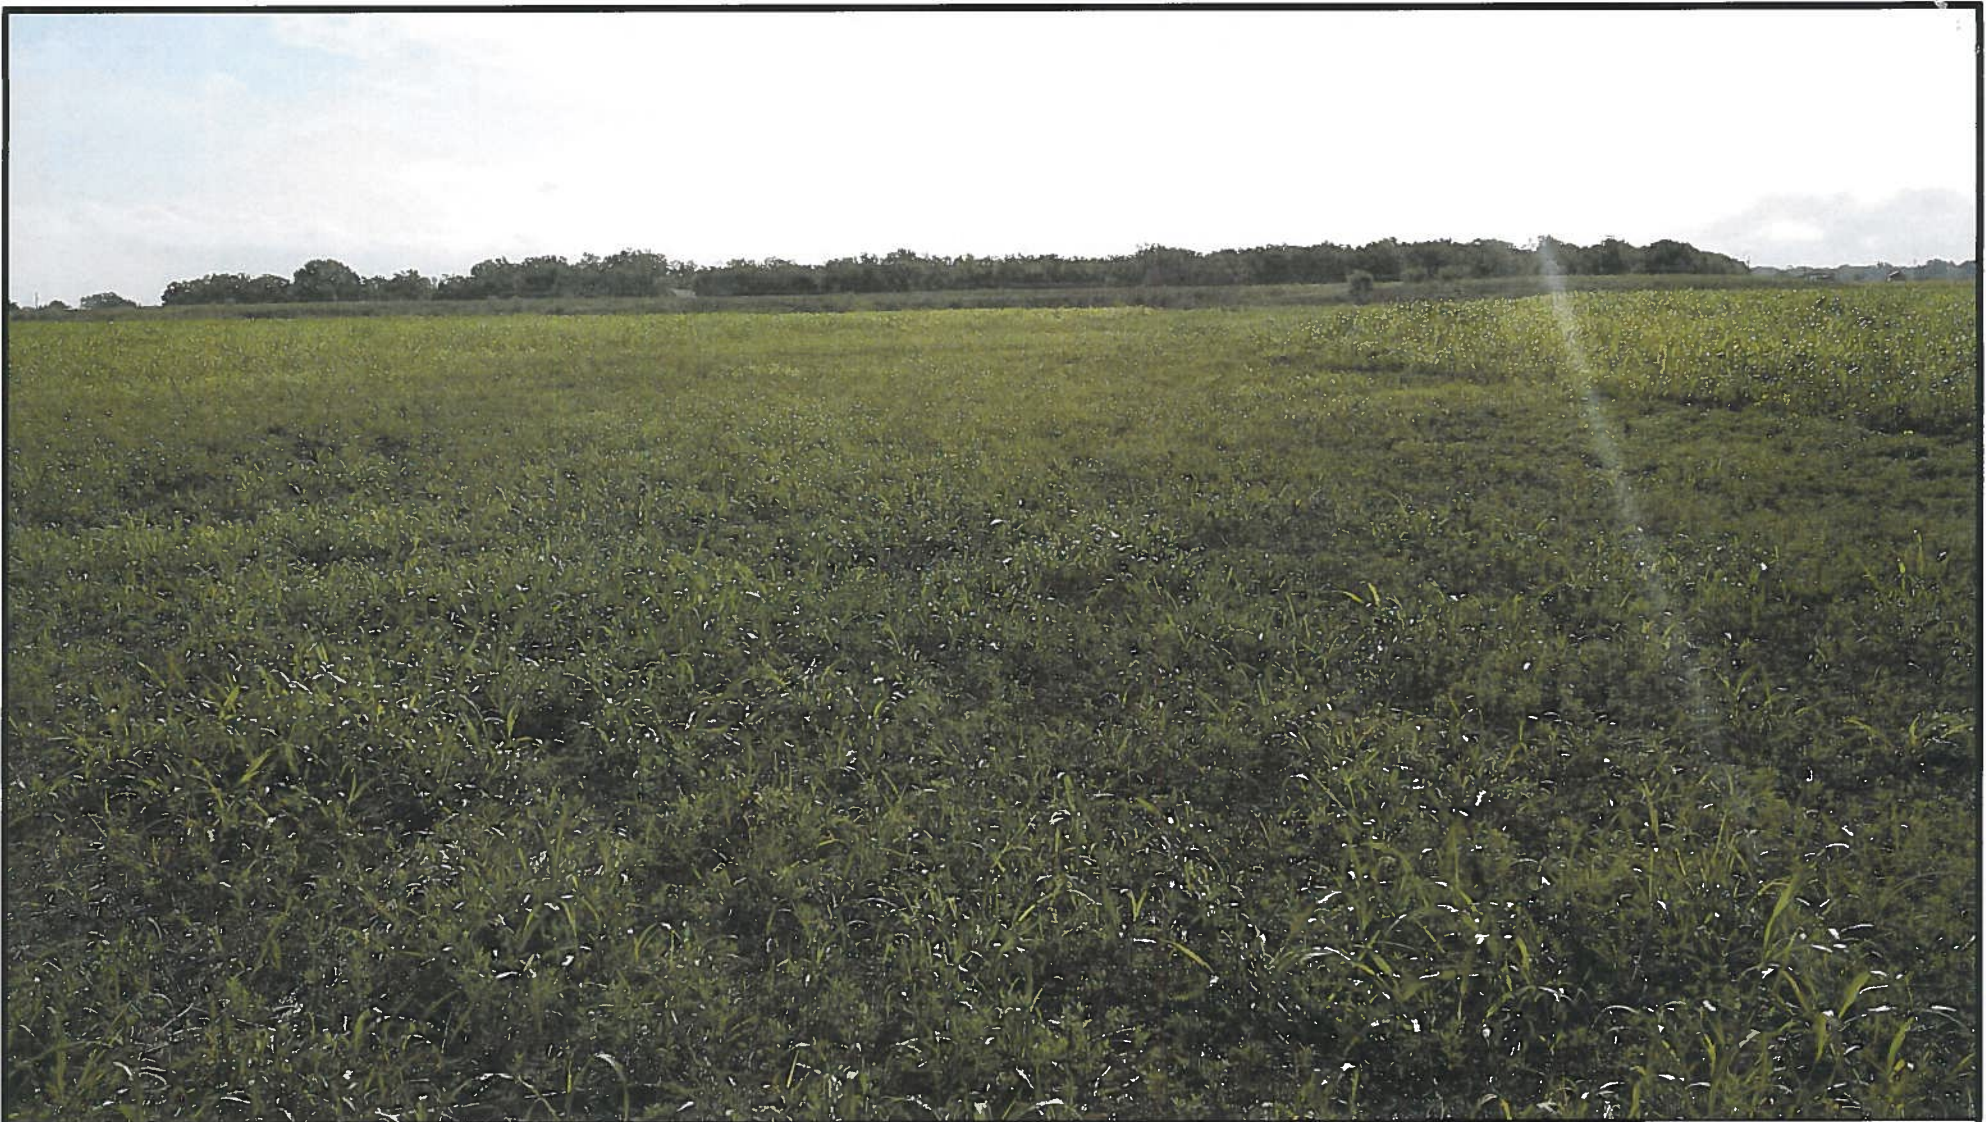
APAC TEXAS - BUCK
SITE PHOTO 3
VIEW DOWNSTREAM IN "CHANNEL"

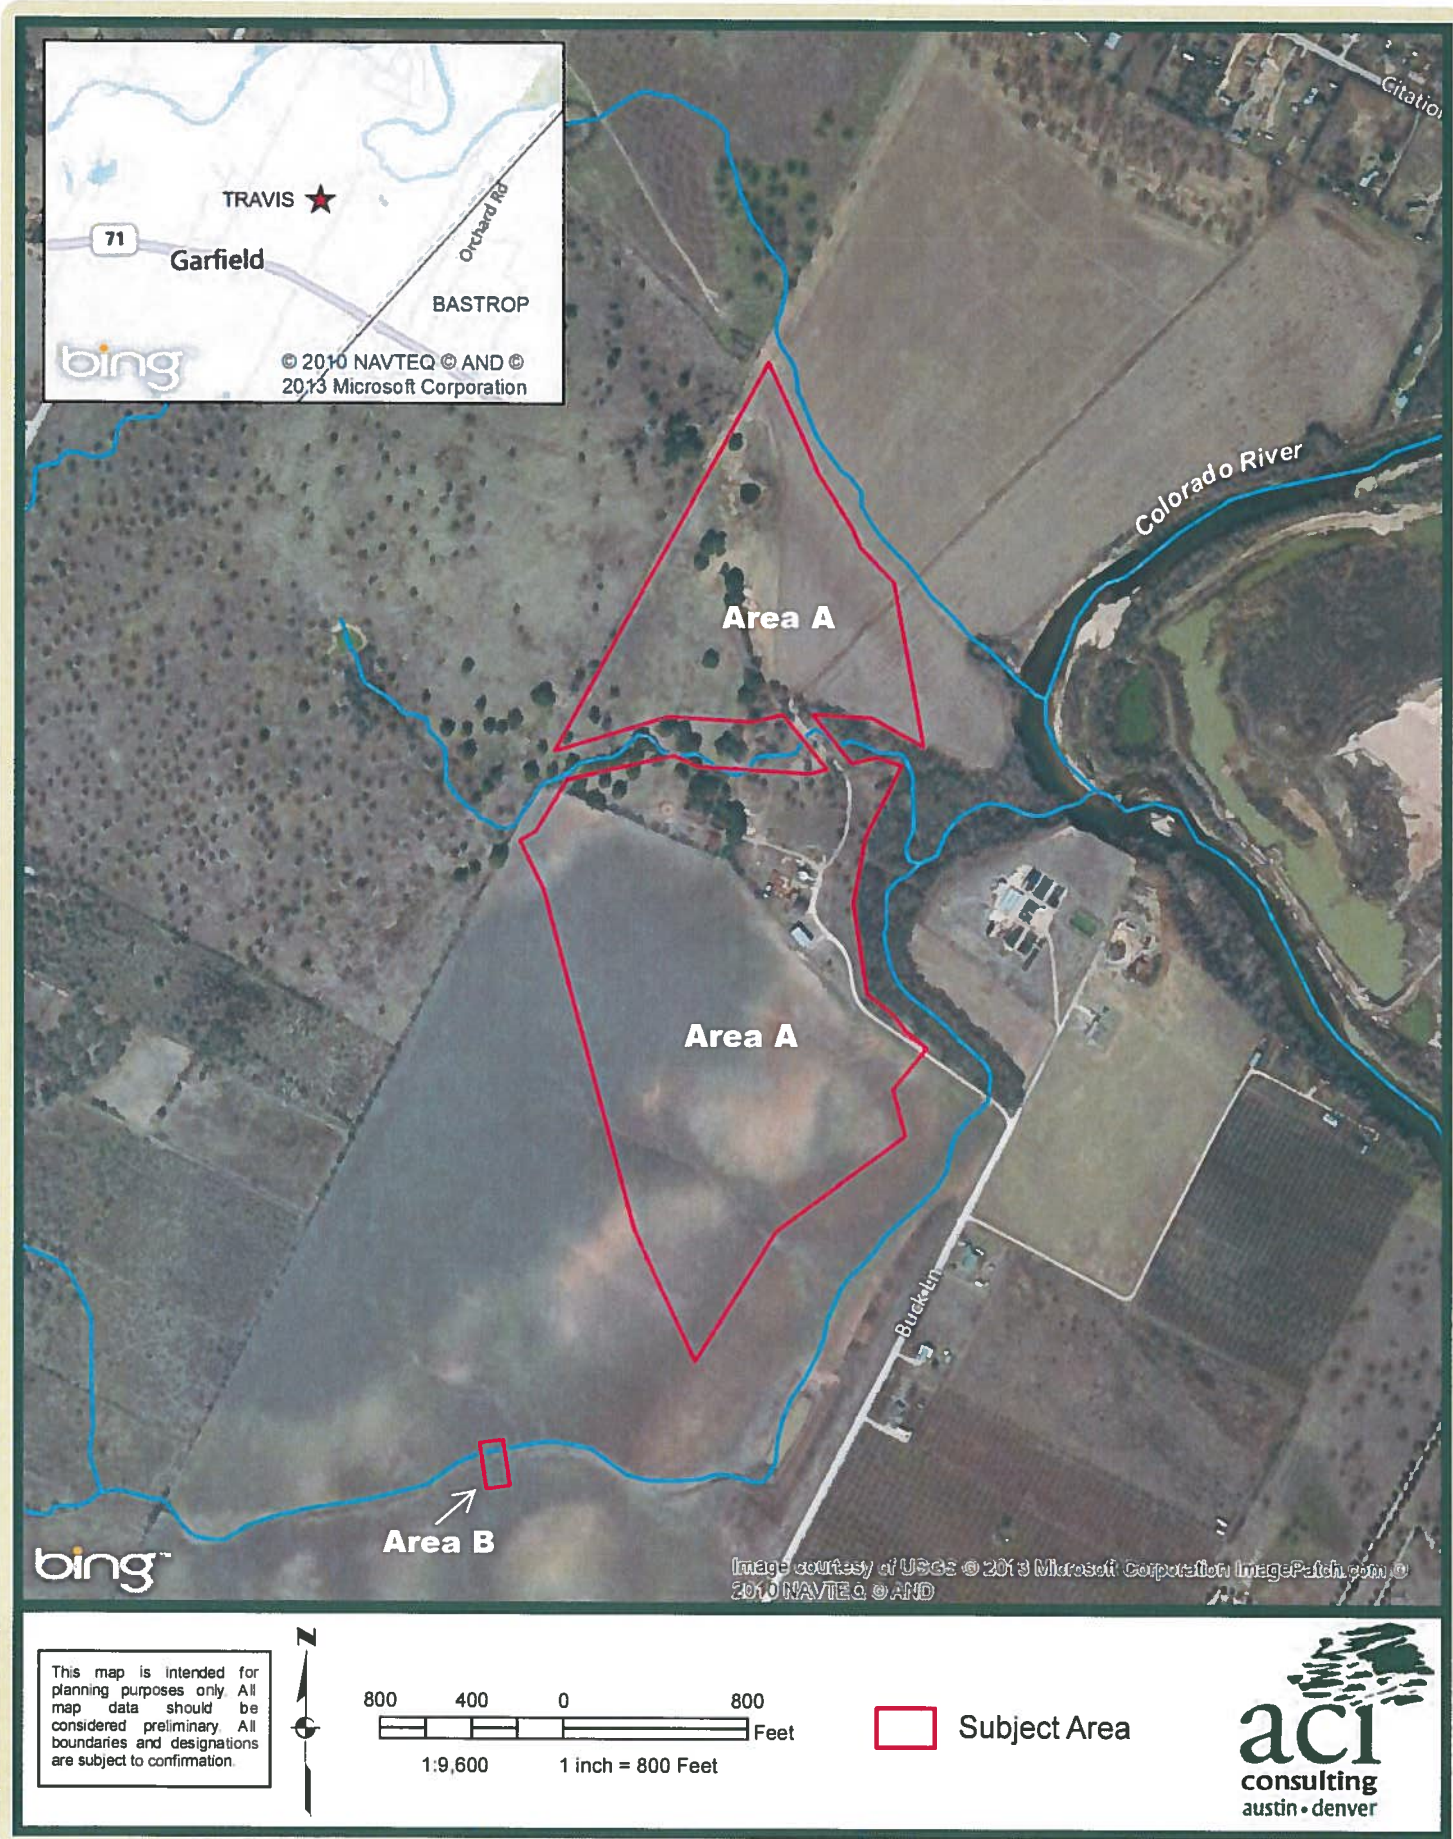
Apac Texas-Buck City of Austin EA
Figure 1: Subject Area

- **Area A** - the approximately 94.1-acre Apac Texas-Buck tract (formerly Shumaker-Buck II tract), and
- **Area B** – the approximately 0.5-acre limits of construction (LOC) of an at-grade crossing in the Critical Water Quality Zone (CWQZ). **Area B** is 100 feet wide by 200 feet long, and is located south of **Area A** (Figure 1).

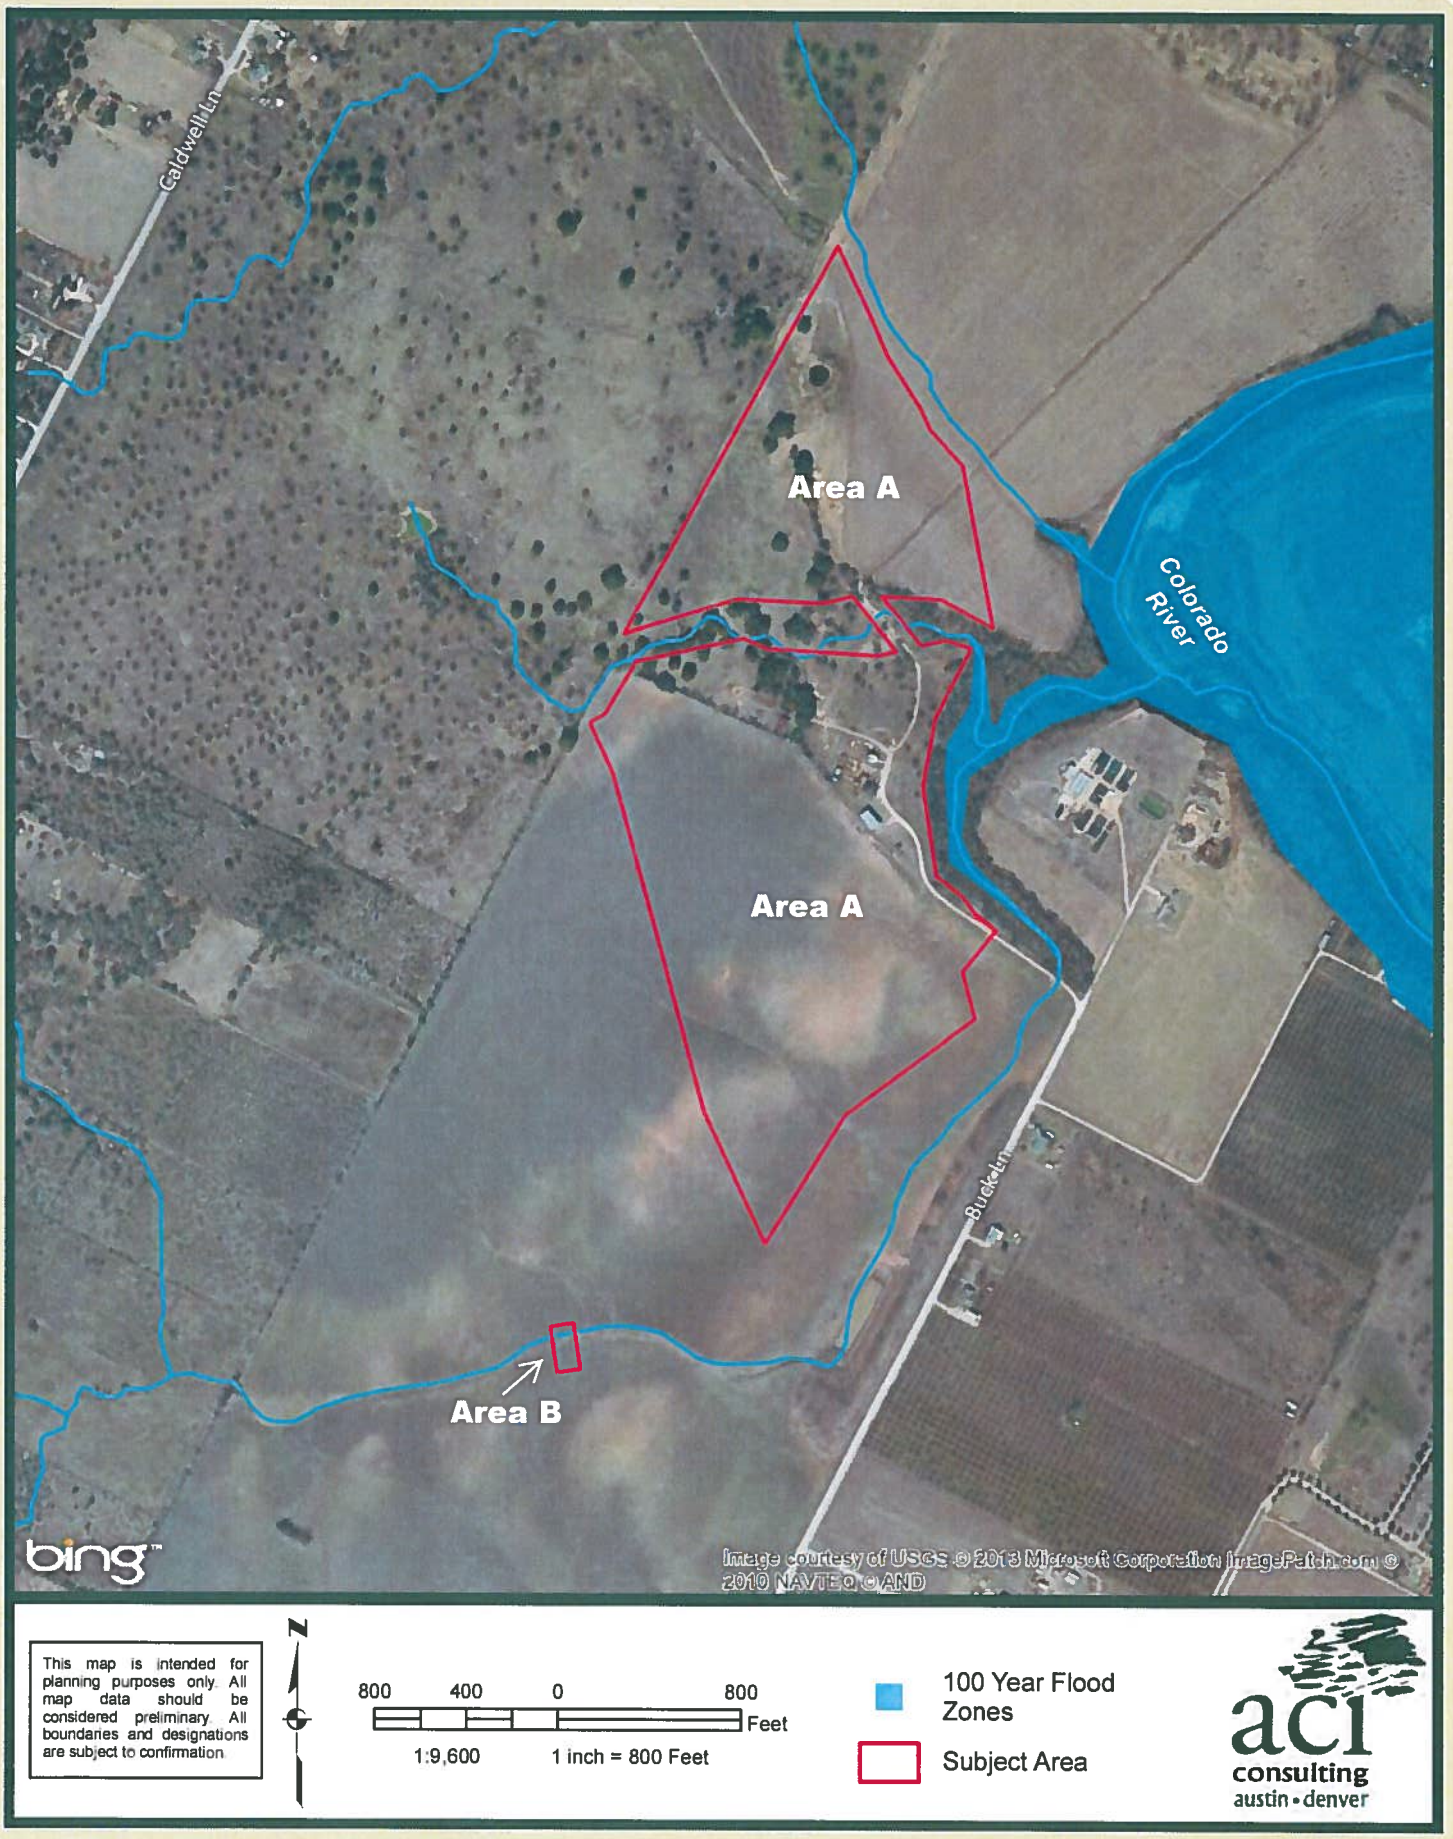
Apac Texas-Buck City of Austin EA August 2013
Figure 2: 100-Year FEMA Floodplains

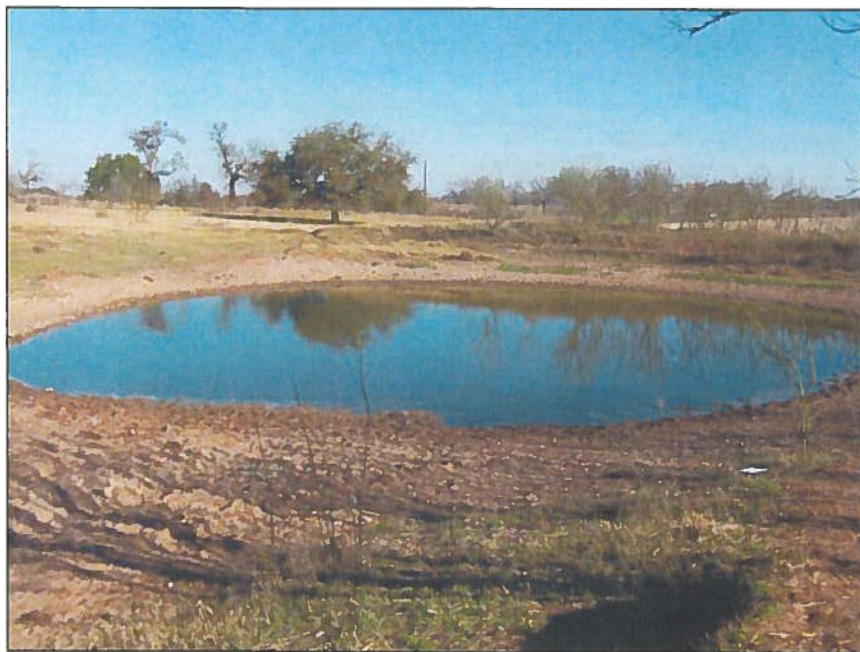
Photo 2: Stock pond and vegetation at northern portion of **Area A**.

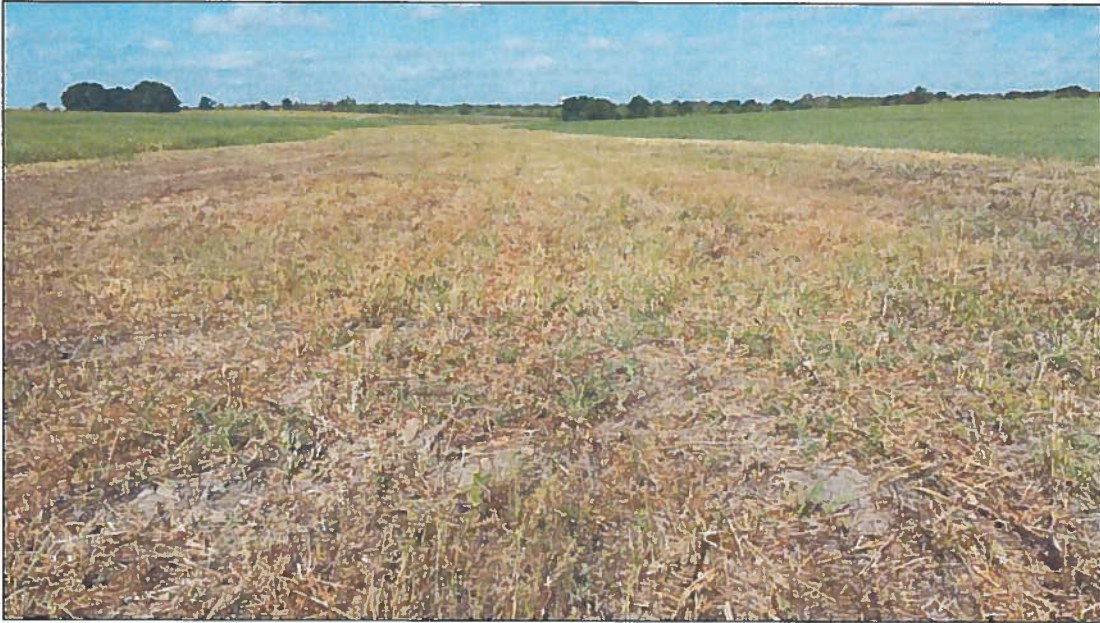
Photo 5: Center of **Area B**, facing west.

Area B is located within maintained crops, with no canopy vegetation present. Vegetation observed within **Area B** includes, but is not limited to: maintained crop vegetation, silverleaf nightshade (*Solanum elaeagnifolium*), buffalobur nightshade (*Solanum rostratum*), common sunflower (*Helianthus annuus*), annual sumpweed (*Iva annua*), western ragweed (*Ambrosia psilostachya*), giant ragweed (*Ambrosia trifida*), spotted beebalm (*Monarda punctata*), johnsongrass (*Sorghum halepense*), prairie coneflower (*Ratibida columnifera*), and immature honey mesquite (*Prosopis glandulosa*)

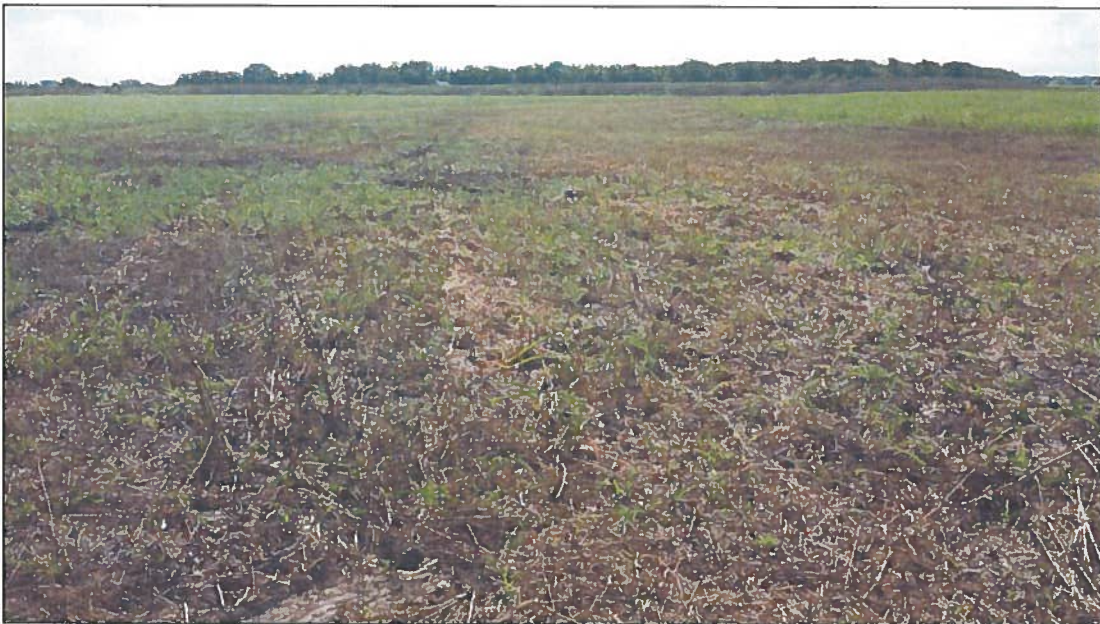
Photo 6: Center of **Area B**, facing east.
